PROPOSED TANKER PARKING AT RUSWARP S.P.S.

ROAD SAFETY AUDIT STAGE 1/2

APRIL 2013

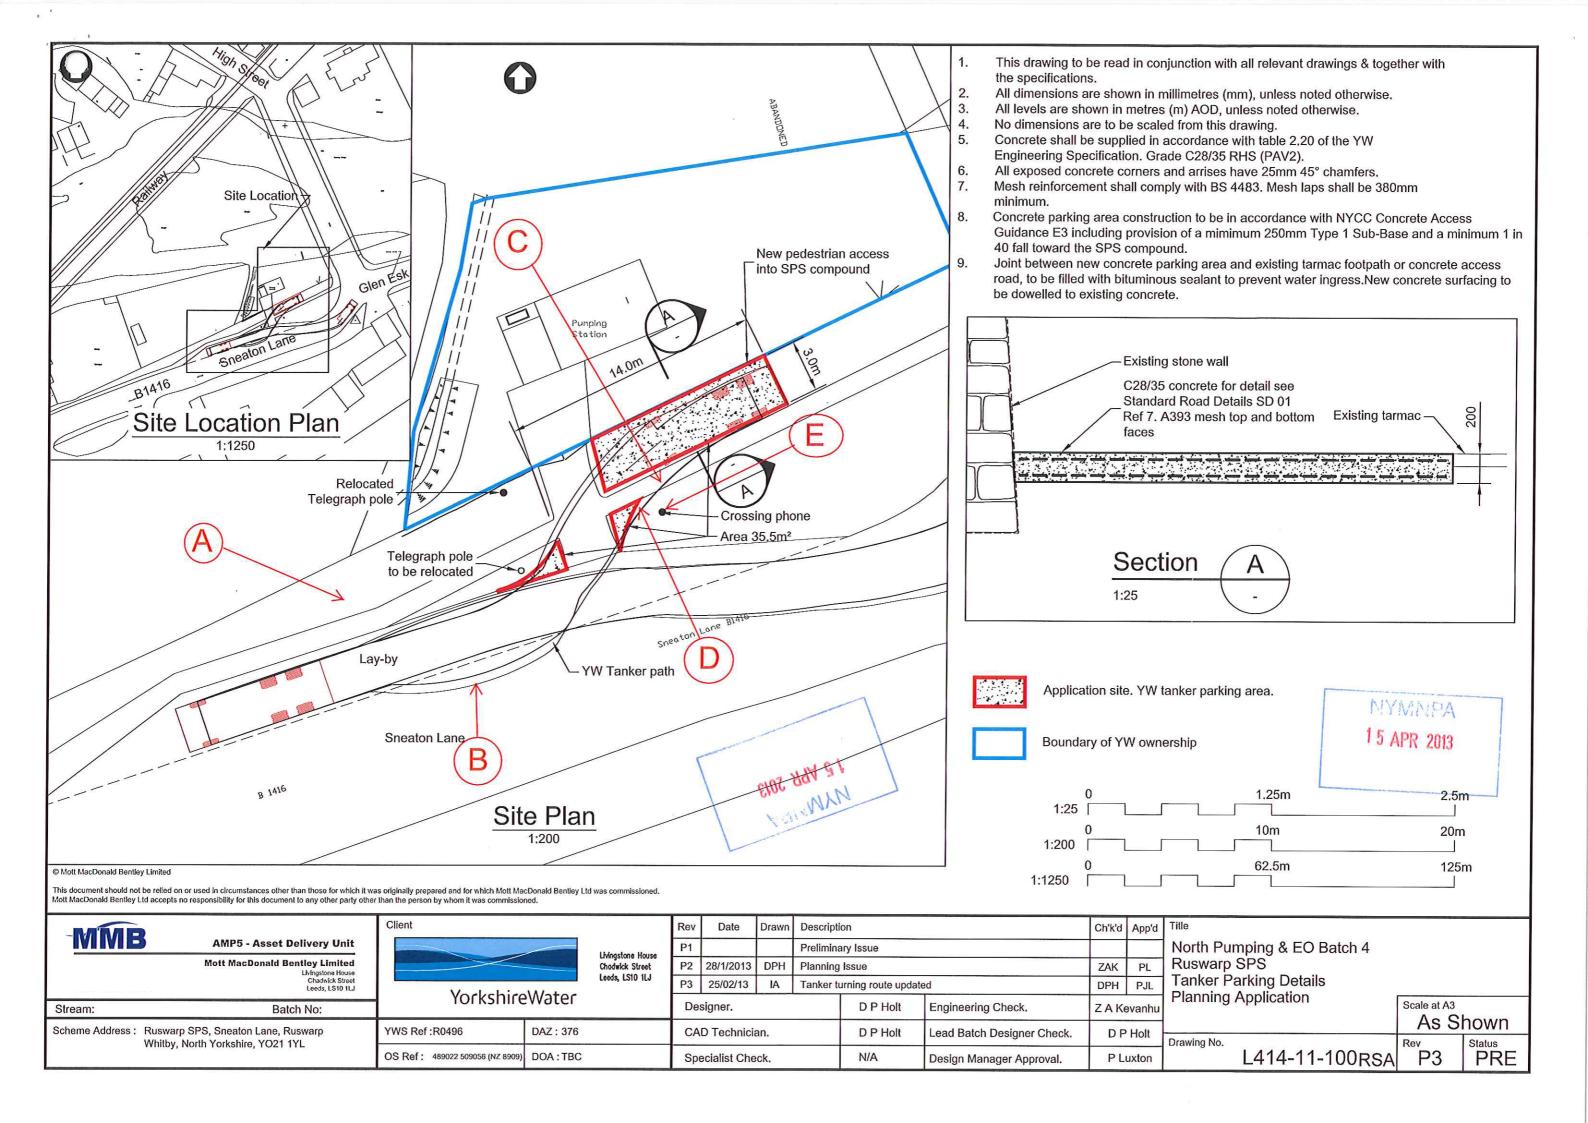
4. Appendix A – Plan of Items Raised in the Audit

Location: E - East of proposed extended vehicular crossing

Summary: Crossing phone close to swept path

Description: It was noted on site that the existing crossing phone is within the vicinity of the proposed extended vehicular crossing. This could result in a vehicle using the crossing colliding with the crossing phone resulting in injury to the driver.

Location: A - Lay-by.

Summary: Vehicles parked in the lay-by could prevent a tanker accessing the pumping station

Description: It was observed on site that the existing road markings denoting parking restrictions are missing end bars and a glass recycling bank is located adjacent to the lay-by. This could encourage vehicles to park in the lay-by thus preventing a tanker accessing the pumping station. A tanker waiting to access the lay-by immediately after the 90 degree bend after the bridge could result in shunt type collisions.

Location: D – East of proposed extended vehicular crossing.

Summary: Over-run of verge resulting in damage to verge and footway

Description: A vehicle carrying out a reversing manoeuvre onto the proposed hard standing may over run the verge resulting in damage to the verge and footway edge producing a trip hazard for pedestrians.

Location: B – Eastbound carriageway adjacent to existing lay-by

Summary: Swept path encroaching into carriageway

Description: A vehicle carrying out a reversing manoeuvre onto the proposed hard standing will encroach into the eastbound carriageway potentially colliding with a passing vehicle resulting in damage and injury.

Location: C - Footway adjacent to vehicular crossing

Summary: Potential collision with pedestrians

Description: A vehicle carrying out a reversing manoeuvre onto the proposed hard standing could collide with a pedestrian using the footway, causing injury.

Recommendation: Relocate crossing phone away from vehicular crossing...

Recommendation: Relocate the recycling bank away from the lay-by and discourage people parking in the layby by ensuring that the waiting restrictions are enforceable.

Recommendation: Ensure that the proposed extension to the vehicular crossing provided sufficient area to carry out the manoeuvre without encroaching onto the verge.

Recommendation: Ensure that the proposed extension to the vehicular crossing provided sufficient area to carry out the manoeuvre without encroaching onto the carriageway.

Recommendation: Ensure that adequate personnel are present to guide the driver and prevent pedestrians being in the vicinity of the vehicle when carrying out the reversing manoeuvre.
