UPDATE 14-07-13

TREE SURVEY AND ASSESSMENT AT HACKNESS GRANGE HOTEL, HACKNESS, SCARBOROUGH

TREE ASSESSMENT AND IMPLICATIONS OF PROPOSED BUILDING WORKS AT HACKNESS GRANGE HOTEL, HACKNESS, SCARBOROUGH

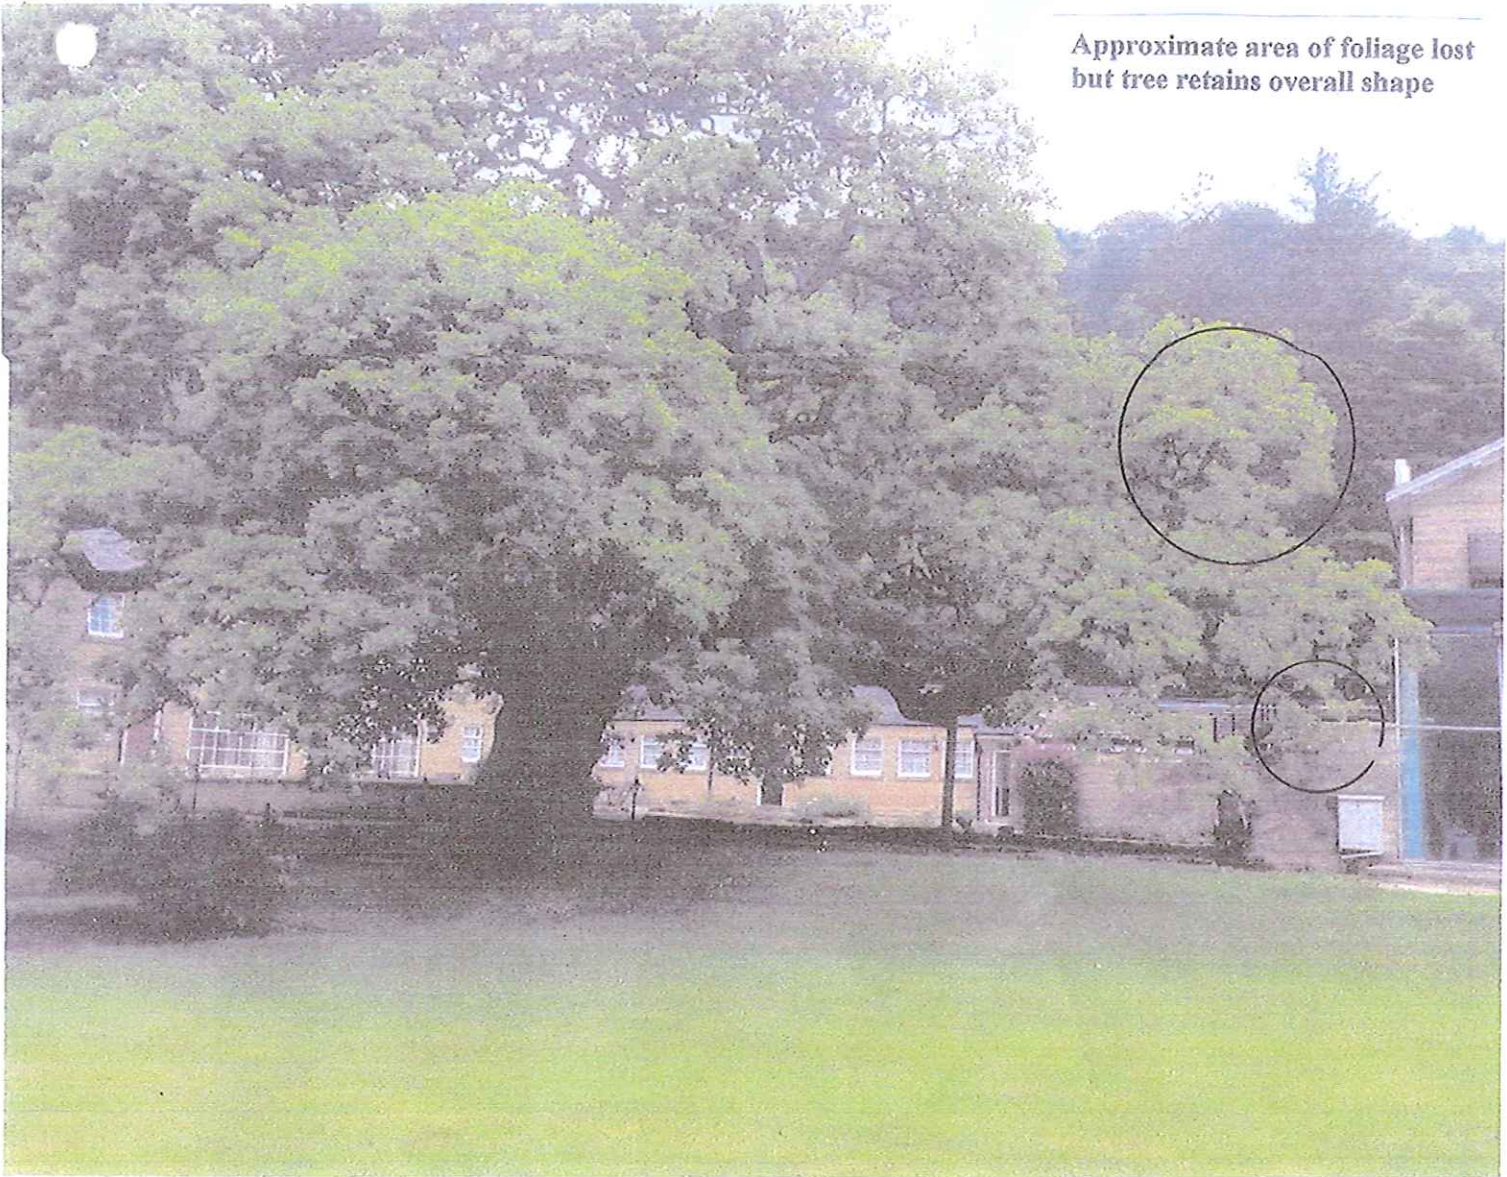
Photo No 3

On photograph number 3 an overall picture of the shape of the tree can be seen, and I have tried to indicate the visual affect which will result following the removal of the two branches. I have concluded that this will be a marginal loss of amenity, which in my opinion, would be better than having the branches touching the new extension and suffering damage which would probably result in dieback.

Approximate area of foliage lost
but tree retains overall shape
