PART STRUCTURAL REPORT  
ON OUTBUILDINGS AT  
EVERLEY HOTEL  
HACKNESS  
SCARBOROUGH  
YO13 0BT

**PART STRUCTURAL REPORT ON OUTBUILDINGS AT  
EVERLEY HOTEL, HACKNESS, SCARBOROUGH, YO13 0BT**

Project Reference: MCB/PS/35305

Date: 28<sup>th</sup> January 2014

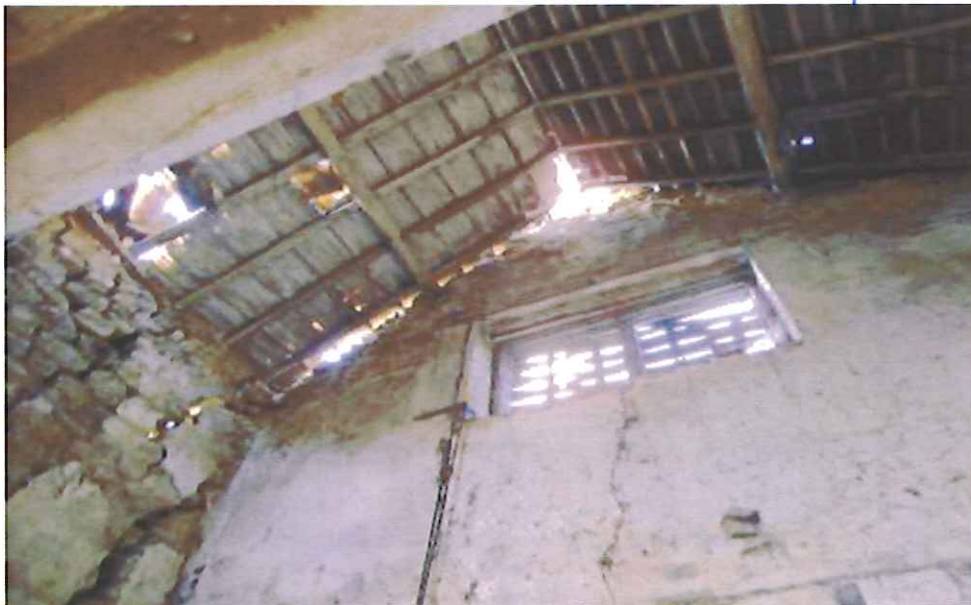
Photo 2

**Above proposed kitchen.**

Roof members rotted and loss of restraint to external wall – roof to be replaced.

Large vertical cracks evident to wall, possibly caused by issues above entrance hall – wall to be rebuilt locally and minor cracks to receive crack stitching,

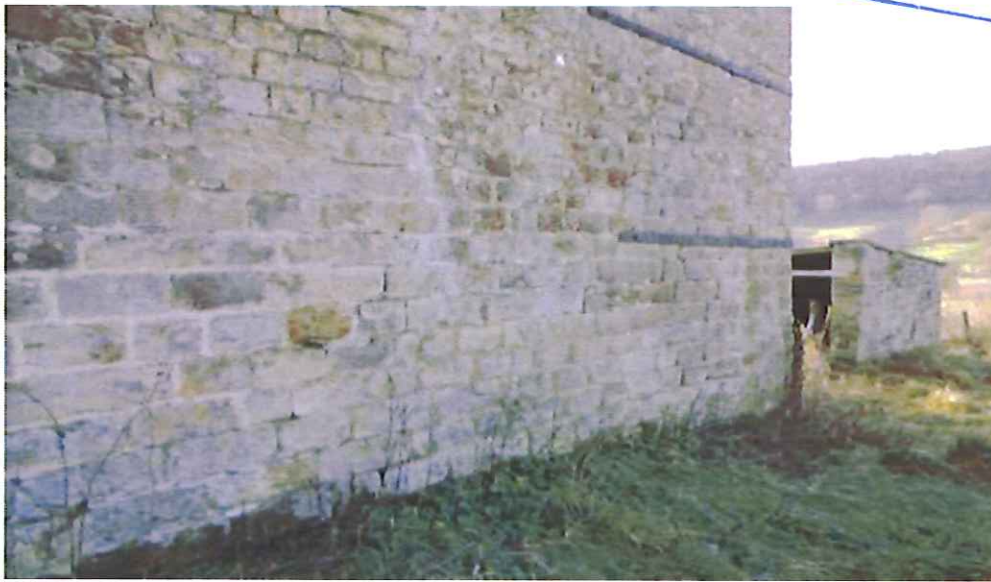
Photo 5

Kitchen wall looking North

Cracking opening up from floor to roof - loss of floor restraint to wall.  
Crack stitch repair and locally underpin to gable wall and return by 3m.

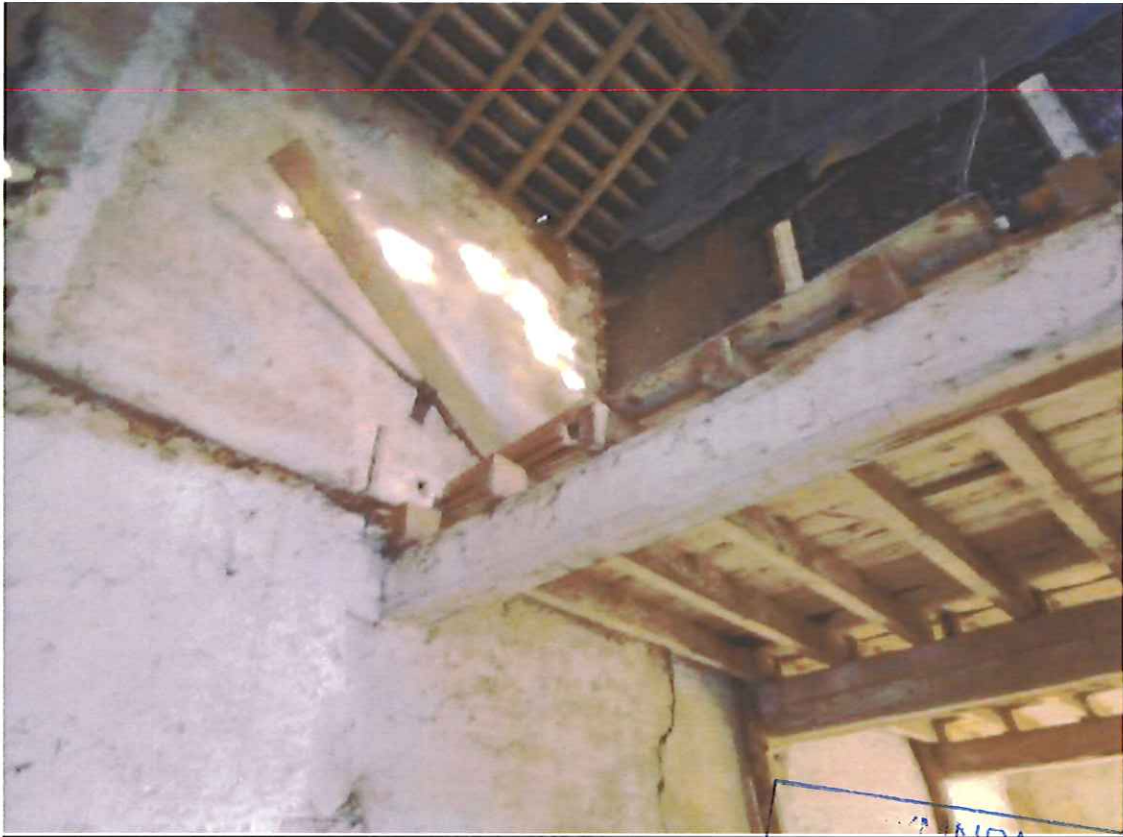
Photo 6

**Kitchen wall looking North East**

Vertical cracking, loss of floor restraint to wall – it is beneficial to replace floor to full area of floor above, crack stitch repairs required.

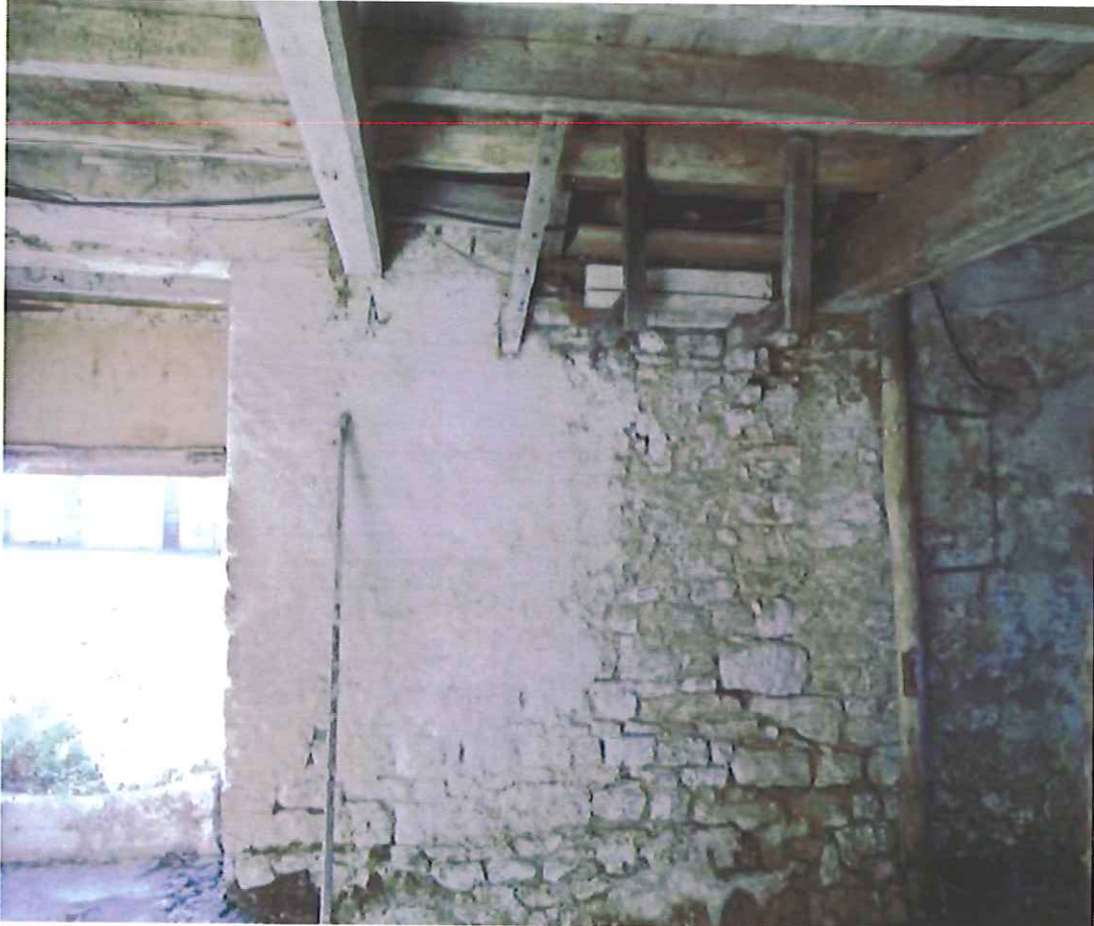
Photo 7

**Kitchen wall looking South**

We are advised that this is where a mains water feed had burst – note wash out of joints. Damage to floor and could have assisted in the failure of foundations to the gable wall.

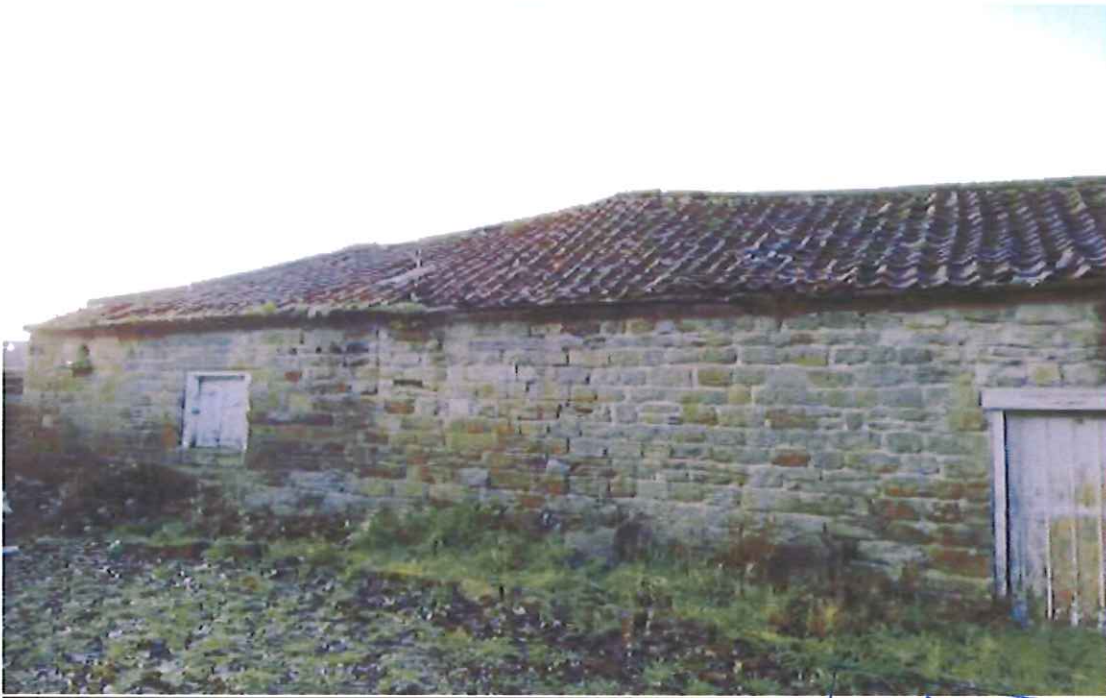
Photo 9

**Courtyard to kitchen roof**

Roofs typically sagging, poor guttering maintenance, wash out of pointing.  
Re-pointing, guttering replacement and re-roofing required.

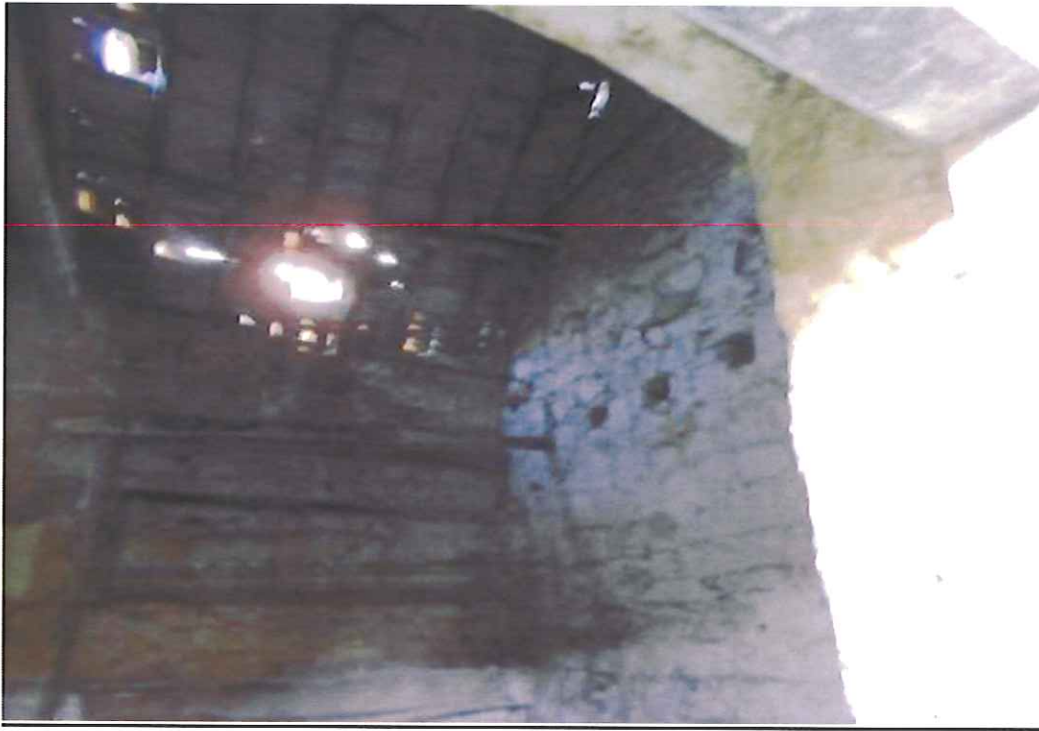
Photo 10

**Cloaks towards snug**

Roof damaged, rotten timbers, possible loss of restraint to existing wall. Re-roof, replace lost stones, crack stitch as required and re-point.

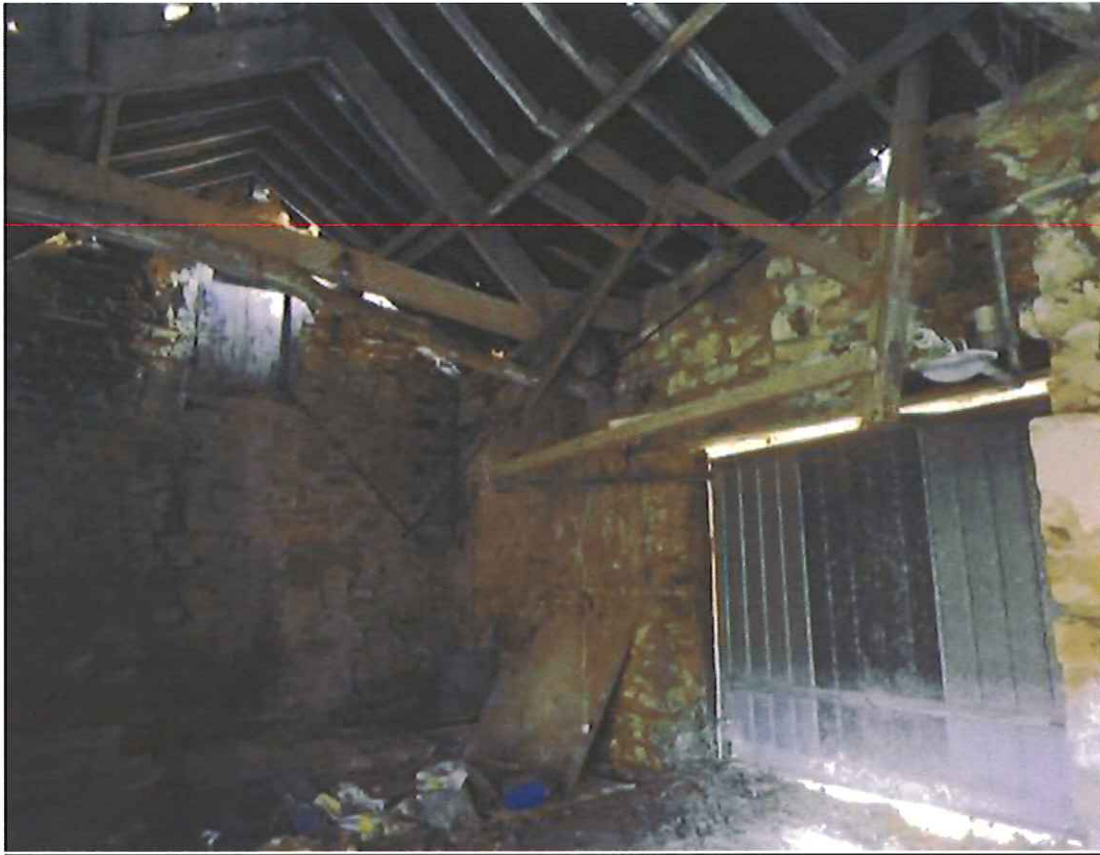
Photo 11

**Cloaks to North East**

Major timber truss failure, cracking to walls, water ingress damage to floor. Roof to be replaced, crack stitching required.
