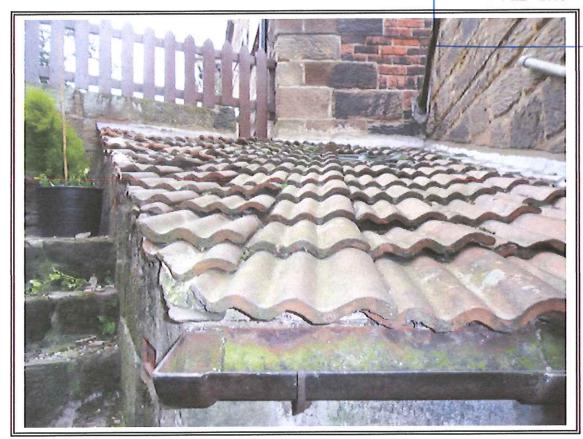
Photo 1 Roof slope to extension in June 2013 prior to works. Note damaged tiles.

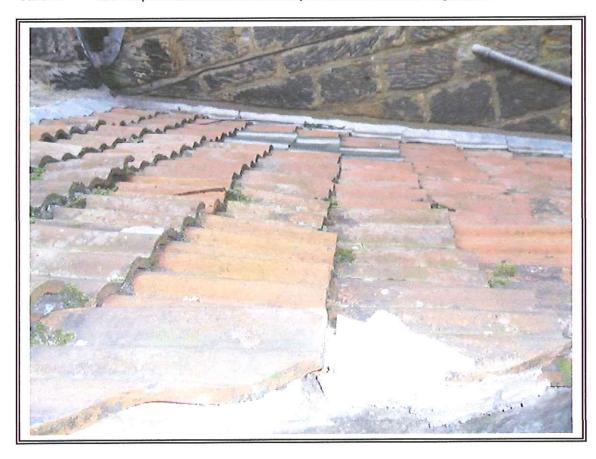
Photo 2 Roof slope to extension in June 2013 prior to works. Note damaged tiles.

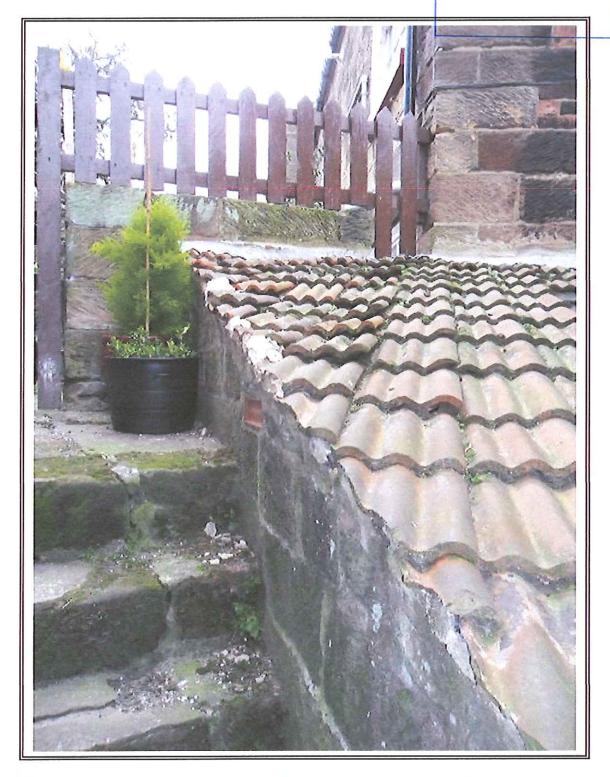
Photo 3 Roof slope to extension in June 2013 prior to works. Note damaged tiles.

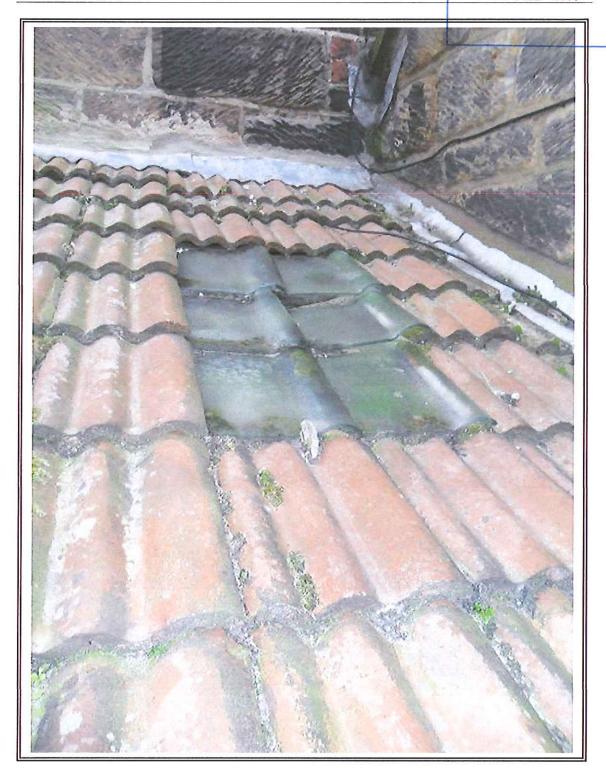
Photo 4 Roof slope to extension in June 2013 prior to works. Note damaged glass tiles.

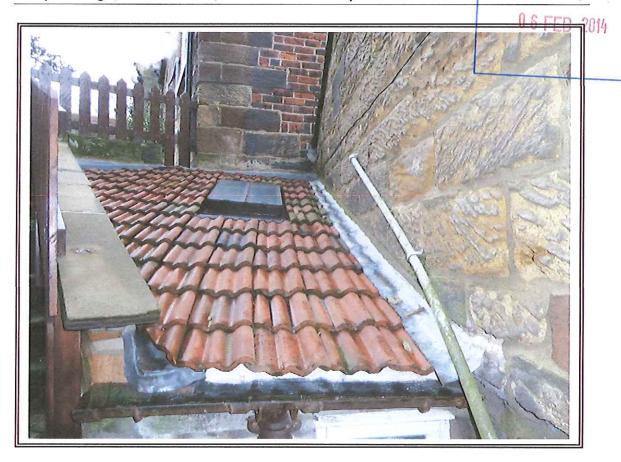
Photo 5 Roof after completion of works. Note same roof pitch and re-used tiles.

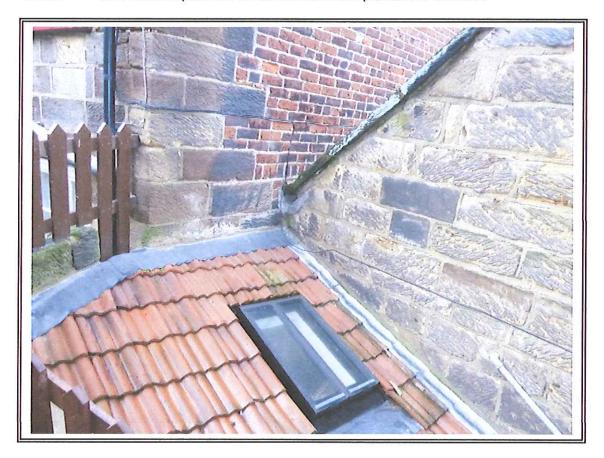
Photo 6 Roof after completion of works. Note conservation rooflight in position of glass tiles.

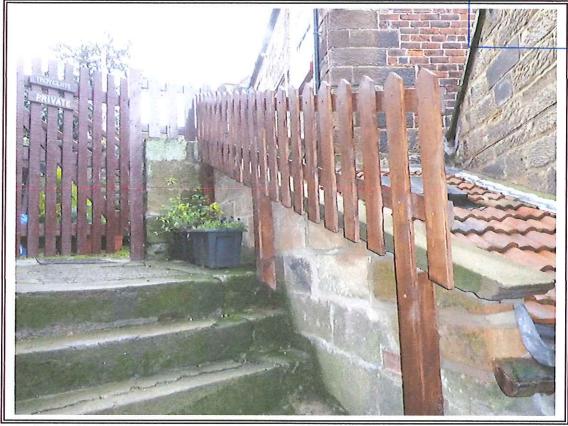
Photo 7 Edge of roof after completion of works. Note picket fence to match existing yard fence.

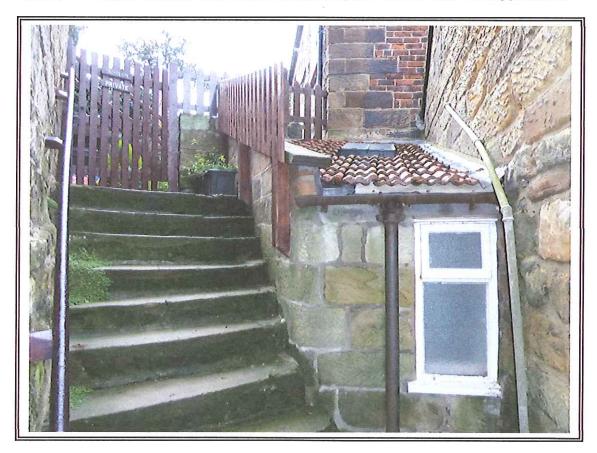
Photo 8 Roof after completion of works.
