Photograph 1: Approach to bridge from south. Note sharp right hand bend on approach.

Photograph 2: View across bridge from south. Note narrowing carriageway width between parapets at centre of bridge.

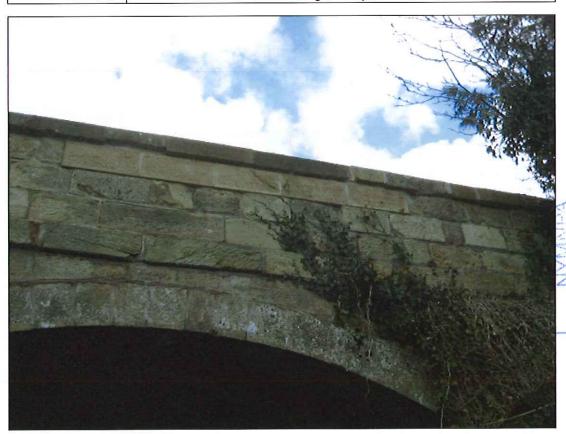
Photograph 12: East downstream elevation northern span with original masonry arch and spandrel walls remaining. Note repairs to parapet.

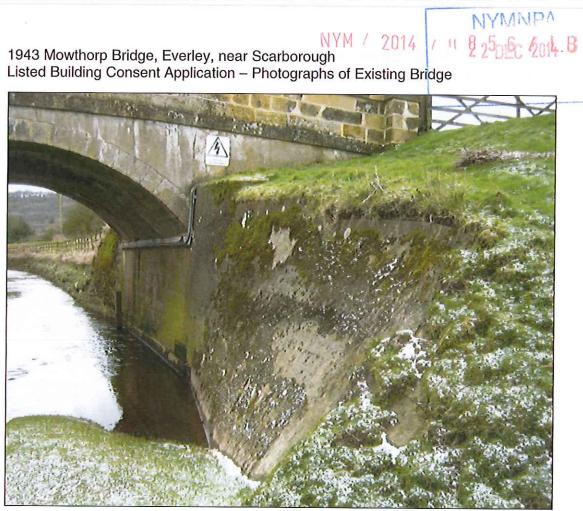
Photograph 13: South abutment and mass concrete south west wing wall.

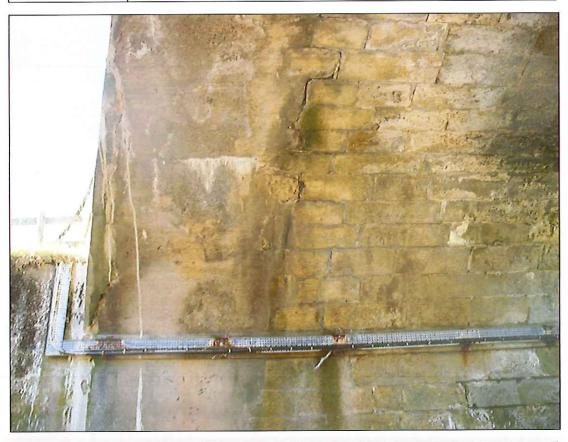
Concrete widening #2 to eastern downstream side of south Photograph 24: span. Note circumferential cracking.

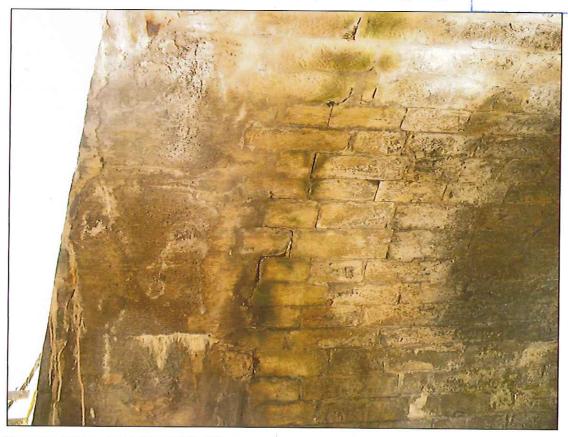
Photograph 25: Concrete widening #3 to eastern downstream side of south span. Note extensive circumferential cracking.

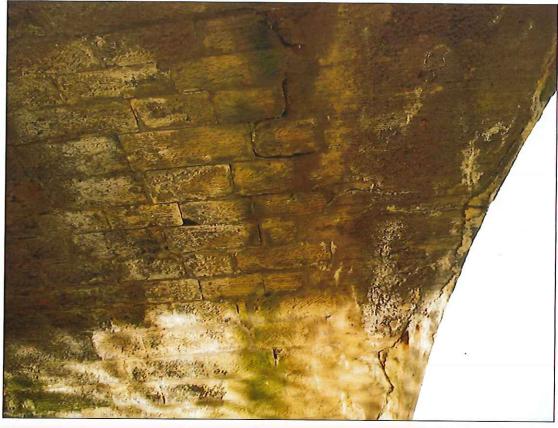
Photograph 26: Concrete widening #4 to eastern downstream side of south span. Note circumferential cracking.

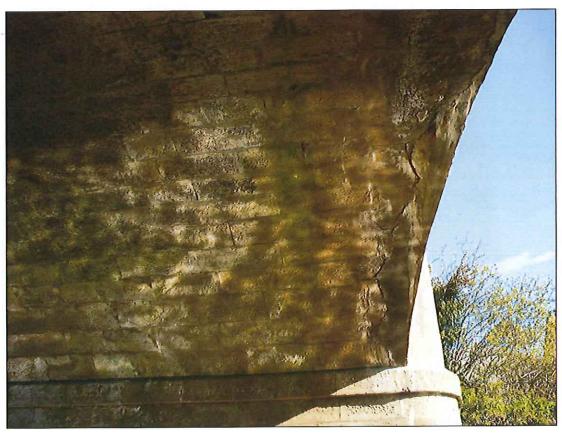
Photograph 27: Concrete widening #5 to eastern downstream side of south span.

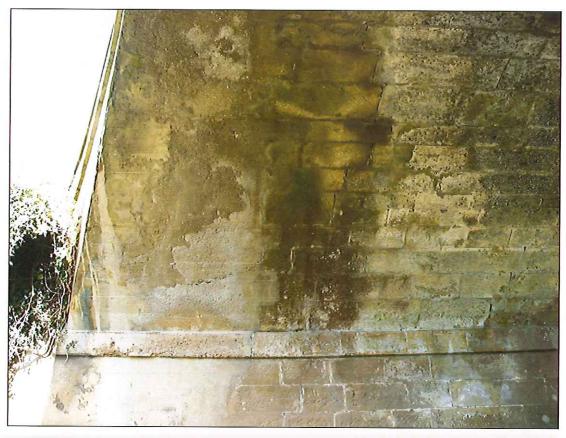
Photograph 30: Concrete widening #2 to western upstream side of north span. Note circumferential cracking in masonry further into arch.

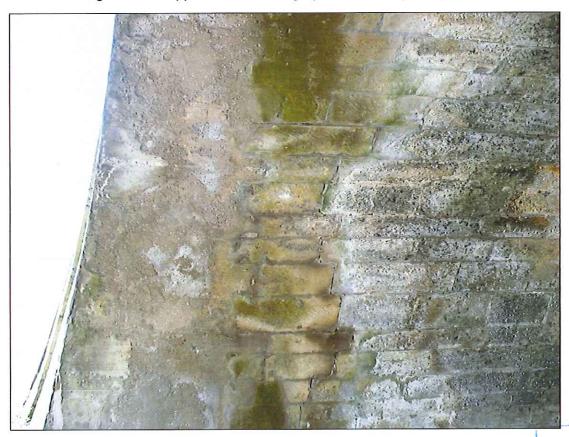
Photograph 31: Concrete widening #3 to western upstream side of north span.

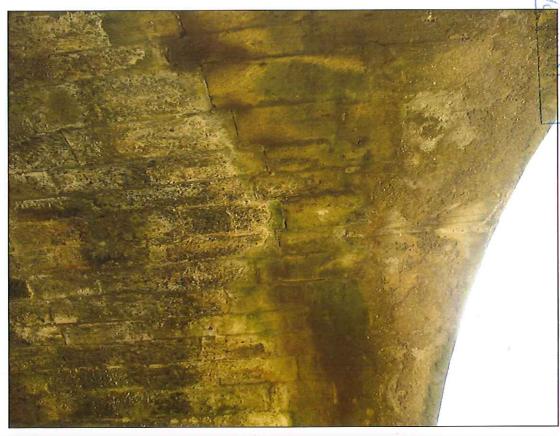
Photograph 32: Concrete widening #4 to western upstream side of north span.

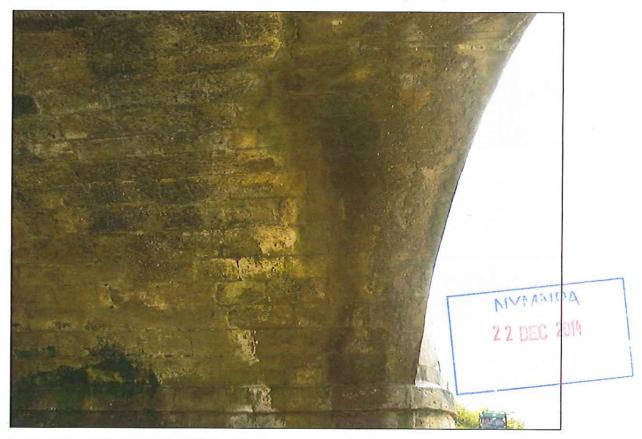
Photograph 33: Concrete widening #5 to western upstream side of north span.

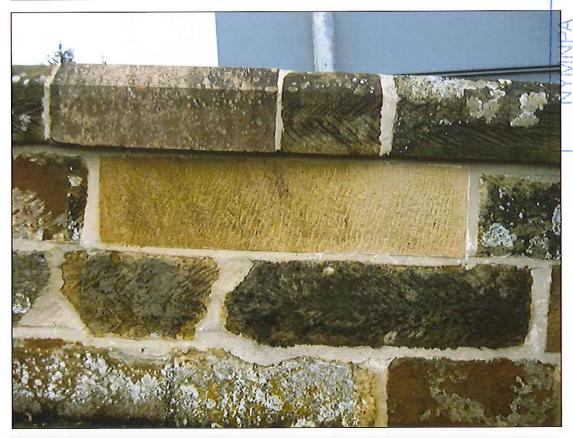
Outside face of parapet near south west corner of bridge Photograph 36: showing replacement stone with incompatible tooling.

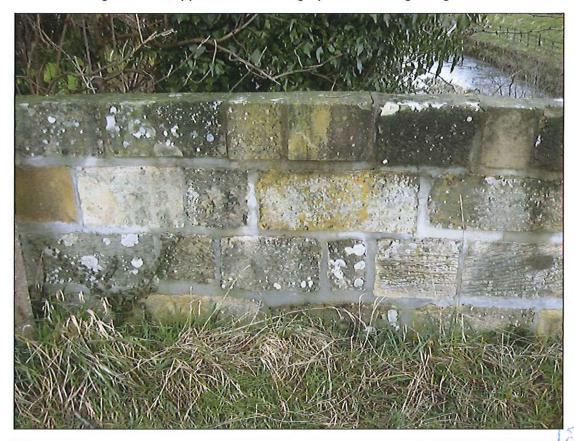
Photograph 39: Repaired area of parapet at north east corner of bridge.

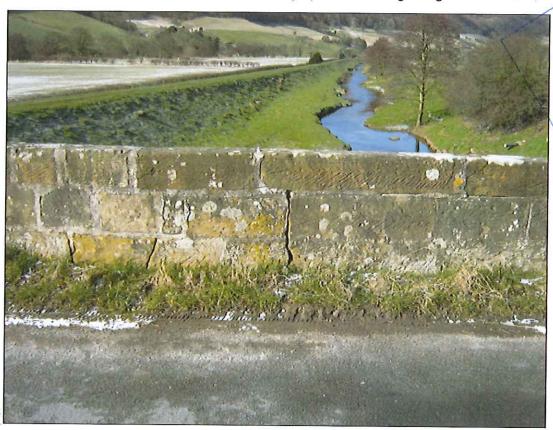
Photograph 41: Cracking to inside face of western upstream parapet, possibly due to vertical joints not being staggered.

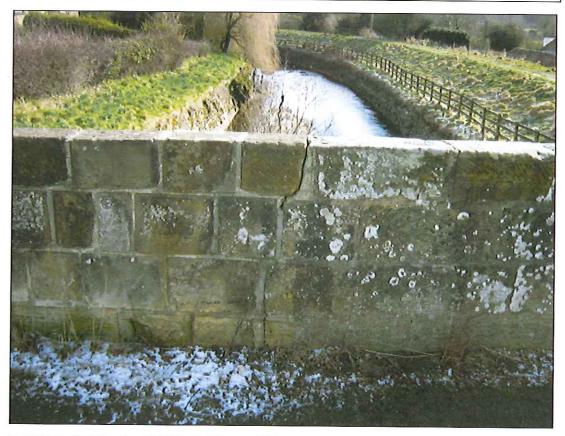
Photograph 42: Cracking to inside face of eastern downstream parapet. Note poor arrangement of vertical joints in stonework.
