TREE REPORT

**in support of a Planning Application
to convert the existing barn, known as
Sunny Bank Barn, into a dwelling**

Altered access at Sunny Bank Barn Broxa Lane Hackness

LAWSON HARPER
February 2015

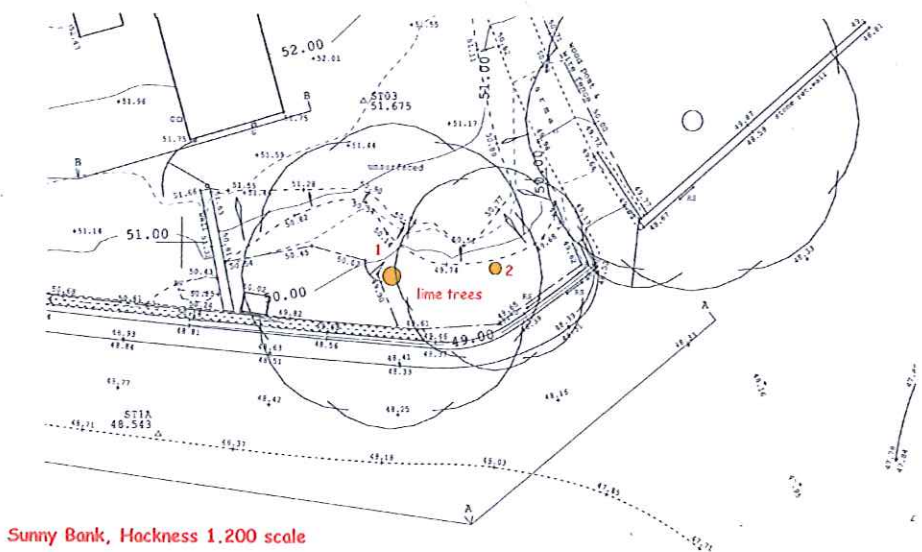
Fig 2 Tree positions and spread

Species	<i>Tilia europaea</i>
Common Name	Common or European Lime
Height	IRO 30 M
Approximate Age	80+ Years
Girth at 1.5 M	1.0 M
Crown Spread North	6.0 M
Crown Spread to East	6.0 M
Crown Spread to South	7.0 M
Crown Spread to West	6.0 M
Overall Condition	Good

Species	<i>Tilia europaea</i>
Common Name	Common or European Lime
Height	IRO 35 M
Approximate Age	80+ Years
Girth at 1.5 M	1.2 M
Crown Spread North	6.0 M
Crown Spread to East	4.0 M
Crown Spread to South	5.0 M
Crown Spread to West	2.0 M
Overall Condition	Good

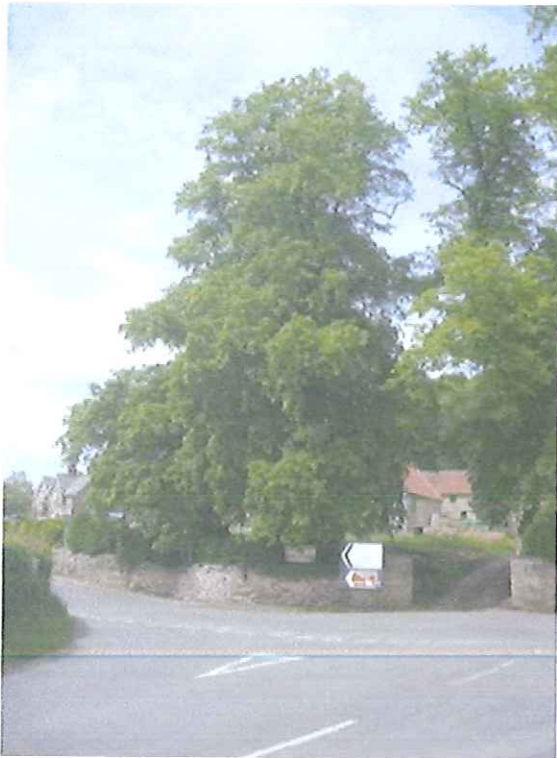
Fig 3 Tree T1 and T2

A pair of mature Limes (T1 and T2) growing approximately five meters apart and having integrated crown. In terms of visual impact the trees are considered as a group along with a third mature lime (T3) on the opposite side of the entrance within the adjacent property.

The overlapping crown of T1 and T2 has resulted in reduced spread for both trees which would be left with unbalanced and poorly shaped crow should either one be removed.

T1 appears to have grown from two leaders which have conjoined . there is a distinct joint ridge on the east and west side of the tree. The dominant lead to the north has a distinct lean to the north. The southern branch has been previously cut back due to overhanging of the highway, this has left a stub with much suckering and several pegs.

There are several short pegs left from previous pruning, most showing dieback, numerous minor healed and healing lesions from minor limb removal. The tree in tandem with T2 has light, balanced crown but is now growing out from previous thinning, spread has been restricted by previous tree work.

The trees are located within 2 m to 3m of a retaining wall which forms a sharp change of level of some 1.3m. There is no sign of heave or root damage to this wall and the roots appear to have established to accommodate the level change.

There was slight late leafing out towards the top of the tree on the northern side but other than this no major issues observes there is moderate to light suckering at the base. Aphid residue is present as expected for the species but there are no signs of gall might or fungal disease
Trees 1 and 2 are in good to excellent condition.

The cutting back of the retaining wall to the extent of the sight line would sever the entire southern rooting plate to within 0.75m of the bowl of both trees T1 and T2 removing both the feeding and anchorage roots of both trees over approximately 30% of the rooting area. Despite the roots to the south being restricted by the retaining wall and cutting back of the crown to prevent overhang to the highway, this is highly likely to result in stability issues particularly when the northward lean of T1 is taken into account. It would also potentially affect the long term viability of the both trees.

Minor works to T1 to remove or balance the reduced limb to the south
reduction in the height of the wall and rebuilding to ensure retention capability and stability

Sightlines be accommodates by changes to ground profile

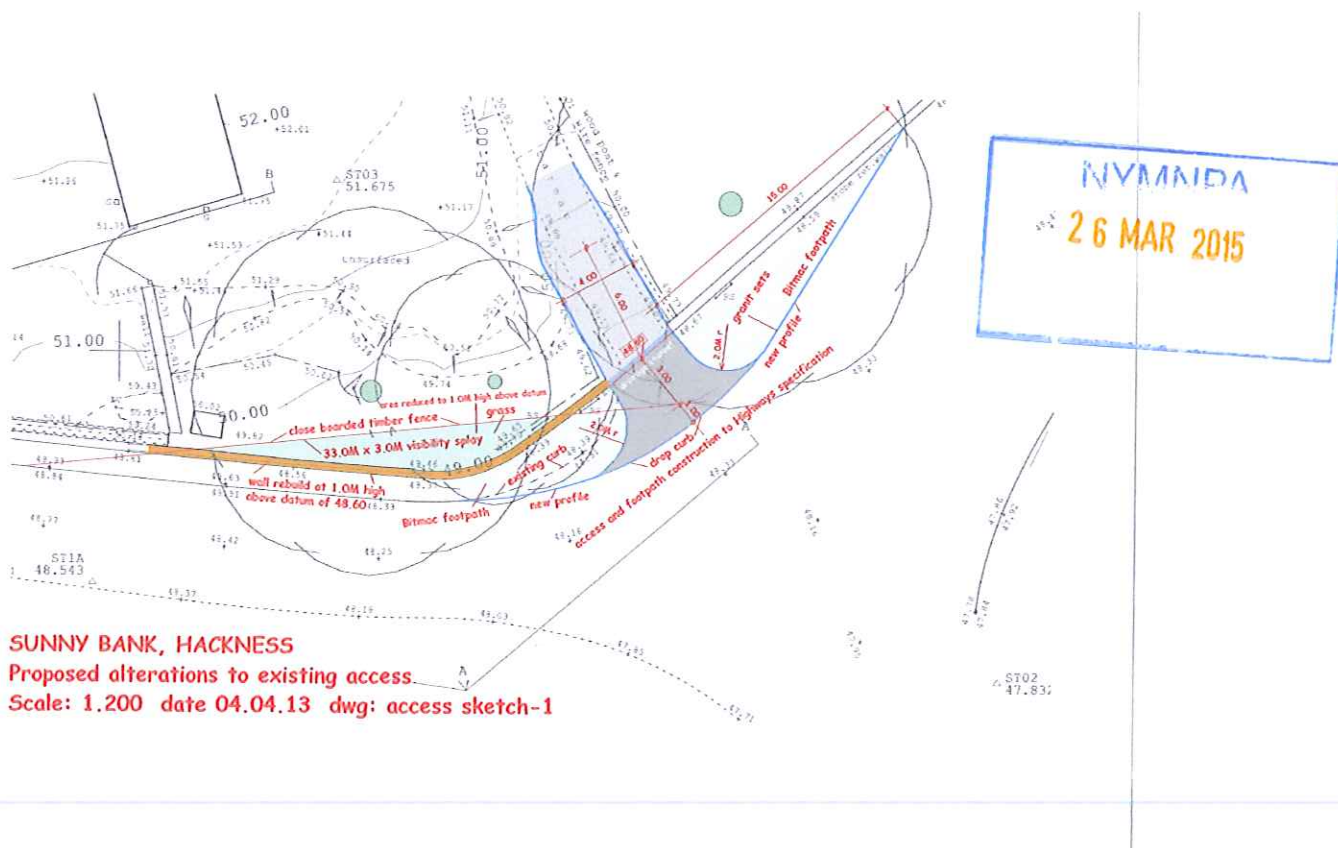
Fig 4: extent of the proposed works

Cutting back of the retaining wall to to ground level to accommodate the sightline would result in the loss of the trees and is considered unacceptable.

However, the sightline can be accommodated by careful hand grading of the ground profile to reduce the level to accommodate a sightline at 1.0m above datum.

The works can be successfully accommodated without detrimental effect to the trees surveyed by reducing the height of the wall and the ground level in a small section of the land to the south of the trees. as indicated in Fig 4 - The extent of the proposed works

It is recommended that the wall be taken down and rebuilt in sections **on the line of the existing wall** to avoid any issues with stability of the retained soil and trees.

The reduction in ground profile to be limited to the areas required by the sightline and to be evenly graded back to the tree bowl. All regarding works to be completed by hand and monitored for root position and damage.

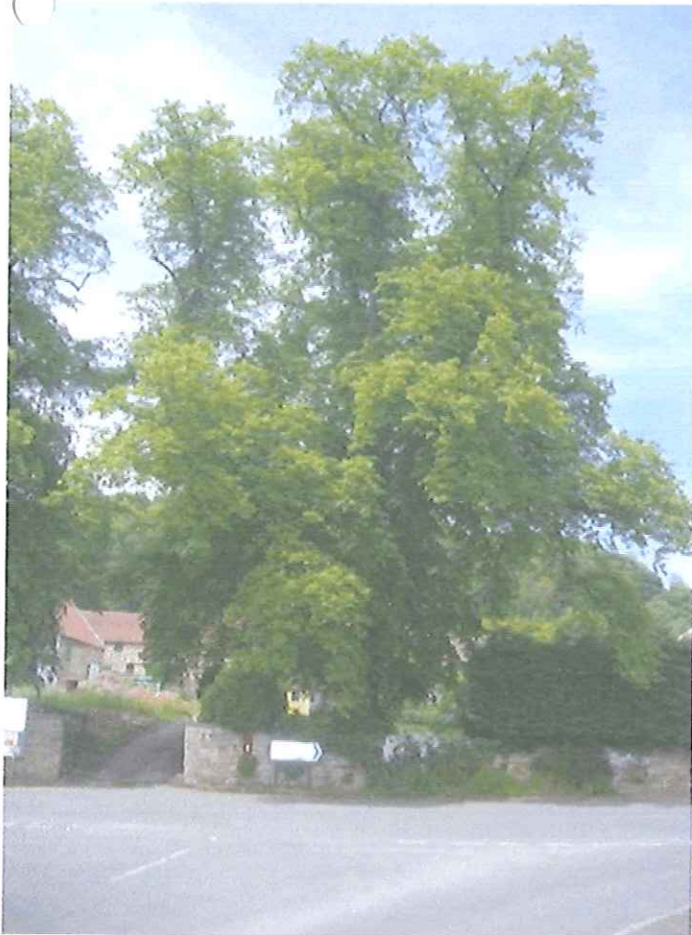
Fig 5: T3

The tree is the largest of the group and appears to have been established prior to those at Sunny Bank. It is not affected by the development and is not subject to the emergency TPO

Th tree has an unbalanced crown with a large limb extending almost right-angled to the south. and three distinct leaders.

The tree showed signs of late leafing and early leaf drop. There was also minor crown dieback on all three stems The tree is showing signs of stress but as no obvious cause can be found and the stress response is general and uniform it is likely to be from age or water table or climatic issues rather than mechanical root damage. The lack of corresponding stress in the trees at Sunny Bank make environmental factors unlikely. The tree is currently in fair condition but this condition can be expected to deteriorate in the near the medium future.

This tree is not affected by the works

Its condition rules out any proposal that the loss of the trees at Sunny Bank would be mitigated by the retention of this tree.
