PHOTOGRAPHS
SHOWING TYPICAL TREE DAMAGE TO WALL AT PARK HALL AISLABY

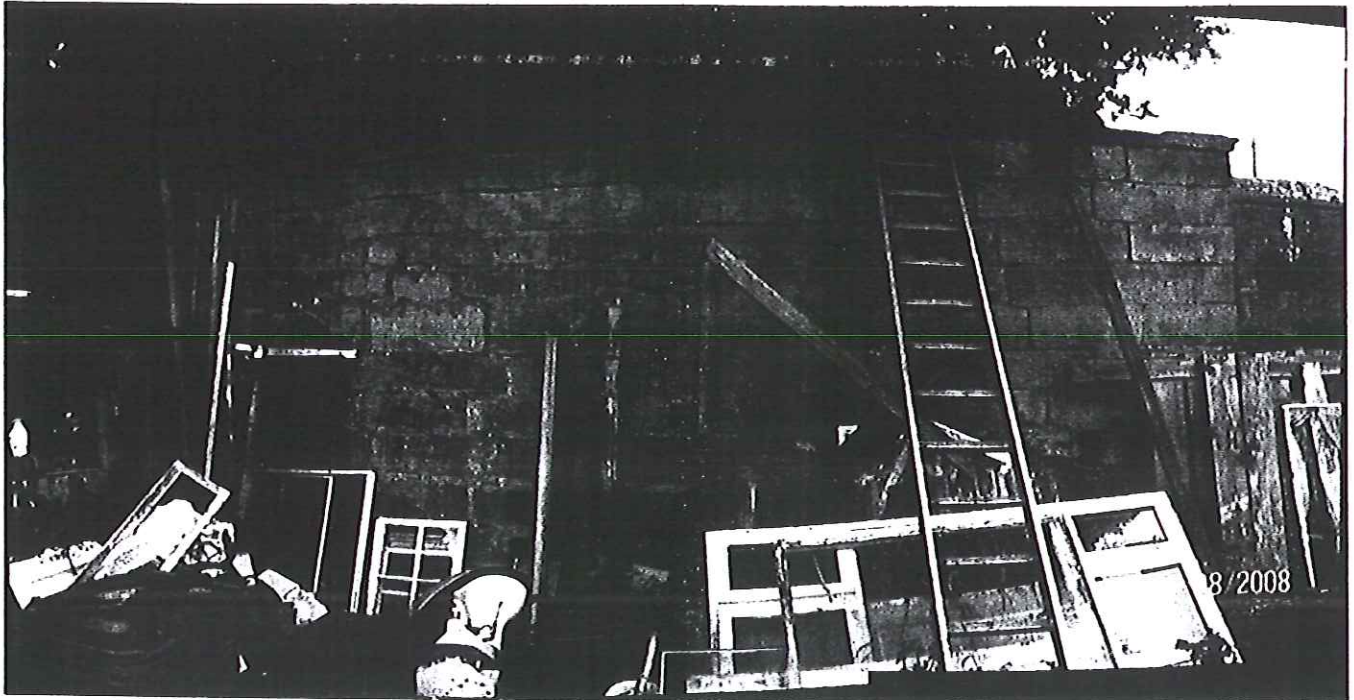
There are at least 7nr. Significant vertical cracks along the short length of wall shown above. Even on this small photograph the cracks are quite clearly visible.
