PHOTOGRAPHS
SHOWING TYPICAL TREE DAMAGE TO WALL AT PARK HALL AISLABY

10A
- 8 JUL 2015

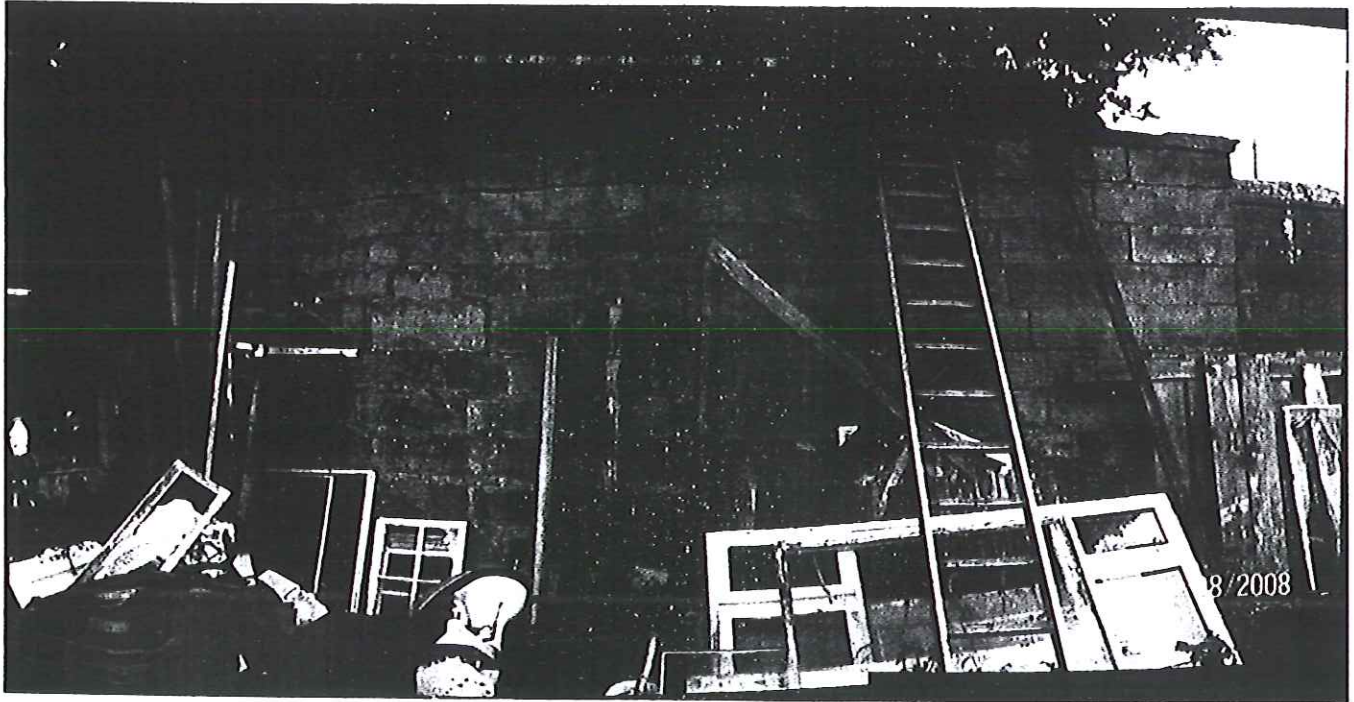
There are at least 7nr. Significant vertical cracks along the short length of wall shown above. Even on this small photograph the cracks are quite clearly visible.

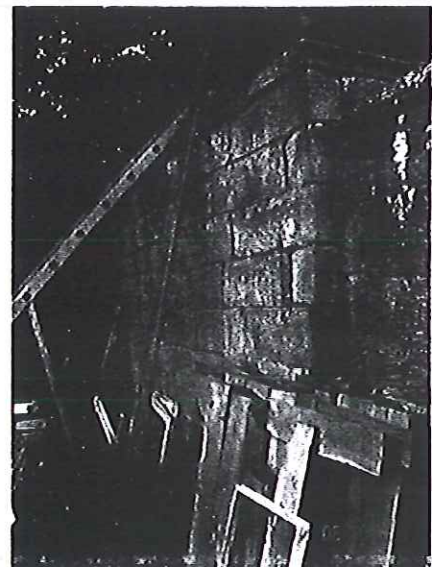
Close proximity of mature tree
