Structural Appraisal

Manor House Farm Barn

Troutsdale – North Yorkshire

Job No. Y15/241

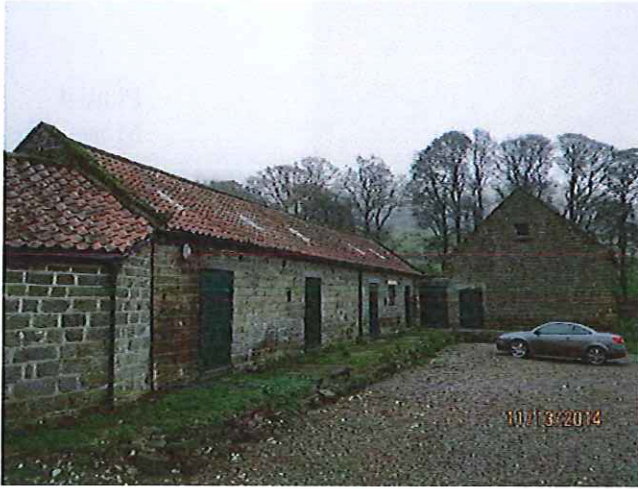
Plate 1
Front Elevation

3. **Observations** – The front elevation had four stable door openings in the dressed stone veneer wall and a further window opening and a door opening to an attached annex that serviced the original stables (see Plate 1 in appendix). The stone walls are in the order of 500mm in thickness and have a dressed sandstone outer leaf with a random rubble stone forming the mass of the wall. Both stone and mortar looked to be in reasonable condition. Granite lintels formed the outer leaf support for the wall to create a square opening and the inner masonry was supported on timber arched lintels (Plate 2). At eaves level there were 8 circular vent holes penetrating the wall and these were in vitrified clay. A vertical crack was noted at the window position extending from the cill to the ground. To the front of the elevation is a raised, level concrete hardstanding of similar datum to the internal ground floor that is generally, approximately 500mm above ground level. The north eastern gable end, Plate 3, when viewed externally is in poor condition, with major mortar erosion and with the mortar being soft and crumbly to the touch (Plate 4). The eastern stone kneeler at eaves level is displaced and rotated slightly from its original position. The rear wall is half submerged by compacted bedding and manure from cattle abutting the wall to a level of approximately 1.2m in depth. In several places the wall had been partly demolished presumably by cattle pushing against the wall resulting in failure/partial collapse of the wall (See Plates 5 and 6). The adjacent steel structure forming the adjoining barn was seen as independent of the stone barn but did not form part of the inspection.

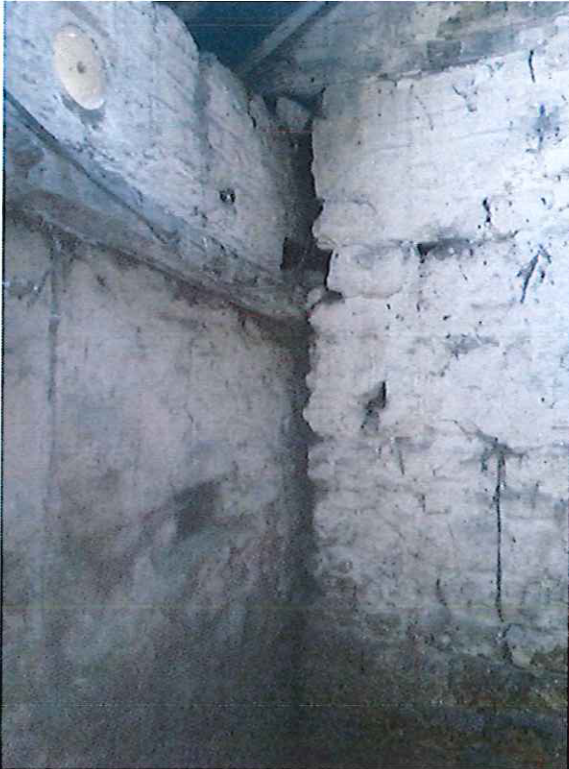
Plate 7
Wall Separation

rear walls from ground to eaves level in some cases and in the worst case movement was as great as 100mm, Plate 7. Elsewhere several vertical cracks were present under purlin bearing positions. Timber tie beams were evident at eaves level and cracking near to these was also evident. The front wall to the property had rotated outwards at eaves and so was not vertical.

4. **Discussion** – The main front elevation forming the main stable block is in satisfactory condition but is not vertical and in its present condition is reliant upon the roof alone as lateral restraint. Intersecting walls have been rendered ineffective as a result of significant cracking. The rear wall is not intended for stacking wet manure against it and this could result in structural instability of the whole building. Damage to the walls will require reconstruction using reclaimed material where possible. To ensure overall stability of the structure is maintained it is essential that structural ties be incorporated from front to rear on gable end and at dividing walls with face plates visible on each elevation just below eaves level. The gable end has severe mortar loss and should be taken down and re-built using the reclaimed dressed stone and random rubble to suit. The coping stones to gables should be removed and made more weatherproof and the kneeler stones reset to line and level.

- e) Through ties and restraint straps with remedial ties are required to all intersecting walls and gables to restore the structural integrity of the building. The lack of verticality of walls can be tolerated structurally providing that the ties are provided.

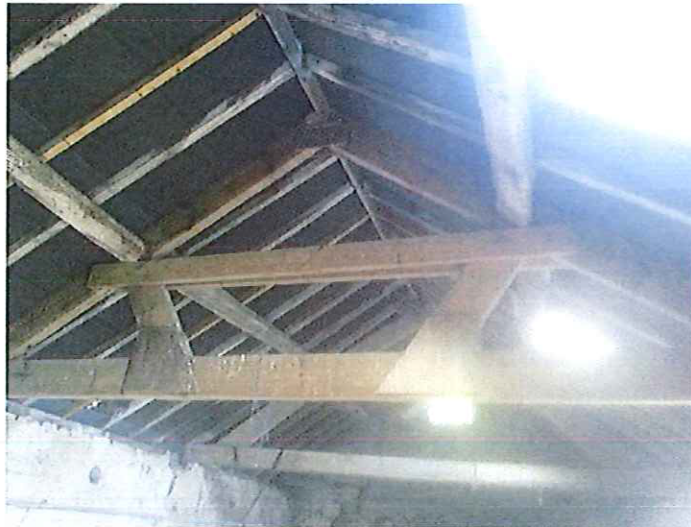
Plate 8
Stiffened Truss

Viewed externally, the roof covering appeared to be in reasonable condition with no significant sag evident. Externally there is no significant sagging evident. When viewed internally the construction comprises traditional common rafters forming the slopes, spanning onto timber purlins (one per slope) and these in turn span onto either triangular timber support frames or masonry crosswalls at typically 2.9m centres. Timbers appear to be in reasonable condition and quality with only a few members subject to wet rot in areas of prolonged exposure to the elements. Beetle/insect infestation was noted throughout, but timber loss was not considered significant. Trusses did not look to be under any significant distress although one truss had shear deflection of the bottom boom and another truss had been stiffened at some time in the past as shown on plate 8.

Roof timbers are generally in good condition but there are some members that are reaching the end of their effective life and may require replacing. Calculations indicate that the roof timbers are generally adequate and may be considered for re-use in their present condition providing that they are effectively treated against fungicide, insect/beetle infestation and rot. Consideration should be given to truss improvement work to at least two of the trusses. One for excessive shear deflection and the other to improve its appearance from that of a previous repair, if it is to be retained.

- c) The roof structure should be checked fully for structural adequacy and timbers strengthened, replaced or stiffened where necessary.
 - d) Internally, new slabs should be incorporated on order to comply with current standards, with an inner cavity and blockwork wall introduced to the whole perimeter wall.
