Preliminary Ecological Appraisal and Bat Survey Report

20 Dikes Lane, Great Ayton TS9 6HA

August 2019

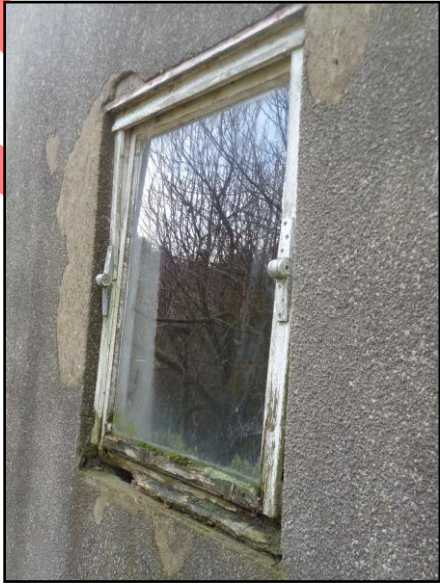
The property, the subject of this application is a redundant, steel frame and blockwork with asbestos sheet roof. This former agricultural building is a poor state of repair – the whitewashed walls were peeling in places and moss is growing where areas are holding water. This has caused wooden features such as window frames to rot away.

Figure 20. Window frames are rotten and in a poor state of repair

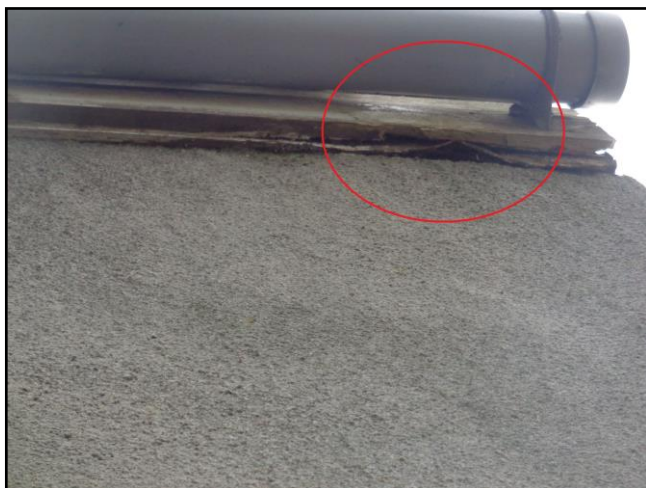
Figure 21. Example of potential access point

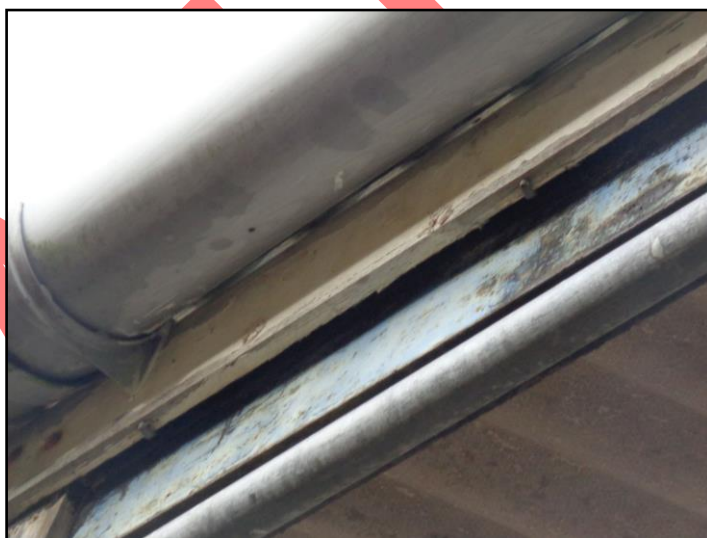
Bat droppings were noted in the north eastern corner (**TN10**) of this section, on the ground and up the walls around the corner. A wooden fascia board is present, although this was too high to see into the gap behind it (**TN15**).

Figure 22. Gap behind fascia board on south eastern elevation

Ecological supervision work will be required during the construction phase. Areas of the roof such as fascia boards, roof sheeting, flashing and guttering should be removed by hand, with the project ecological checking that no bats are present. Some post-development monitoring may be conditioned. Mitigation measures / roost replacement details will be discussed with the client and specified in the licence application.

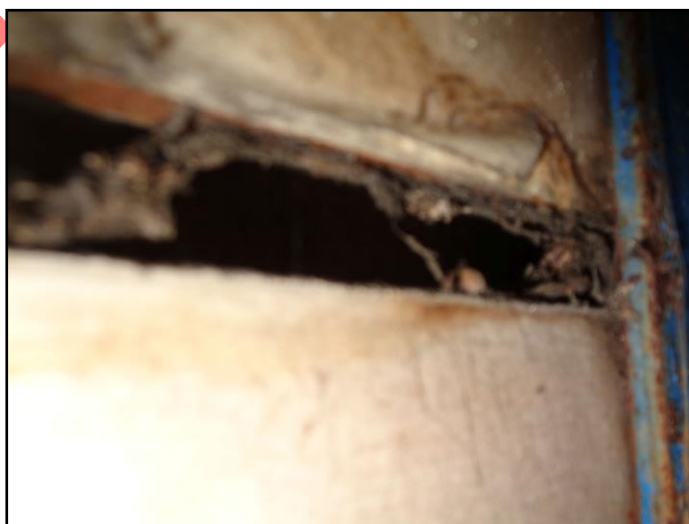
Bat droppings were noted across most of the upper floor (TN8) with a couple of areas where they were denser, suggesting access/roost locations. These were predominately in the north west, north east and south east corners (TN10). Gaps were present between asbestos sheets in the roof. Endoscope inspection showed very few cobwebs present in these gaps.

Figure 28. Gaps present in the ceiling below the asbestos sheeting

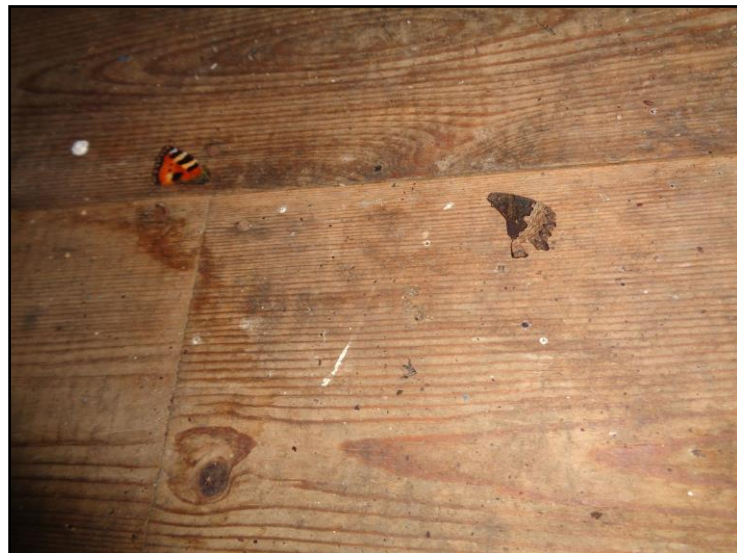
Two gaps in the floorboards along the northern elevation (eastern end) were noted (TN7) – these are directly above where bat droppings were concentrated on the floor below. Butterfly wings consistent with feeding remains from brown-long-eared bat were found in the centre of the room (TN8).

Figure 29. Butterfly wings – possible bat feeding remains

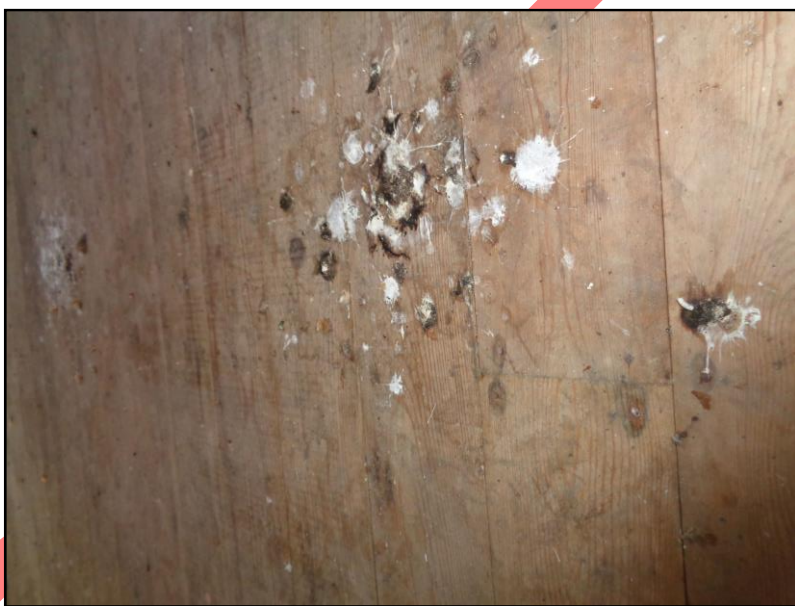
Internally signs of damp can be seen underneath the roof, particularly in the corners. In places the whitewash from the breeze block constructed walls is peeling. The single glazed windows in wooden frames are in a poor state of repair and the rot damage has created access gaps to the outside. Bird droppings were noted in the upper floor, but no evidence of nests.

Figure 30. Bird droppings noted on first floor

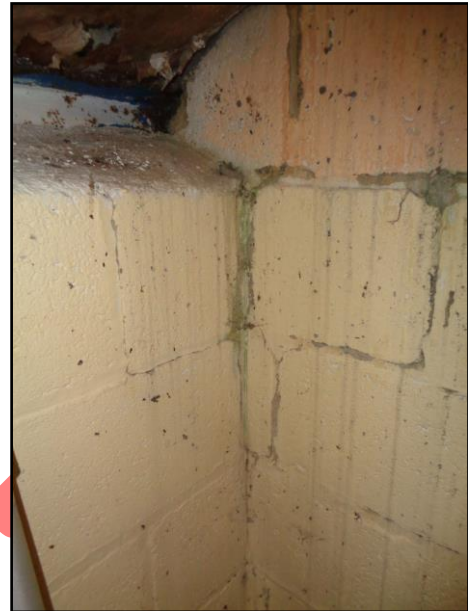
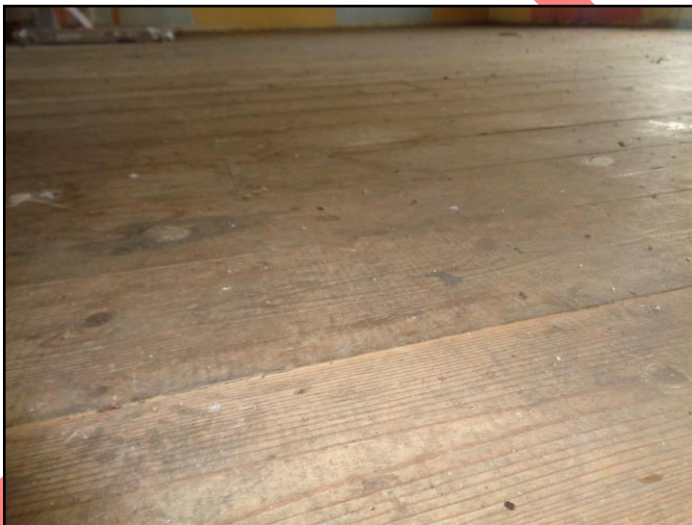
Figure 31. Bat droppings scattered across the first floor – on the floor, walls and wall tops

Figure 32. Bat droppings scattered across the first floor – on the floor, walls and wall tops

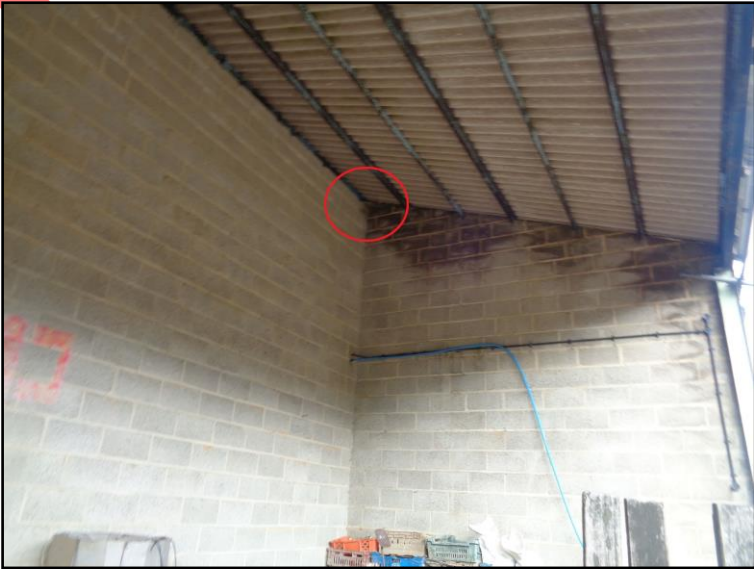
Figure 33. Open barn on south eastern elevation. Remnant bird's nest and potential bat roost entrance marked

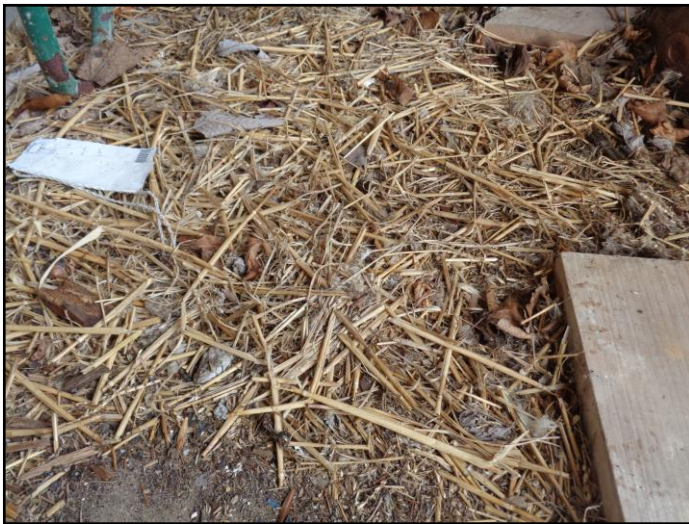
A concentration of owl pellets was noted in this area and small number of feathers. No other signs of owl were noted (**TN12**). The pellets do not look recent and are consistent with belonging to tawny owl (*Strix aluco*). A remnant bird's nest (consistent with house martin - *Delichon urbicum*) was noted in the upper north east corner.

Figure 34. Area of owl pellets in south east barn (TN12)

Signs of birds (remnant nests and droppings) were noted in the building. Owl pellets were also found, consistent with tawny owl. A tawny owl nest box should be added to the south east elevation of the building¹⁹.

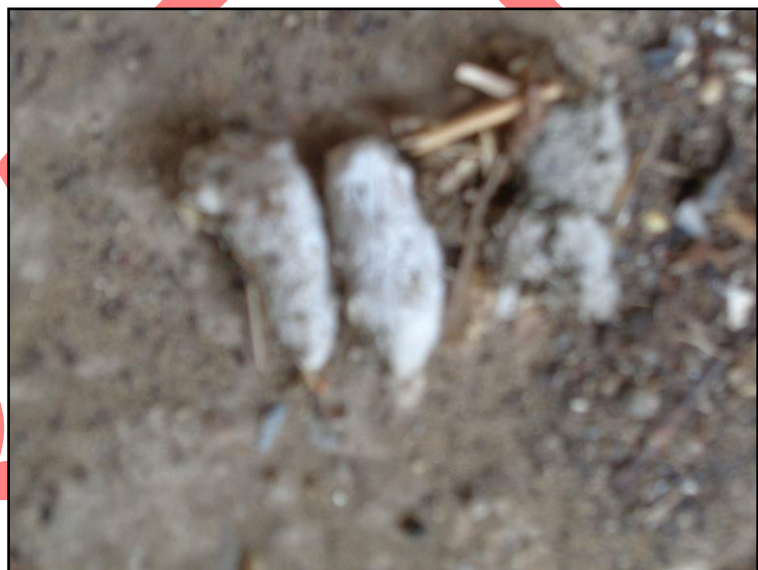
Figure 35. Owl pellets; possibly belonging to tawny owl (TN12)

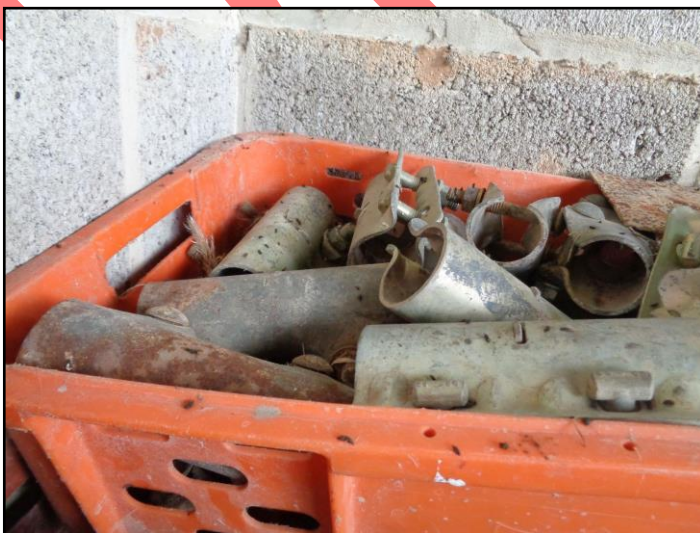
Figure 36. Bat droppings scattered in corner of south eastern barn below possible roost entrance

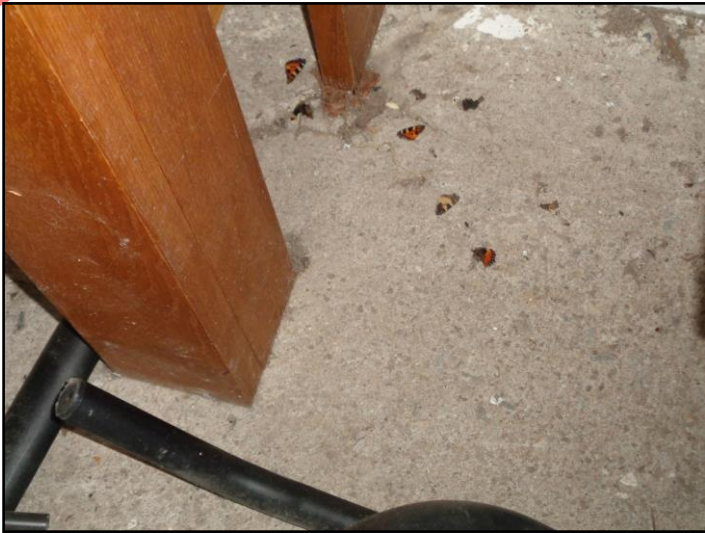
The concrete floor has bird droppings present, with some butterfly wings (consistent with bat feeding remains) present towards the south east corner (TN11). A few bat droppings were noted scattered across the area, with a concentration in the north east corner – in the region of where gaps are present in the floorboards from the upper floor (TN7).

Figure 39. Butterfly wings on the ground floor – possible bat feeding remains

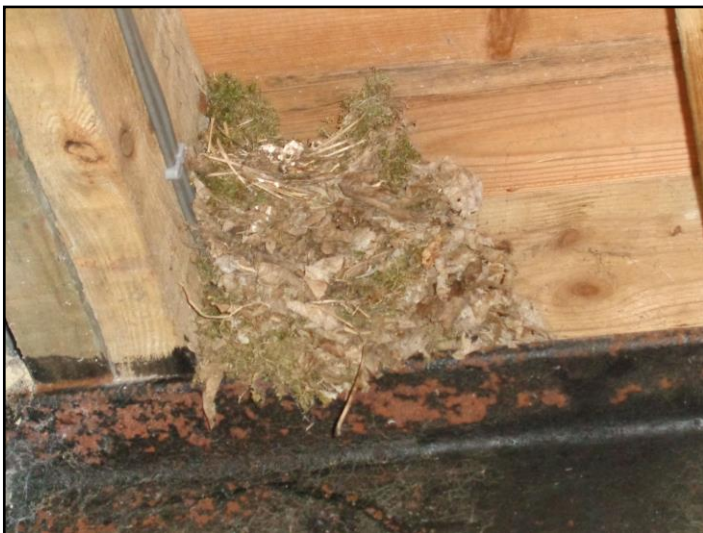
A vacant bird's nest was noted on a wooden beam just inside the entrance (TN9).

Figure 40. Remnant bird's nest on the ground floor (TN9)

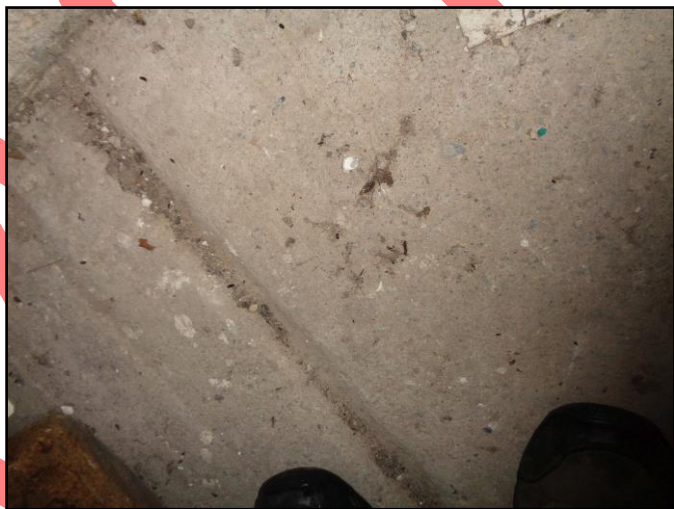
Figure 41. Bat droppings present on the ground floor

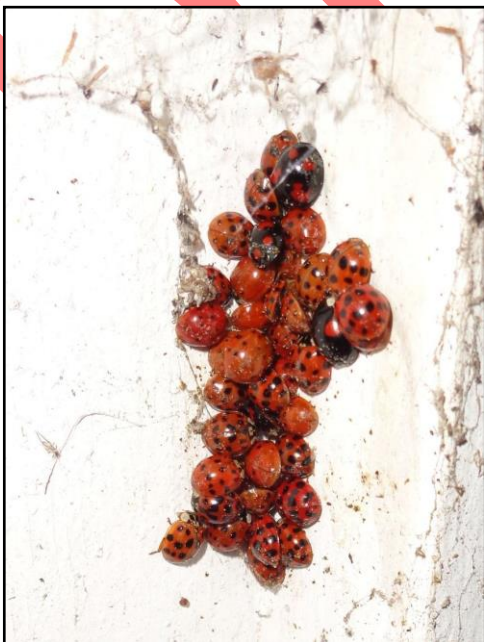
Harlequin ladybird (*Harmonia axyridis*)⁹ was noted in large numbers hibernating in clusters within this section; primarily around the entrance on the south western elevation (TN9).

Figure 42. Harlequin ladybird

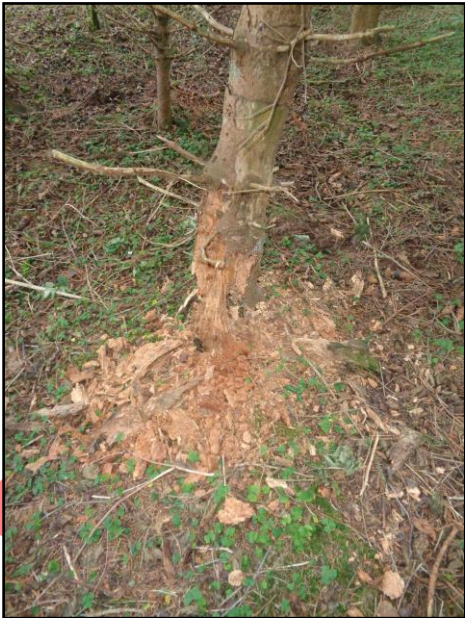
Evidence of moles and deer were noted within the woodland. The trees have extensive damage consistent with the actions of deer and the carcass of a young deer was discovered (**TN19**). Various mammal tracks were noted – consistent with both deer and rabbit.

Figure 45. Possible damage by deer

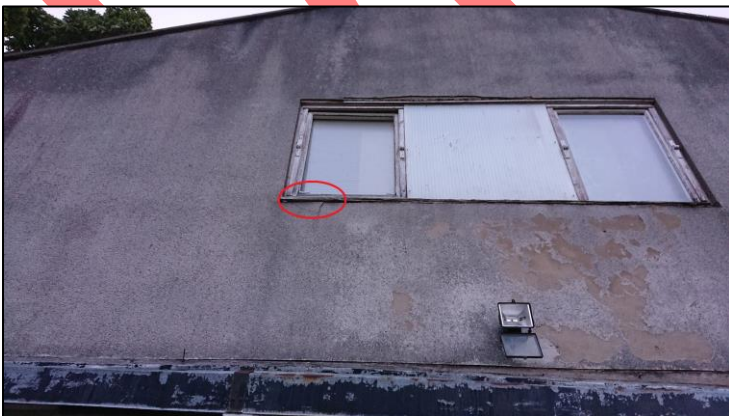
A common pipistrelle roost of 3 bats was noted around the window ledge on the SW elevation left hand window. Closer examination from inside the building revealed an external gap which led into the wall cavity. A natterers' roost of 2 bats is located in the upper room of the building. The bats enter the premises *via* a gap in the upper south west corner of the open barn.

Figure 65. Common pipistrelle roost entrance

The plastic sheet on the windowsill covering the common pipistrelle roost MUST be left *in situ*. Removal will alter the roost conditions and may constitute a criminal offence. A bat loft for natterer's bats should be created during the renovation works. Integrated features suitable for bats will be required to be incorporated. Full details will be provided with the Natural England Mitigation Licence application.

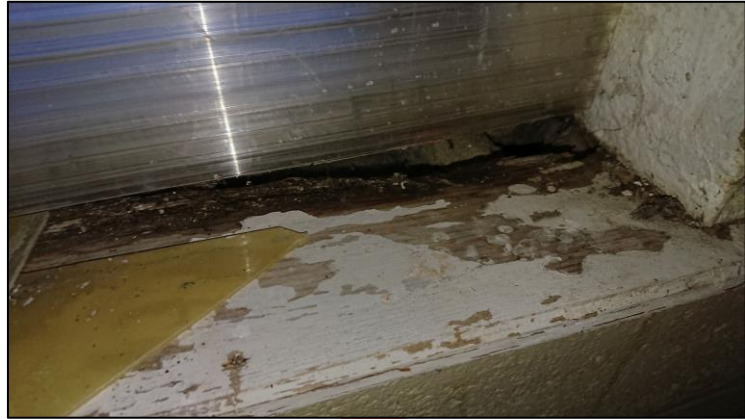
Figure 66. Common pipistrelle roost internally
