Location:
**Valley View, Golden Grove,
Whitby**

Report Type:
Arboricultural Impact Assessment

Ref:
ARB/CP/2217

Date:
August 2019

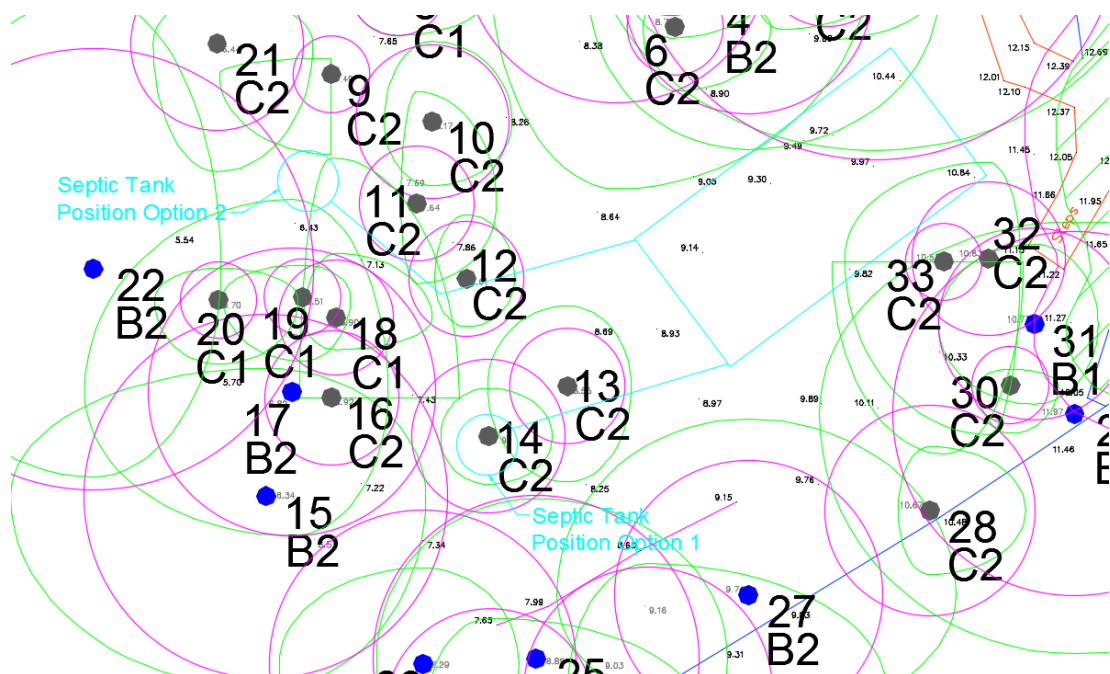
Figure 2: Proposed Layout

5.3 Conflict 1: Loss of trees due to the proposed layout.

It will be necessary only to remove a small number of saplings that were too small to be included within our survey to allow construction of the cabin. Beyond that, the client wishes to remove three small trees to install a septic tank and improve the outlook. In order to replace the barn, one tree is likely to be removed.

5.4 **Conflict 2: Construction within root protection areas.**

There would be some encroachments from proposed structures within root protection areas of the trees within the woodland.

Mitigation / Countermeasure: Trees 12-14, all Hawthorn, are proposed for removal to create space for a septic tank and to improve the outlook from the cabin. The trees were classified as Category C so the arboricultural loss will be low. Being surrounded by numerous larger trees their loss will not be noticeable from outside of the

woodland and therefore the visual impact to the wider landscape will be negligible. In order to replace the barn it will be necessary to remove Tree 41, a semi-mature Hazel that was classified as Category C. Its removal will have a minor impact arboriculturally and also from a landscape visual perspective given that a backdrop of trees will be maintained when viewed from the road to the north.

Mitigation / Countermeasure: The cabin will be completely constructed on site with all materials brought by hand along the existing footpath which will be repaired beforehand. The cabin will be raised off the ground using stilts anchored into the ground or by utilising adjustable foundation supports such as Swift Plinths (https://swiftfoundations.co.uk/swift_plinth/). Either system should allow for minimal impact upon the woodland floor and raising the cabin will allow for root retention beneath the structure. In order to prevent the soil beneath the cabin becoming dry a rainwater harvesting system which distributes water through perforated irrigation hoses will be installed. The cabin has been positioned within a natural clearing and given that no mechanical plant will be utilised during its construction we believe that it could be installed with only minor disruption and without a significantly detrimental impact upon the retained trees. It will be necessary to install a septic tank and two possible locations have been identified on site, as indicated upon the Arboricultural Impact Plan, Appendix 3. The client intendeds to hand excavate the site chosen to position the tank with the spoil being distributed to avoid build up in any one area. Either position identified on the plan should allow for tank installation without a detrimental impact on the surrounding trees.

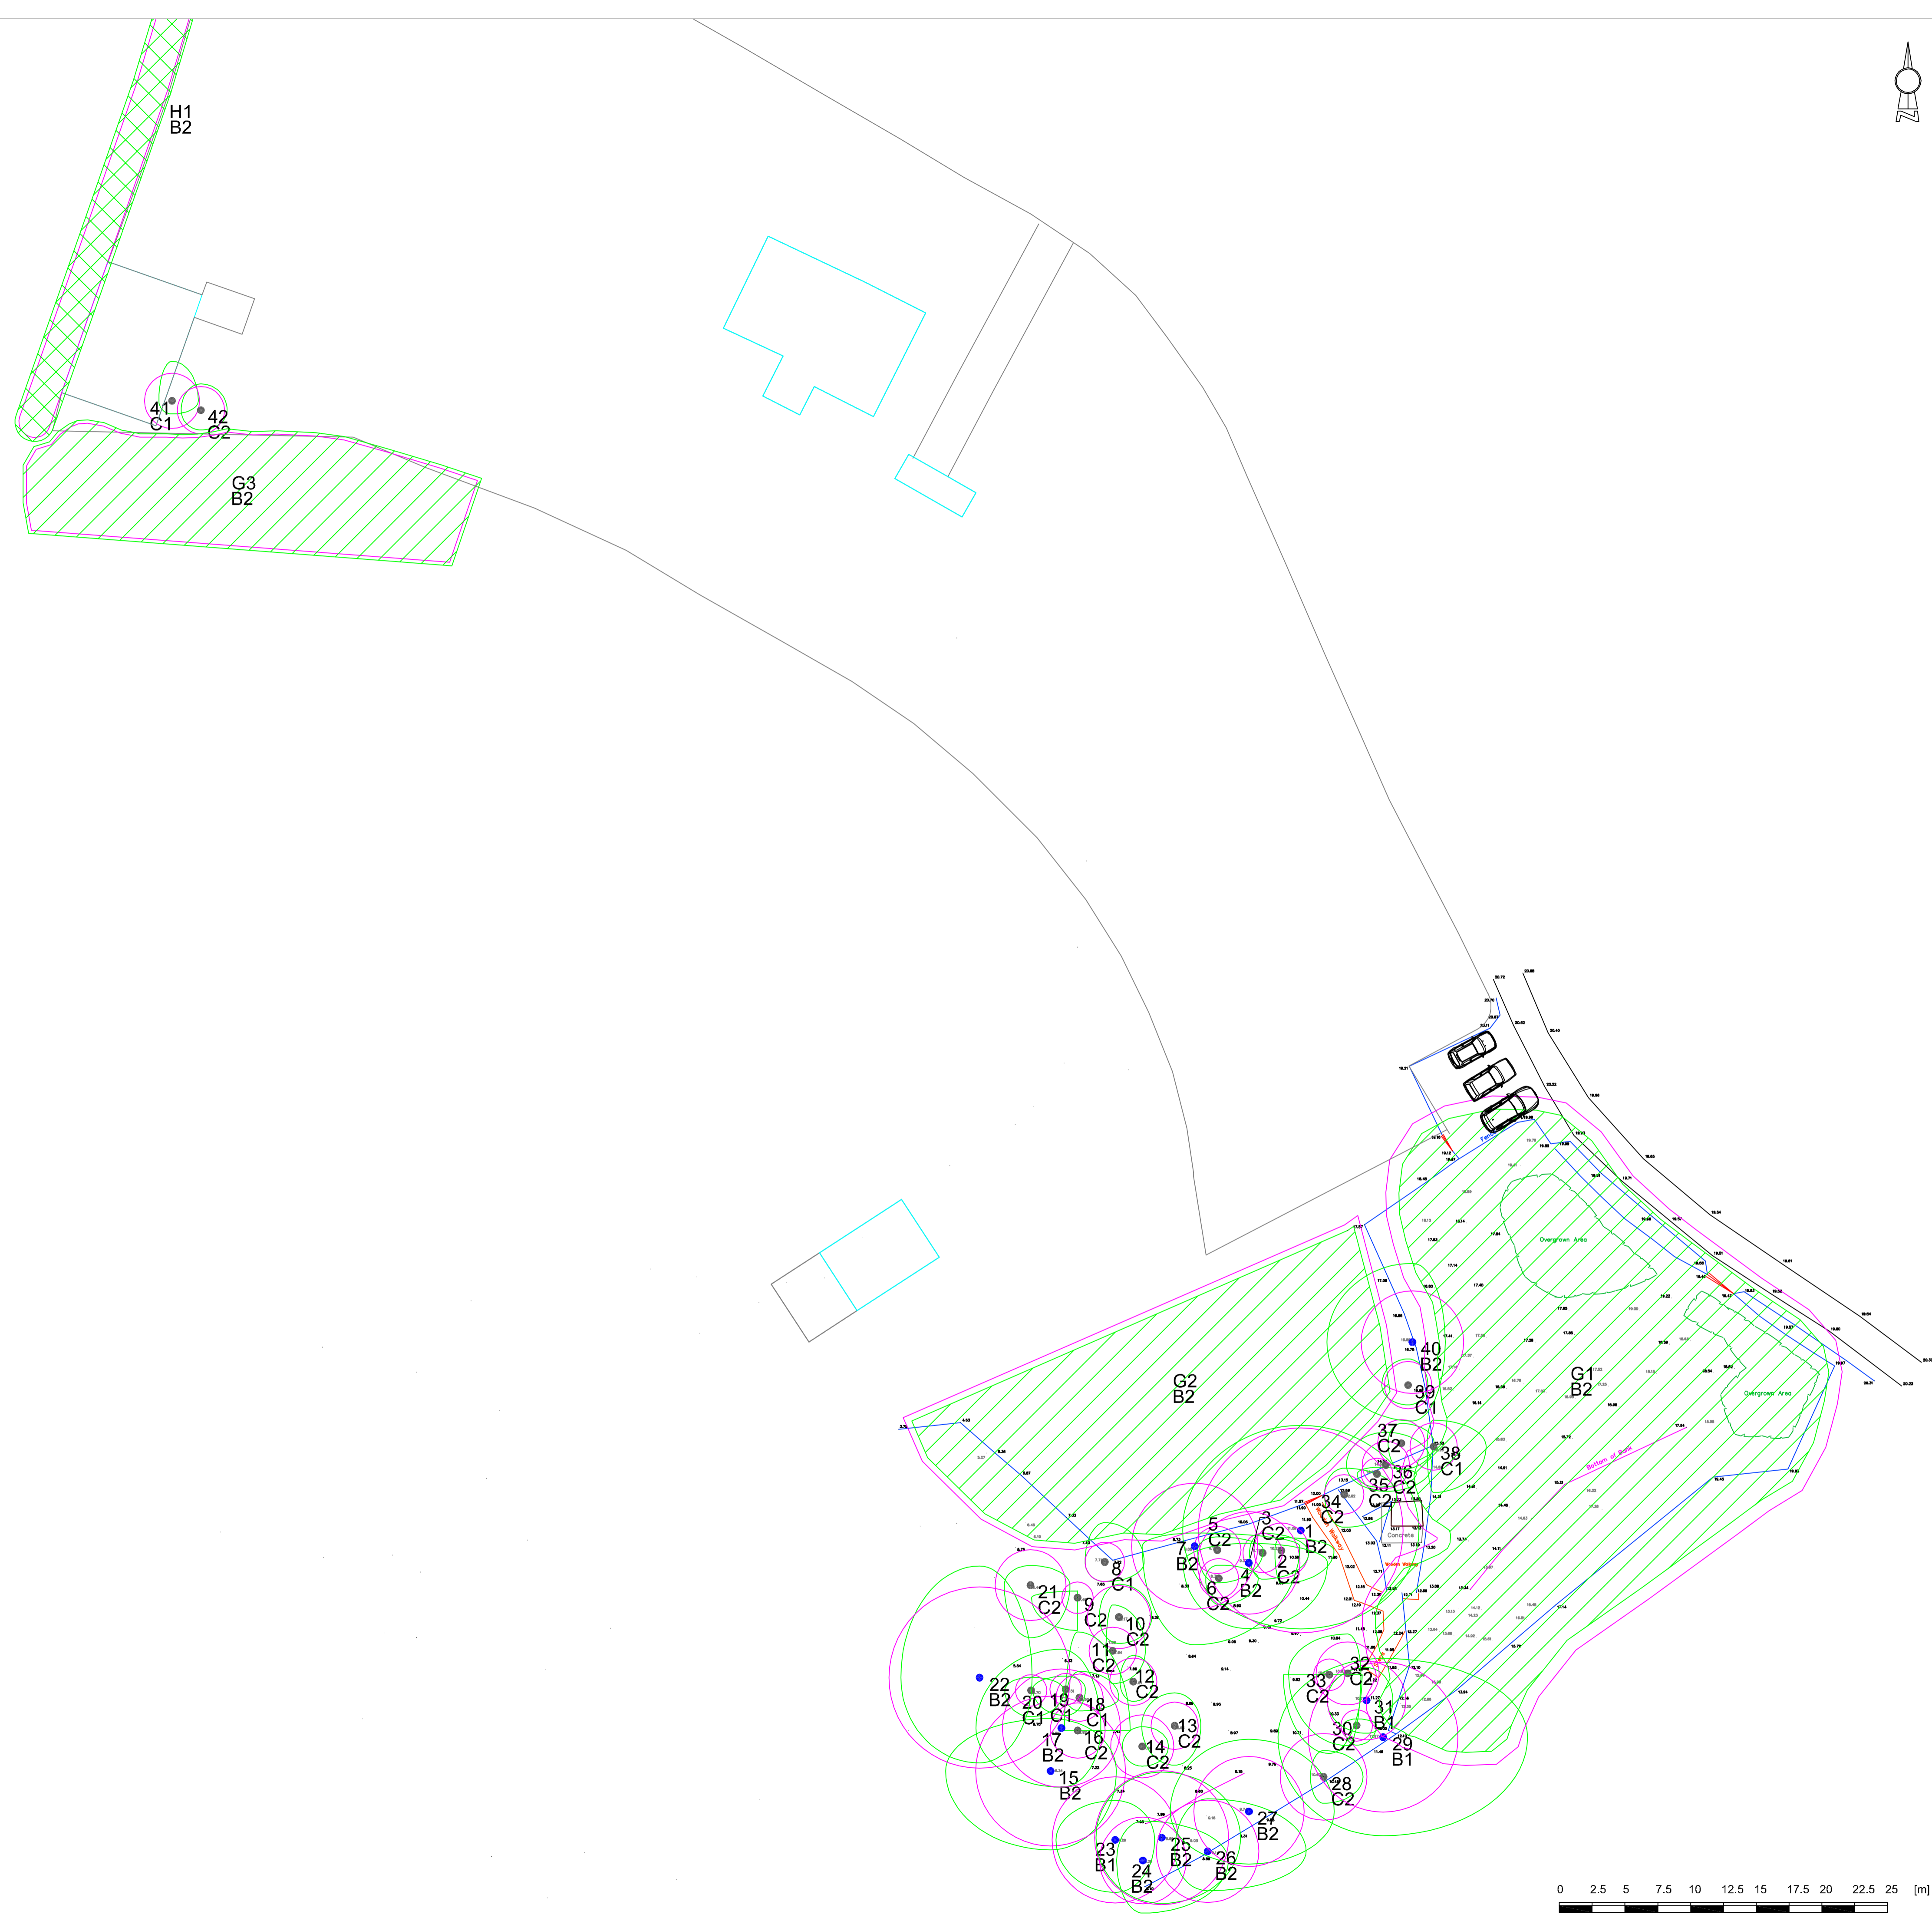
Drawing Title: Tree Constraints Plan
 Project: Valley View, Golden Grove, Whitby
 Drawing Number: ARB/CP/2217/TCP
 Date: August 2019
 Scale: 1:250 @ A1

3.3 Overall the majority of the trees within the site are of reasonable to good physiological and structural condition with few arboricultural issues noted. Specific details for trees and groups can be found within Appendix 1.
