## the earth stone and lime company building conservation consultancy and practice

Thirley Cotes Farm, Harwood Dale.

29.03.2019

Brief analysis of mortars and pattern of construction and method statements for the mixing and use of earth-lime and hot mixed lime mortars.

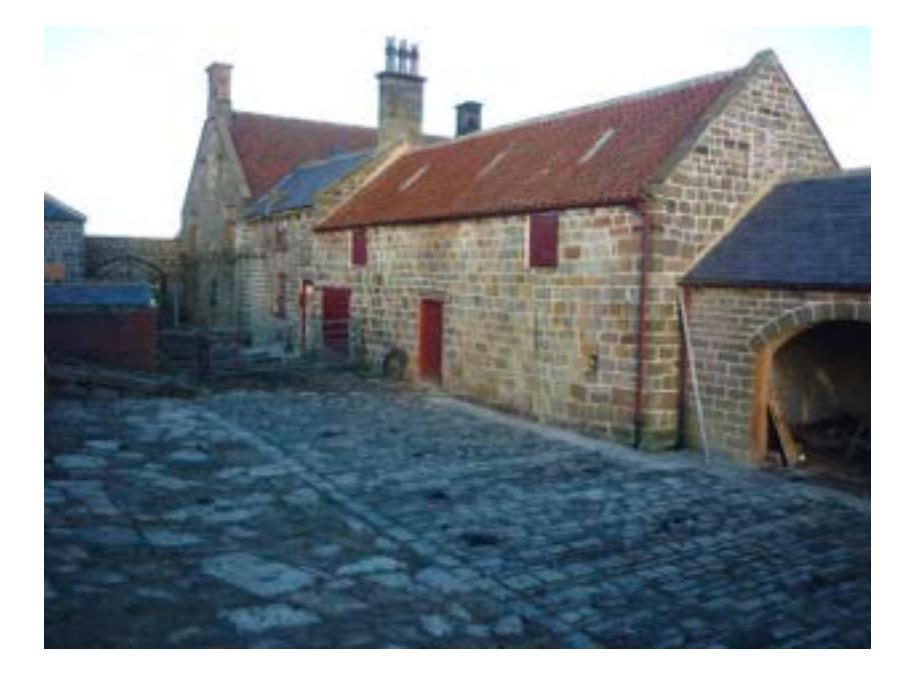
Barns, Swallowhead Farm, Fylingdales, 2012:

Immediately after repointing:

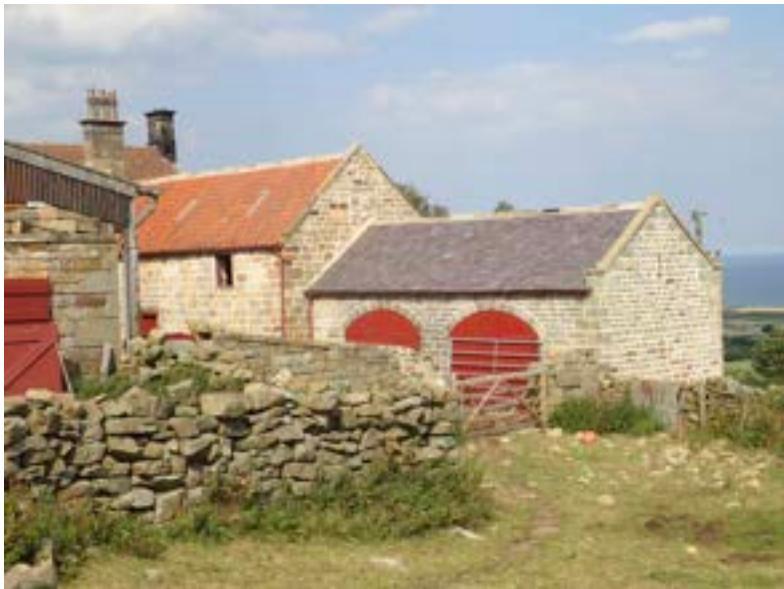
1 year after repointing:

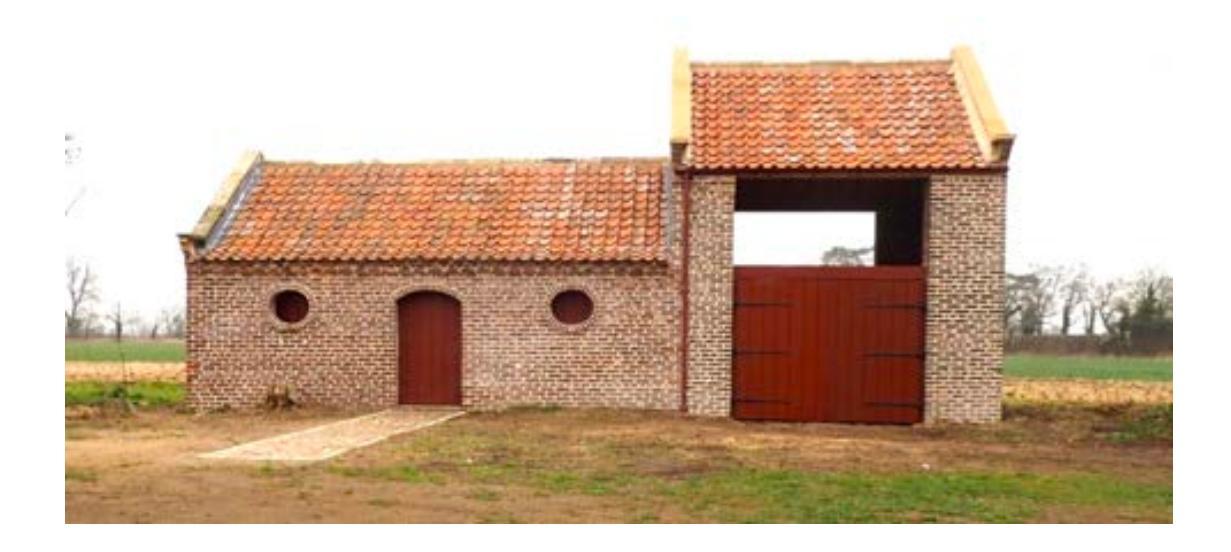
Scampston Hall, 18thC horse shelter and cart-shed, 1 months after repointing:

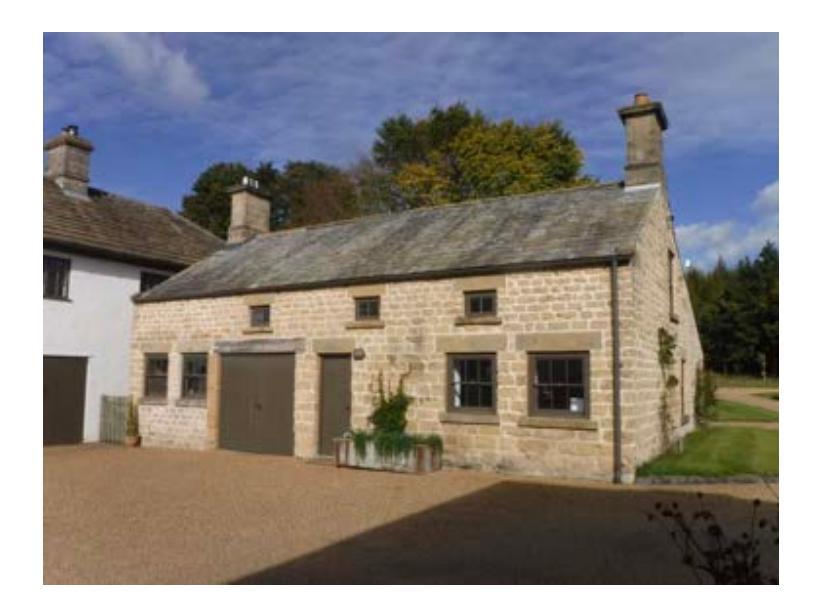
Nawton Towers, Pockley. ! year after repointing:
