AMENDED

Arboricultural Impact Assessment

Forge Valley, Yorkshire

September 2019

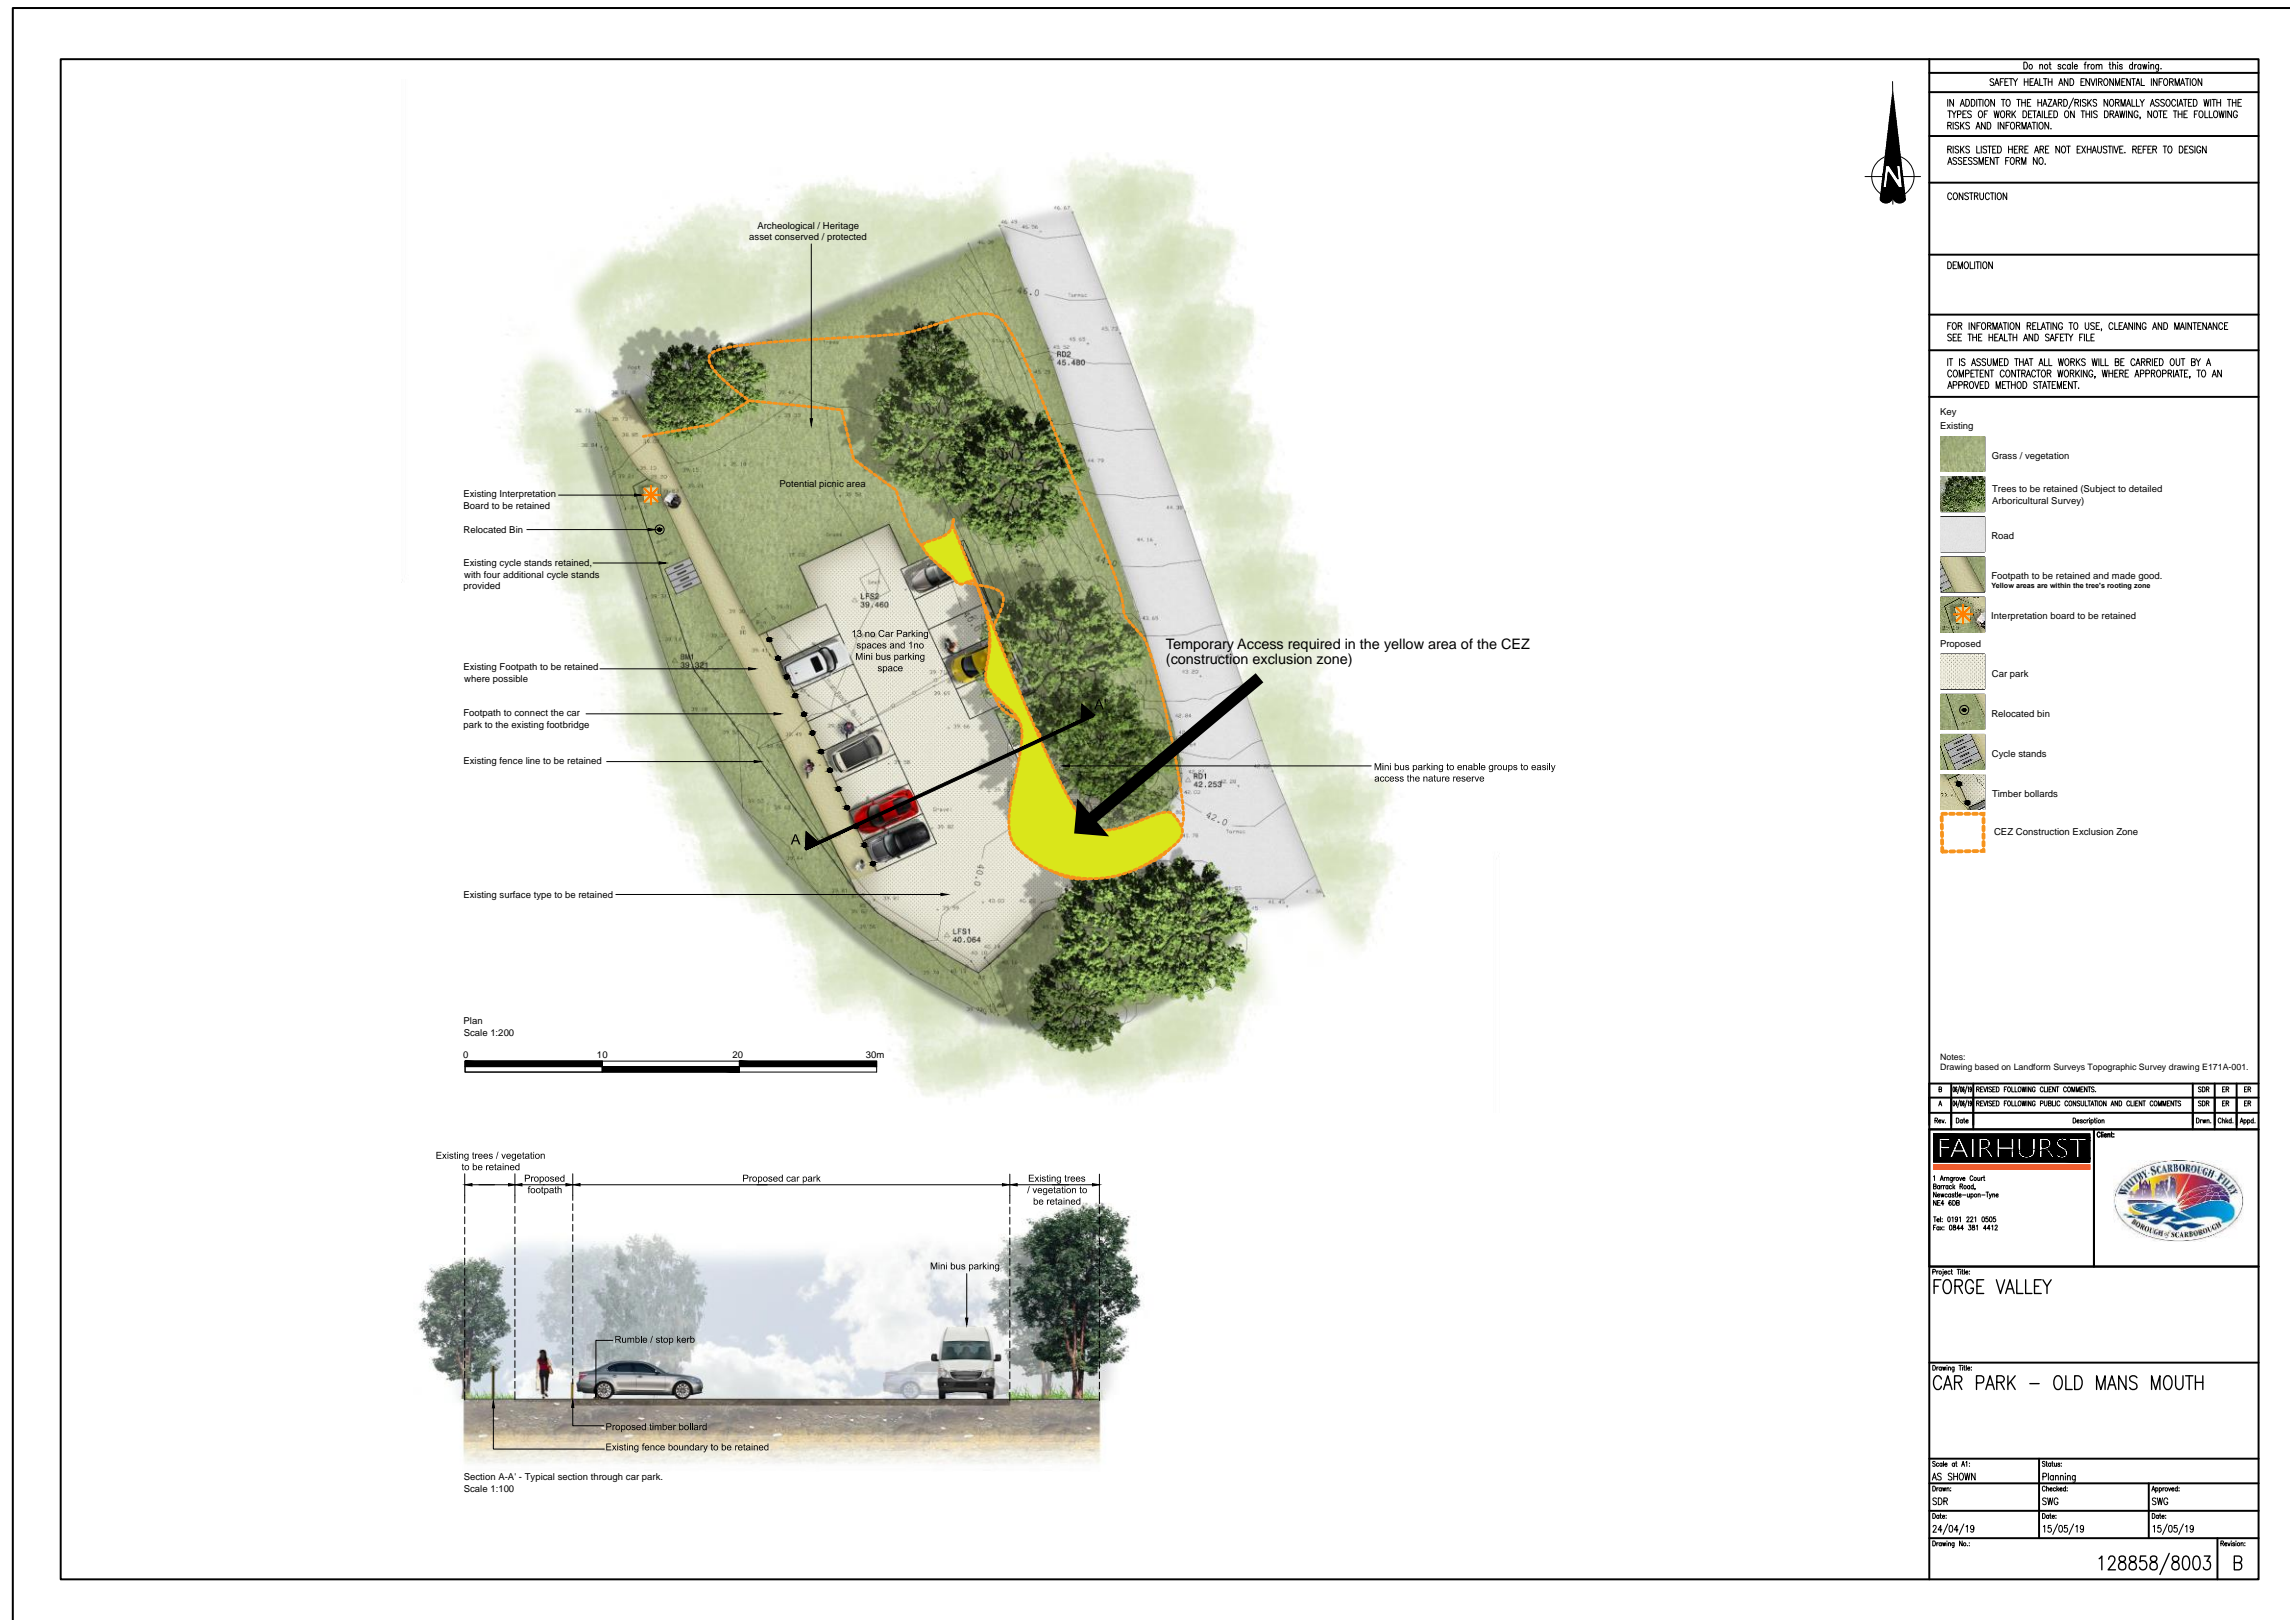
Figure A1: Tree Protection Plan A (Construction Exclusion Zones (CEZs) marked by orange dashed line). Yellow zones indicate areas where temporary access will be required to the CEZ.

Some construction work will occur within the RPA of trees as shown on the survey tree constraints plan (Figures A1, A2 and A3 in Appendix A). The removal of some surveyed trees is necessary for the construction to proceed. The remaining trees should not require removal or major works as long as tree root protection is in place. If work is unavoidable in these zones, then the Guidelines for the Planning, Installation and Maintenance of Utility Apparatus in Proximity to Trees (NJUG, 2007) should be followed to prevent damage to a large proportion of the tree roots of affected trees.

It is advisable that mechanical excavation within the RPA is kept to a minimum and any exposed roots are avoided and protected. Materials and spoil should not be stored in this area. Work should minimise root damage.

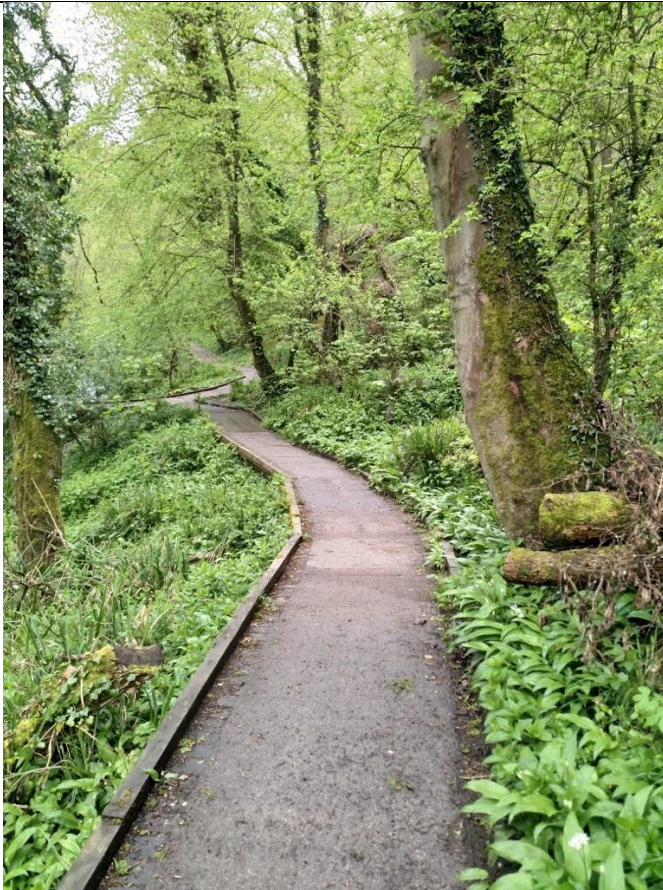
Location B7. Note the large, mature Sycamore restricting any widening of the path at that point.
