Forge Valley Woods NNR, Seavegate, East Ayton
Consultee: West Ayton Parish Council
Date: 4/09/2019

Additional information for Planning Committee

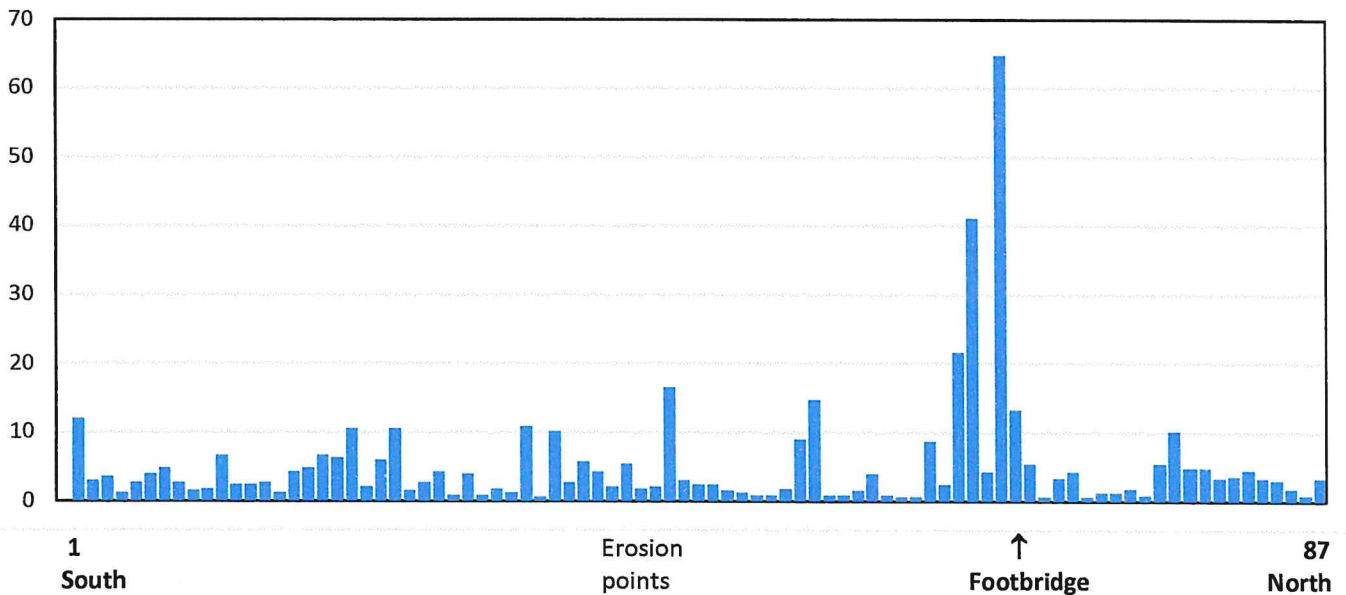
Forge Valley - riverbank erosion next to boardwalk
(metres affected at each erosion point 1 - 87)

- Riverbank erosion in Forge Valley was assessed on 28/08/19. There are 87 point sources of erosion from the south end of the boardwalk to the north end.
- The total length of riverbank affected is approx. 454 metres, 20% of the length of the boardwalk.
- The length of the erosion points varies from 0.6 to 64.8 metres, with the most affected areas close to the footbridge. In places, the erosion is starting to undermine the boardwalk.
- The vast majority of erosion points are caused by dogs, as pawprints are evident.
- Silt can be seen on the riverbed at each access point. The River Derwent is a high priority river for sediment issues in the River Humber Basin Catchment under the European Water Framework Directive and is a drinking water protected area under WFD.

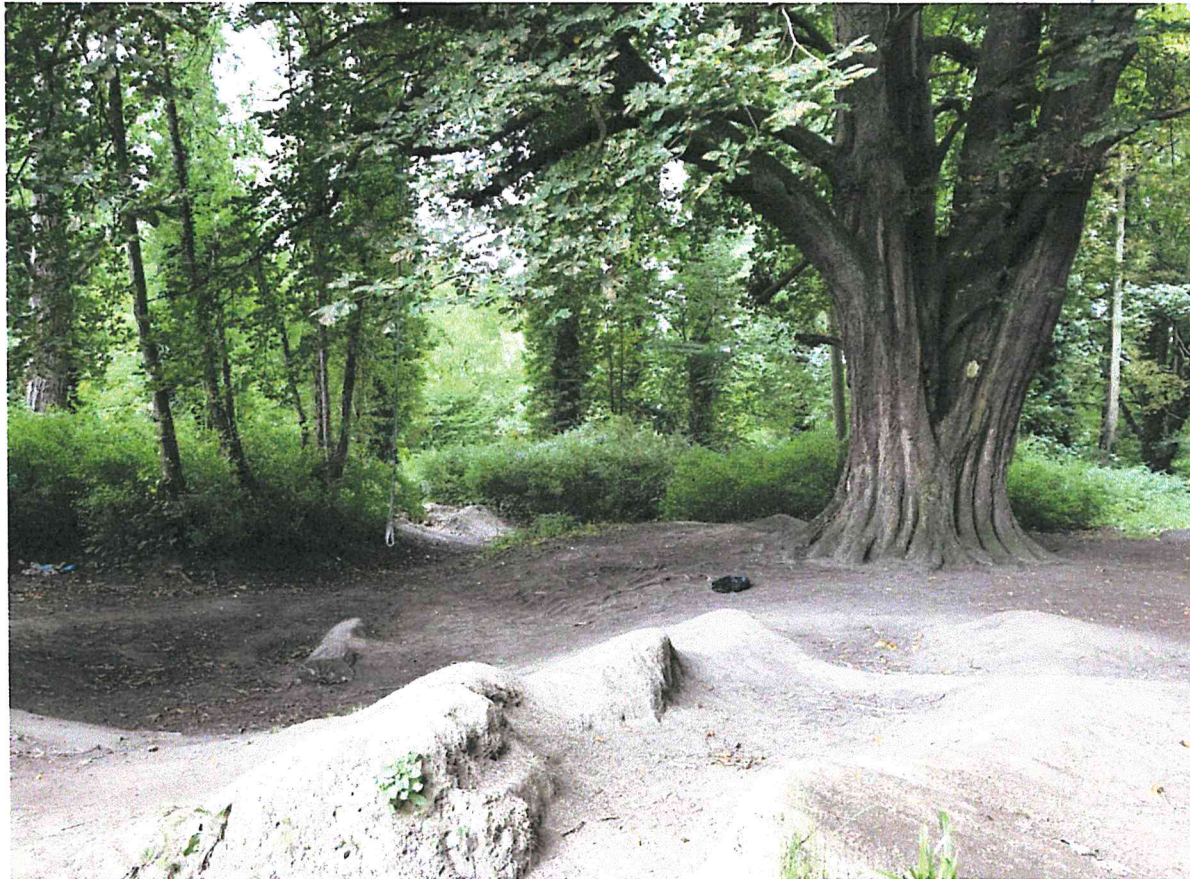
- The Seavegate Gill area for development within the planning application excludes more than half of the woodland area in this location. In particular, it excludes the heavily trafficked area around the Champion veteran horse chestnut tree, as shown in the picture below. This is probably one of the oldest and largest trees in Forge Valley. Its root plate area has been severely eroded by bike tracks and ramps, and rubbish is frequently left in this area. Great consideration has been given in the application to protect much younger and less valuable trees in the development area but this fabulous tree and its surrounding area has been excluded.
