BAT RISK ASSESSMENT

Faceby Lodge Farm, Faceby

MD2

Report Reference & History: Document 1, version 1.

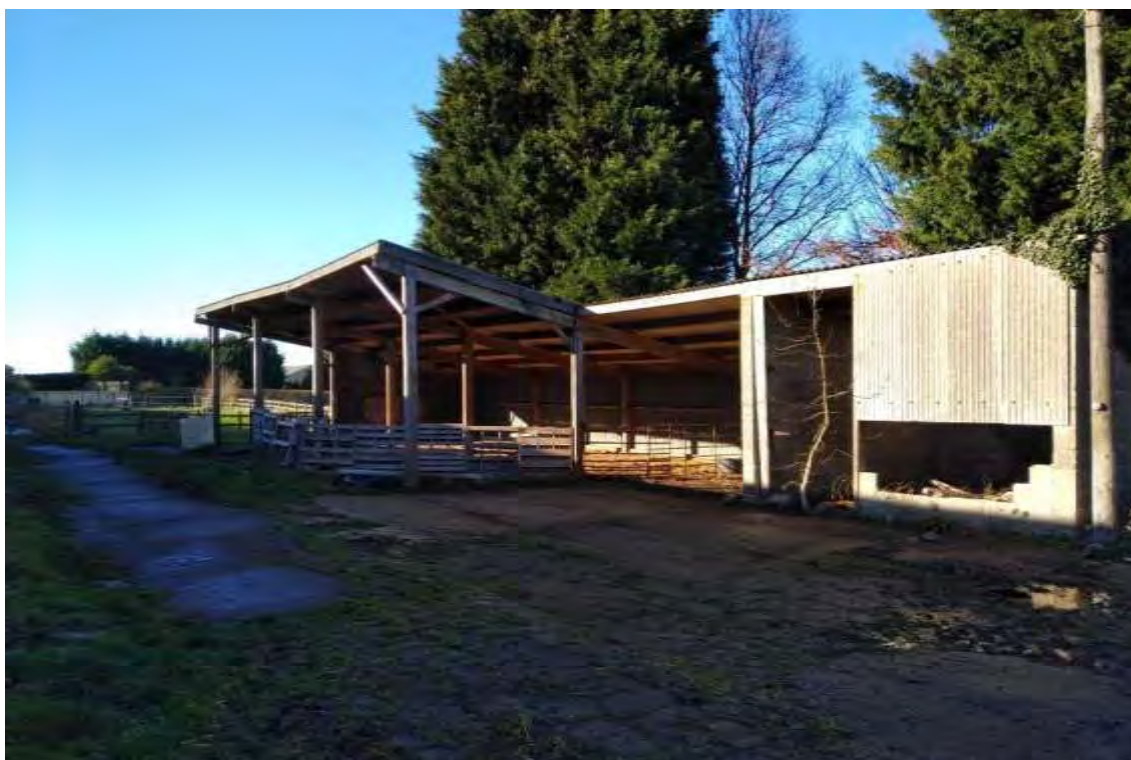
Photograph 1 Building 1 southern aspect.

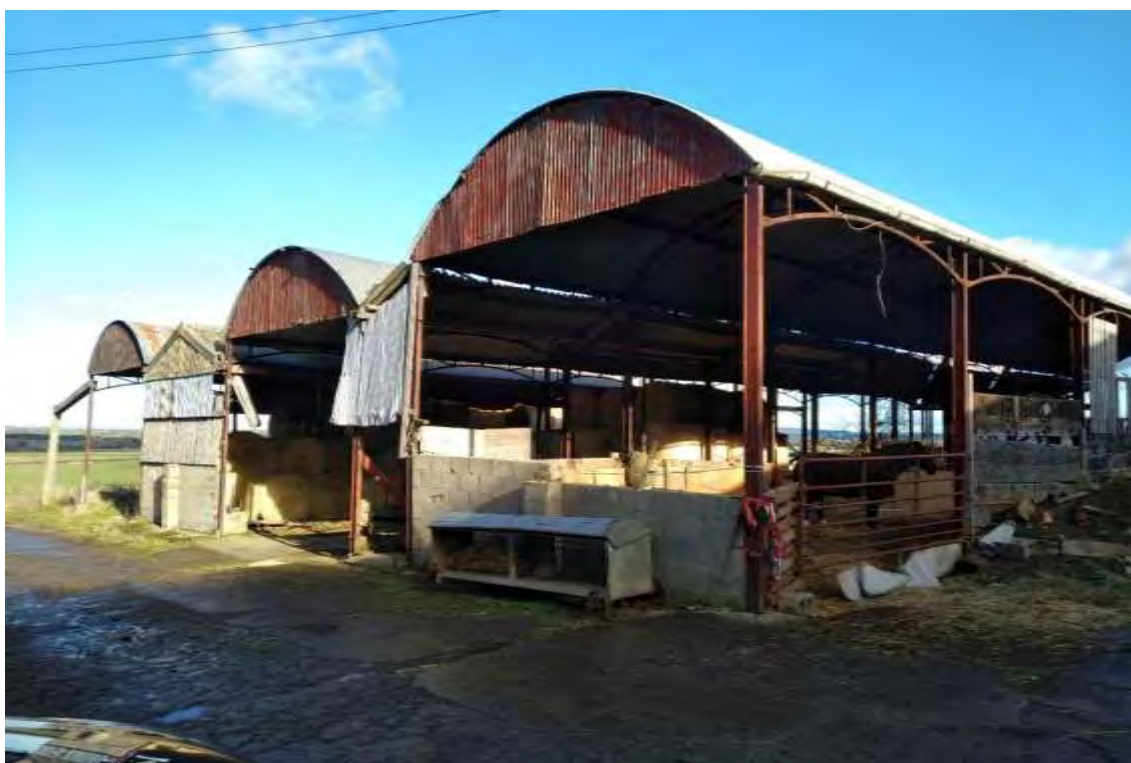
Photograph 2 Building 2, hay barns currently housing two horses.

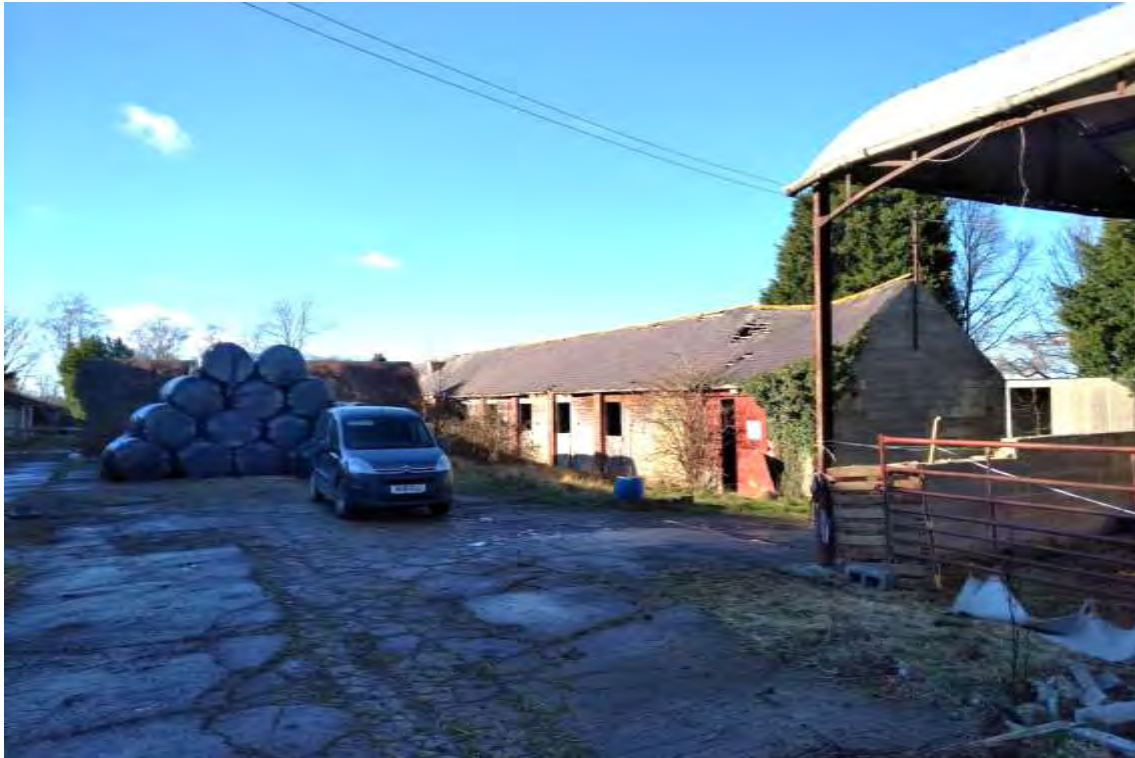
Photograph 3 Building 3 southern and eastern aspect.

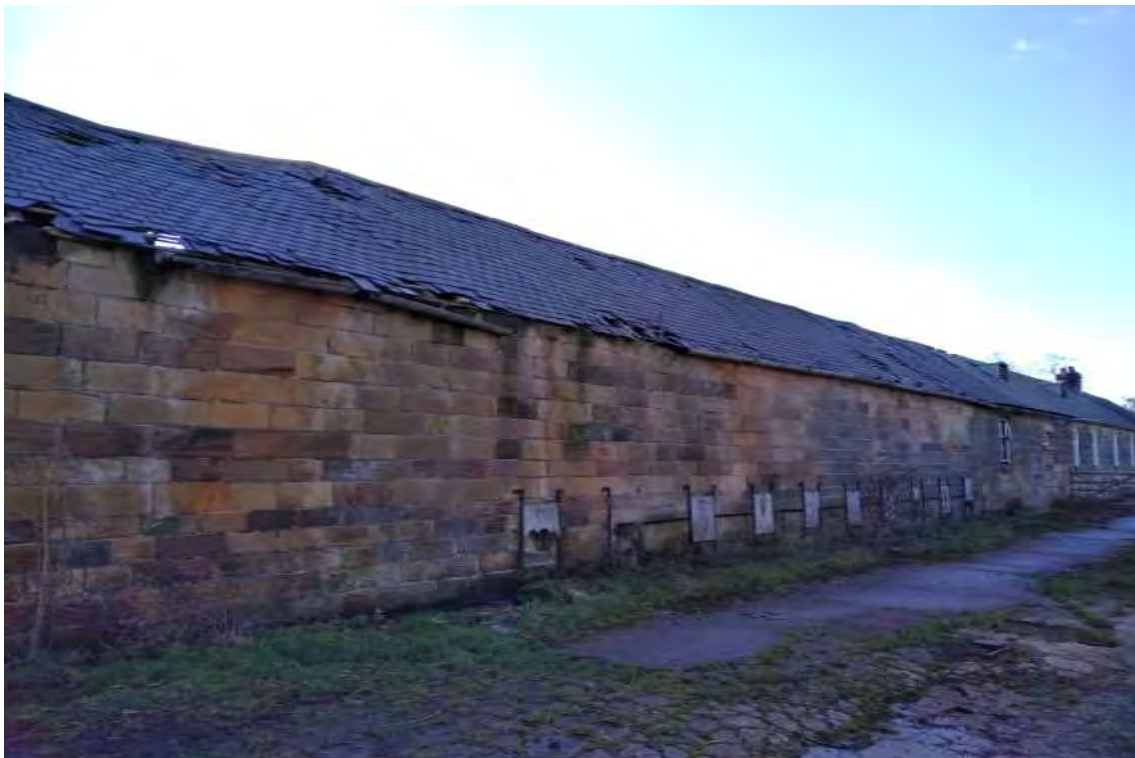
Photograph 4 Building 3 northern aspect. Showing roof in poor condition.

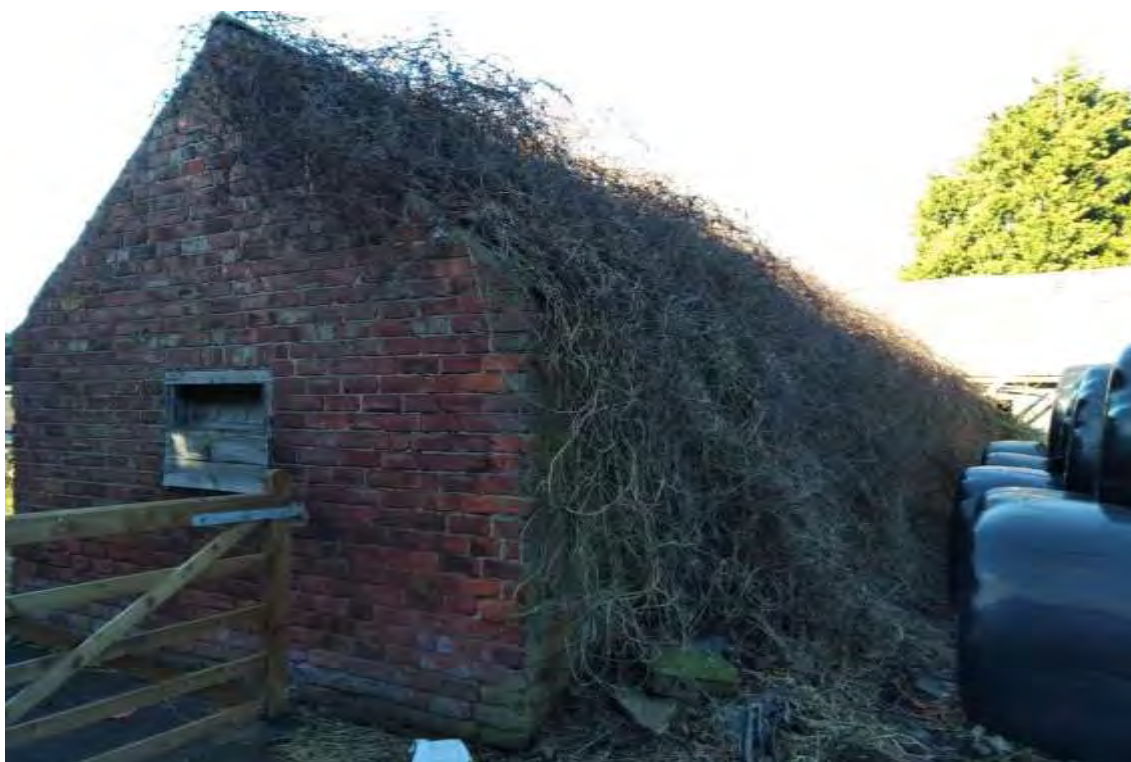
Building 4	A brick-built, single-storey stable block with pitched slate roof and wooden framed windows and doors. Close-coupled roof construction with wooden beams, joists and purlins. Condition of roof has deteriorated considerably due to climbing plant.	Feeding roost
Building 5	Large stone-built storage building comprising with a pitched corrugated sheet roof. The building adjoins building 6 on its eastern side. The interior roof structure is a collar beam roof with beams resting directly on the top of the walls. Many crevices within internal walls particularly along the southern wall of the building. The southern wall	Known roost

Photograph 5 Building 4, eastern and southern aspect. Roof in poor condition and damaged due to climbing plant.

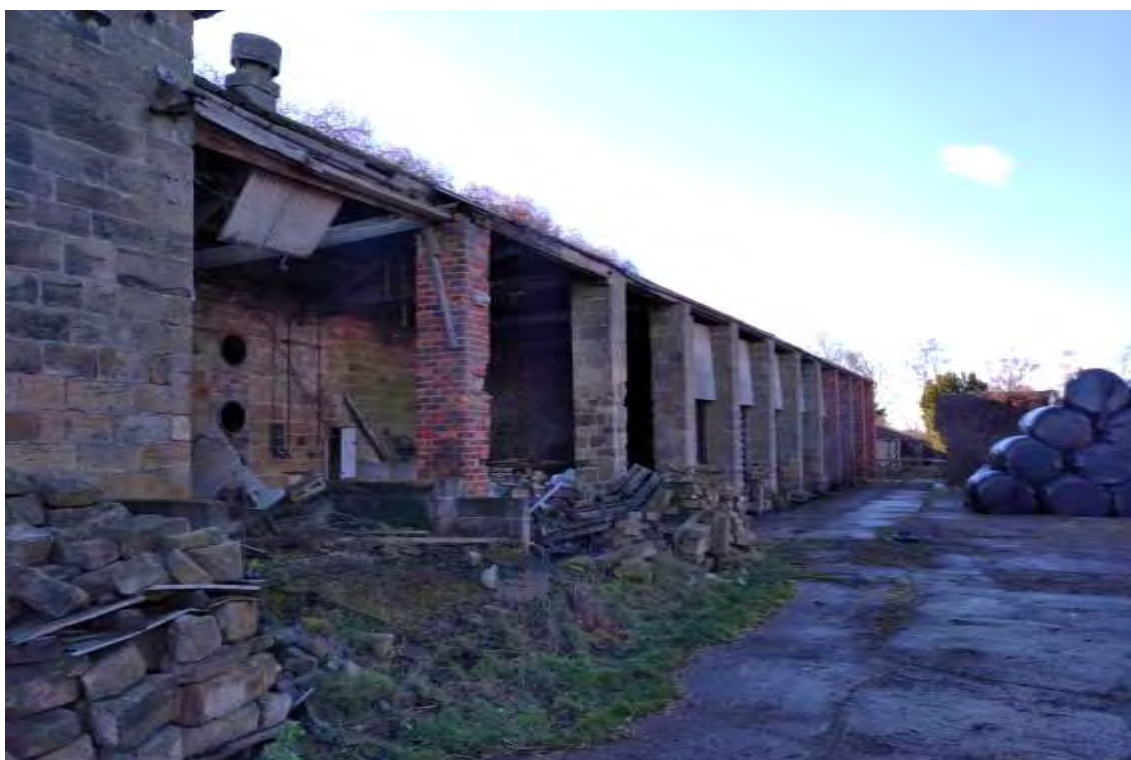
Photograph 6 Building 5, northern aspect.

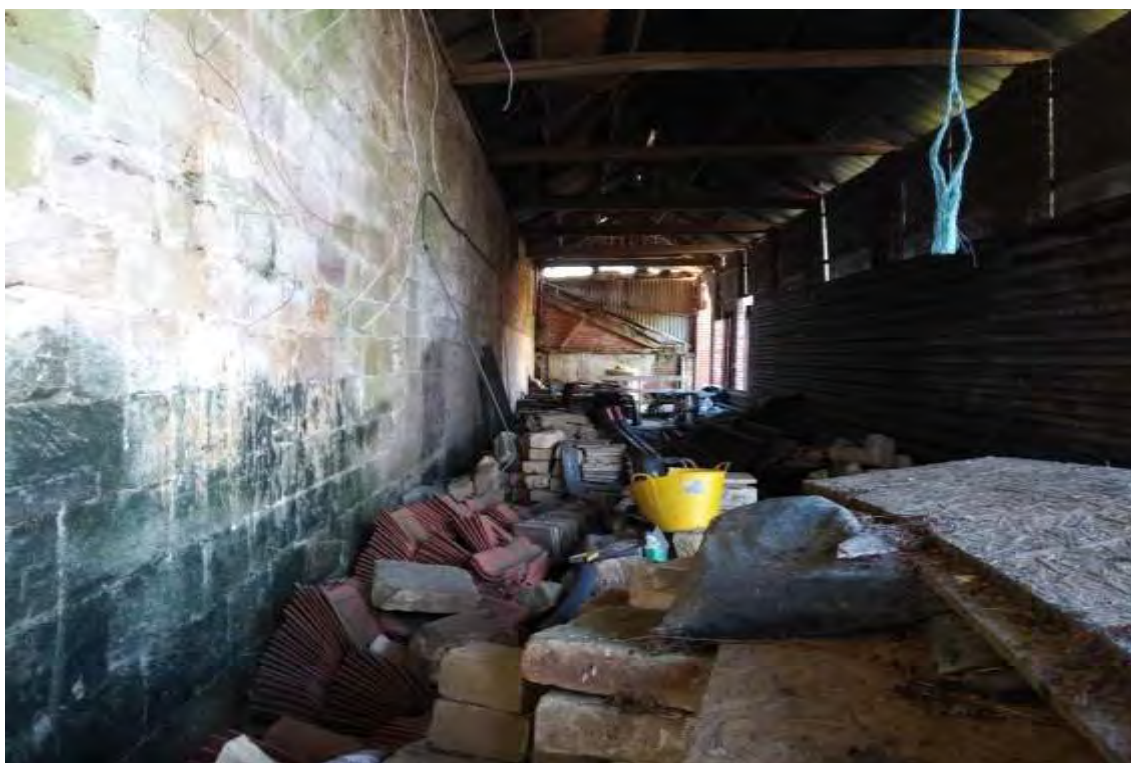
Photograph 7 Building 5 internal structure. Illustrating storage of reclaimed building materials.

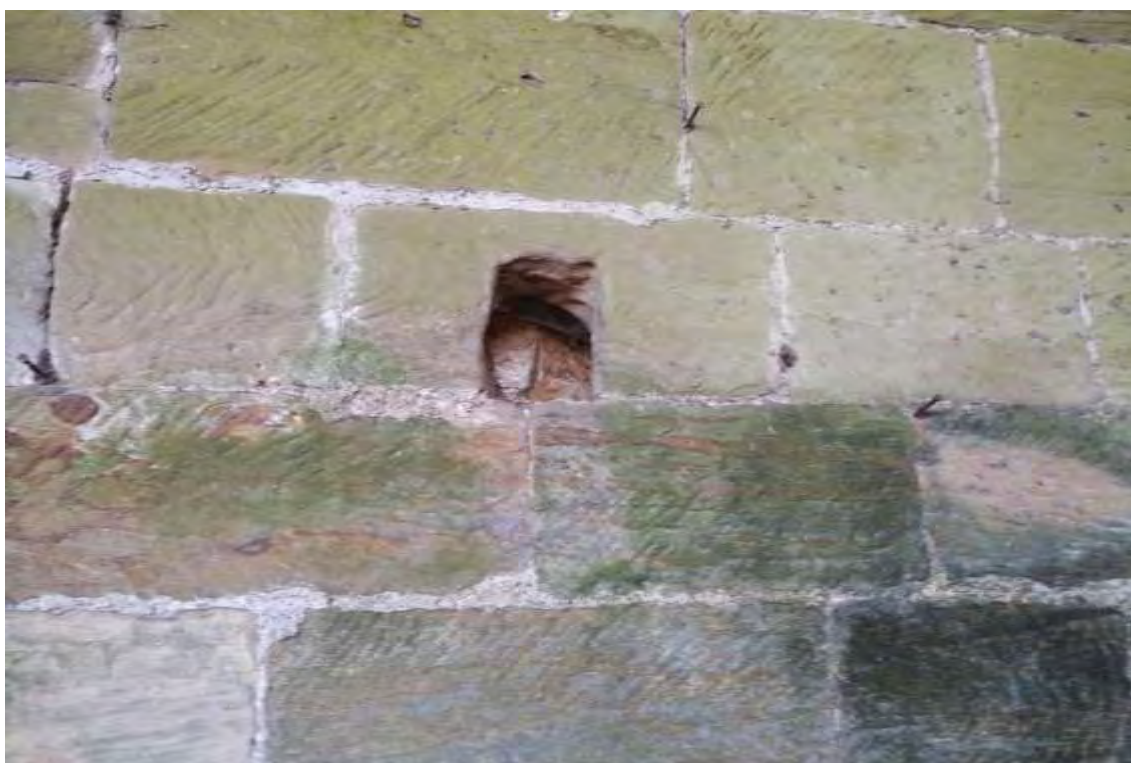
Photograph 8 Interior wall of building 5 showing example of hole in brickwork.

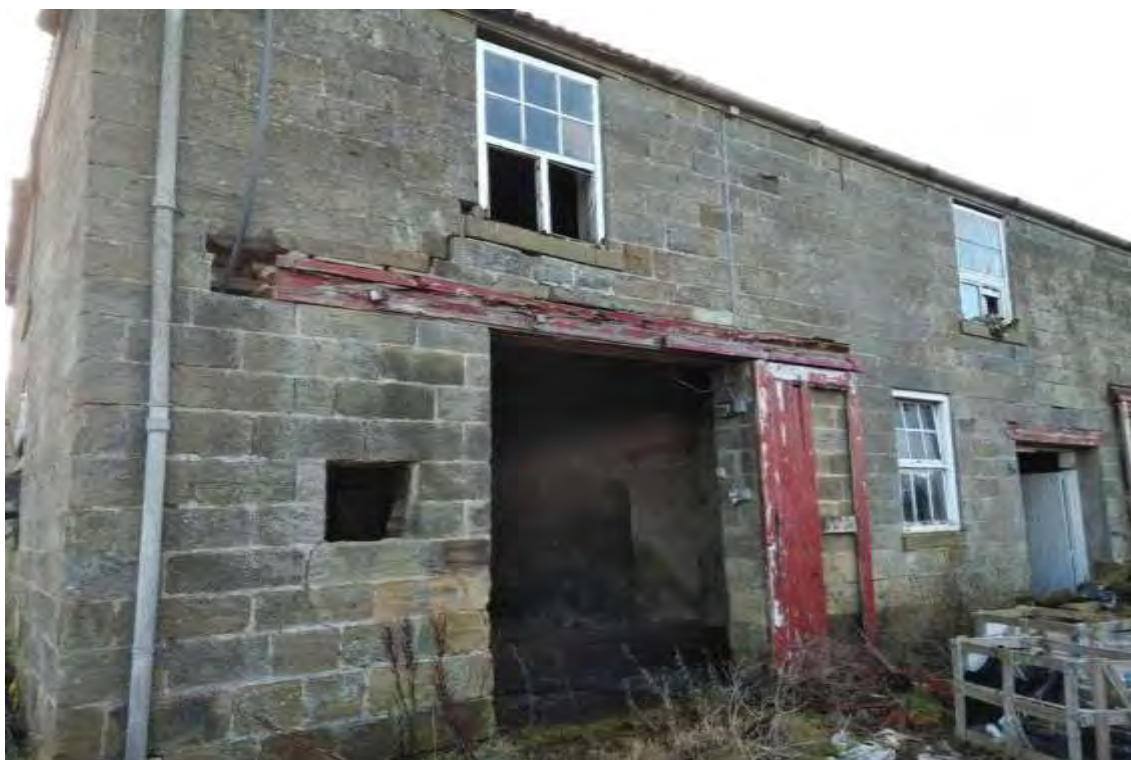
Photograph 9 Building 6, northern aspect showing cracks in stonework due to failing wooden lintel and missing stones.

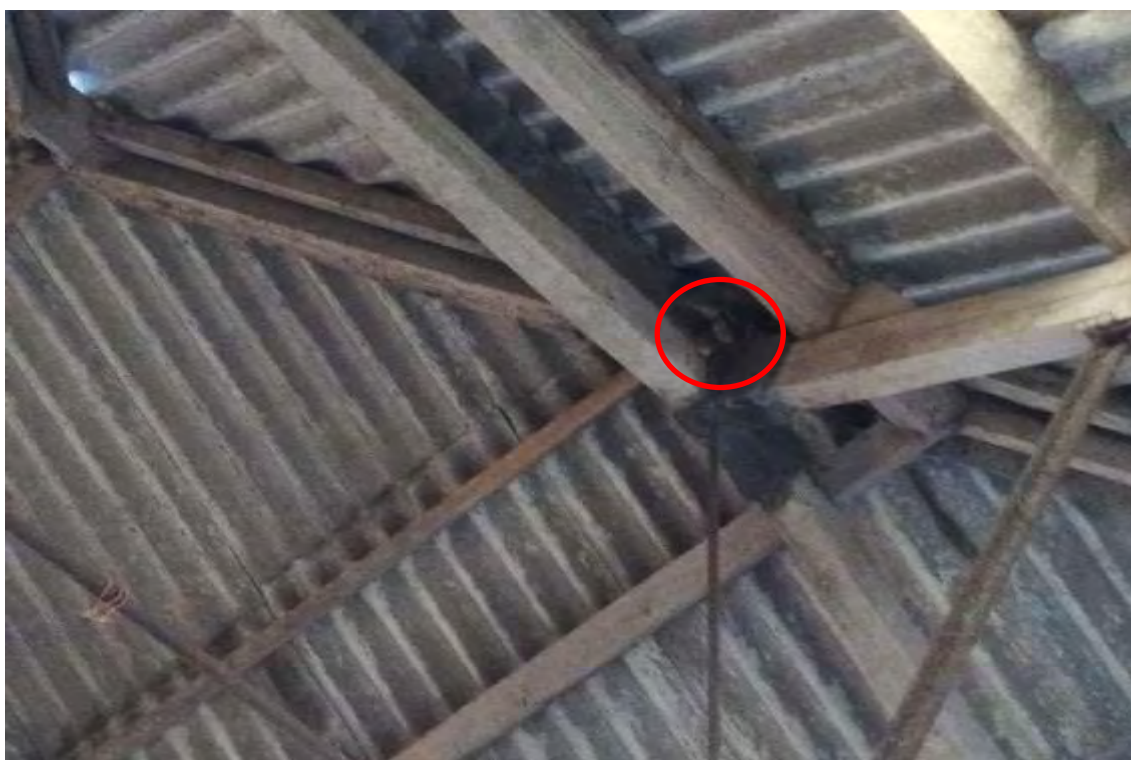
Photograph 10 Building 6, internal roof structure examined through holes in floor. Circled area shows location of roosting tawny owl.

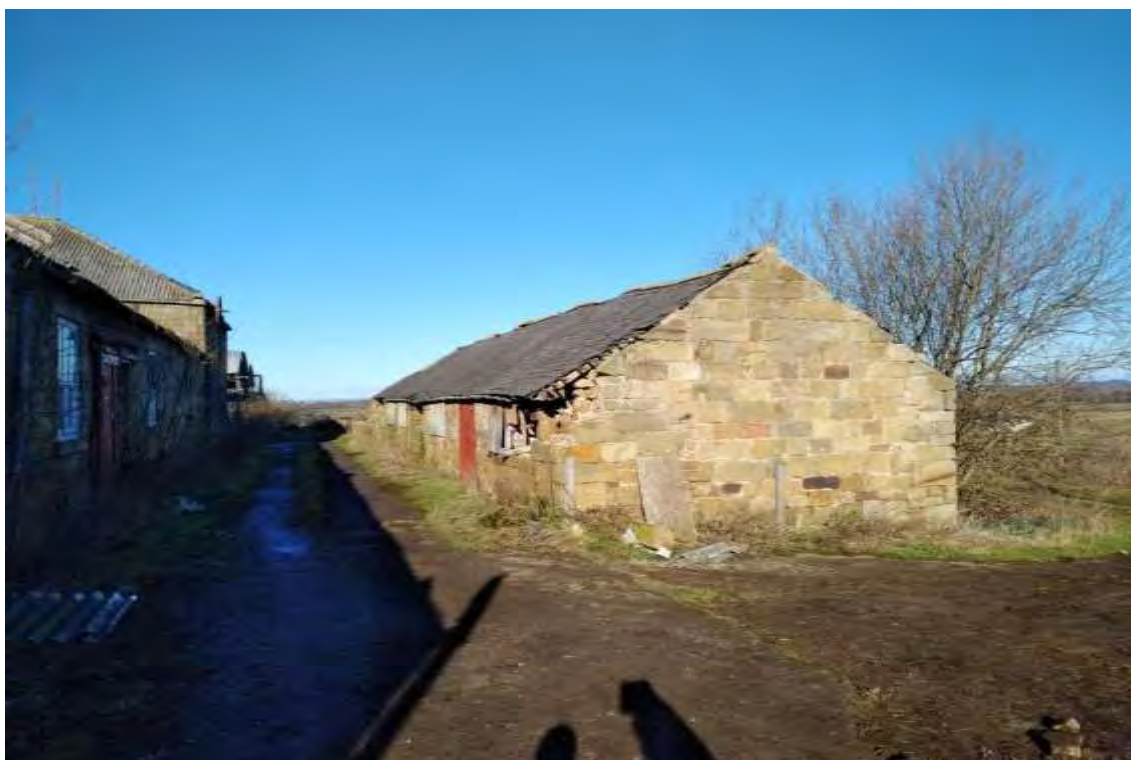
Photograph 11 Building 7, southern and western aspect showing collapsed corner of building.

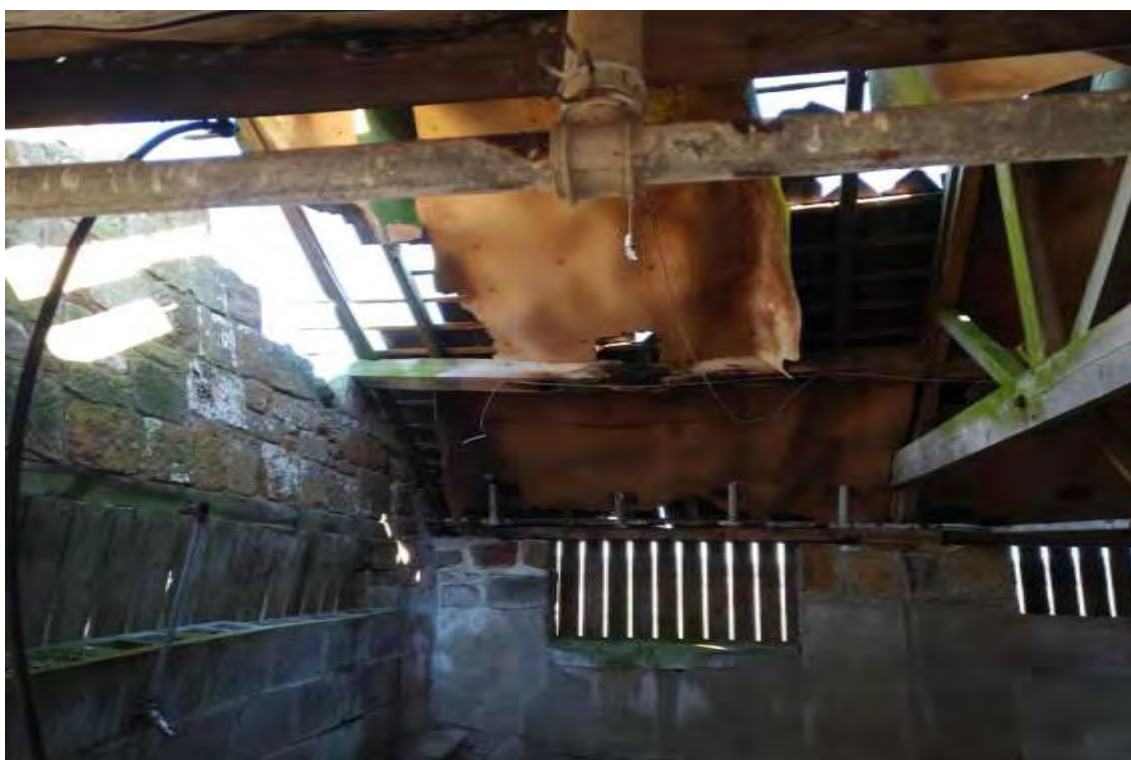
Photograph 12 Building 7, internal structure showing area of missing roof slates at northern end of the building. Building is in a state of disrepair.

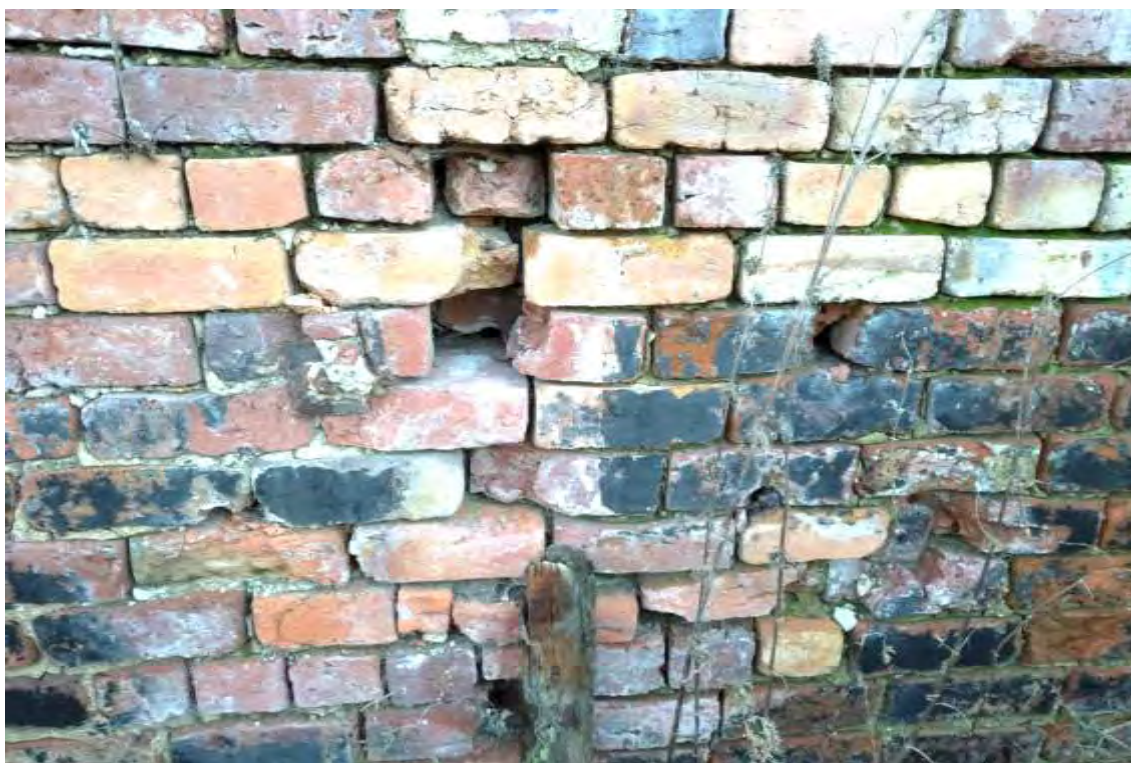
- 5.2 The roofs of the eastern part of Building 14, Building 13 and Building 9 have all collapsed. A dividing brick wall between Buildings 8 and 9 remained and still provided opportunities for bats to gain ingress into the structure.

Photograph 13 Brick wall between buildings 8 & 9 showing deep cracks in brickwork, some of which lead deep into the cavity.

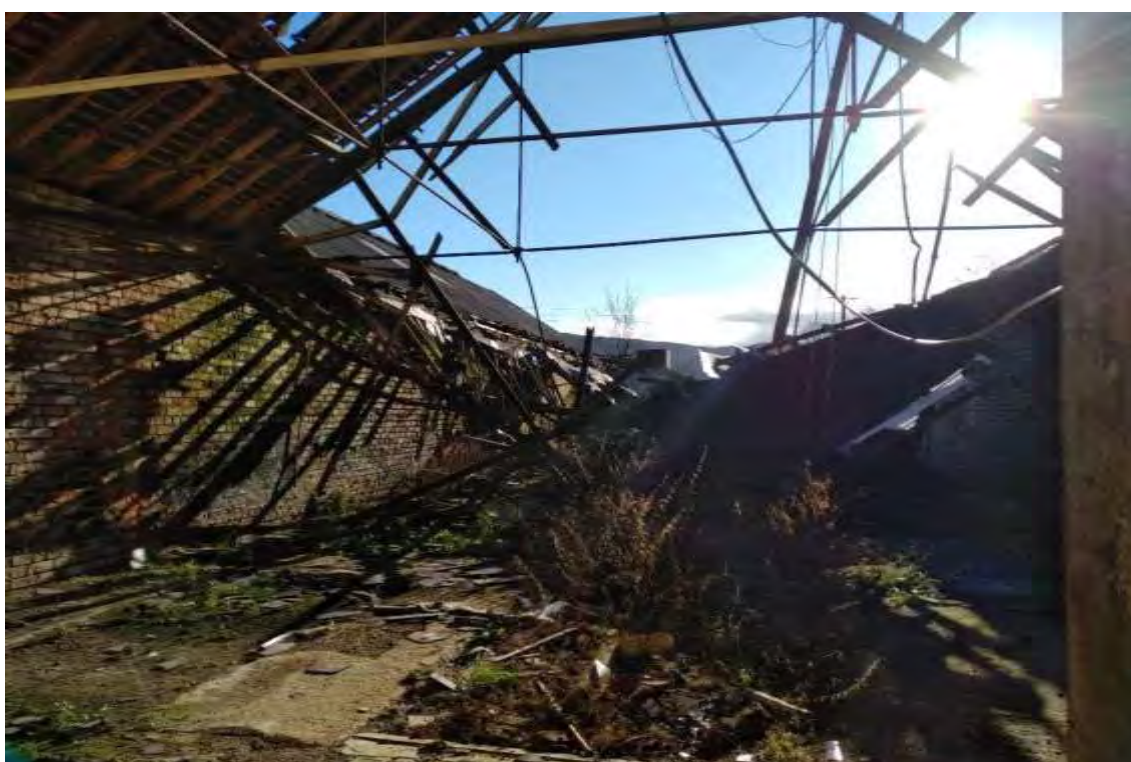
Photograph 14 Building 9 – Roof has collapsed exposing the interior to the elements. Walls with gaps in brickwork remain.

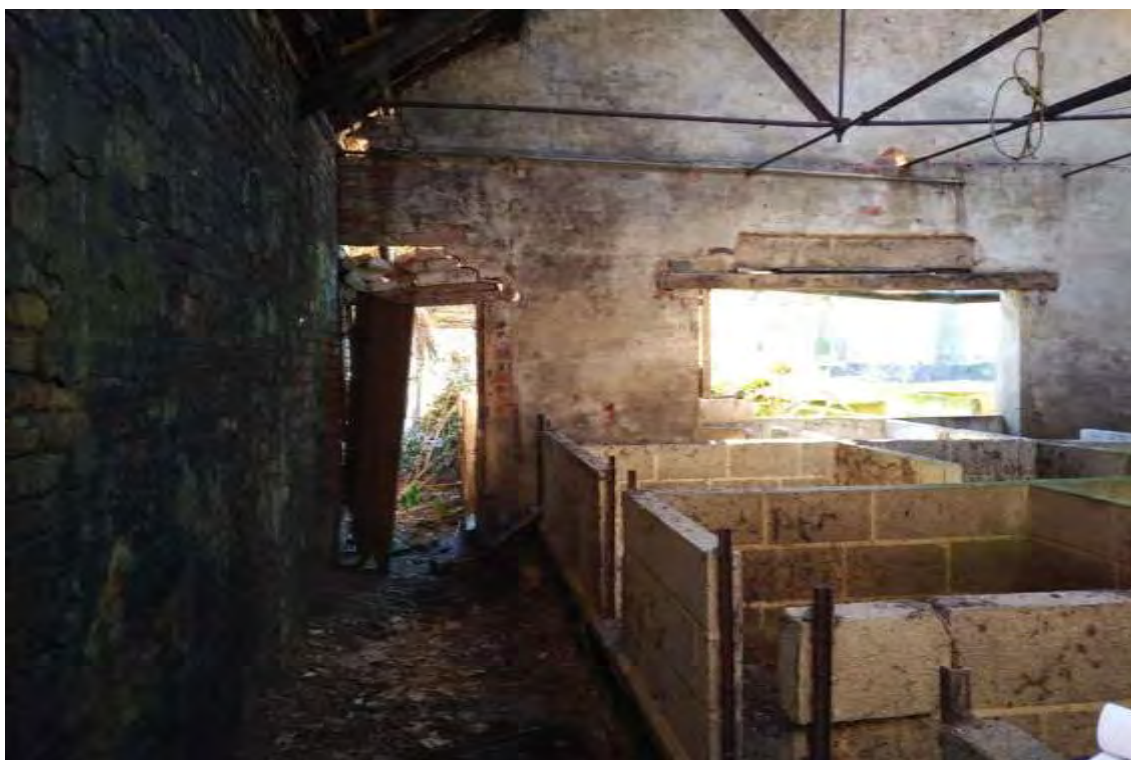
Photograph 15 Northern part of piggery (Building 10) in a state of disrepair, but roof is still standing.

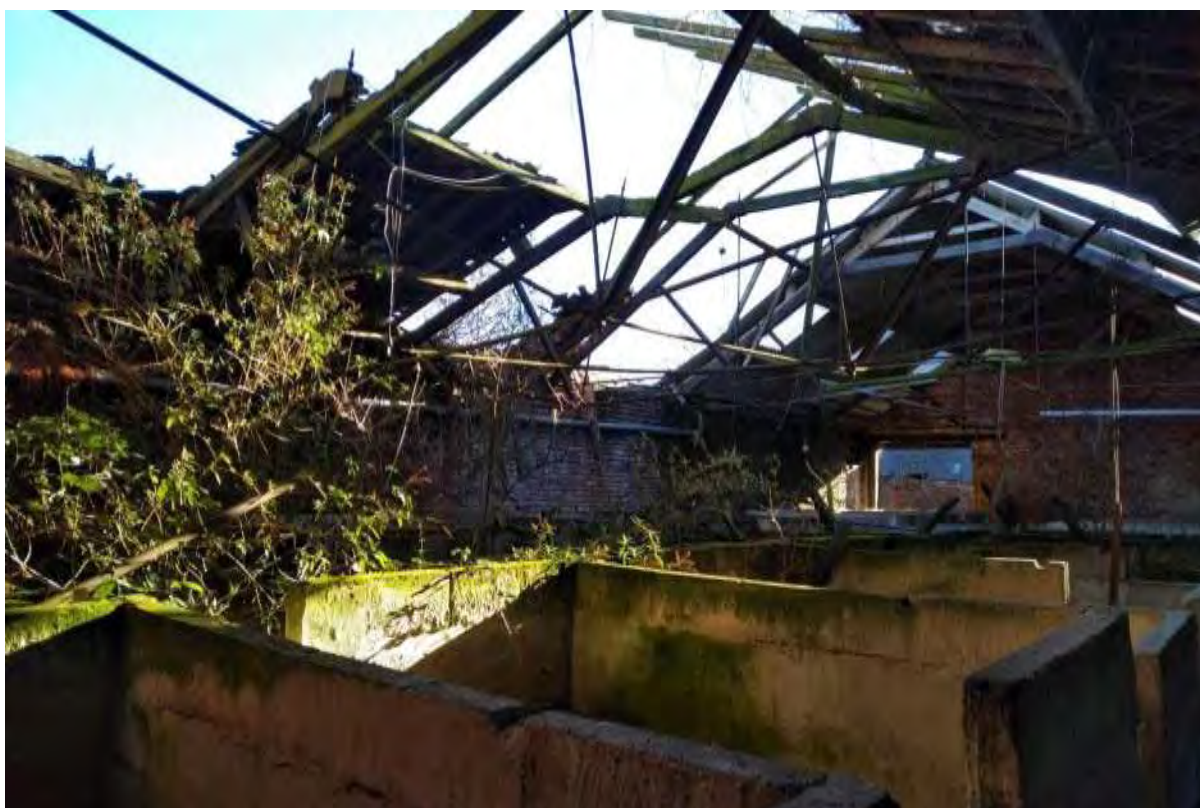
Photograph 16 Southern part of piggery, roof has collapsed exposing it to the elements.

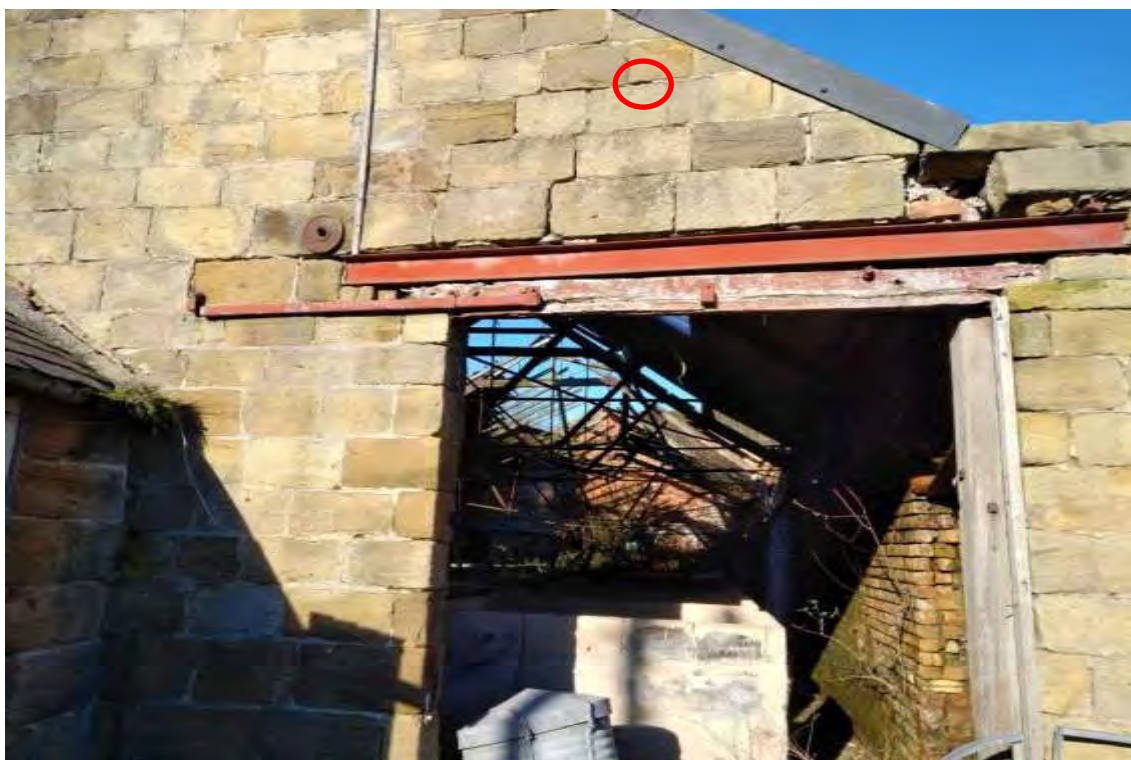
Photograph 17 Cracks in stonework on southern aspect of piggery evident, with former roost site still present (circled) along with larger holes and cracks.

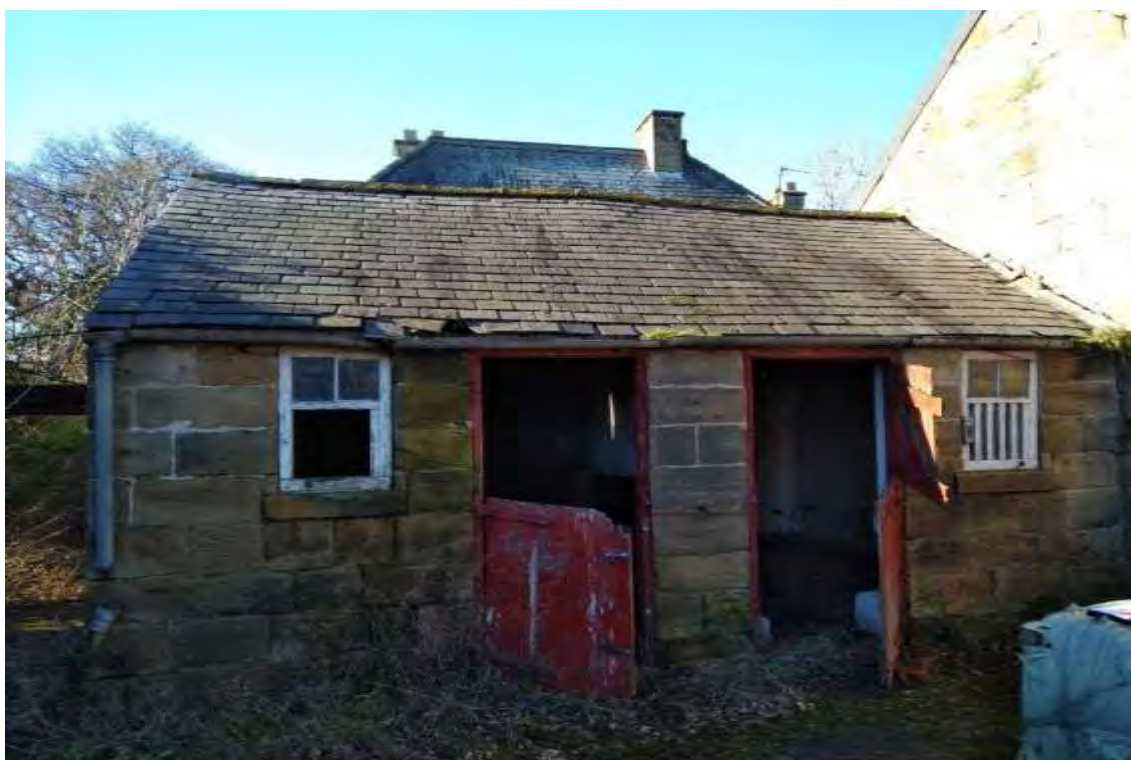
Photograph 18 Building 11 - still has opportunities for void and crevice dwelling bats.

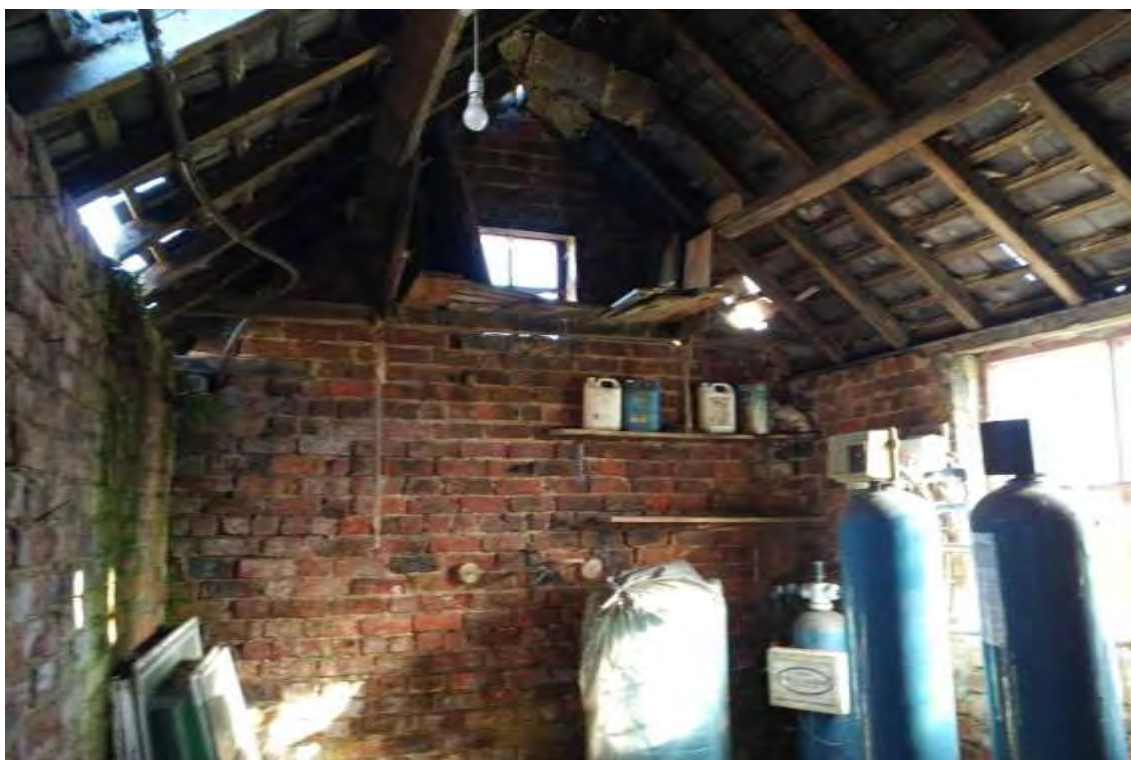
Building 12	<p>Single-storey, brick-built building used for feed and tack storage. Pitched slate roof of wooden framed construction with roof lights. Roof in very poor condition with lots of missing ridge tiles and slates exposing the ridge beam to the elements.</p> <p>Old birds' nest on fuse box and evidence of previous use by swallows.</p>	Negligible
Building 13	<p>Building has collapsed just corrugated sheet walls and a small central section of the roof remain.</p>	Negligible
Building 14	<p>Dilapidated hay barn complex with breeze block lower walls and upper walls and pitched roofs of corrugated sheet with plastic roof lights. Interior is of trussed rafter construction with wooden beams and rafters. Internal walls are of breeze block construction. Wooden framed wooden doors on northern aspects.</p> <p>Western barn has now totally collapsed whilst the eastern barn is still standing and currently houses sheep.</p> <p>Previous surveys have recorded common pipistrelle leaving the building and common pipistrelle, soprano pipistrelle and brown long-eared bats feeding in close proximity. Also a roost of <10 common pipistrelle.</p>	Known roost

Photograph 19 Building 12 has lots of ridge tiles missing and missing slates. Ridge draughty, negligible potential.

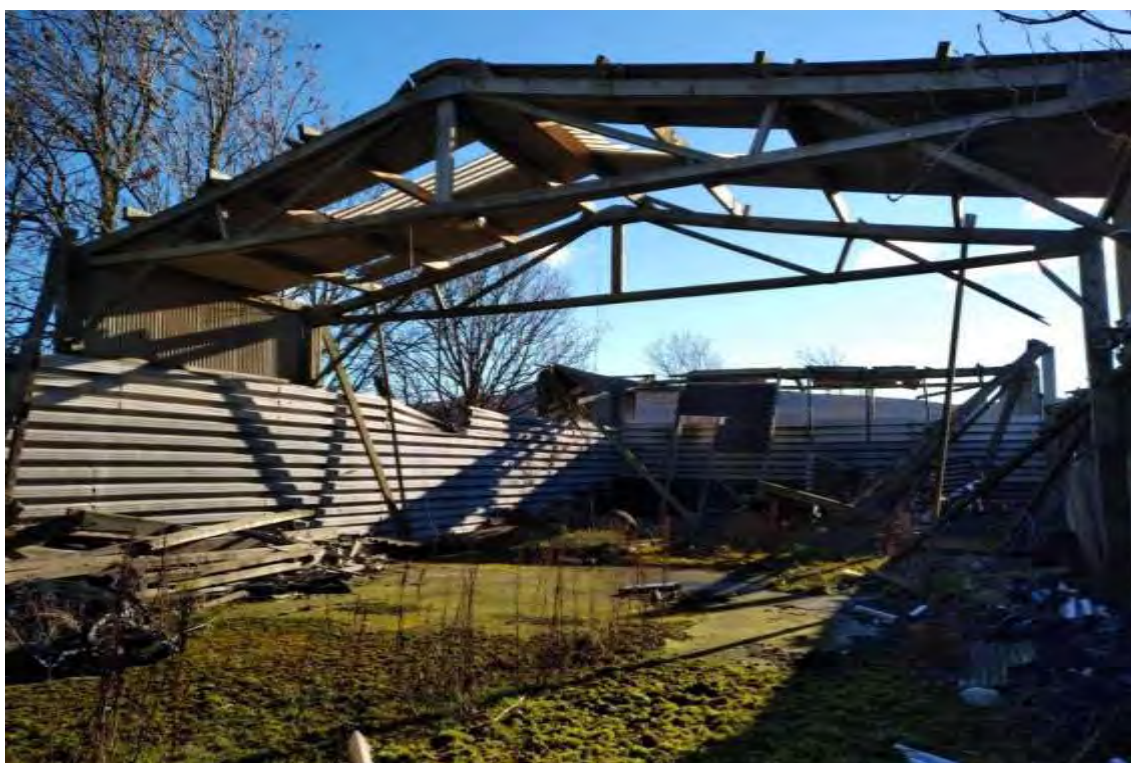
Photograph 20 Building 13, mostly collapsed, just a small central section of roof and corrugated sheet walls remaining.

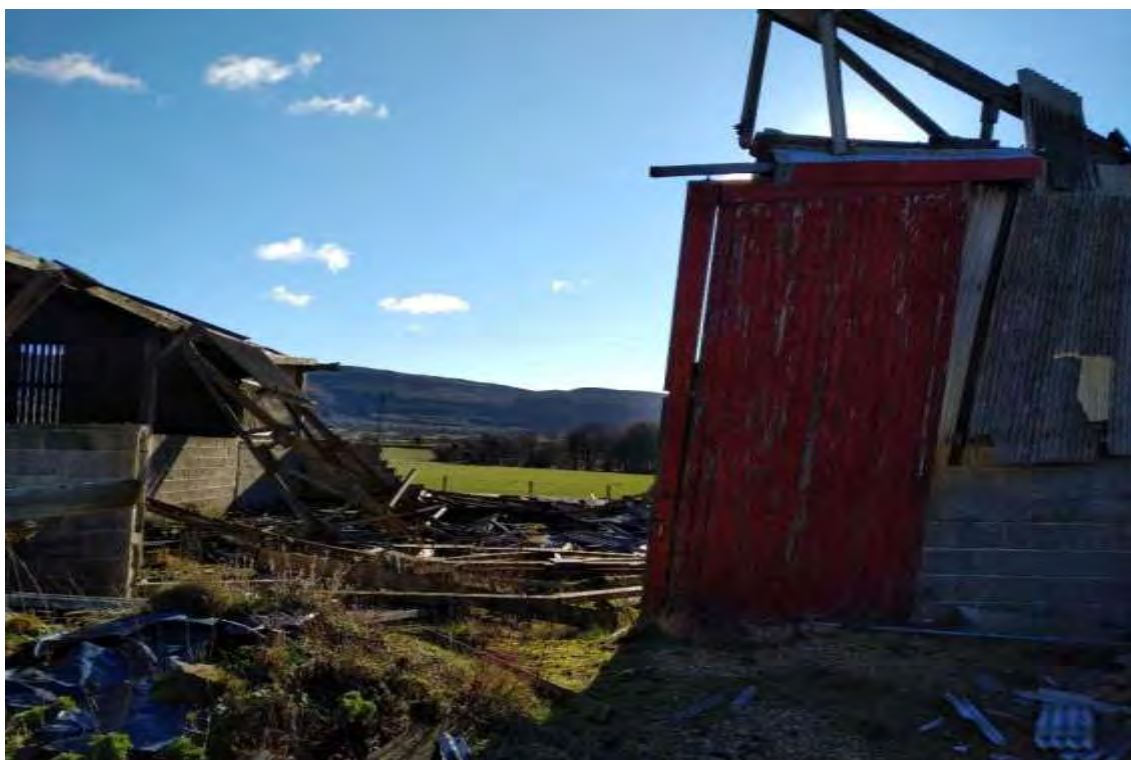
Photograph 21 Western part of Building 14, mostly collapsed.

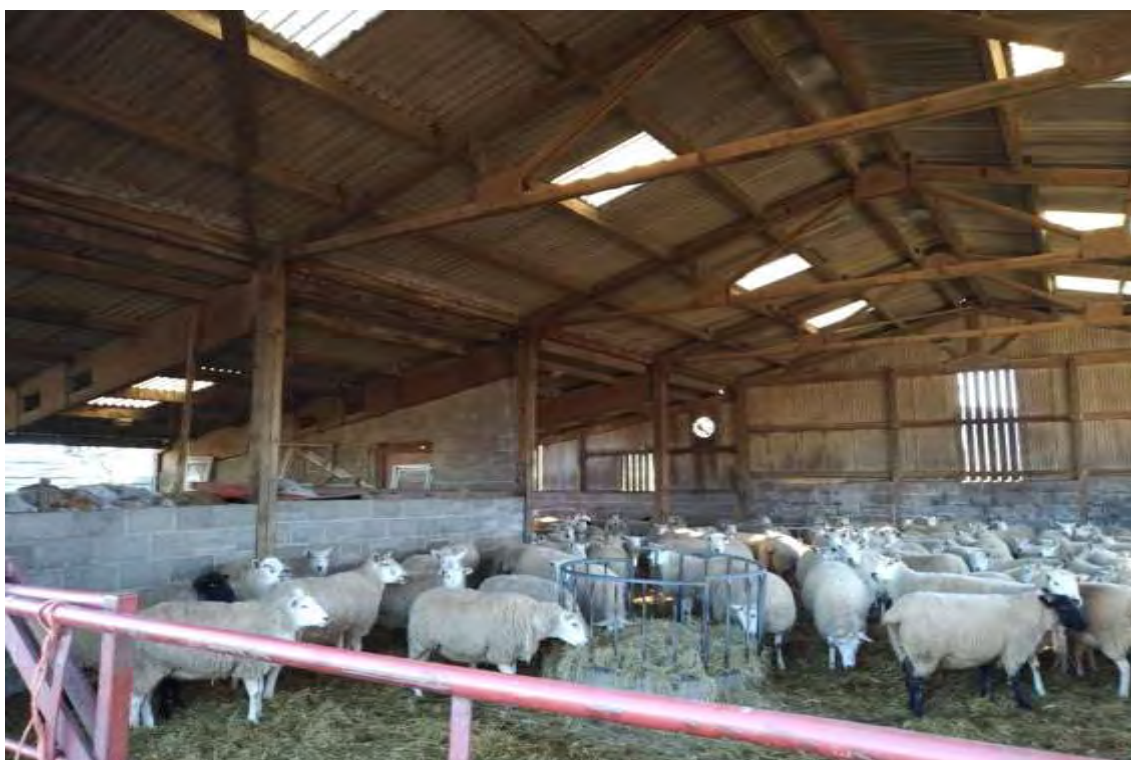
Photograph 22 Western part of Building 14, barn still intact and houses sheep.
