### Refurbishment and Rear Extension

Downhill Cottage, New Road, Robin Hoods Bay, YO22 4SF

## Heritage Statement

STABILITY INSPECTION

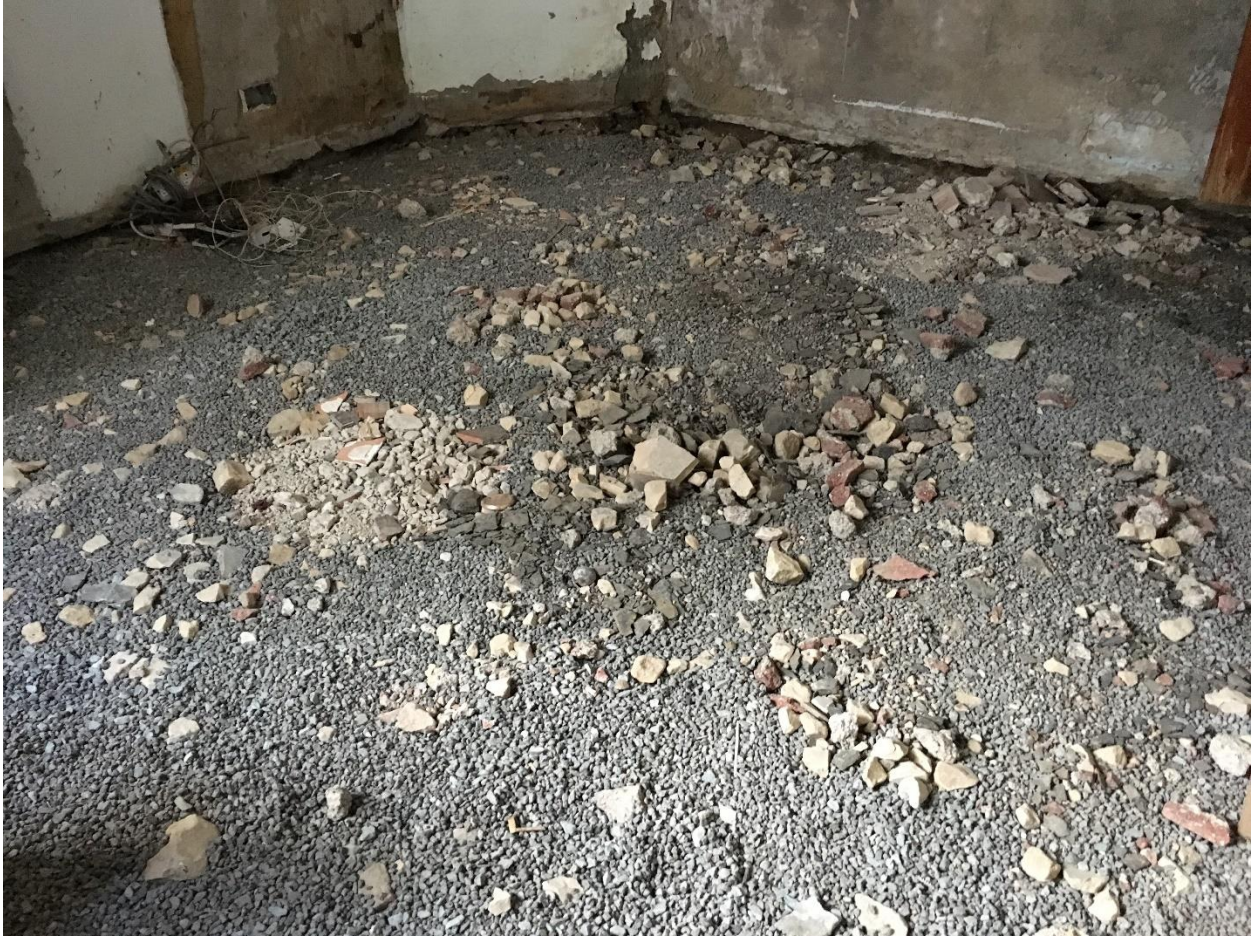
Photograph 1  
Kitchen Floor, concrete finish removed, modern inappropriate hardcore exposed

The previous, recently removed concrete floor, had been badly constructed and its description is noted in the structural report from 2010.

The cause of the heave in the kitchen floor is almost certainly sulphate attack of the hardcore filling on the concrete slab in the presence of damp. The hogging is caused by the concrete slab expanding against the containment of the perimeter walls. In more recent less robust construction the walls can be affected by the force involved. In this case there were no signs of the walls, which are of considerable thickness being forced outwards.

New works will remove the inappropriate fill previously used. Test holes suggest the original shale bed is approximately 170-200mm below the existing surface.

Provide damp proof membrane, Newton type, which allows water to percolate below and prevents a build up of water pressure by not interfering with current water passage or levels.

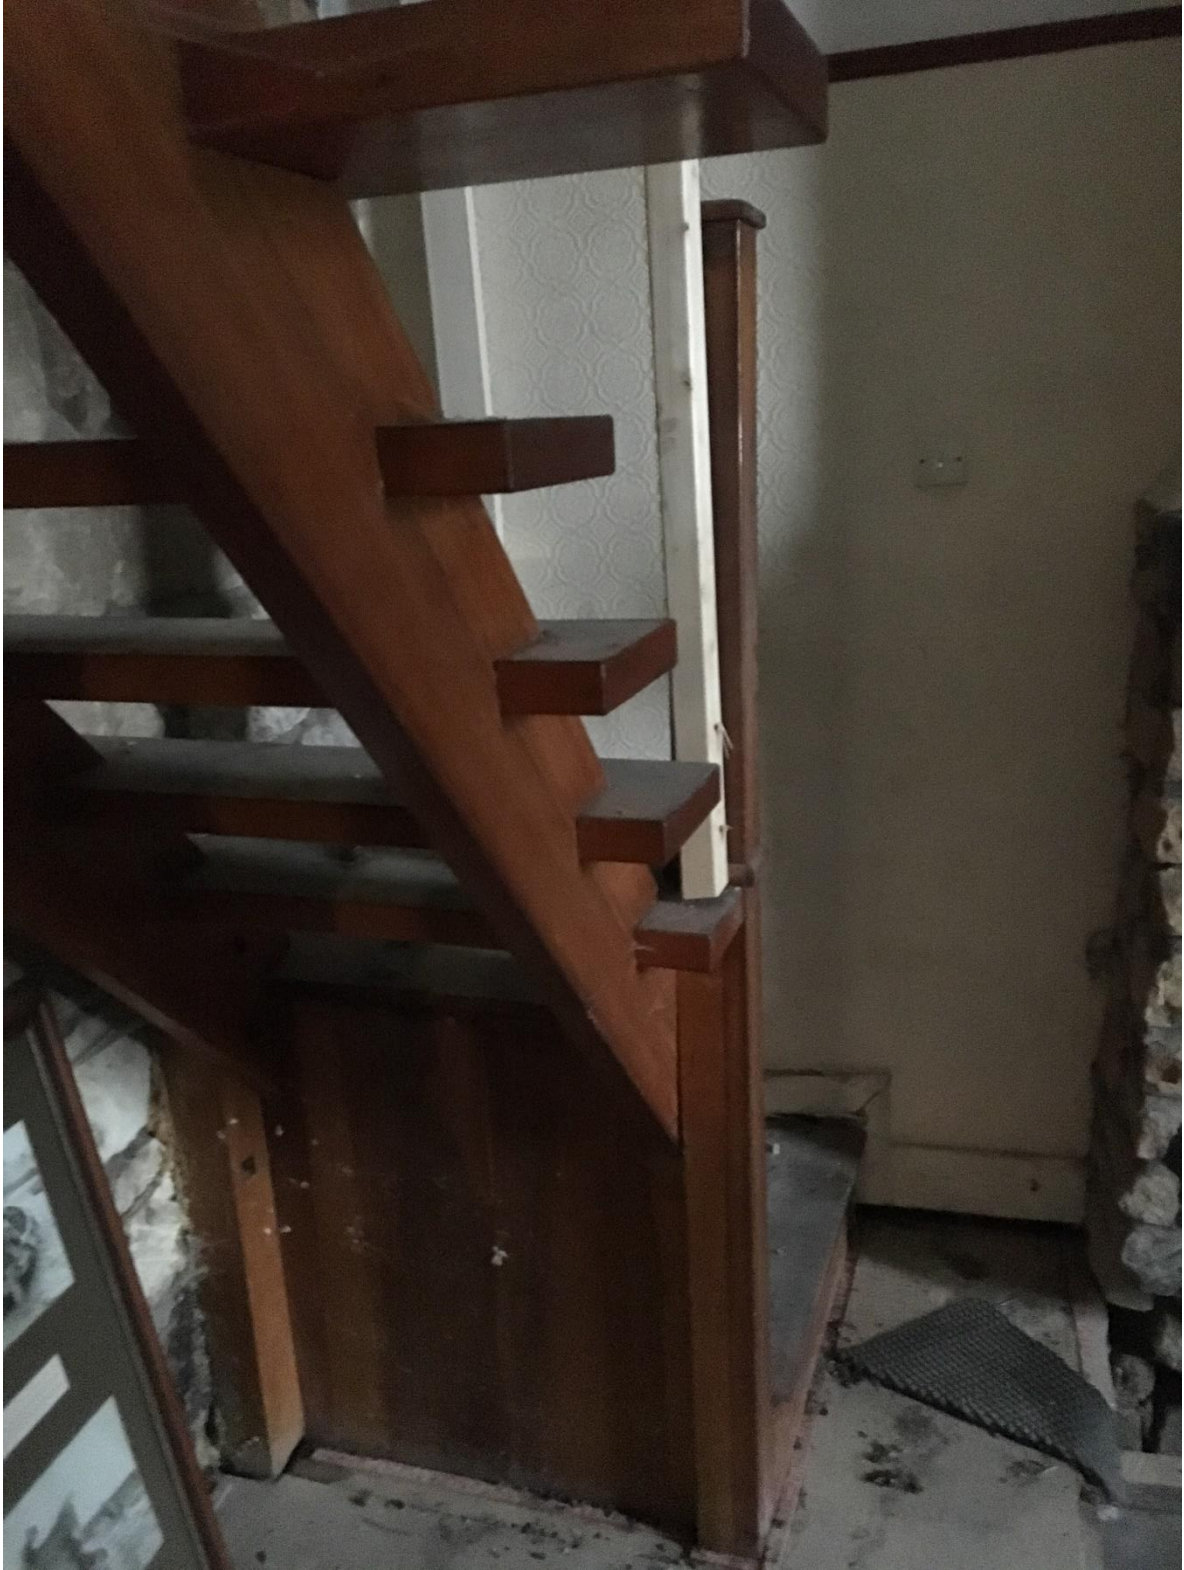
Photograph 2  
Open plan stair to lounge

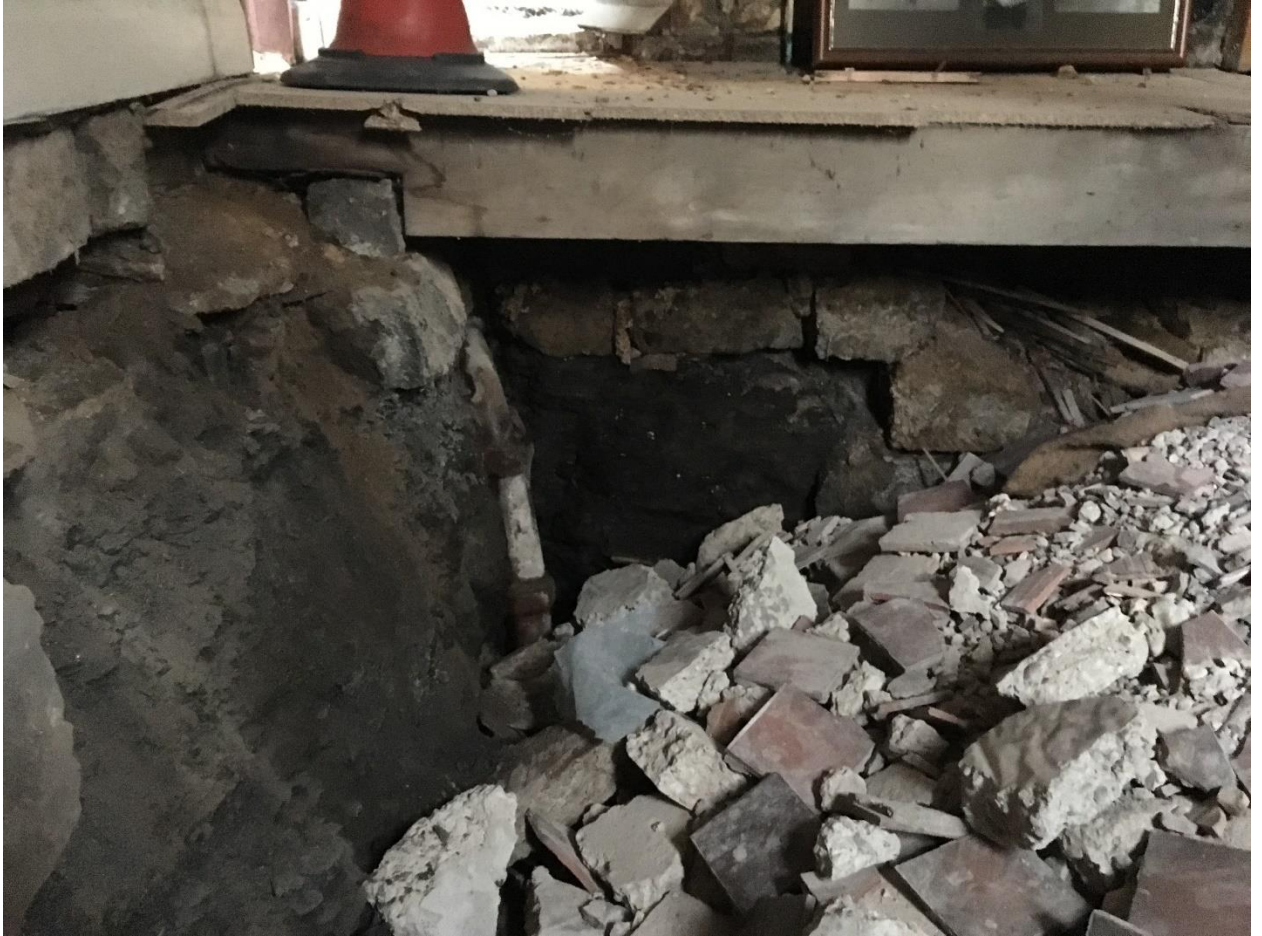
Photograph 3  
Lounge floor, void below former timber floor

Prior to installation of the timber floor and floor joists remedial work is required.

Removal of temporary debris. This will leave a large void which is deeper than the base of the stone walls which sit on the shale bed.

Line the walls and the base with the Newton membrane to allow existing hydrostatic pressure from any ground water to remain unaltered and therefore not change its affect upon the existing fabric of the building.

Concrete is then to be laid on top of the membrane to a depth of 250mm, to provide a base for a perimeter of concrete block below ground walls. These walls will be taken up to a level that ensures the base of existing stone walls is not left exposed and at risk of collapse. Any of the voids left between the new concrete walls and the existing wall and rough edge below is to be filled with concrete, again to prevent any further movement.

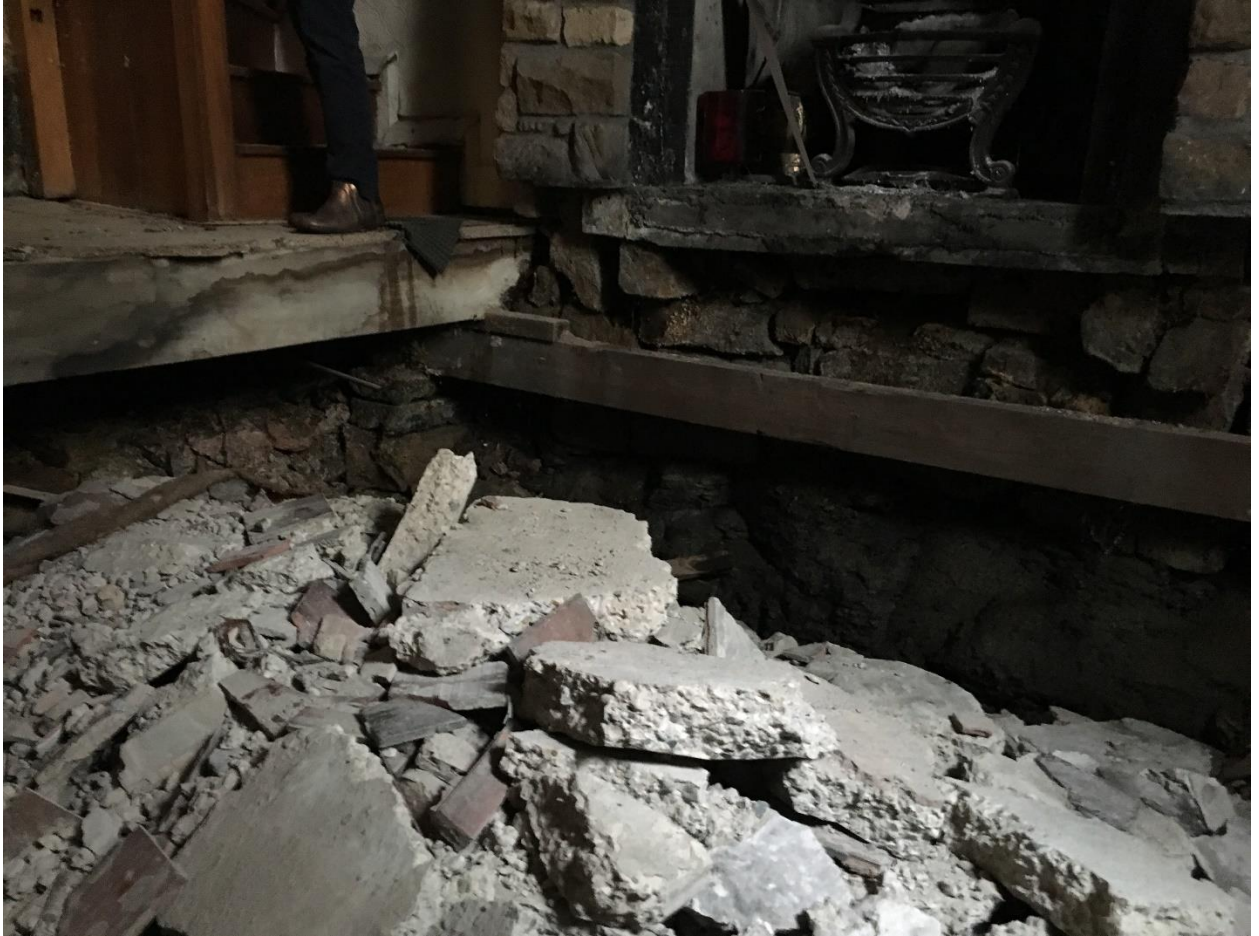
Photograph 4  
Lounge floor, void below former timber floor,  
dumped waste from kitchen floor to be removed

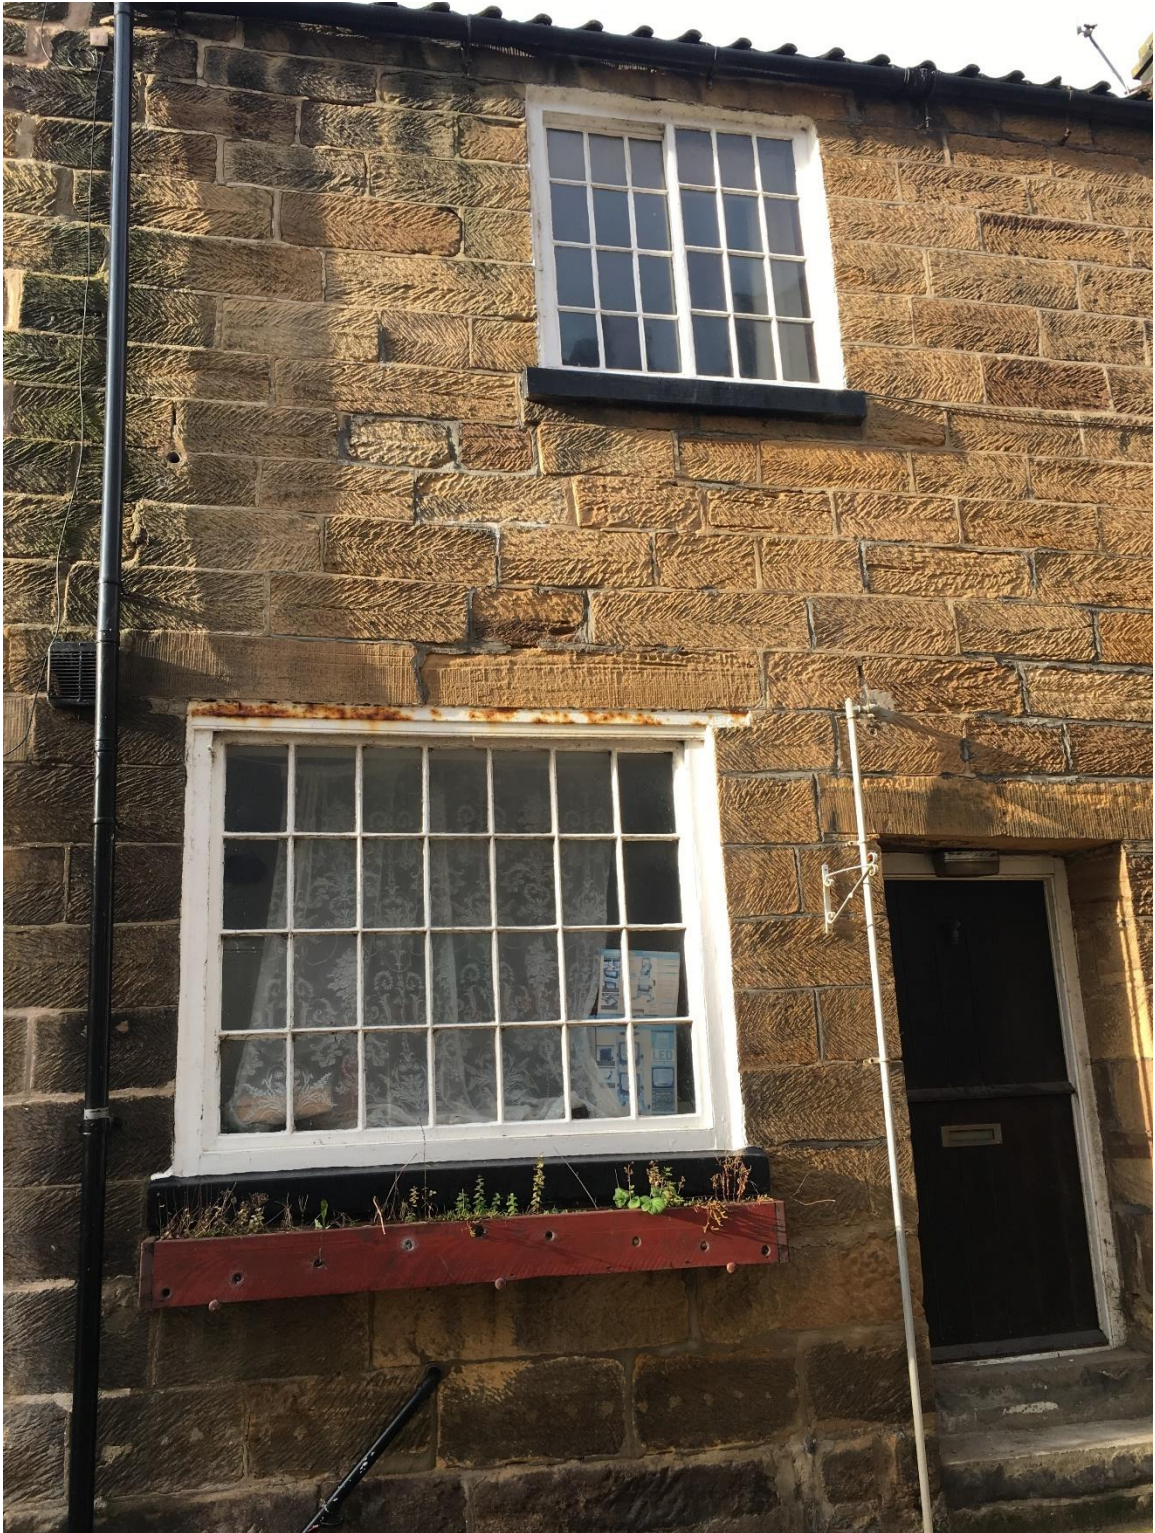
The kitchen window W1, has been amended at some point, although quite historic. It appears that due to a failure of the stone lintel above, a steel support was inserted below the stone lintel and cut into the coursed stone on either side. Possibly at the same point in time a fixed sash was inserted.

Photograph 5  
Part Front Elevation, W1 and W3

Although there is some variation, generally the stonework is pointed using a slightly raised, weathered style. This style of cement based pointing is not appropriate for the location or the coursed sandstone, often leading to premature erosion of the stone face.

W1; the fixed window is to be replaced with 2 vertical sliding sash windows. This we suggest will be closer to the original version and match the other ground level windows in the row.

W3; The vertical sliding sash window will be replaced by a vertical sliding sash window of the same proportions.

It is proposed to rake out using hand tools and repointing with a lime based mortar with a mix of 1:2:9 (cement lime sand). This should be finished slightly recessed with a brushed or 'bagged off' technique.

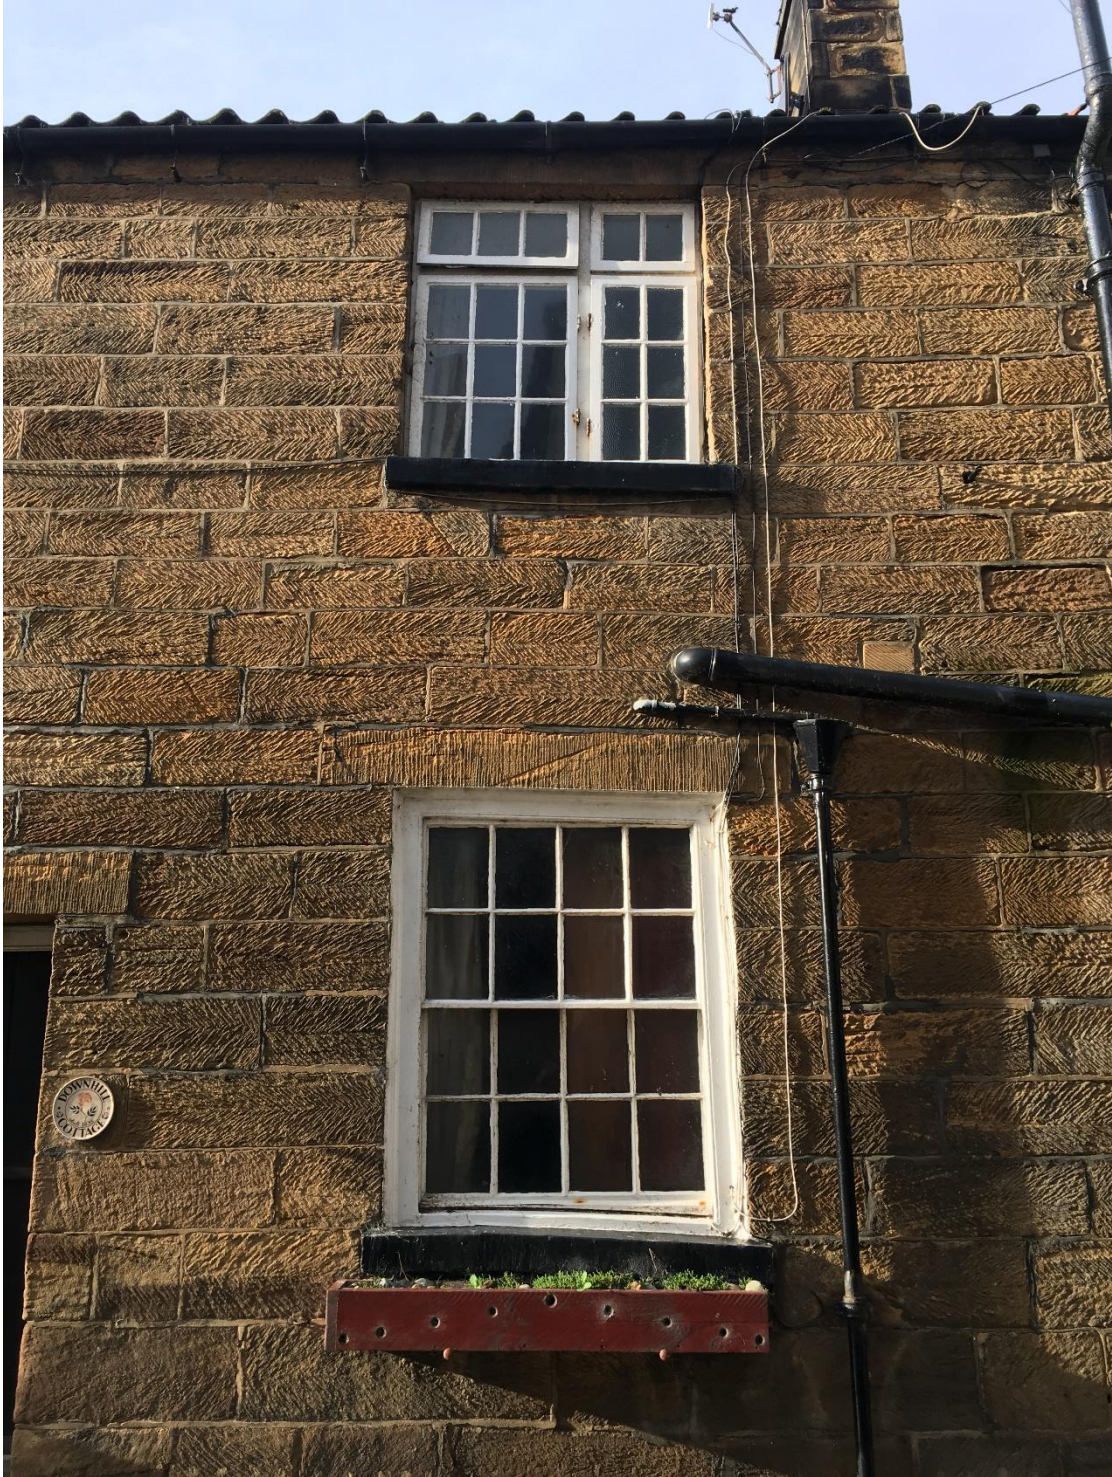
The front elevation contains 4 windows and the entrance door. The windows have undergone some alteration, in particular W4, which is a relatively modern casement window, presumably altered and replaced to allow the historic subdivision of a first-floor bedroom to create a bathroom.

Photograph 6  
Part Front Elevation, W2 and W4

W2; the horizontal sliding sash window will be replaced by a horizontal sliding sash window as Beadle Cottage.

W4; The side hung casements will be replaced by a pair of vertical sliding sash windows. This will allow the internal partition wall which splits the window to be formed by a simple timber between the 2 sashes.

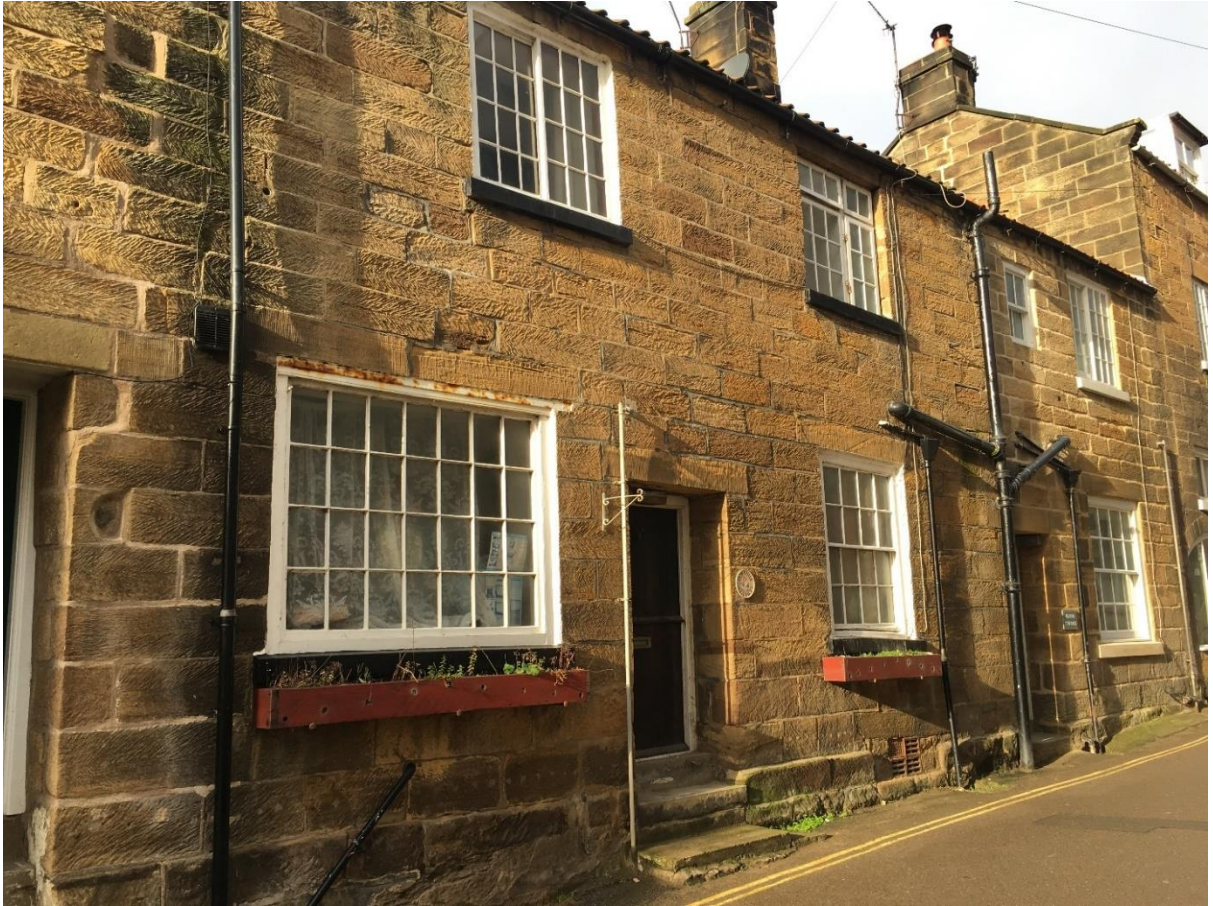
Photograph 7  
Front elevation with Beadle Cottage beyond

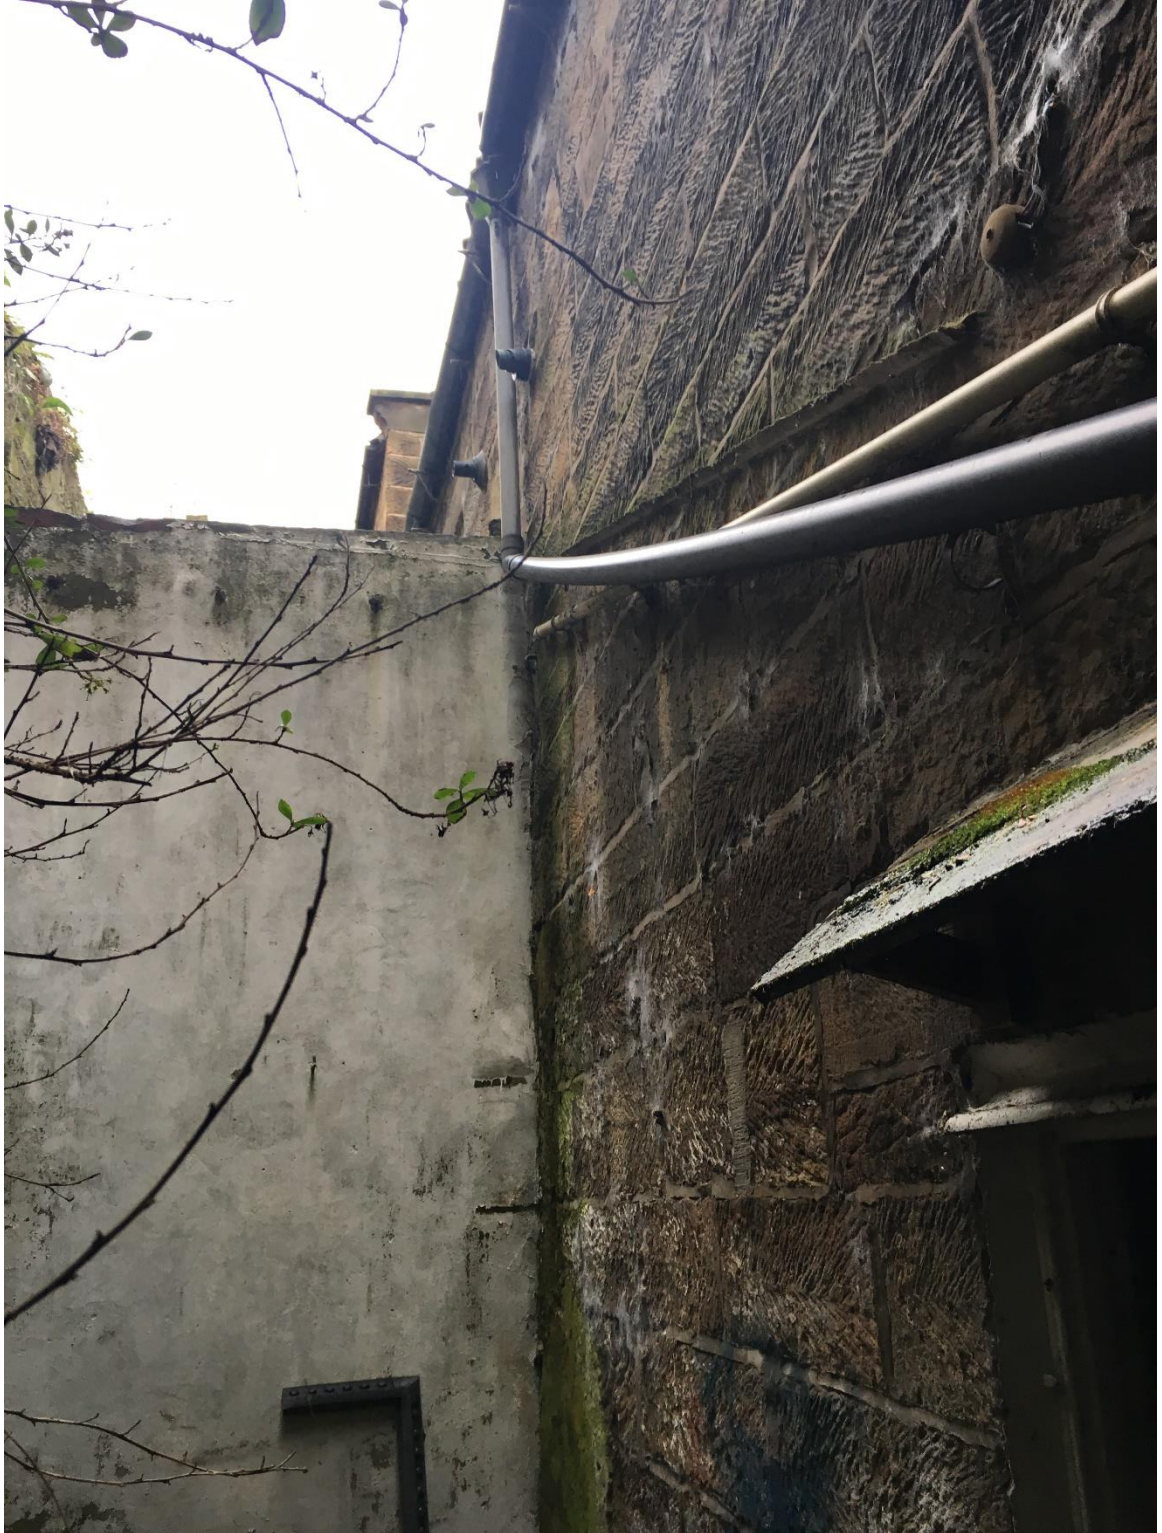
The Yard is bounded by 2/3 storey high Party Walls to either side and a very high (5m +) stone retaining wall to the rear. Due to its relative low position, the Yard will appear dark and damp for most of the time.

Photograph 8  
Rear Yard looking at Party Wall of Beadle Cottage

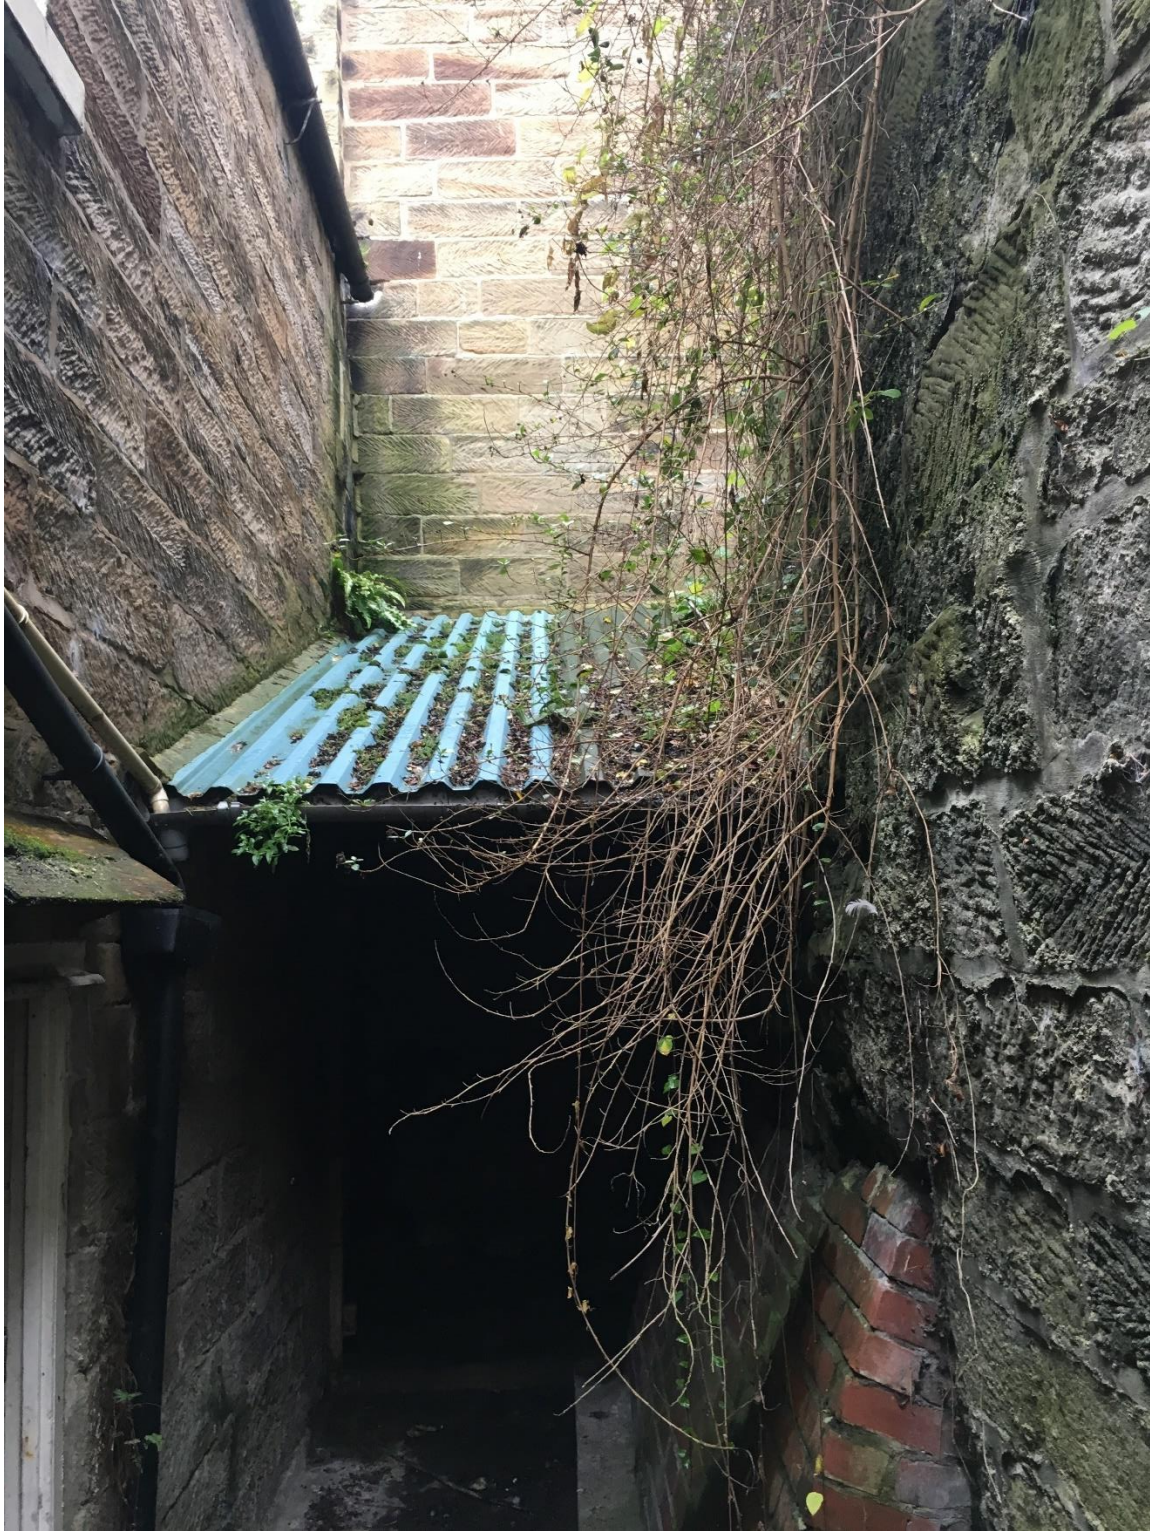
The rear retaining wall has a significant bulge in the centre and a relatively modern brick buttress has been constructed.

Part of the Yard has a modern steel sheet cover. Also apparent are the remnants of haunching, presumably from a previous roof attached to the rear house wall.

Photograph 9  
Rear Yard looking at Party Wall to the south  
Note; covered area and brick buttress

A simple monopitched roof extension is proposed to provide storage and utility space, this will consist mainly of a clay pantiled roof. The small amount of exposed walling will be finished with concrete natural stone. This will also provide significant structural support to the rear retaining wall.
