From: Kieran Robinson
Sent: 04 December 2019 18:53
To: Ailsa Teasdale
Subject: Ladycross - tree and impact assessments

Drawing Title: **House - Impact Assessment**

Lady Cross Caravan Park

Drawing Title:
Entrance - Impact Assessment

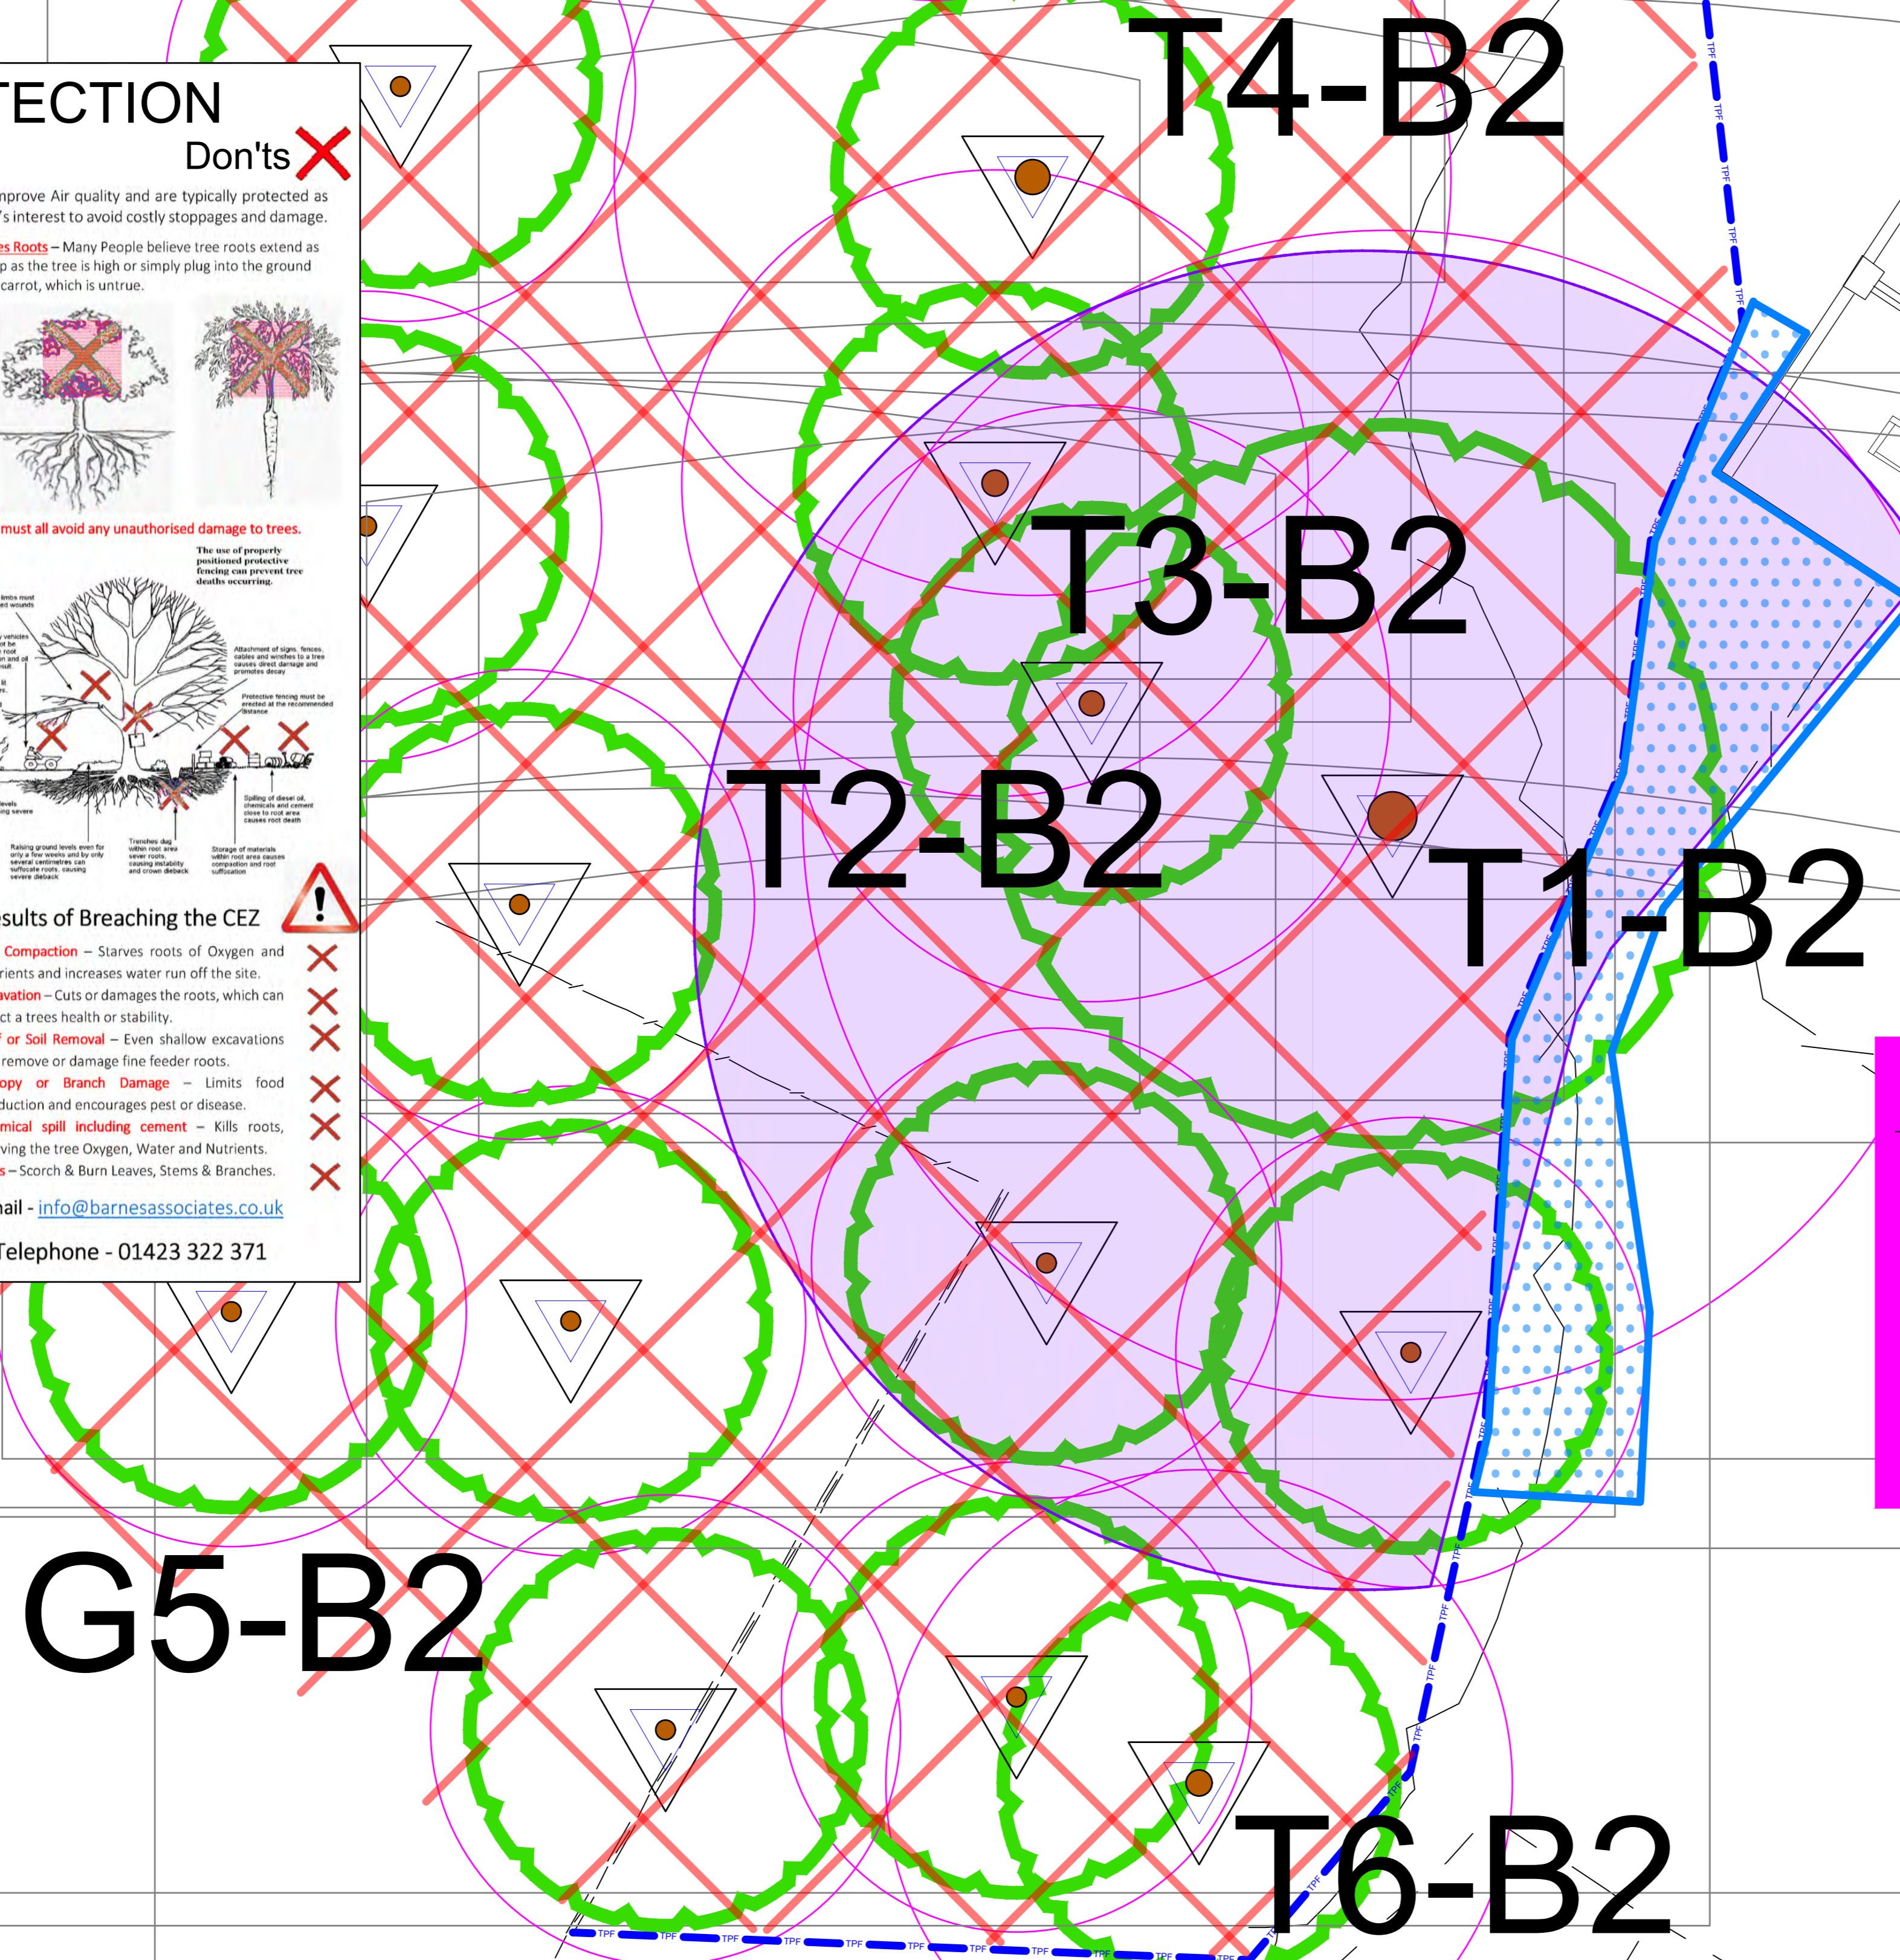
RPA infringement of T1
Infringement has been estimated at 4% where traditional foundation type is thought to effect the health of the tree.

Tree Protection Zone.
The volume of soil adjacent to the proposal is to be protected by Ground Protection during the construction phase to limit compaction or contamination.

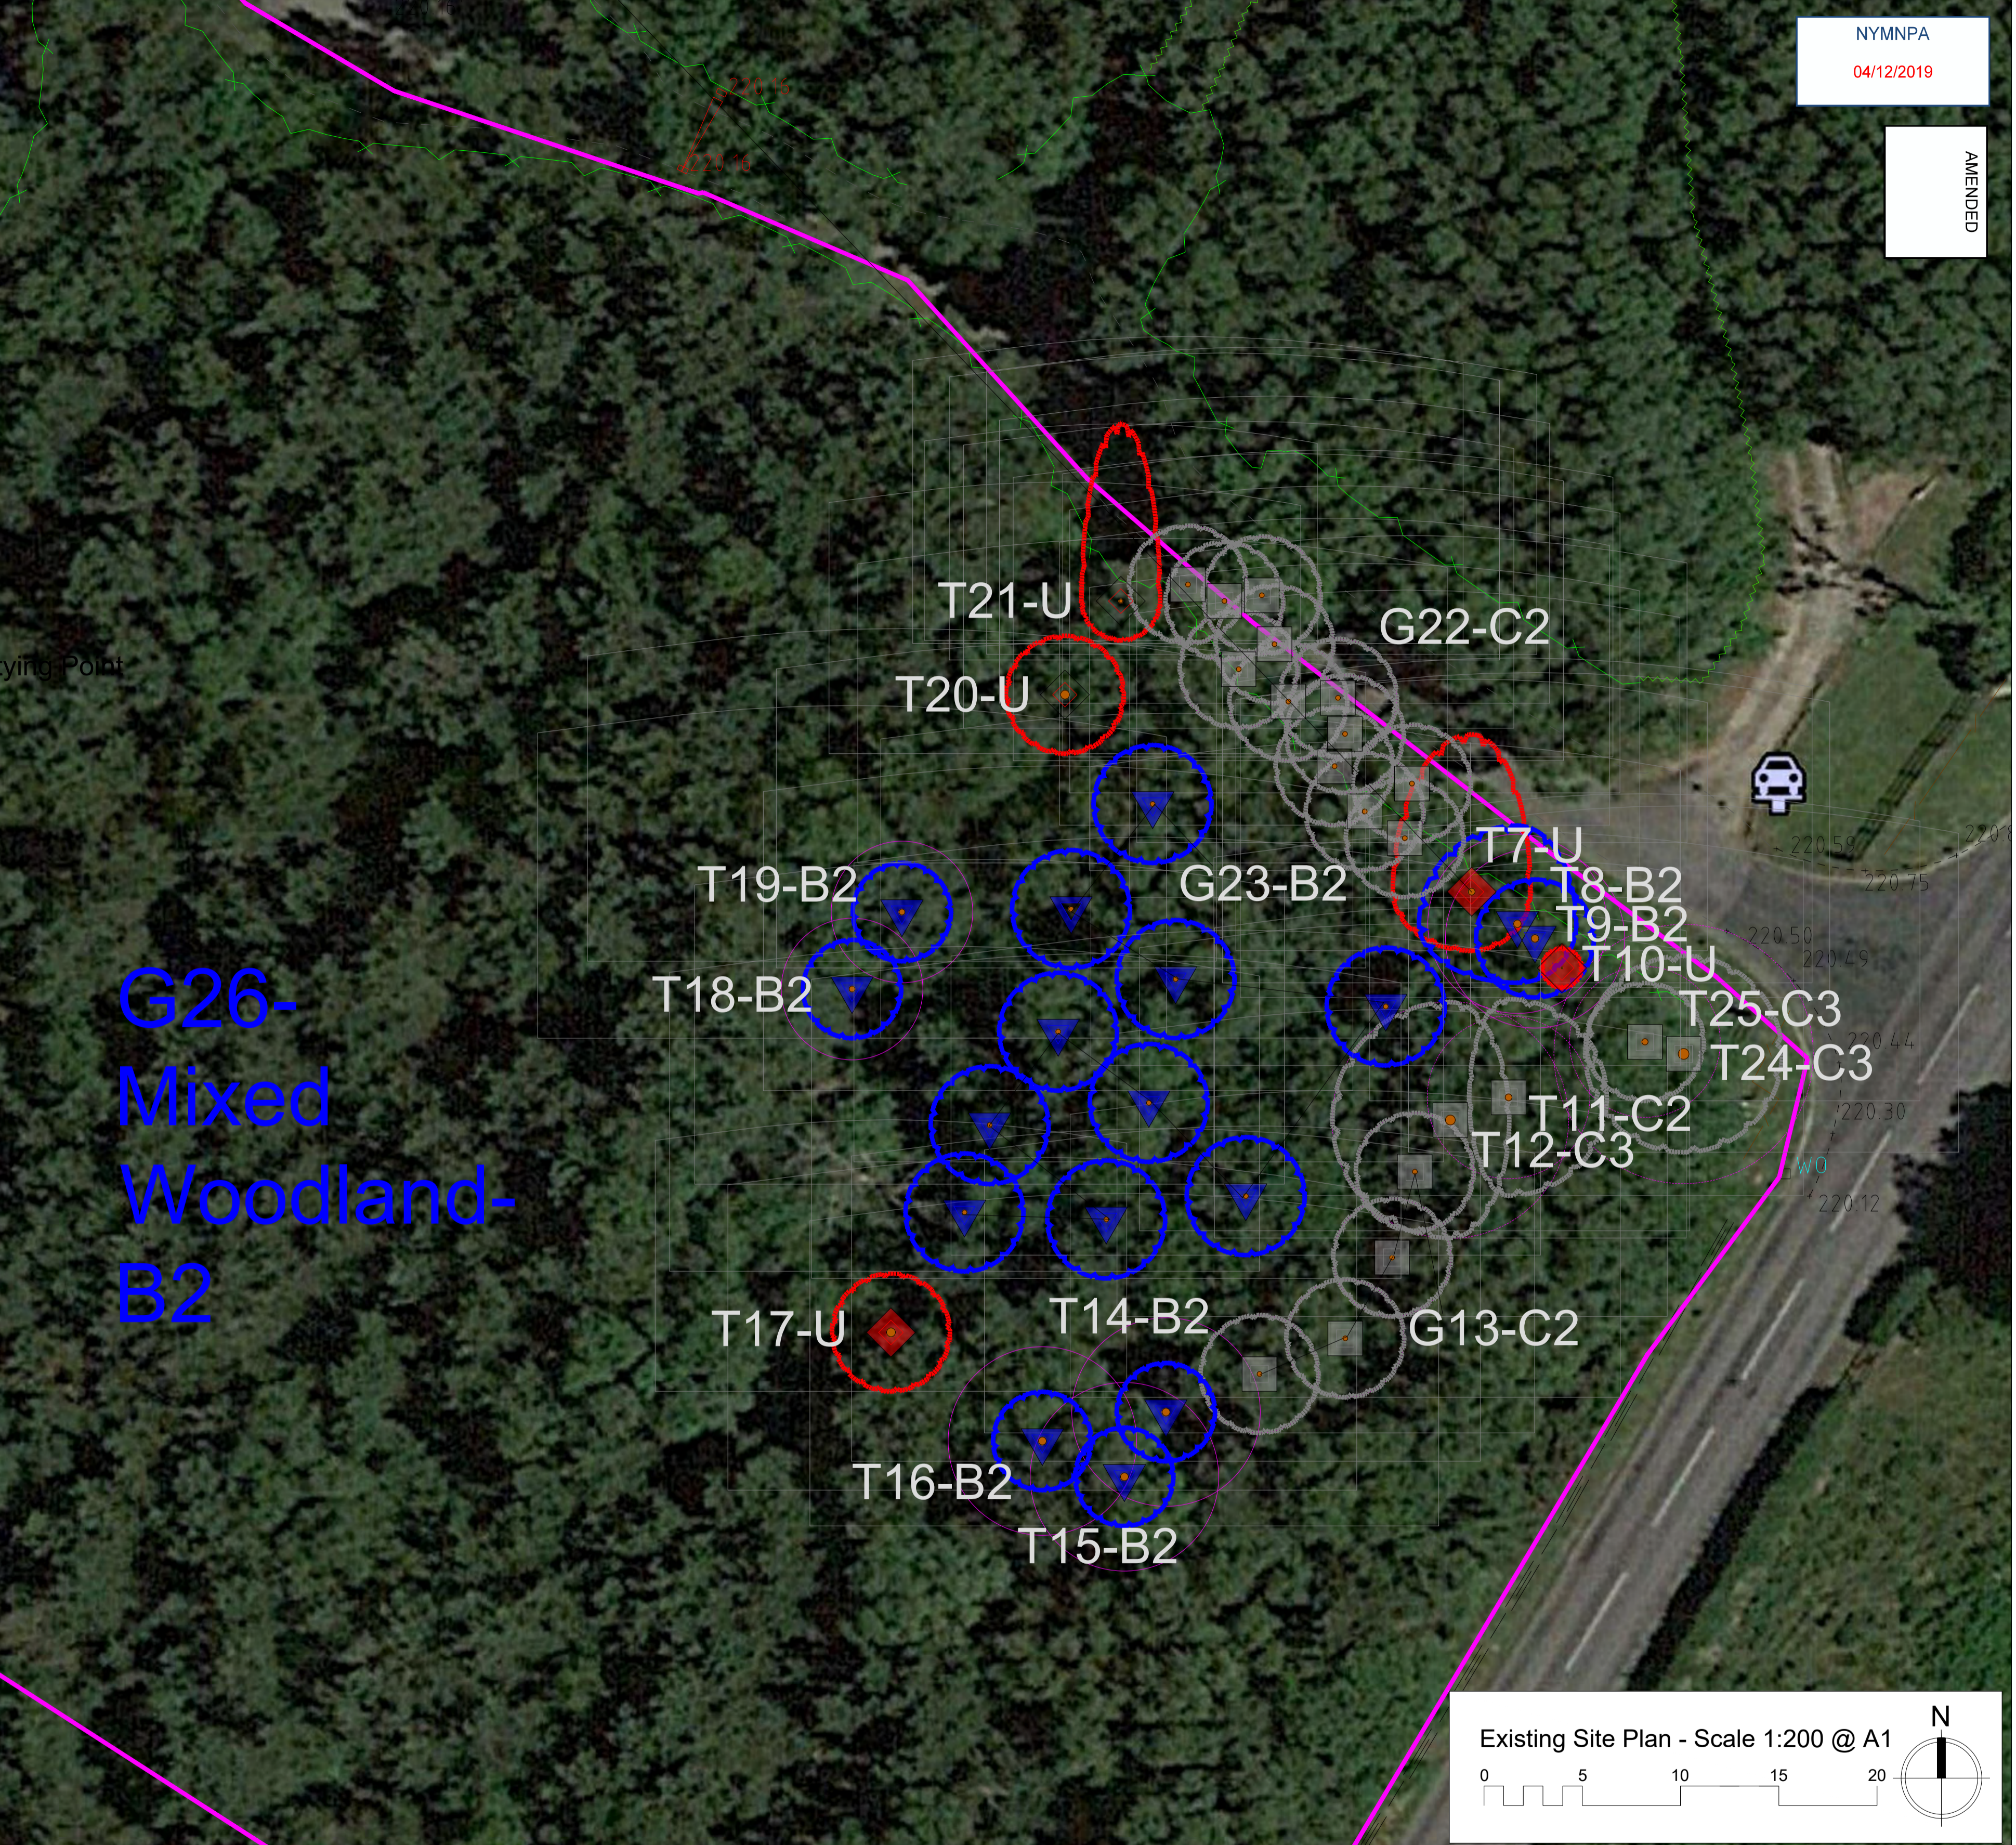
Drawing Title:
Entrance - Tree Survey & Constraints Plan

Est Pos	T6	Pinus sylvestris (Scots Pine)	M	16	2			3	3	3	3	Good	20+	U	400	1	Growing as part of woodland next to drive. Multiple stemmed close to ground level. Large diameter deadwood within the canopy.	Crown lift to 5m over road.	Low	4.8	72.39
Est Pos	T7	Quercus robur (Common Oak)	EM	12	4			8	3	3	4	Poor	<10	U	350	1	Growing as part of woodland above main driveway. Single stem which is likely to fall. If forks below the canopy, significant included union visible with signs of falling. Crown is distorted due to group pressure.	Remove the tree.	Moderate	4.2	55.42
Est Pos	T8	Betula pubescens (Downy Birch)	M	15	4			5	3	3	5	Good	20+	U	380	1	Growing as part of woodland.		Low	4.56	65.33
Est Pos	T9	Betula pubescens (Downy Birch)	M	15	4			3	3	3	3	Good	20+	U	380	1	Growing as part of woodland.		Low	4.56	65.33
Est Pos	T10	Betula pubescens (Downy Birch)	M	6	4			1	1	1	1	Dead	<1	U	100	1	The tree is dead.	Remove the tree.	Low	1.2	4.52

Est Pos	T11	Betula pubescens (Downy Birch)	M	15	3			5	5	5	2	Fair	10+	C2	345	3	Growing as part of woodland.		Low	4.14	53.85
Est Pos	T12	Salix caprea (Goat Willow)	M	12	2			6	6	3	6	Fair	10+	C3	502	3	Growing as part of woodland. Typical example of the species.		Low	6.02	113.87
Est Pos	G13	Salix caprea (Goat Willow), Betula pubescens (Downy Birch), Pinus sylvestris (Scots Pine)	EM	14	3			3	3	3	3	Fair	10+	C2	250	1	Growing as part of woodland.		Low	3	28.28
Est Pos	T14	Pinus sylvestris (Scots Pine)	M	16	4			2.5	2.5	2.5	2.5	Good	20+	U	400	1	Broken branches visible within the canopy.	Remove broken/damaged branches.	Low	4.8	72.39
Est Pos	T15	Pinus sylvestris (Scots Pine)	M	16	4			2.5	2.5	2.5	2.5	Good	20+	U	400	1	Broken branches visible within the canopy.	Remove broken/damaged branches.	Low	4.8	72.39
Est Pos	T16	Pinus sylvestris (Scots Pine)	M	16	4			2.5	2.5	2.5	2.5	Good	20+	U	400	1	Broken branches visible within the canopy.	Remove broken/damaged branches.	Low	4.8	72.39

Est Pos	T17	Pinus sylvestris (Scots Pine)	M	12	2			3	3	3	3	Dead	<1	U	450	1	The tree is dead.	Remove the canopy & retain the stem.	Low	5.4	91.62
Est Pos	T18	Pinus sylvestris (Scots Pine)	M	16	4			2.5	2.5	2.5	2.5	Good	20+	U	300	1	Growing as part of woodland.	Remove broken/damaged branches.	Low	3.6	40.72
Est Pos	T19	Pinus sylvestris (Scots Pine)	M	16	4			2.5	2.5	2.5	2.5	Good	20+	U	300	1	Growing as part of woodland.	Remove broken/damaged branches.	Low	3.6	40.72
Est Pos	T20	Pinus sylvestris (Scots Pine)	M	12	3			3	3	3	3	Dead	<1	U	450	1	Growing as part of woodland. The tree is dead.	Remove the canopy & retain the stem.	Low	5.4	91.62
Est Pos	T21	Salix caprea (Goat Willow)	EM	10	4			9	2	2	2	Poor	<10	U	200	1	Growing above drive with a significant lean, which is expected to fall.	Remove the tree.	Low	2.4	18.1
Est Pos	G22	Pinus sylvestris (Scots Pine), Betula pubescens (Downy Birch), Salix caprea (Goat Willow)	EM	14	2			3	3	3	3	Fair	10+	C2	250	1	Growing as part of woodland.		Low	3	28.28

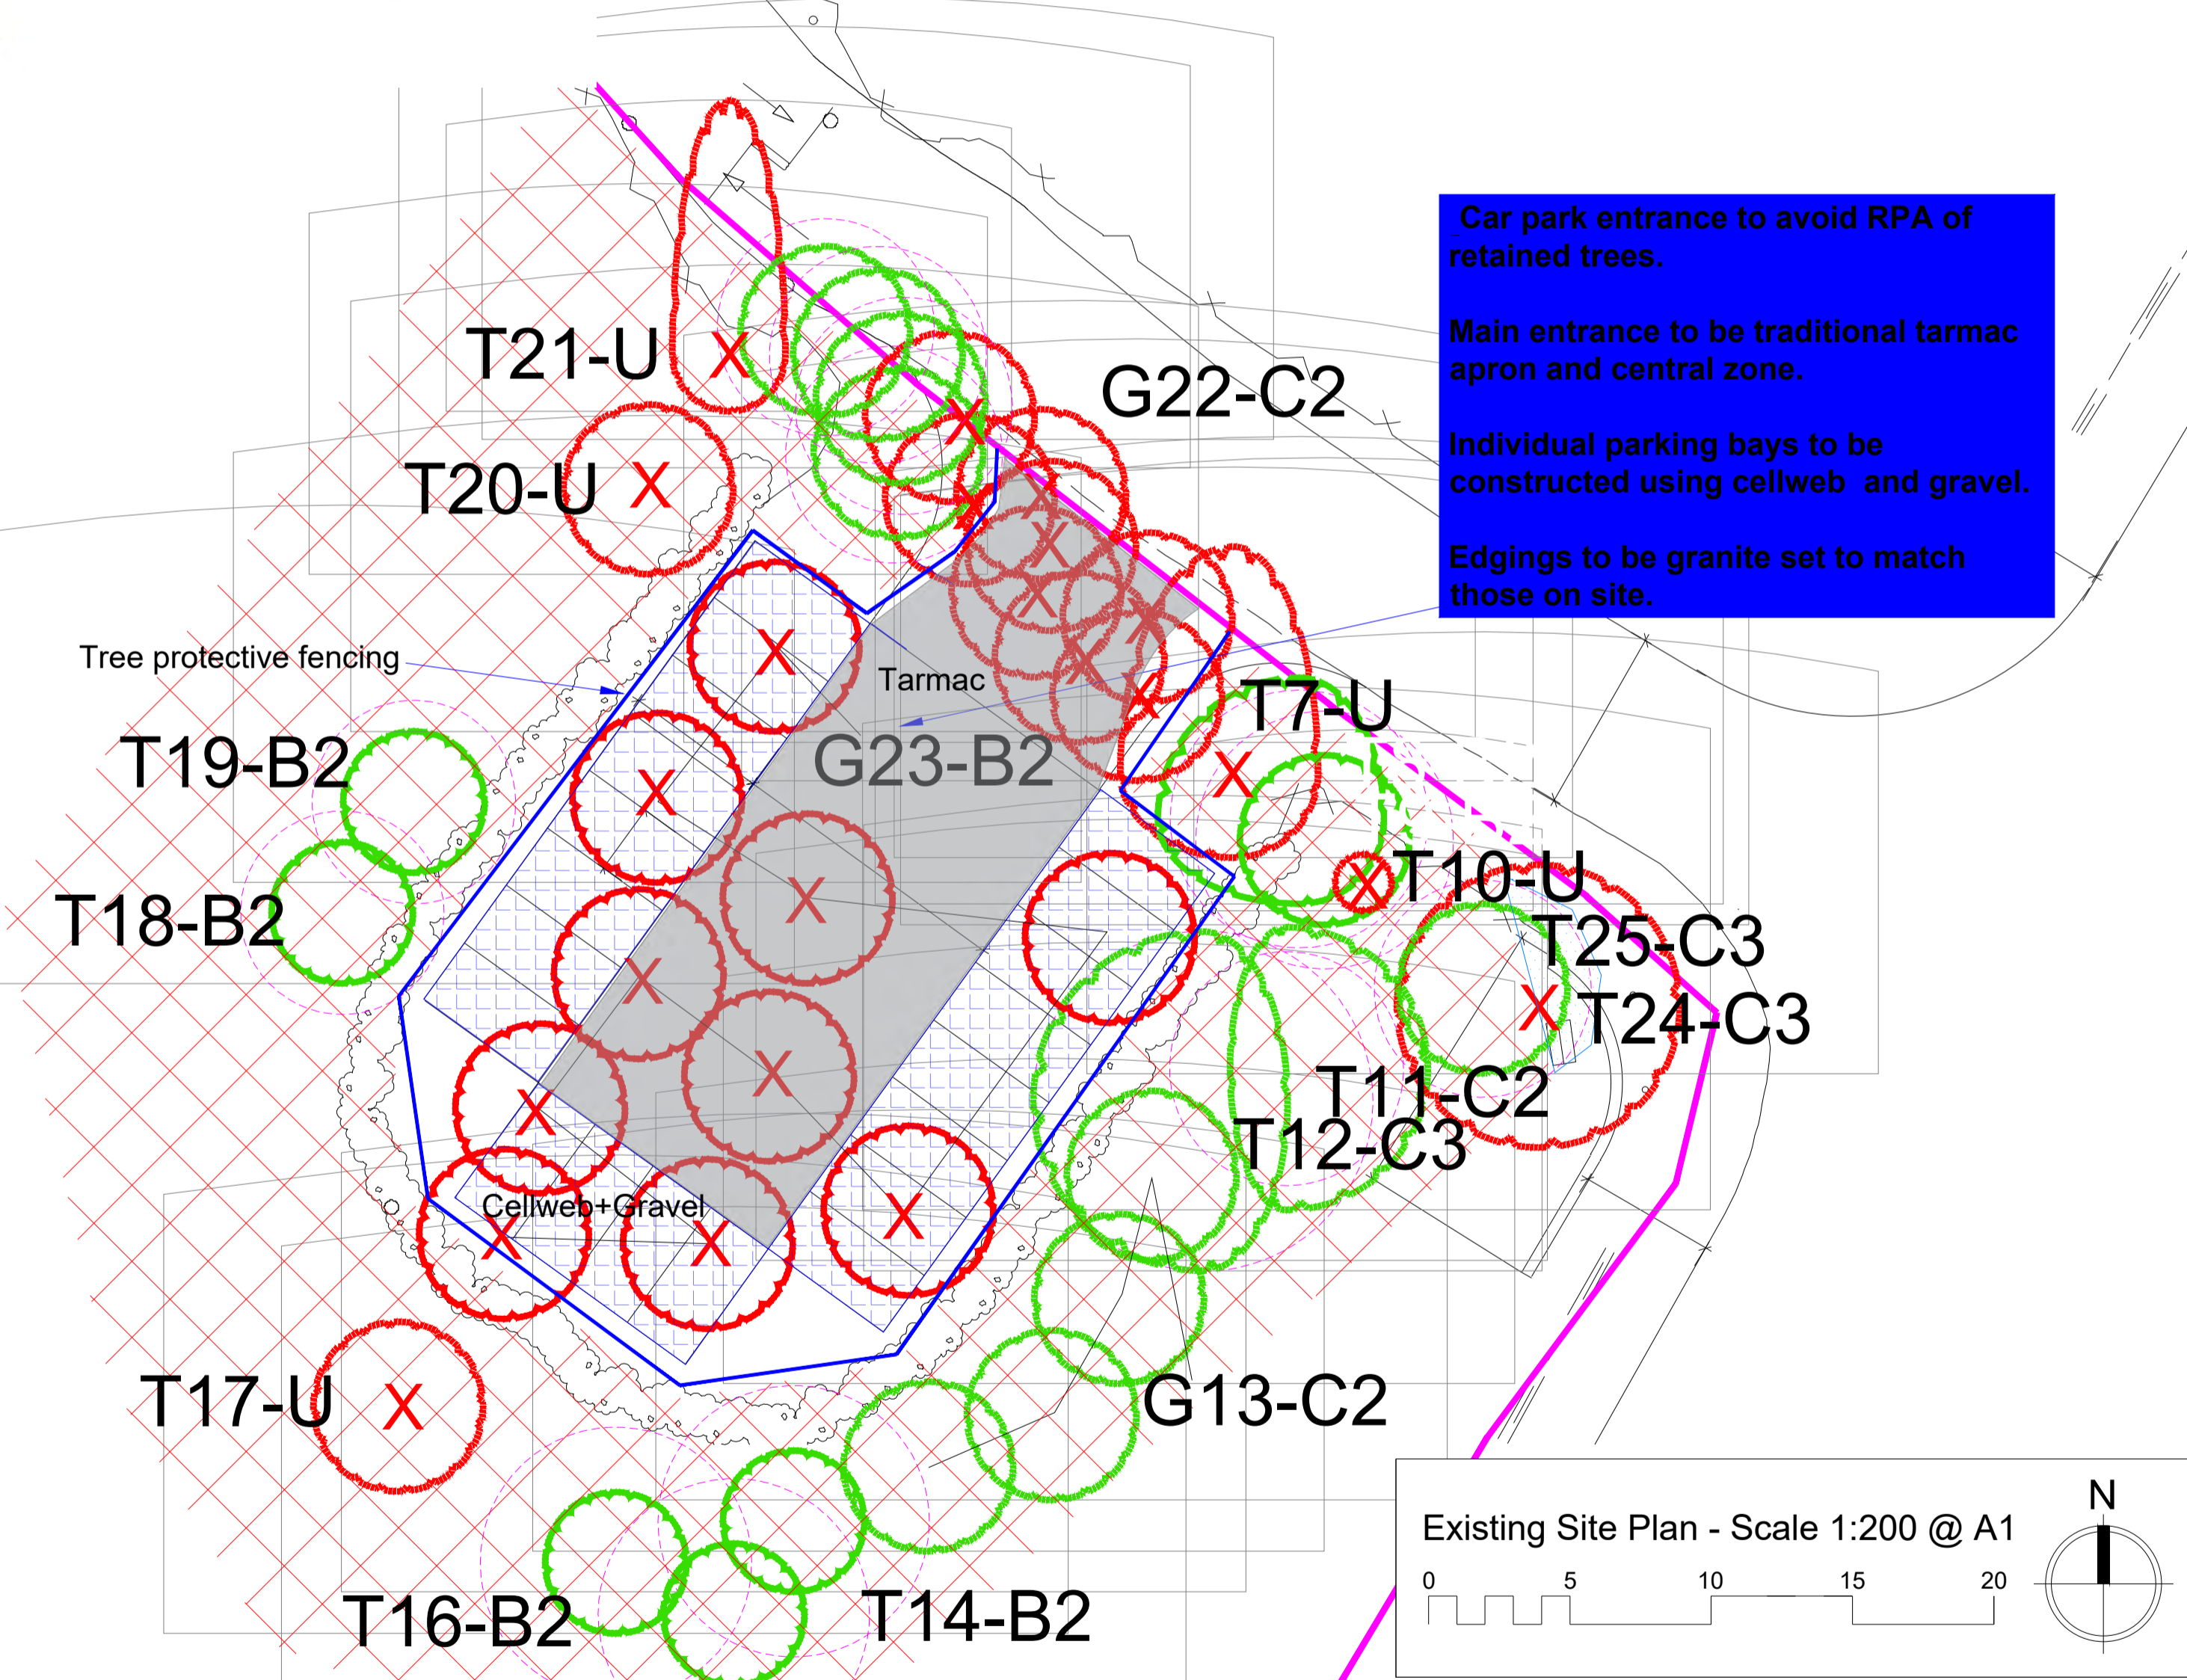
Car park entrance to avoid RPA of retained trees.
Main entrance to be traditional tarmac apron and central zone.
Individual parking bays to be constructed using cellweb and gravel.
Edgings to be granite set to match those on site.
