### **CONVERSION OF REDUNDANT FARM BUILDINGS TO FORM A DWELLING AT BORROWBY BARN HINDERWELL**

**STRUCTURAL APPRAISAL**

**STRUCTURAL APPRAISAL  
OF  
OUTBUILDING  
AT  
BORROWBY BARN, HIGH STREET  
HINDERWELL, NORTH YORKSHIRE  
FOR  
MR & MRS J WHARTON**

**Bat Roost Potential Survey**

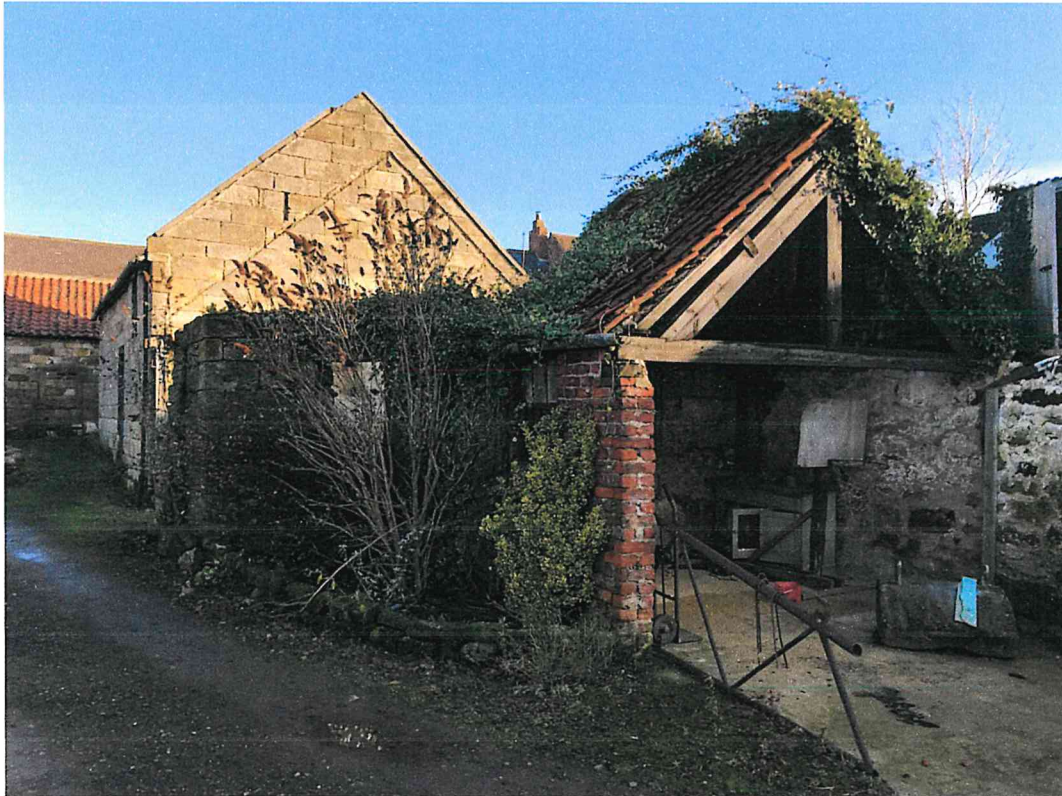
**Photo 1. Western and southern elevations of the surveyed barn.**

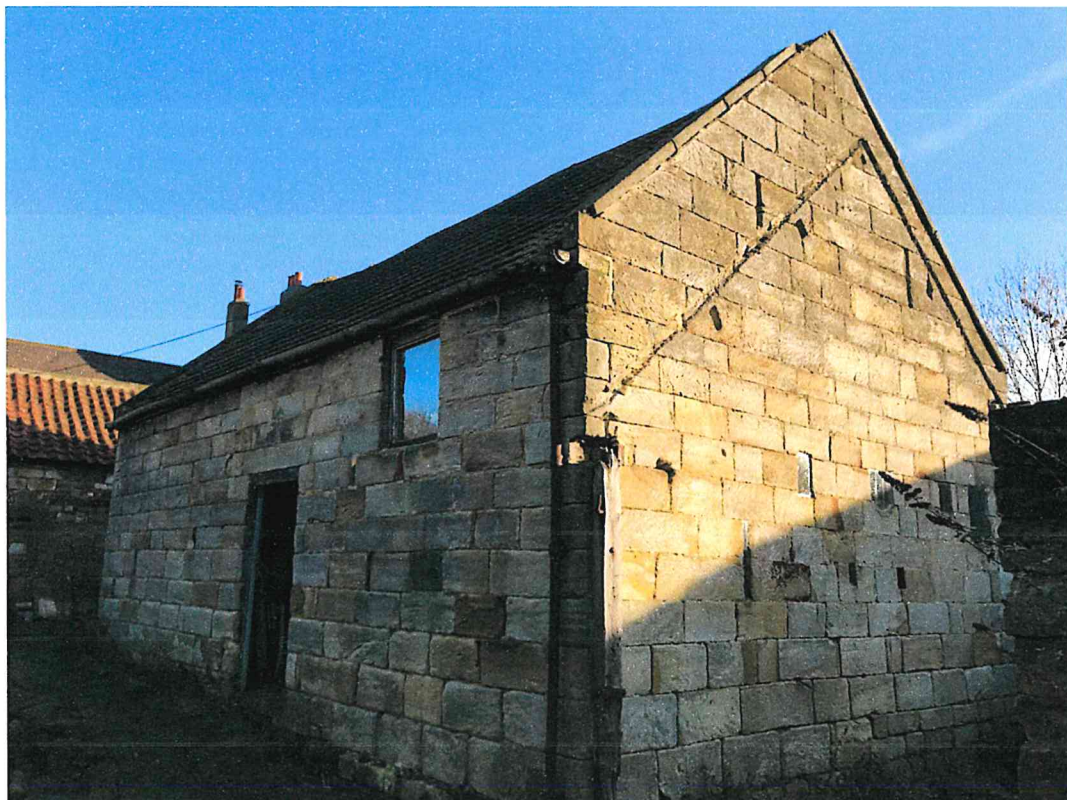
**Photo 2. Western and southern elevations of the northern part of the surveyed barn.**

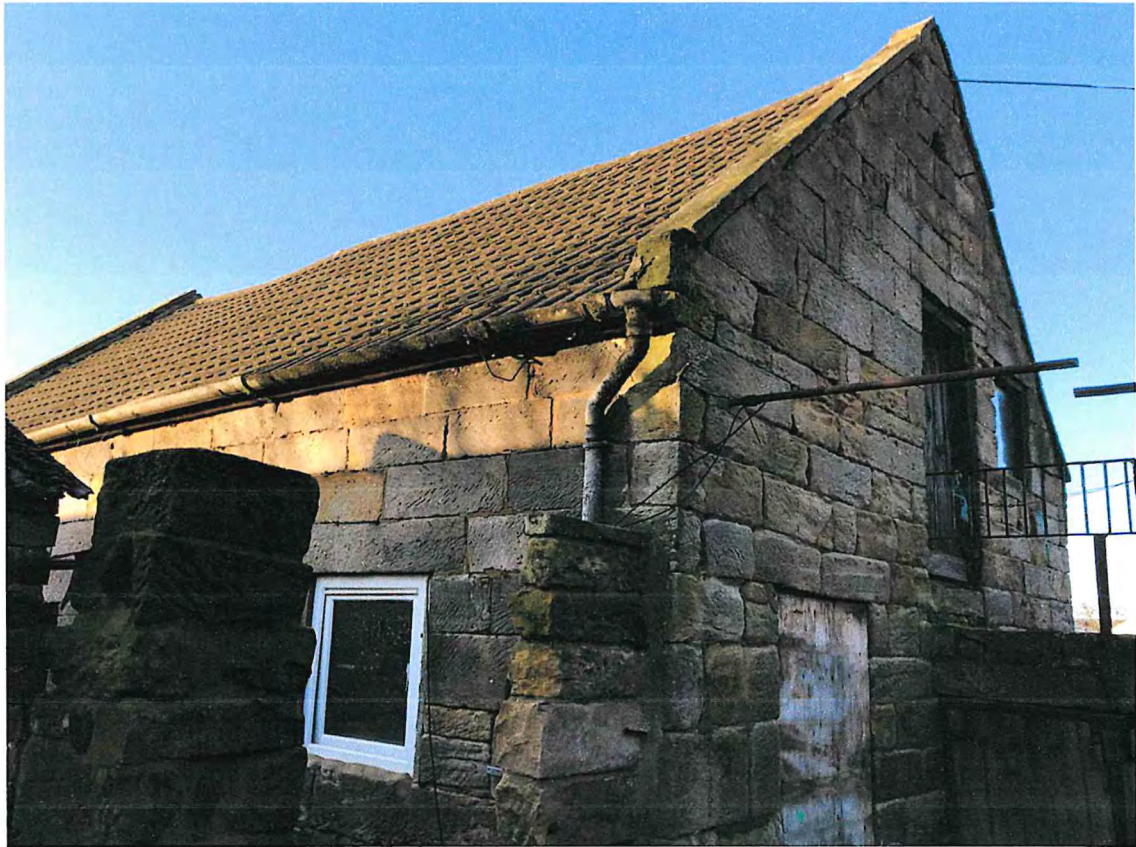
**Photo 3. Eastern and northern elevations of the northern part of the surveyed barn.**

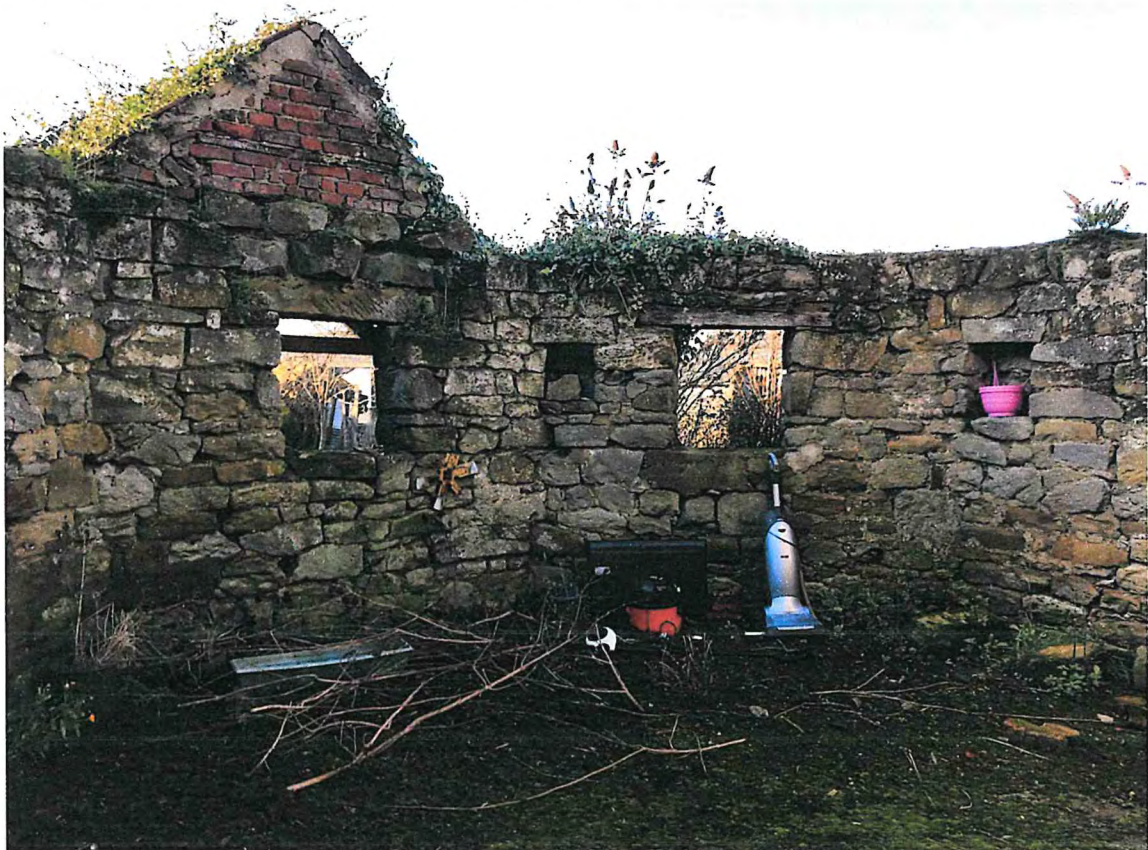
- 3.2.1.3 The central part of the barn measures approximately 7 m (W) x 8 m (L) and has sandstone external walls with no roof and was considered to be in a poor state of repair. This part of the barn is not in use and is empty. The walls and timber lintels above the windows are damp and exposed to the elements (rain and wind). There is an opening (former doorway) on the western elevation of the central part of the barn. Appendix 2: Photo 4.

**Photo 4. Internal area of the central part of the barn.**

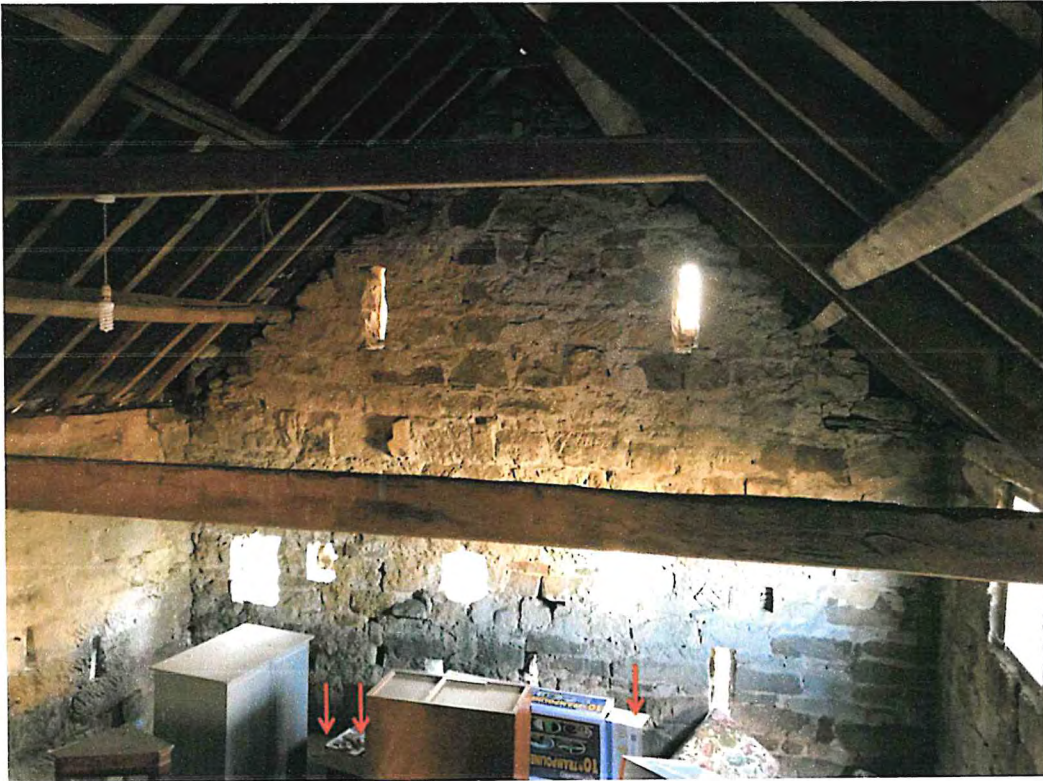
**Photo 5. Internal area of the northern part of the surveyed barn. red arrows show locations of bat droppings.**

- 4.2.1.2 It would be recommended that dusk emergence surveys or dawn re-entry surveys be undertaken on the barn between May and August inclusive to determine the presence or likely absence of roosting bats within the building.

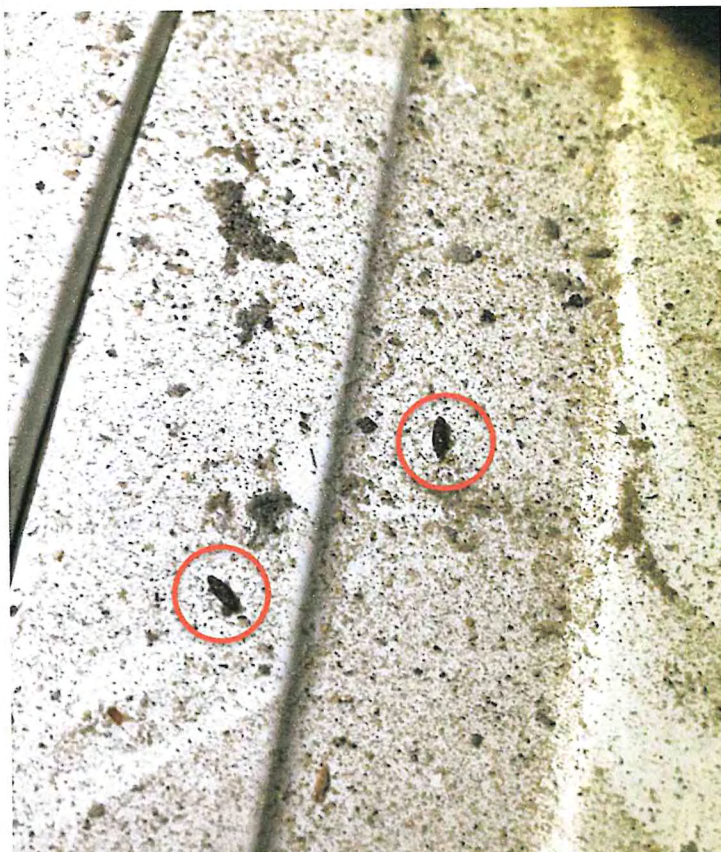
**Photo 6. Bat droppings (red circles) recorded on stored items within the northern part of the barn**
