## **Materials... details of Listed Building Alterations as per application form...**

## **Heritage Statement for Cliffroyd, Covert Hill, Robin Hoods Bay .. YO22 4SN**

## **Pre-application advice for internal and external refurbishment works at Cliffroyd, Covet Hill, Robin Hood's Bay**

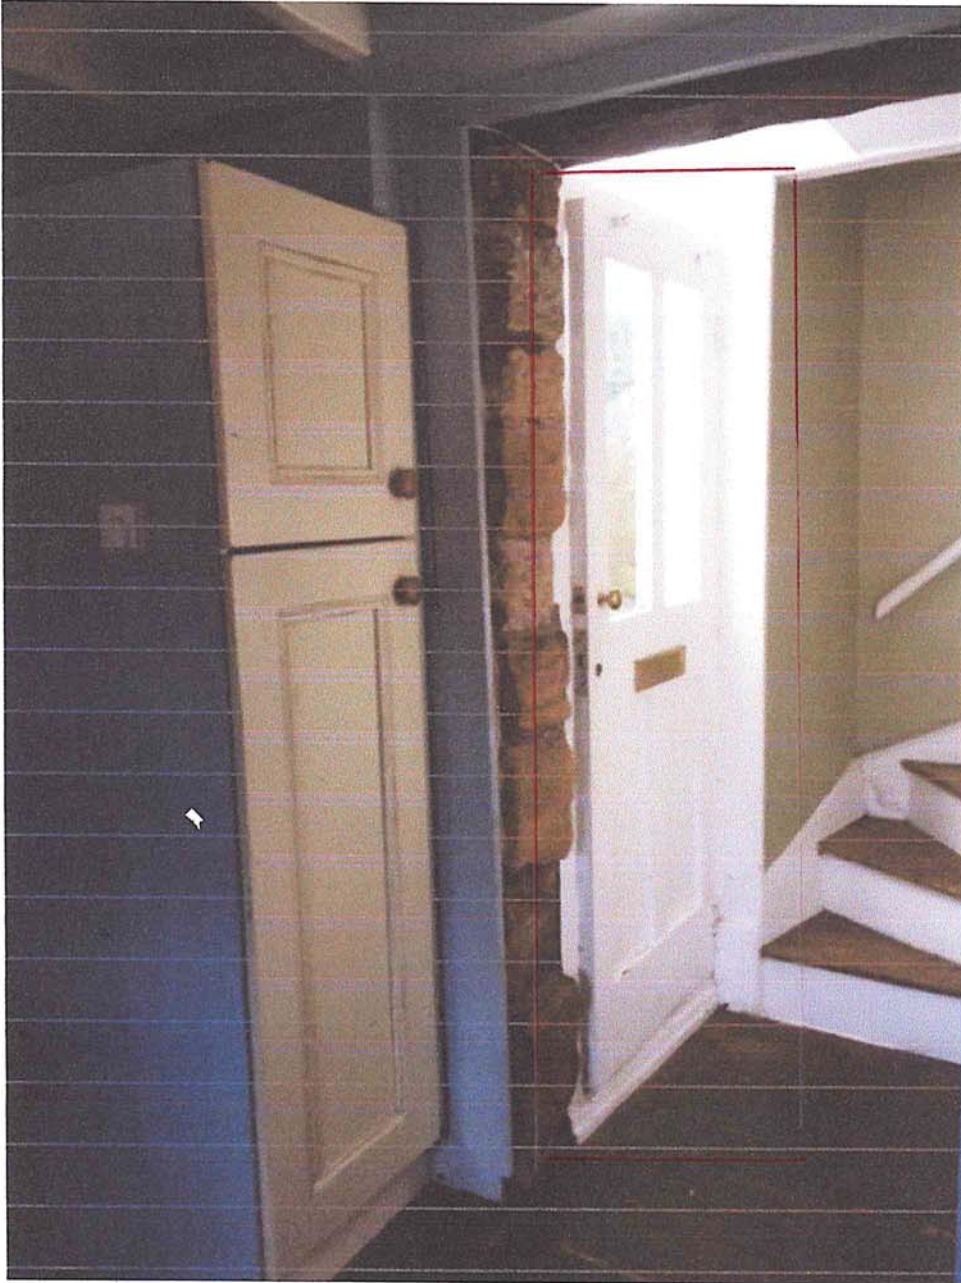
front door - replacement like for like

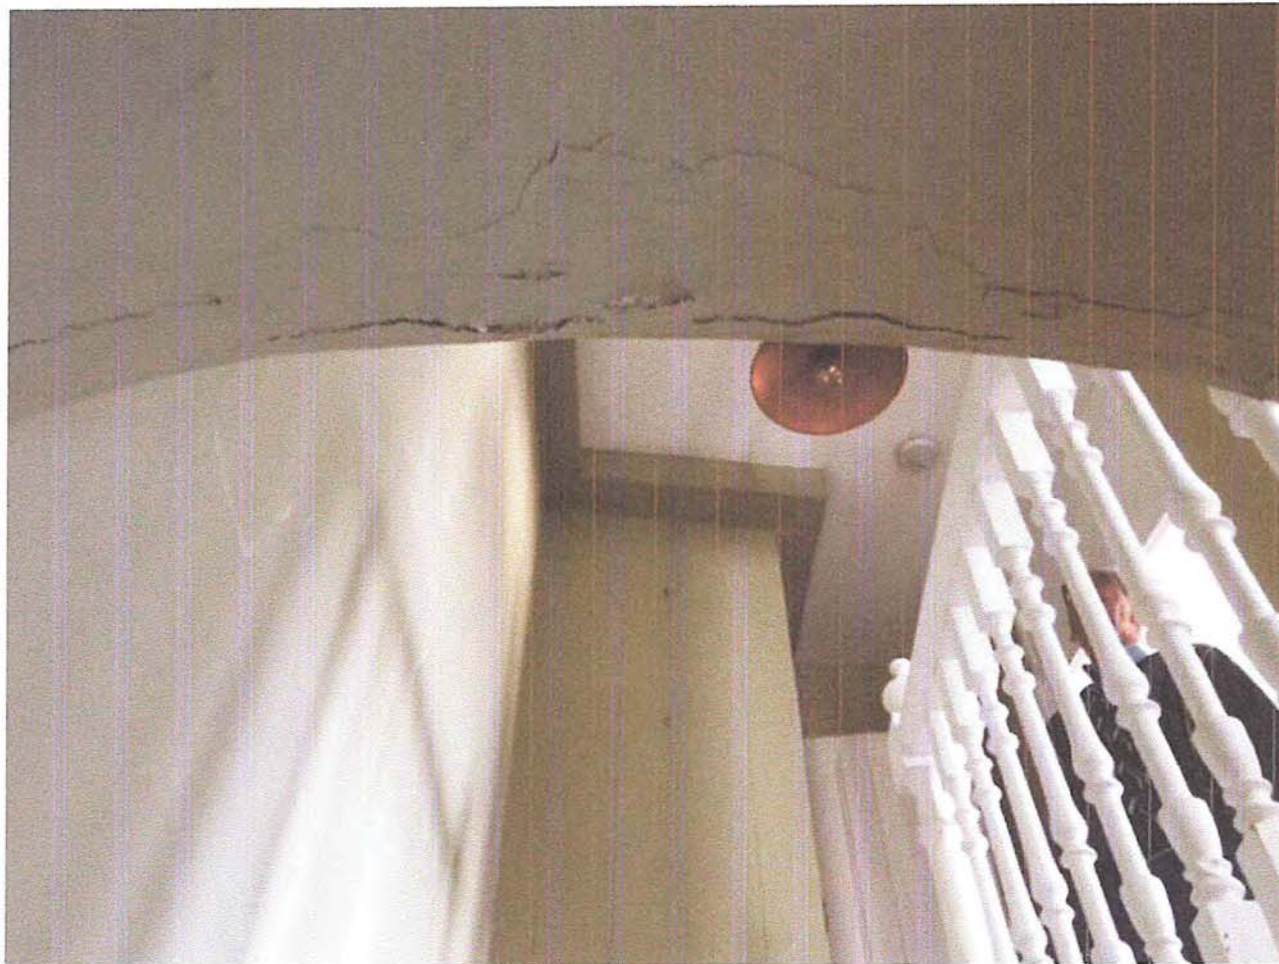
overstair paneling  
(replace like for like  
if required once  
cleared of paper)

5. First floor w/c (Throne Room): No objections to the replacement of the washbasin and w/c providing the new facilities utilise existing pipework etc. LBC not required. There were some signs of damp to the timber wall over the staircase. It was advised that once the cause of the damp had been addressed and the wallpaper removed, the timberwork may be in sufficient condition to just dry out. If the timber is found to be decayed then replacement would need to be on a like for like basis. LBC required.

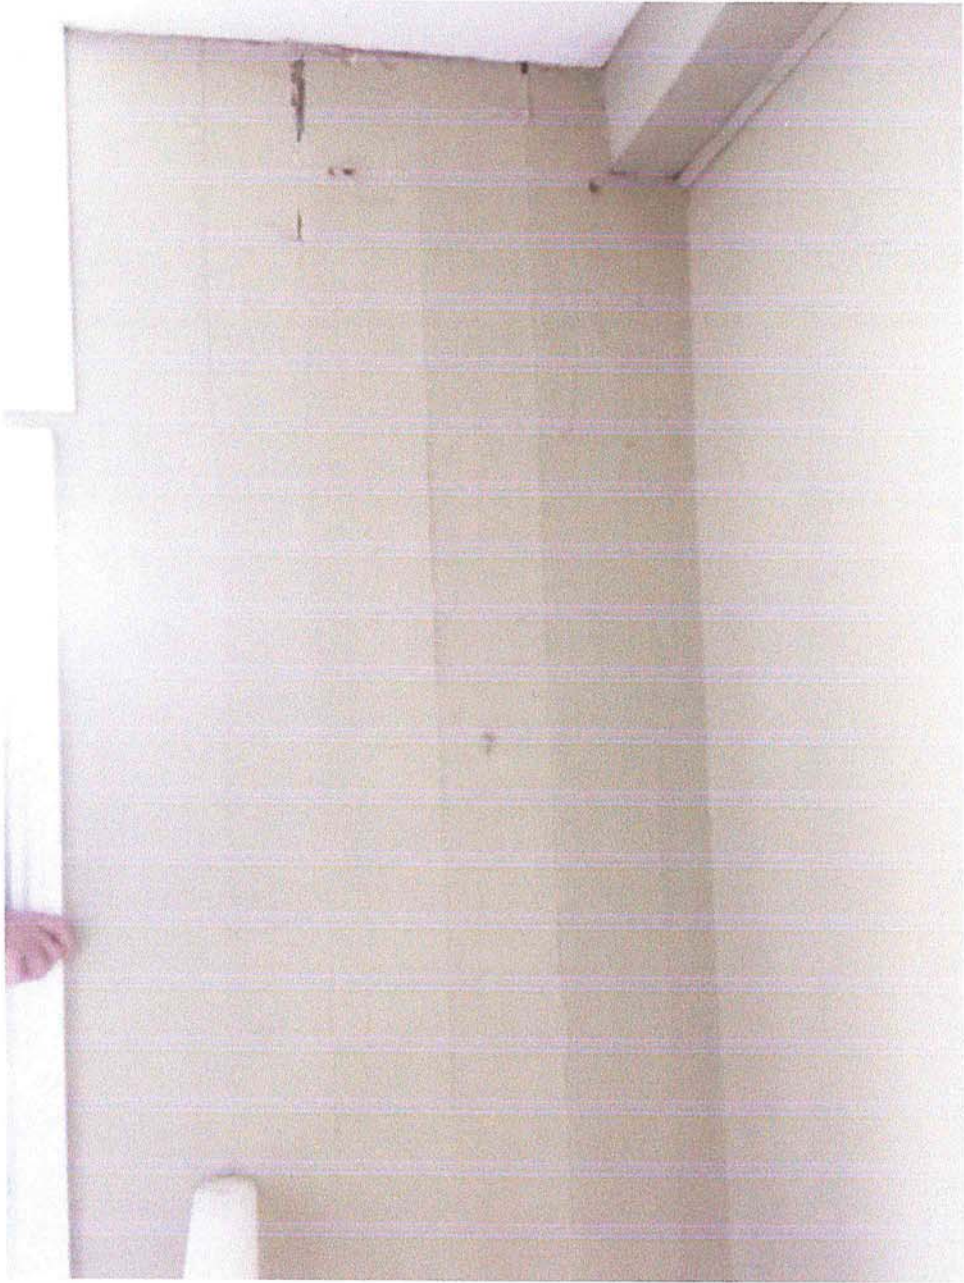
under the  
overbains paneling  
arch

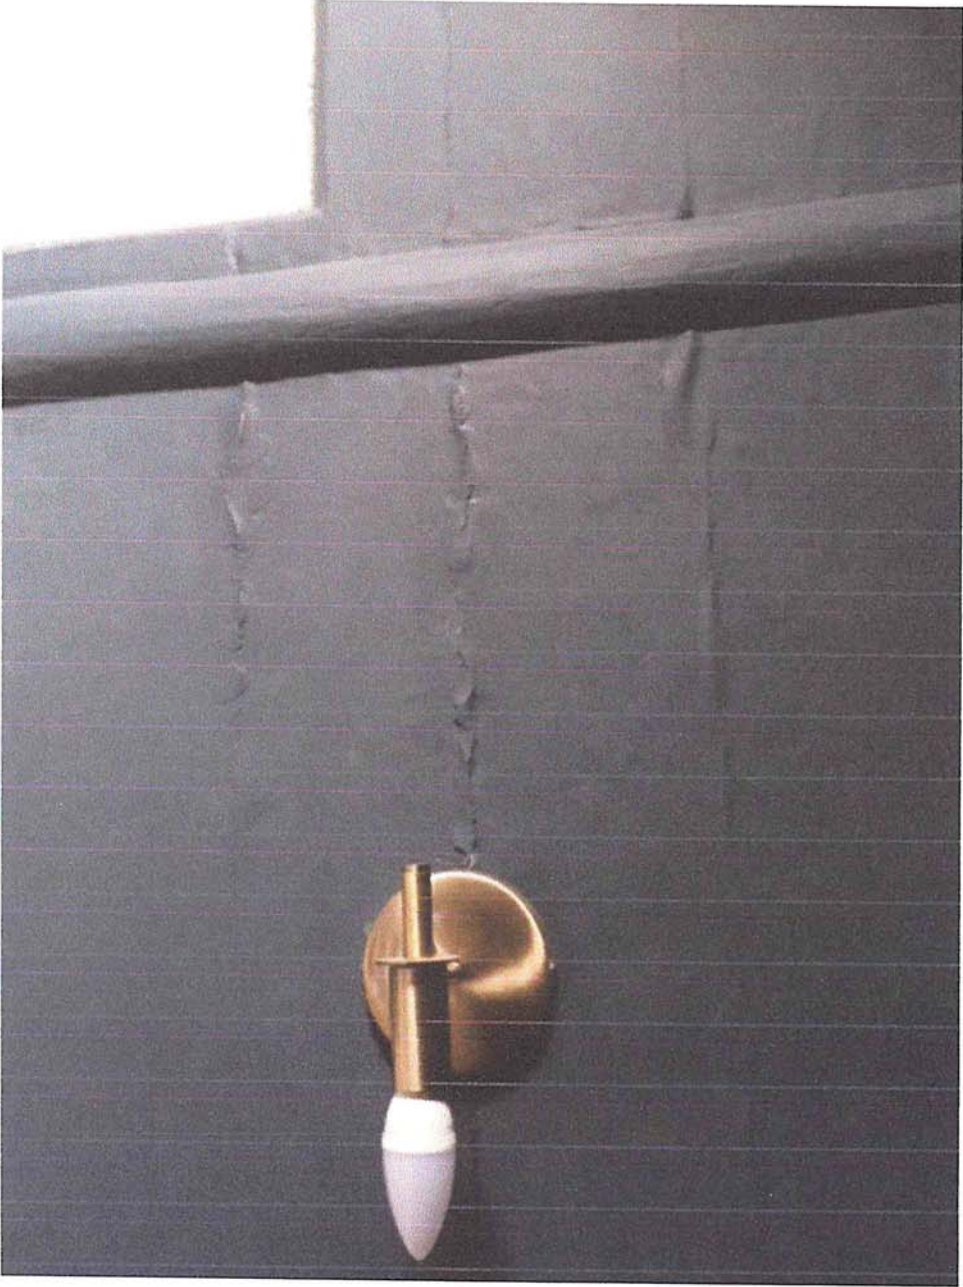
Similar  
paneling  
boy bedroom  
(replace like  
for like)

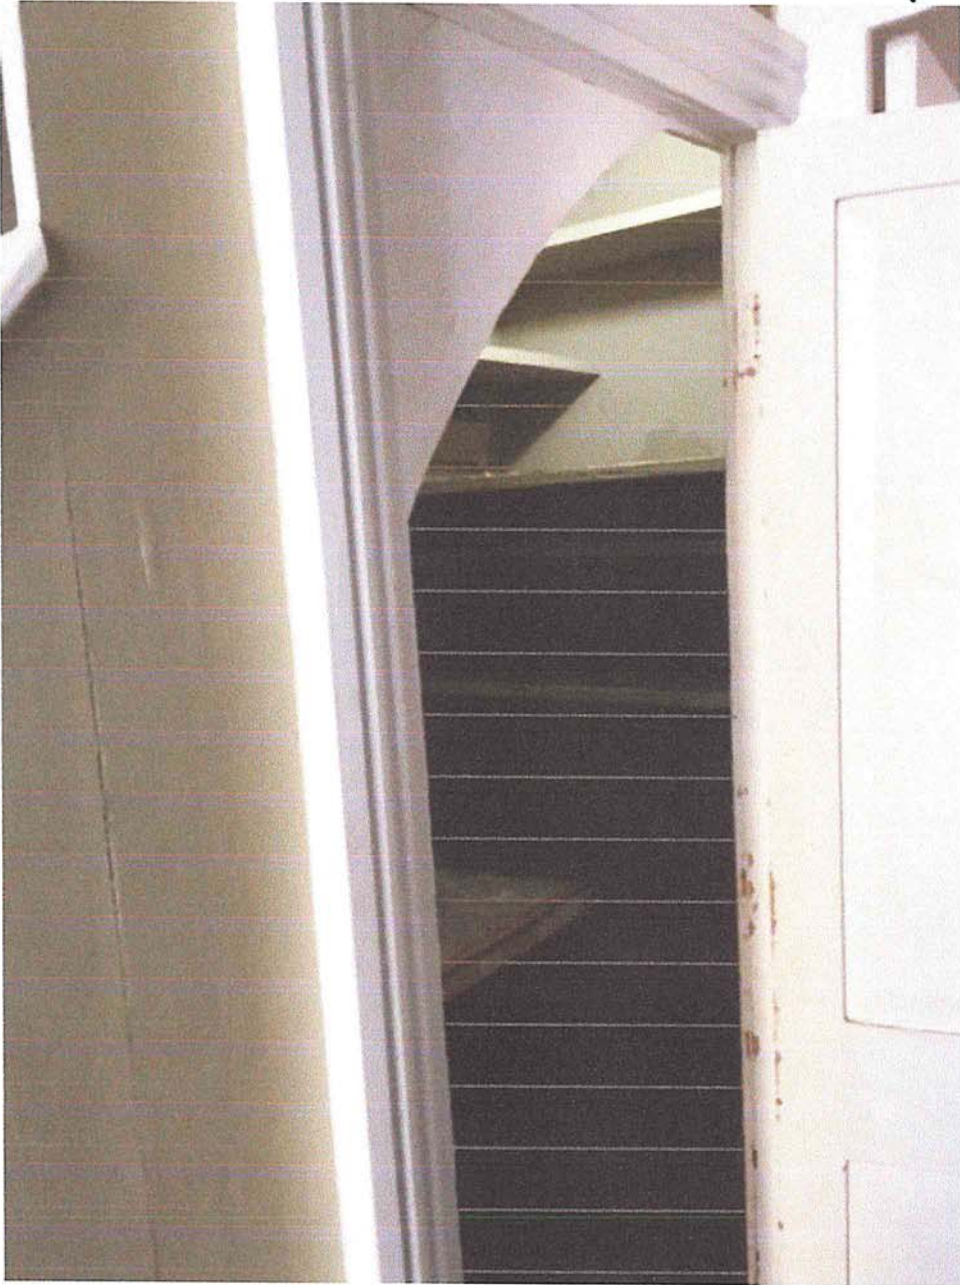
undersains cupboard.

3. Cooker range: No objections to the replacement of the range and re-tiling of the surround. LBC not required.
4. Ground floor understairs cupboard: There is evidence of damp to the floor. No objections to the removal of the modern boxing-in, LBC not required. It was also advised that the removal of the concrete floor would be beneficial as this would be trapping moisture and increasing damp in the walls. LBC not required for the removal of the concrete but we would require details of what replaces it, e.g. a limecrete or timber floor. As LBC is being sought for other works I would advise you to include this element.

- .. ground floor understairs cupboarding.. remove panelling and address damp issues, remove concrete flooring and replace with lime crete floor;
- .. installation of four panelled fire door to kitchen with self closure and intumescent strip, with fire resistant boxing of space above;

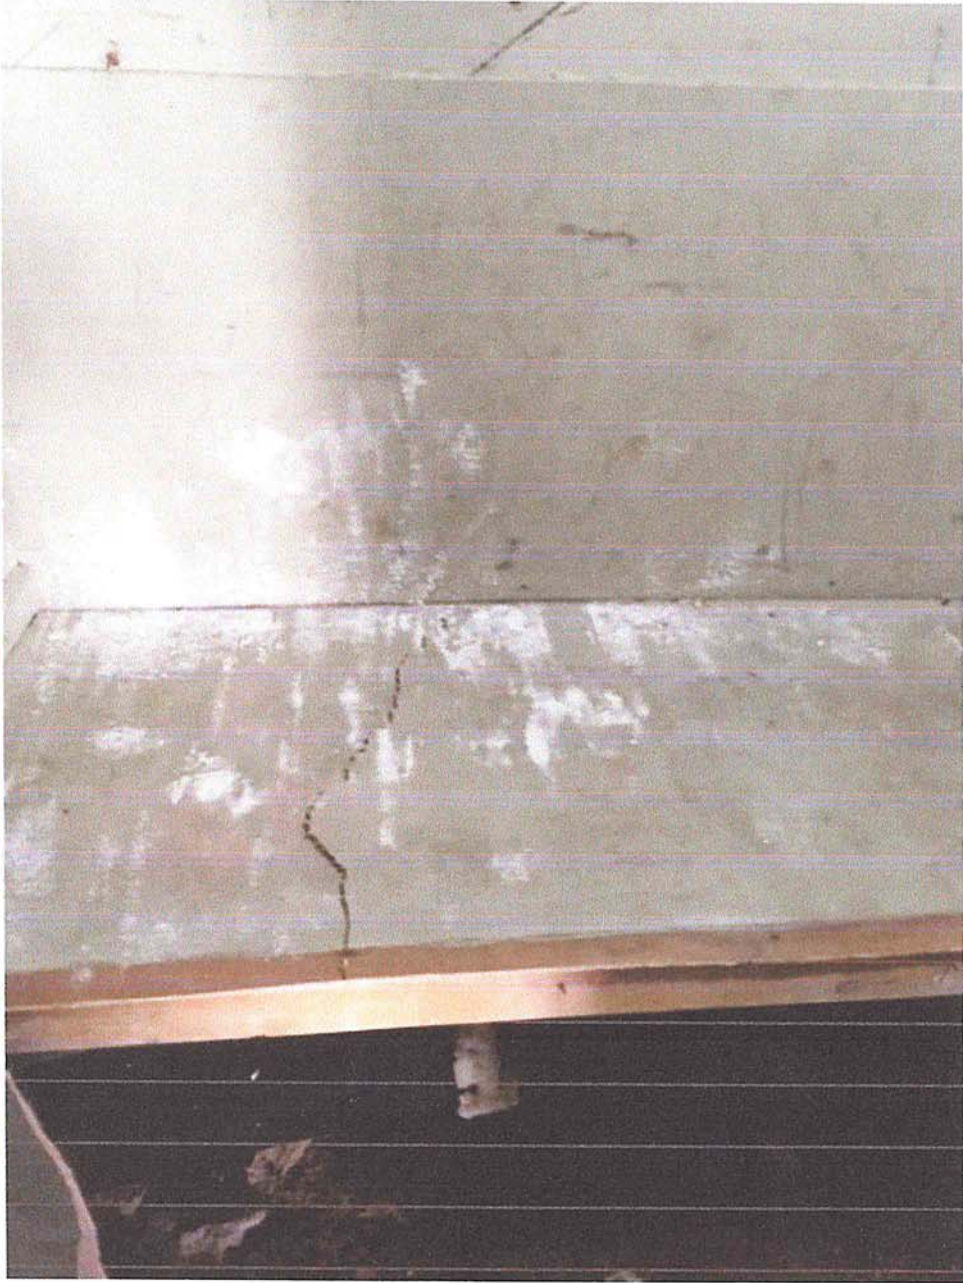
concrete needing  
removal and  
replacement  
with limecrete

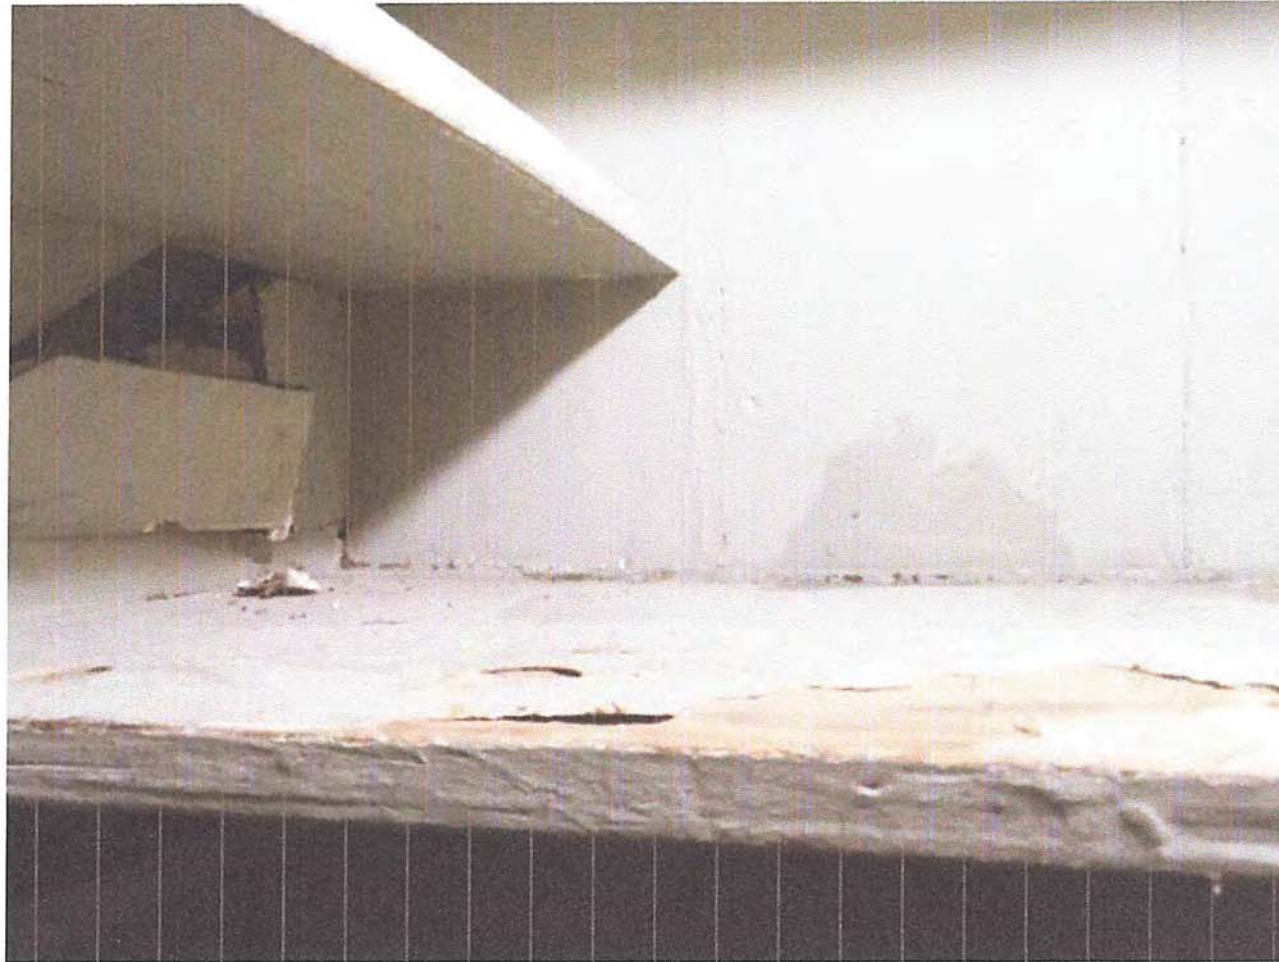
Modern  
paneling  
needing  
replacement

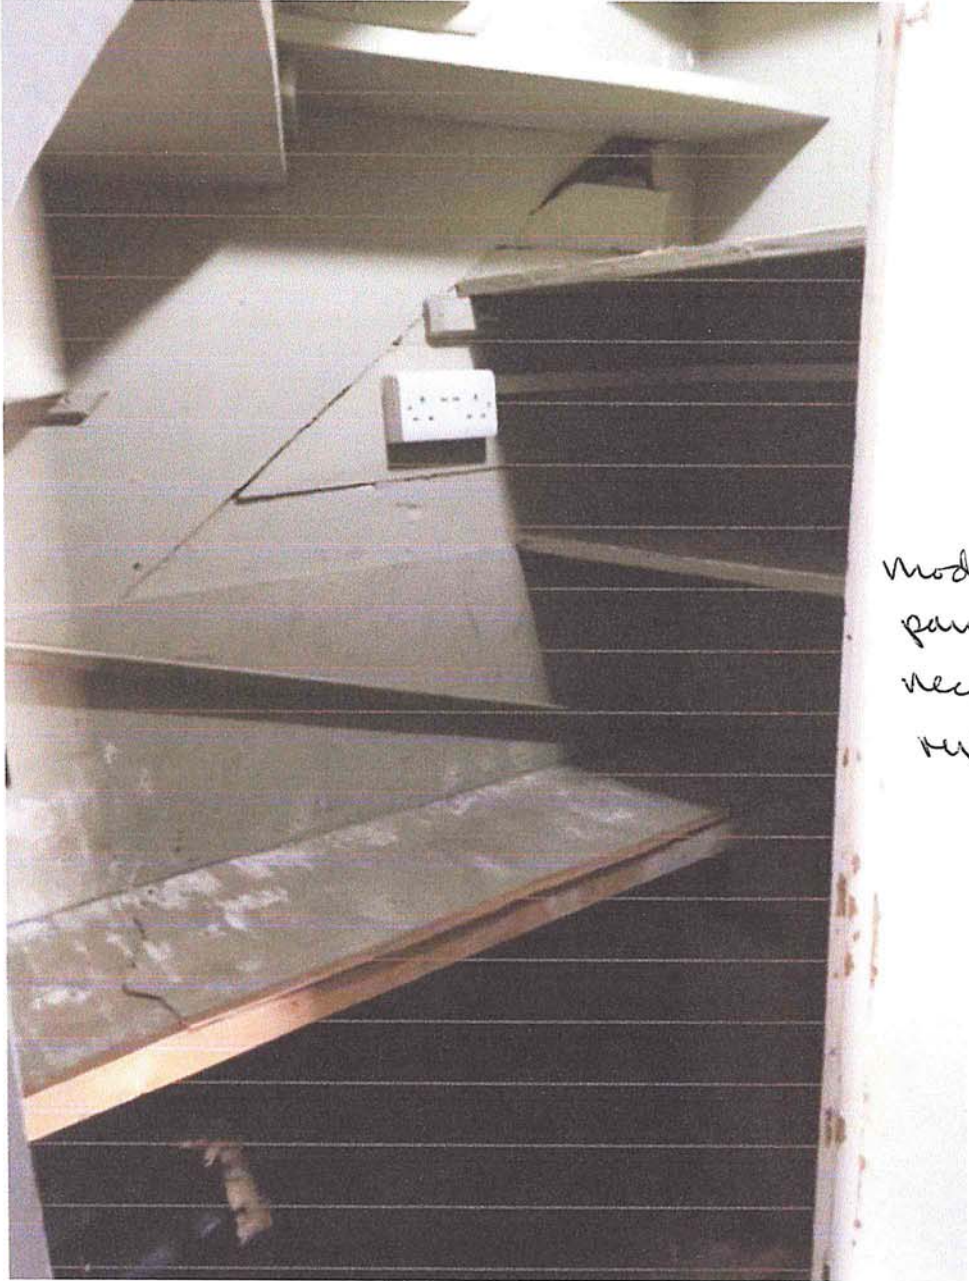
Modern shelf and  
panelling needing  
replacement

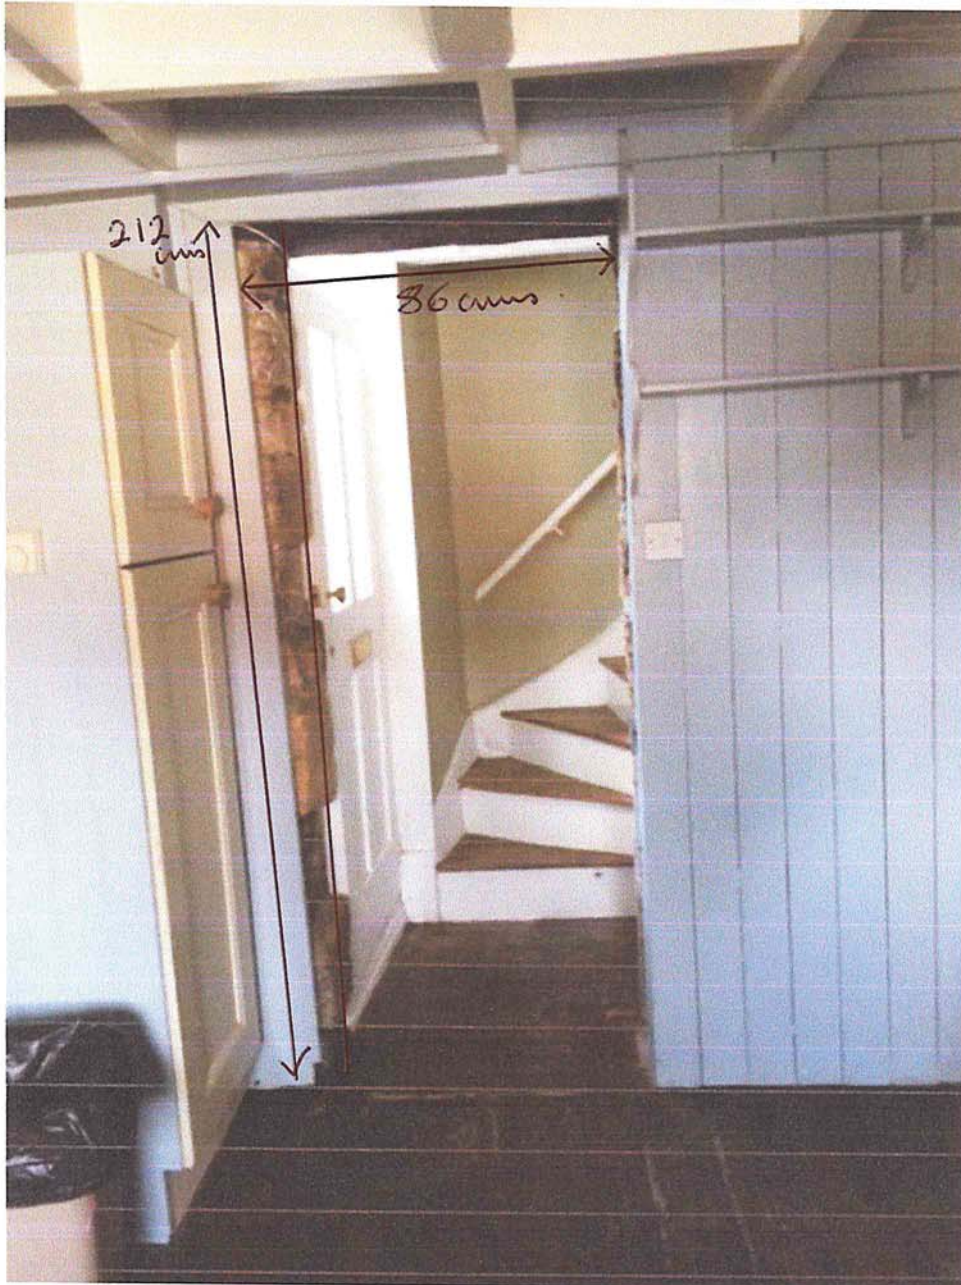
Modern  
panelling  
needing  
replacement

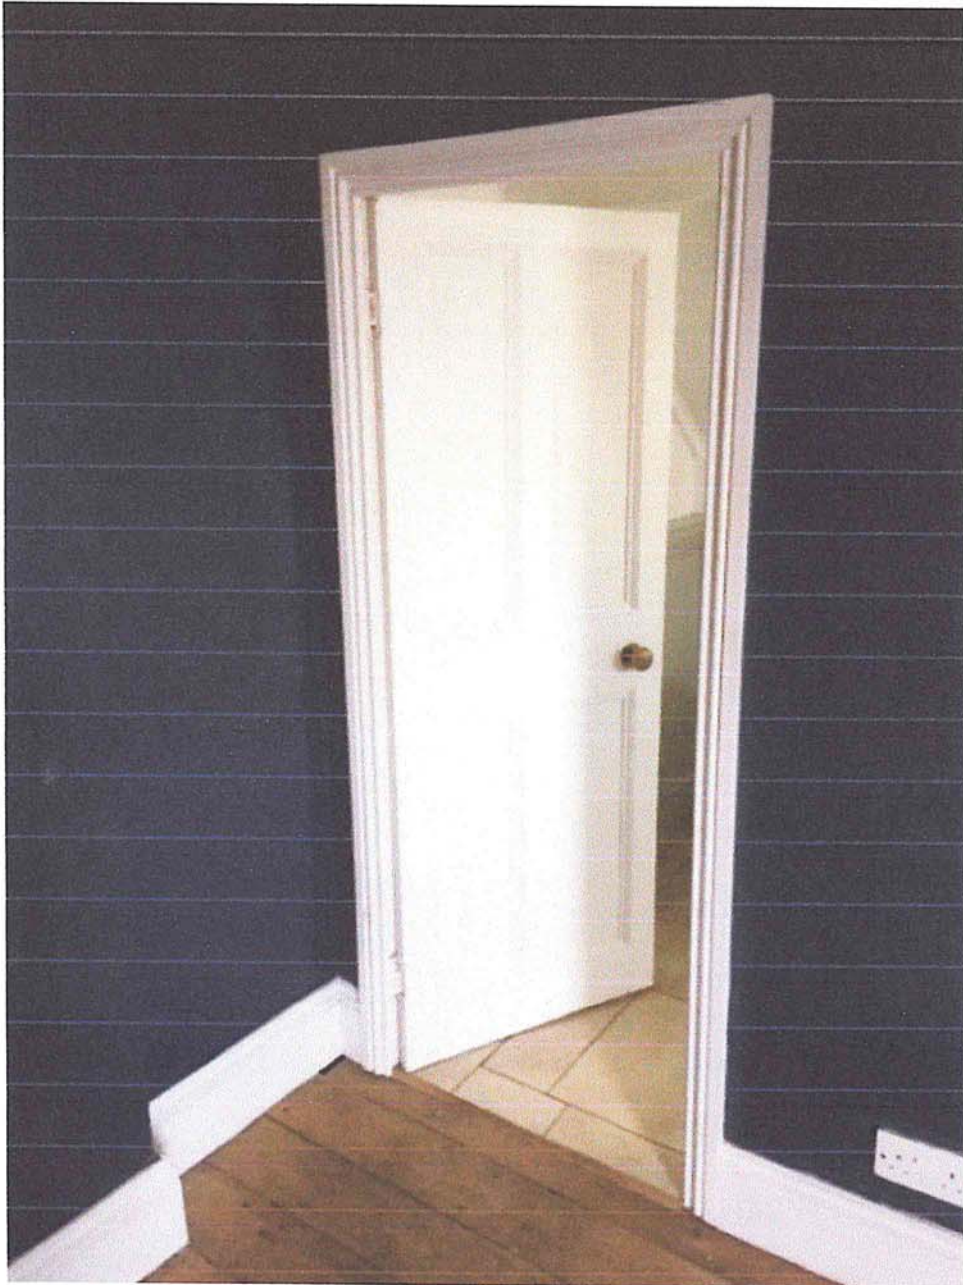
Replace like for like in design but as a fire door — at present this door has a large ( $>3\text{cm}$ ) gap at the bottom edge —
