SF3014-2 Woodland Rooms, Raithwaite

ARBORICULTURAL SURVEY REPORT | BS 5837:2012

Revision B - July 2020

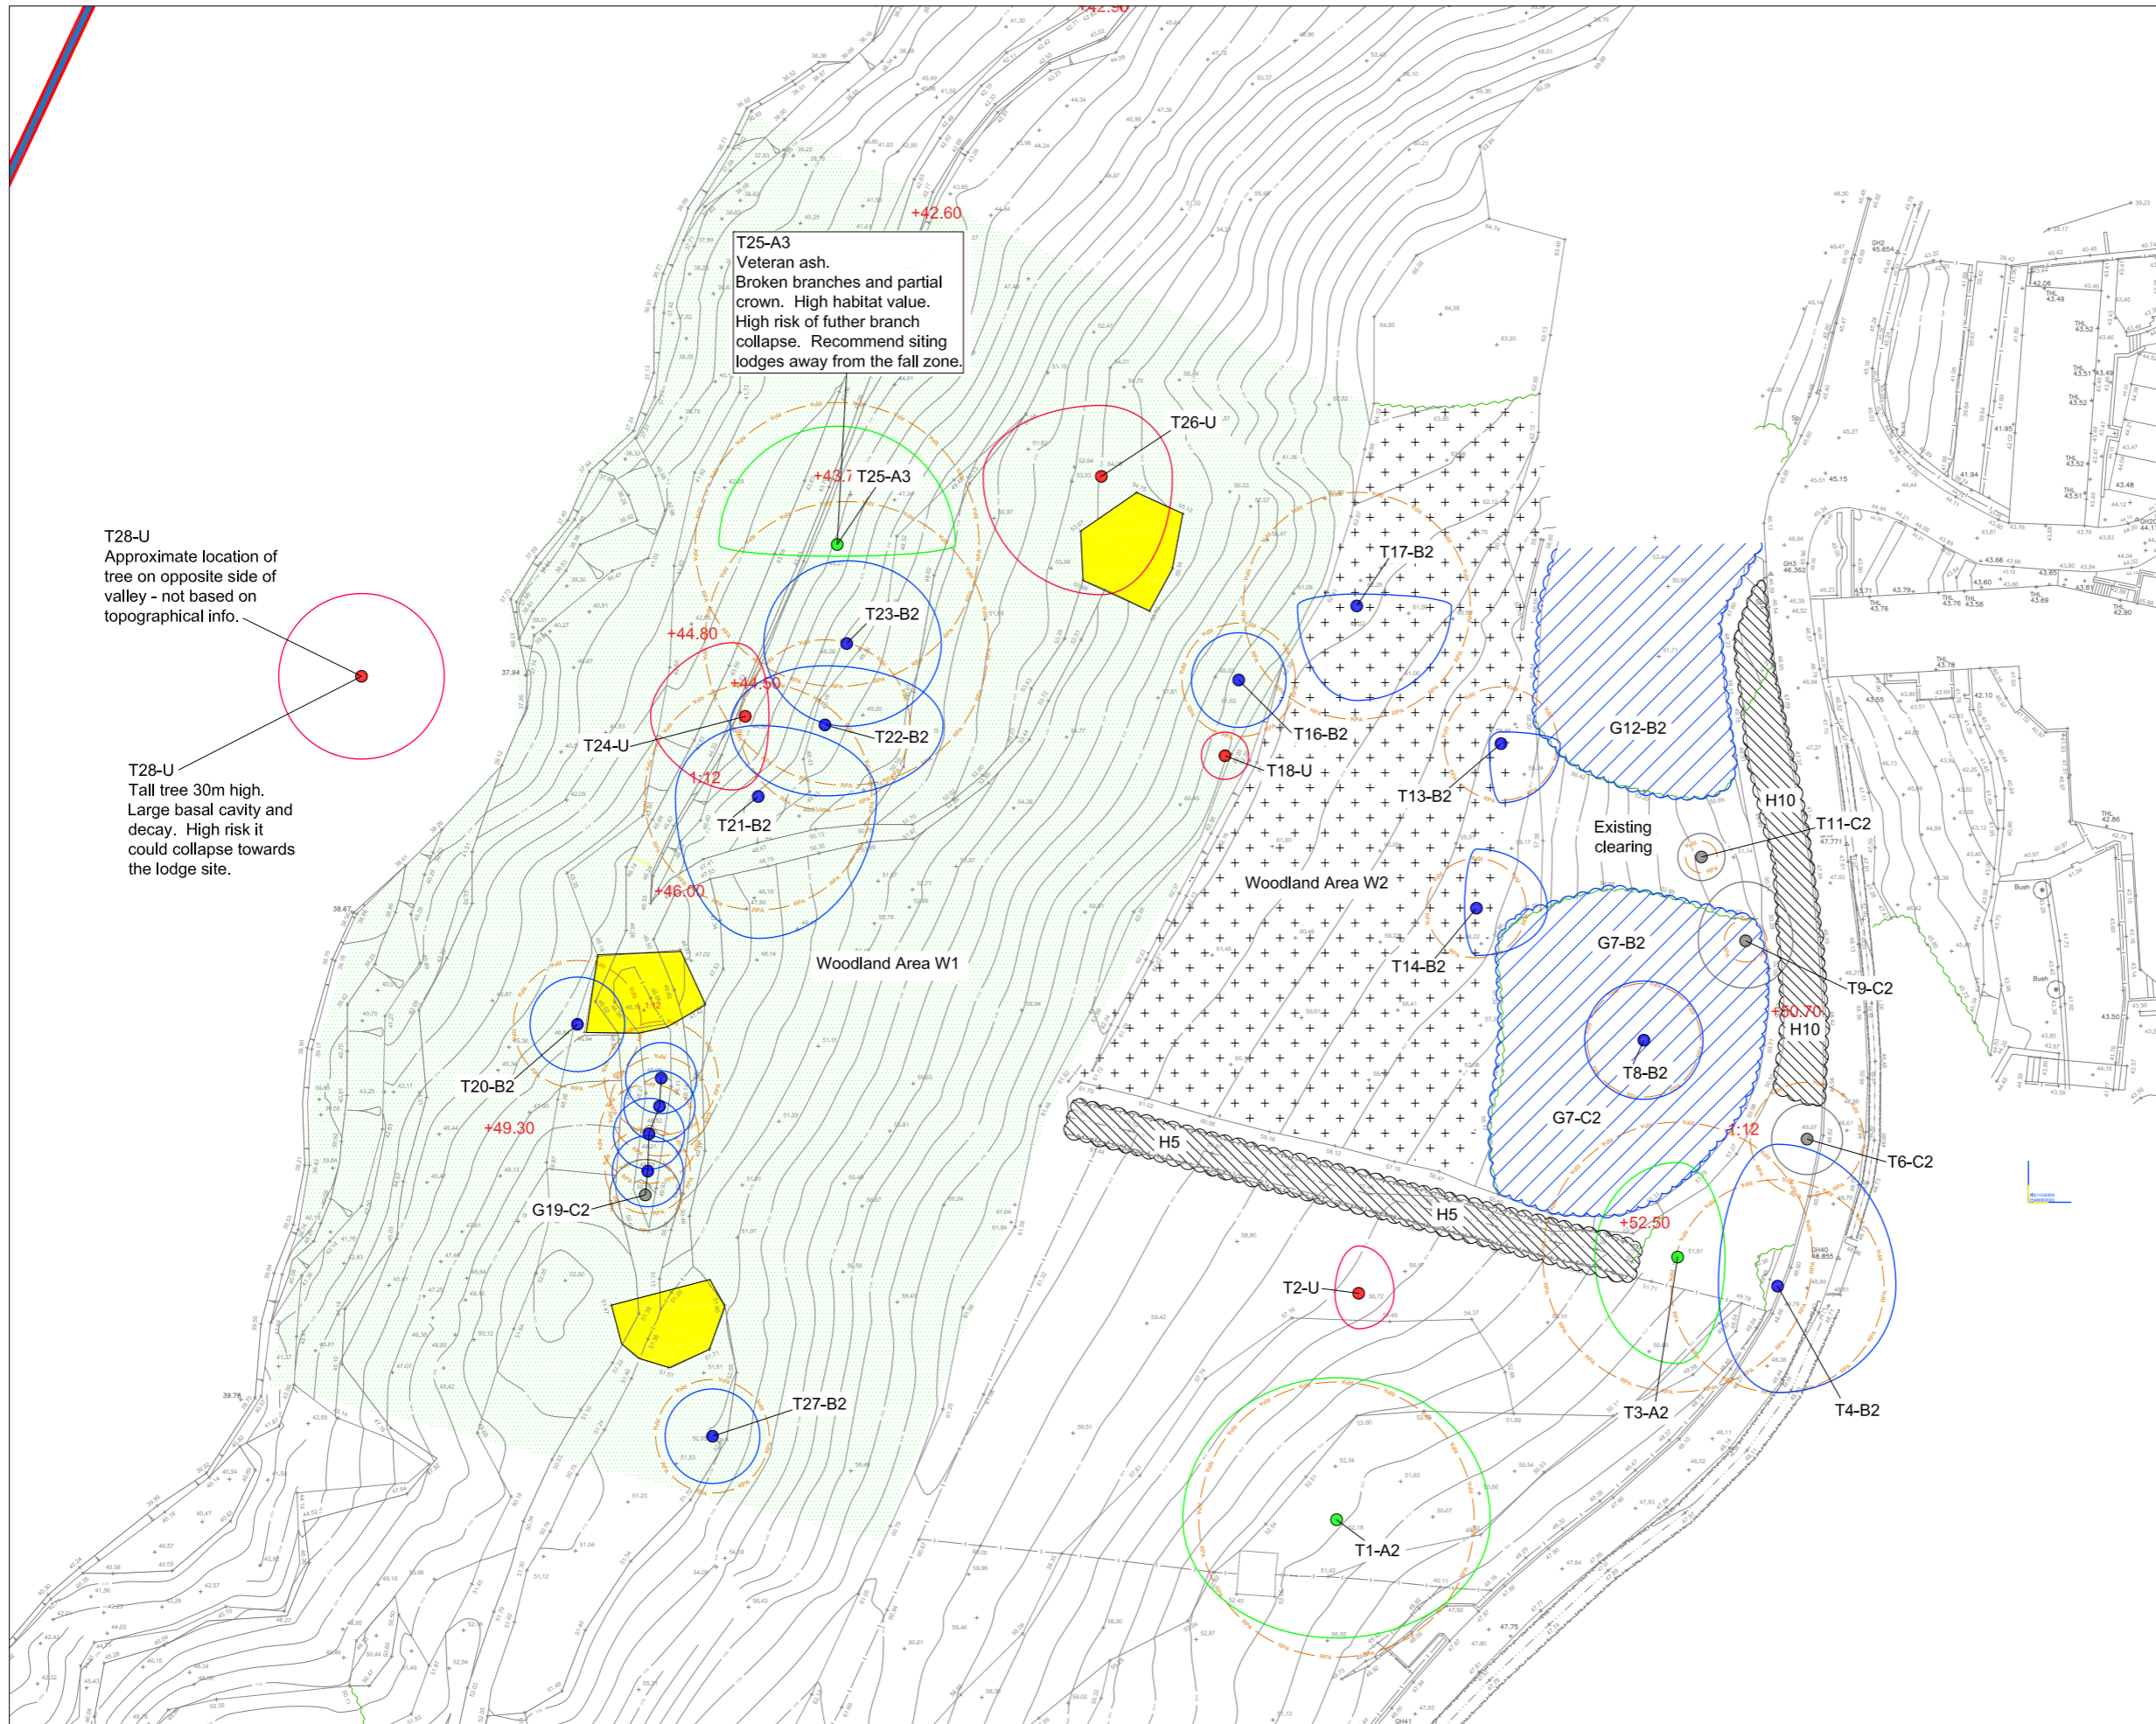
SF3014 TC02 Tree Constraints Plan

T28-U
Approximate location of tree on opposite side of valley - not based on topographical info.

T28-U
Tall tree 30m high. Large basal cavity and decay. High risk it could collapse towards the lodge site.

T25-A3
Veteran ash. Broken branches and partial crown. High habitat value. High risk of further branch collapse. Recommend siting lodges away from the fall zone.
