**Addendum to planning application for High Buildings, Fryup Dale Head.**

# Design and Access Statement

### ***Structural appraisal of Dale Head Farm***

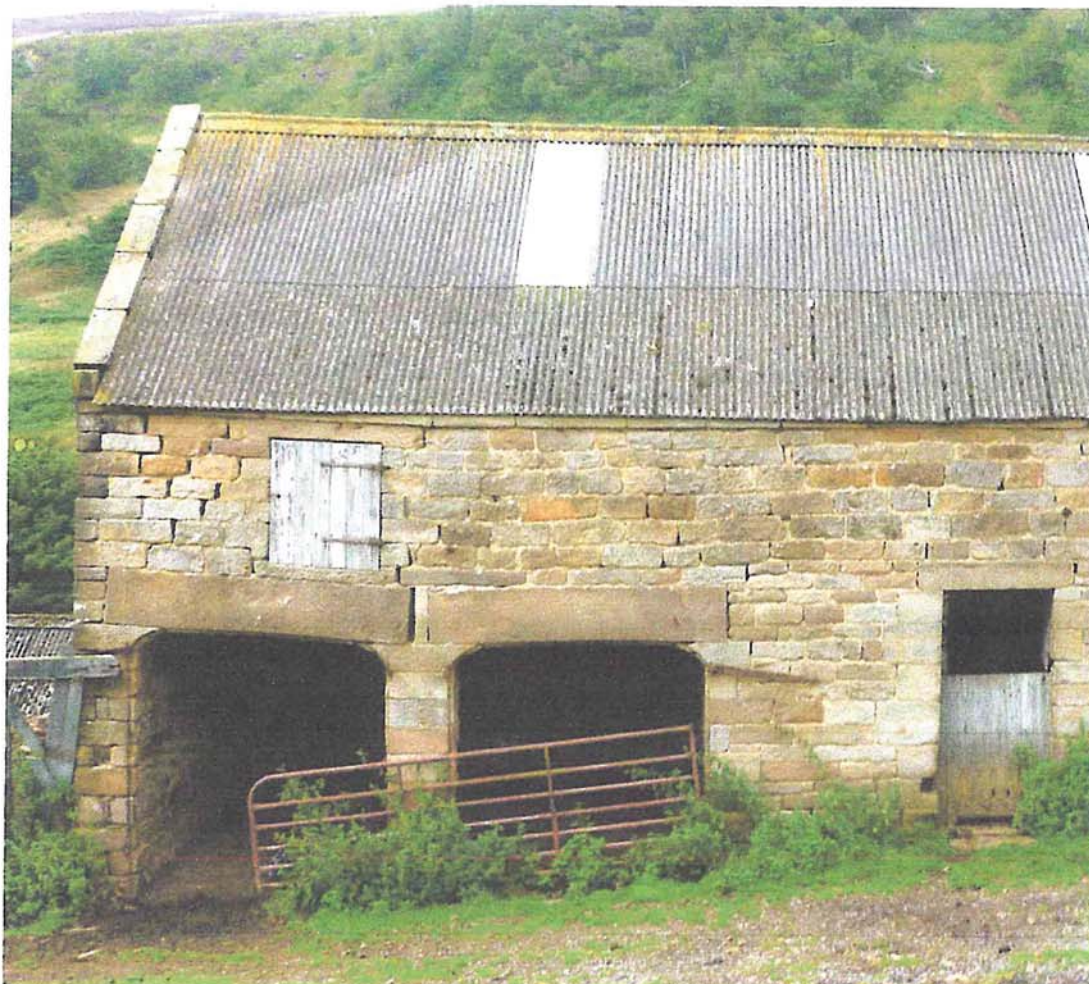
There has been severe settlement (approx max 150 mm) of the pier on the front ( west ), leading to dropping of the masonry over, which is also bowing out and has major cracking. (see photo 1). It is not clear what has caused the failure, possibly the subsidence is due to insufficient size of footing and/or poor ground conditions, and it is evident that it probably occurred early on its life. The rear (east) wall is relatively plumb. The north gable is slightly bowing in with relatively minor cracks. The south gable is bowing out slightly with minor cracks. The internal cross wall has vertical cracks adjacent to and below the central opening. There is a lack of bond at the corners of the walls and between the side walls and the internal buttresses/cross walls with gaps between the masonry. The iron (?) ties and *tales* provided at the corners and at the buttresses to give some bond are corroded and are inadequate in any case to provide good lateral stability to the structure. Recommendations for the repair of the masonry in this building are given in paragraph 5 below.

Photo 1 Photo of front (west) elevation of building A (barn) showing settlement of pier and dropped masonry over

5.1 Before starting work on the rebuilding, the roof truss and purlins should be propped (assuming the roof is not being restored at this stage?). It is also advisable to provide lateral stability to the gable with raking shores. I recommend that the pier and masonry of the west wall above is dismantled and rebuilt on new foundations. The base for the pier should be a minimum of 1.5 metres by 1.5 metres in plan by say minimum 600 mm deep concrete founded on firm clay. In rebuilding the masonry, stainless steel ties can be introduced at say approx 450 centres vertically between the south end of the wall to bond into the internal cross wall.

5.2 The internal cross wall is needed to provide overall lateral stability to the building. Openings can be formed as required but at least say a minimum of 600 mm wide masonry should be retained as buttress to the west wall which would incorporate the stainless steel ties from the rebuilt west wall (see 5.1 above). An alternative to ties is to tooth in the new masonry of the west wall into the cross wall buttress, if this is also being rebuilt at the same time. The east end of the cross wall appears to be reasonably bonded into the east side wall and as much of this should be retained. The bond of the two internal buttresses on east and west sides of the south bay (supporting the truss) should be restored by drilling say approx 20 mm diameter holes at approx 600 centres vertically, filling with suitable epoxy resin such as the *Rawl R-KER* cartridge system and then inserting a 16 mm diameter stainless steel bar. Alternatively *cintec* anchors could be used (see attached leaflet) by approved installers.

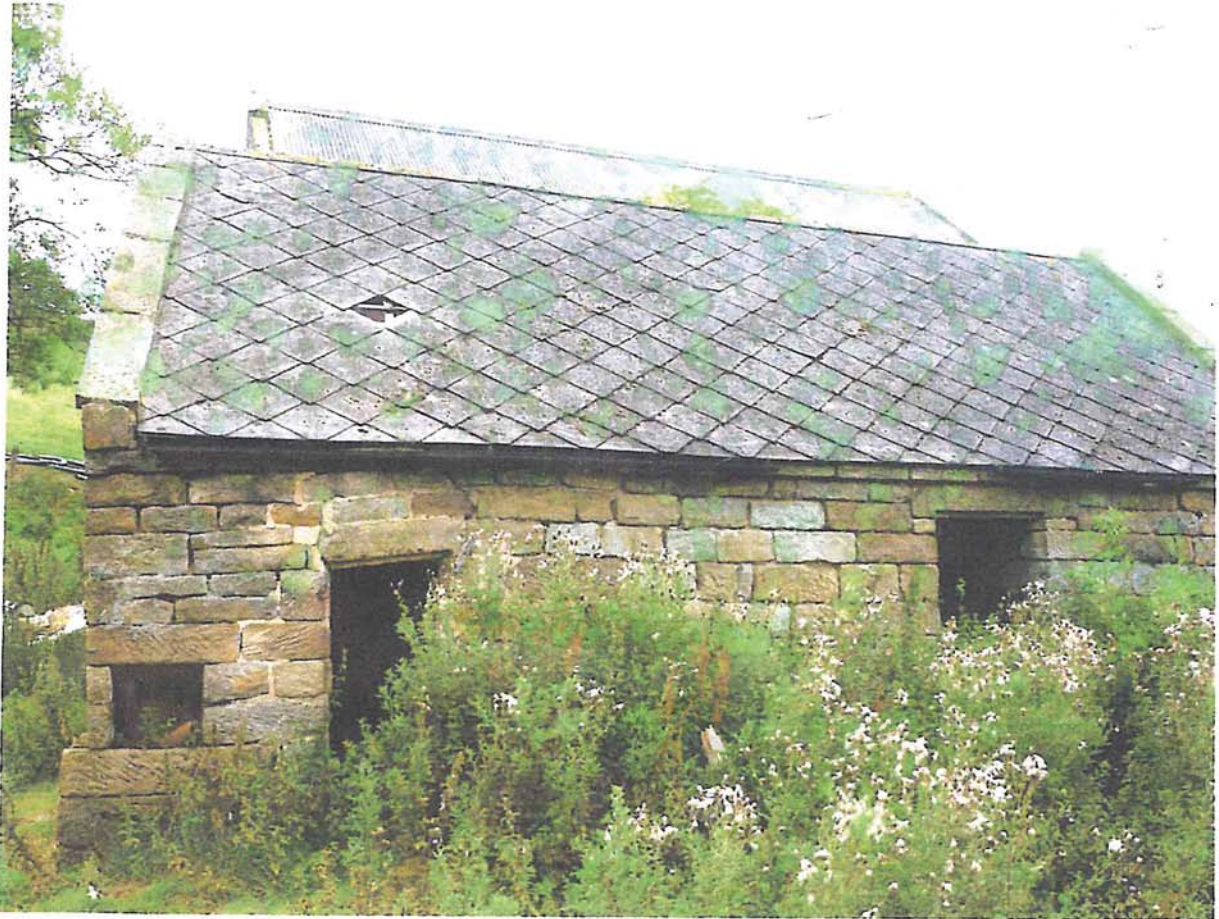
The major problem with the masonry is the movement of the south east corner which has dropped possibly due to subsidence of the ground ( see photo 2 ). Otherwise the walls, except for the south gable, which is bowing in slightly, are reasonably plumb with minor cracks. The corner will need to be rebuilt properly on new footings, say approx 900 wide by minimum 200 deep concrete footings, founded on firm ground. The walls should generally be repointed and the cracks filled in.

Photo 2 Photo of east elevation of building B showing settlement of south east corner of masonry
