Bat, Breeding Bird and Barn Owl Survey
Red House Farm, Egton

October 2021

Red House Farm
Egton
Whitby
YO21 1TY

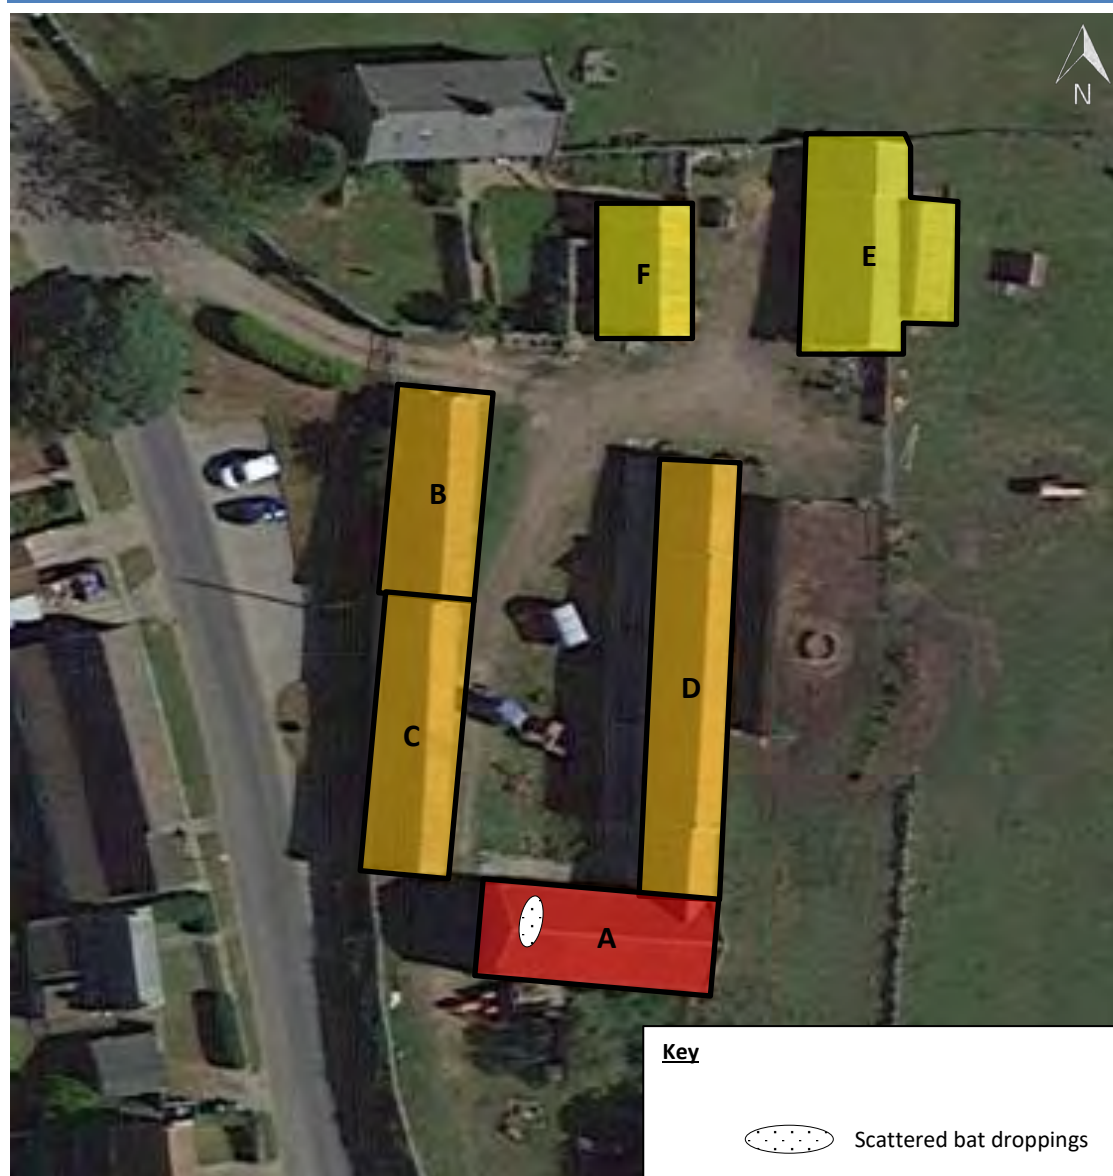
Figure 4: Visual inspection results.

Building ref.	Description	Features with potential bat roost habitat (PBRH).
Building A – High risk of supporting bats	<p>Two-storey, stone-built barn with a clay pantile roof. Gaps exist under the eaves and some lifted roof tiles provide PBRH (Photos 3 - 8). Used as hay storage, with a hayloft located on the western side of the barn. Scattered droppings found on floor of hayloft, indicative of <i>pipistrellus sp.</i> and brown long-eared bats (Photo 9).</p> <p>Evidence of nesting birds and low use by barn owls (pellets) were found in the hayloft (Photo 10).</p> <p>1x barn swallow nest, 1x passerine nest</p>	High PBRH between lifted tiles and bitumastic-lined roof. PBRH for void species and limited PBRH for crevice-dwellers.
Building B - Moderate potential risk of supporting bats.	<p>Single-storey, stone-built barn internally connected to Building C. Currently used in storage capacity. Stone walls largely intact with some missing tiles and a partly collapsing roof (Photos 11 & 12).</p> <p>2 x barn swallow nests</p>	Low PBRH between eaves, lifted tiles and liner and masonry crevices.

Building C - Moderate potential risk of supporting bats	<p>Single-storey, stone-built barn internally adjoined with building B. Currently used in storage capacity. Cobwebbed void area, relatively undisturbed. Most the mortar is intact with few masonry gaps. No droppings were found (Photos 11 – 13).</p> <p>1x barn swallow nests</p>	PBRH between liner and roof tiles. Some crevice habitat exists in masonry gaps.
Building D – Moderate potential risk of supporting bats	<p>Single-storey, stone-built barn with a lathe-lined clay pantile roof. The barn is divided into three inside. Draughty and damp inside. There are some loose roof tiles and gaps under coping stones and ridge tiles. Small ventilation holes exist on north gable wall. No droppings were found (Photos 14 – 19).</p> <p>3 x barn swallow nest 1 x passerine nest</p>	PBRH between lathe lining and clay pantiles. Limited crevice habitat exists in gaps in masonry.

Building E – Low potential risk of supporting bats	<p>Stone-built building with a corrugated asbestos roof and wooden slat doors. Draughty and cobwebbed inside. No droppings were found (Photos 20 – 22).</p>	Limited PBRH – access via a few masonry crevices.

Building F – Low potential risk of supporting bats	Stone building with a clay pantile roof. Generally well-pointed, recently re-mortared. Draughty, damp and heavily cobwebbed void space with undisturbed cobwebs. No droppings were found (Photos 23 – 26). 2x barn swallow nest	Limited PBRH between occasional lifted roof tile and liner. Few masonry crevices.
---	--	---

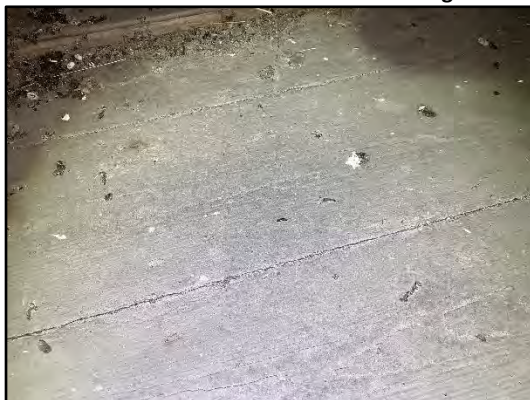
The dusk emergence survey carried out in September 2021 by MAB Ecology revealed a solitary brown long-eared bat roosting in Building A. Scattered droppings were also found on the floor of the hayloft in building A. No bats were seen emerging from Buildings B, C or D. This bat is likely to be transient but a further emergence survey post planning will inform whether a licence is required.

Photo 7: Scattered droppings in building A.

Bat roost and potential roost habitat lost to the development will be mitigated for via the installation of 2 long lasting professional quality woodcrete bat boxes (see Section 9: Method Statement for full information).

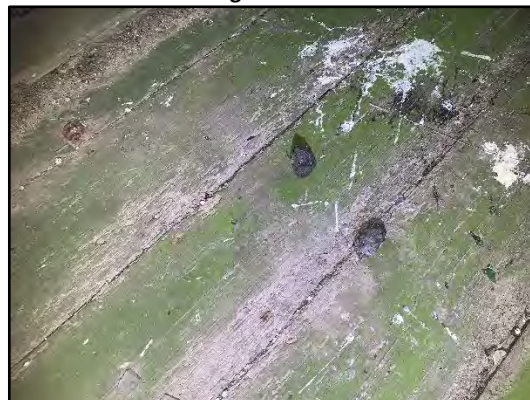
Photo 8: Barn owl pellets on floor in building A.

Development of Building A will also result in the loss barn owl roosting habitat. To ensure that the site remains ecologically functional for barn owls post development, one permanent barn owl box should be installed within one of the outbuildings.

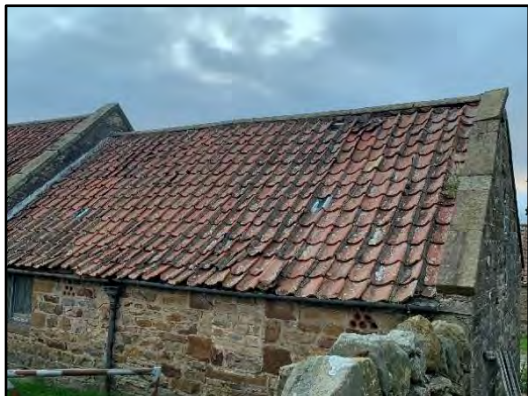
Photo 15: Missing roof tiles on building D.

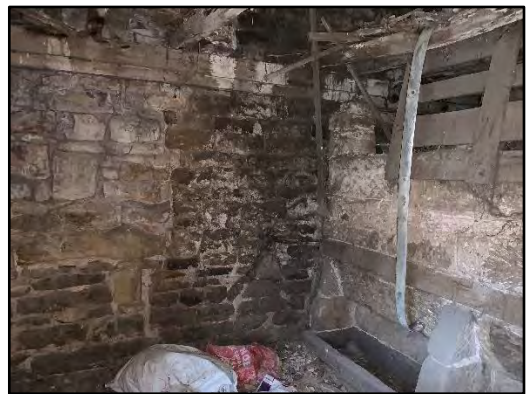
Photo 22: Inside building F; cobwebbed and damp.

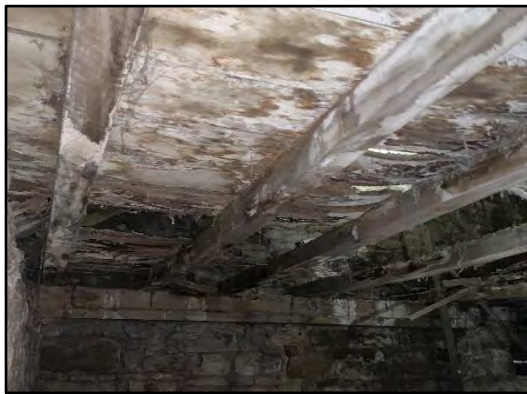
Photo 23: Cobwebbed inside of building F.

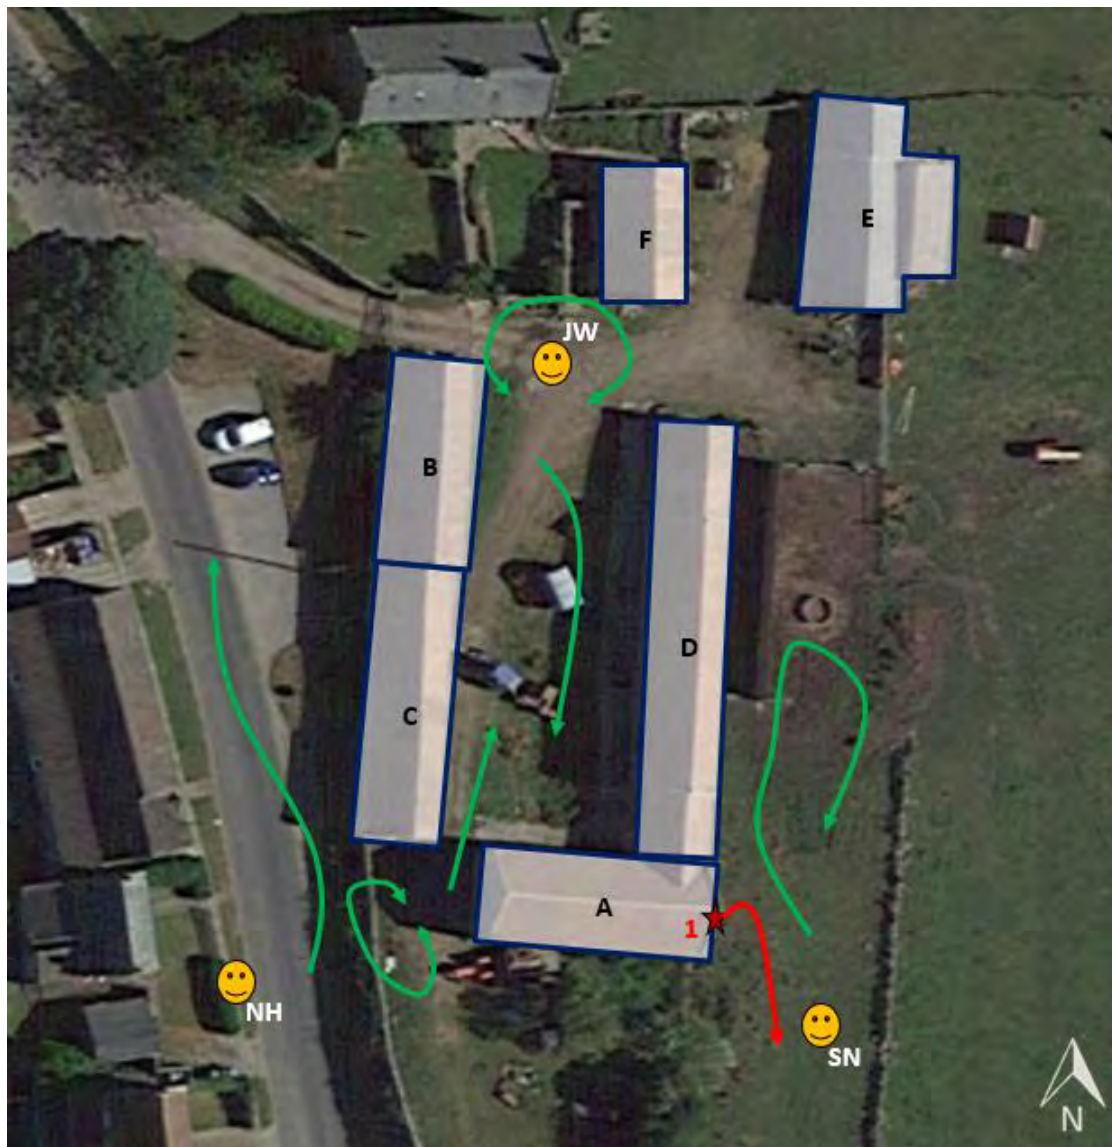
Figure 5: Surveyor locations and bat activity recorded during survey 1 (23/09/2021).

Results summary: Bat activity was low throughout the survey. One brown long-eared bat emerged from the ridge of building A. Common pipistrelles were identified foraging intermittently around the site. A noctule was heard flying overhead.
