Old Carriage House,

Mowthorpe Road,

Arboricultural Report

Report reference	1598
Revision	2
Prepared by	James Blades
Approved by	James Stacey
Issue date	18 th November 2021

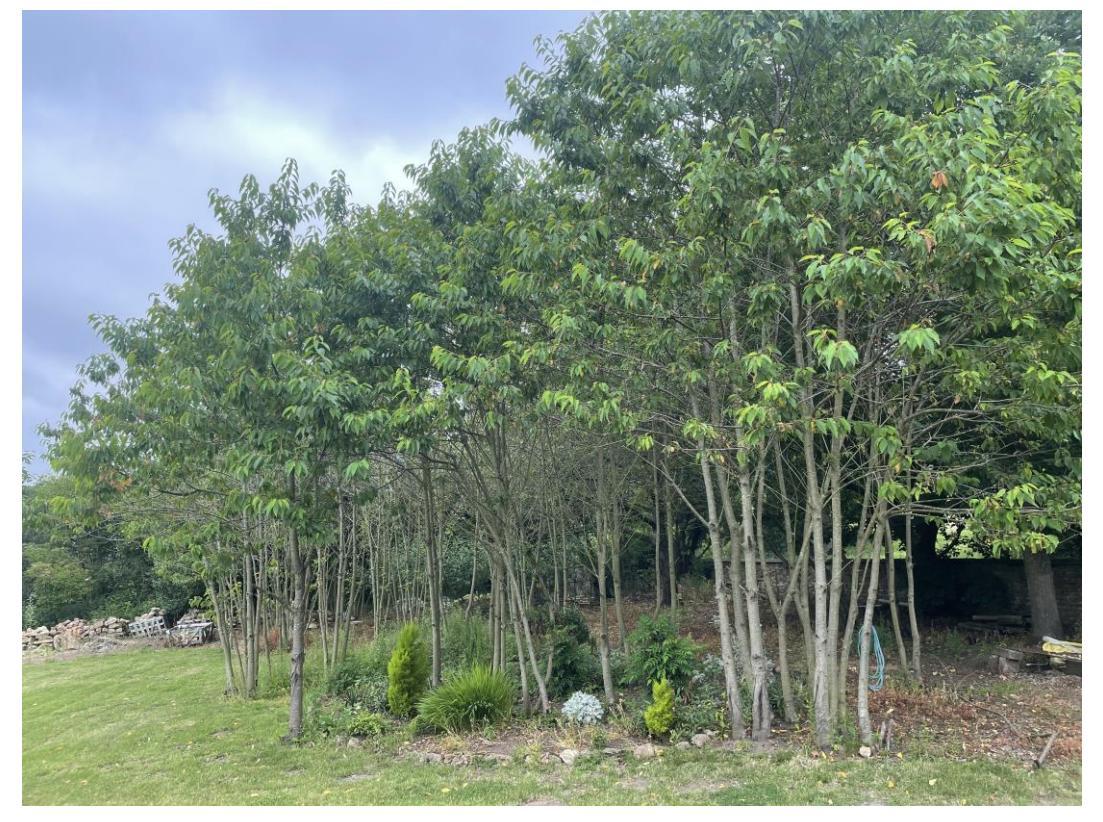
Image 1 – Looking north to G2.

- 4.4.1.1 Trees within G2 are all small sucker growth stems from T3 and will conflict with the proposed parking bays and access paths and overall proposed landscaping. These are small trees and not considered to present a significant contribution to the wider landscape.
- 4.4.1.2 Replacement planting will be required to mitigate the loss of these trees. Replacement planting with longer lived species such as oak will improve the longevity of canopy within the site.

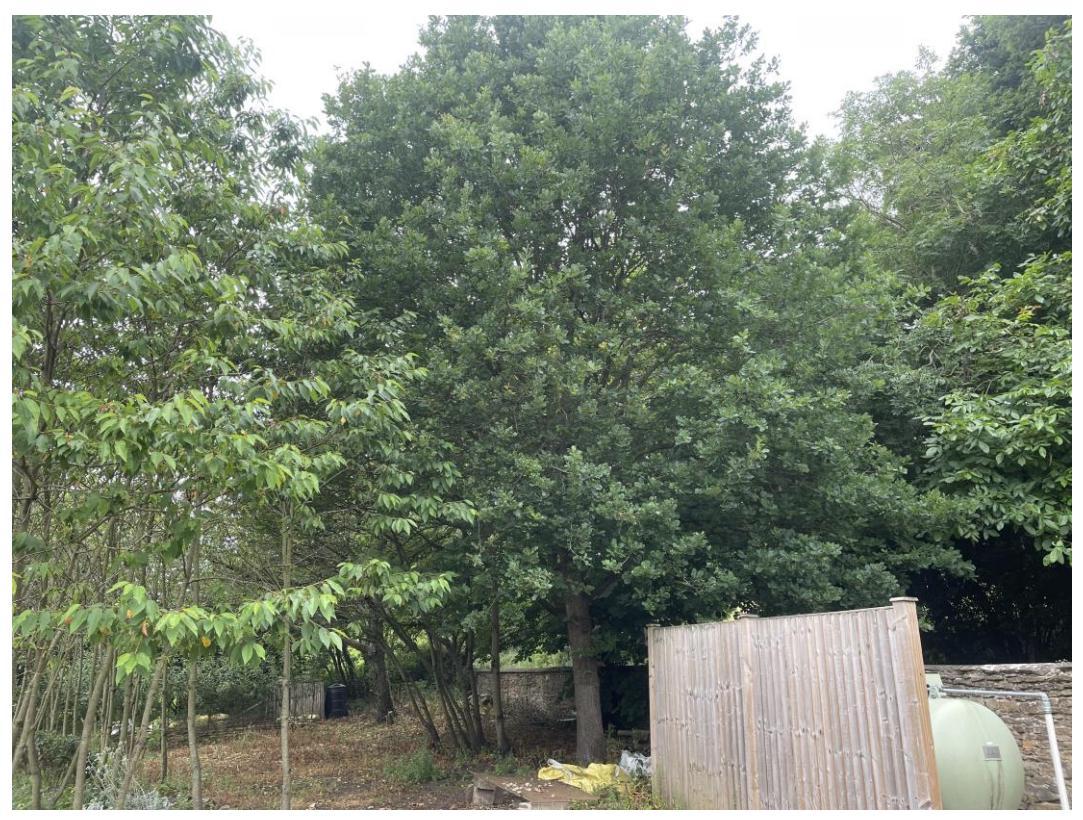
Image 2 – Looking north to T1.

- 3.1.1.5 Trees cover on the site is moderate despite the small nature of the application area and consists of mainly of G1 and T1-T3.
- 3.1.1.6 T1 is the most valuable tree on site due to its position and uncompromised condition. The tree is in good general health and form and can be seen from the adjacent road as well as the main dwelling next to the application area. The tree is considered to be BS5837:2012 Category B2.

4.6.1.1 Minor crown lifting of T1 may be required where necessary to provide clearance over proposed access driveway.

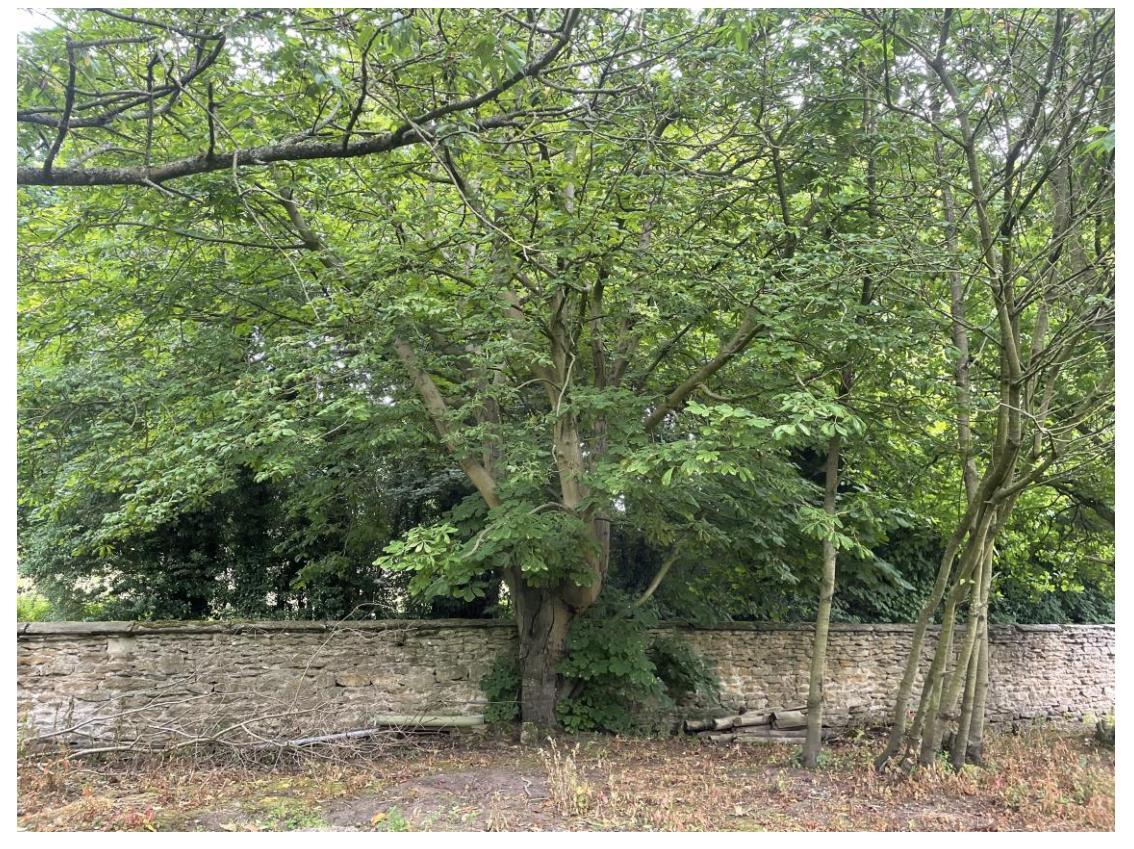
Image 3 – Looking north east to T2.

- 3.1.1.7 T2 is a moderately sized horse chestnut tree growing in close proximity to the boundary wall. The tree is in a compromised condition due to the presence of a decay pocket (approx. 30 cm in diameter) at the base of the stem on the eastern side. The tree also has a co-dominant stem at 1.5 m which is heavily included. Although the tree is well sheltered from excessive wind loading, due to the species profile for failure at an included union it is thought that the defect is of concern. The tree is considered to be BS5837:2012 Category C2.

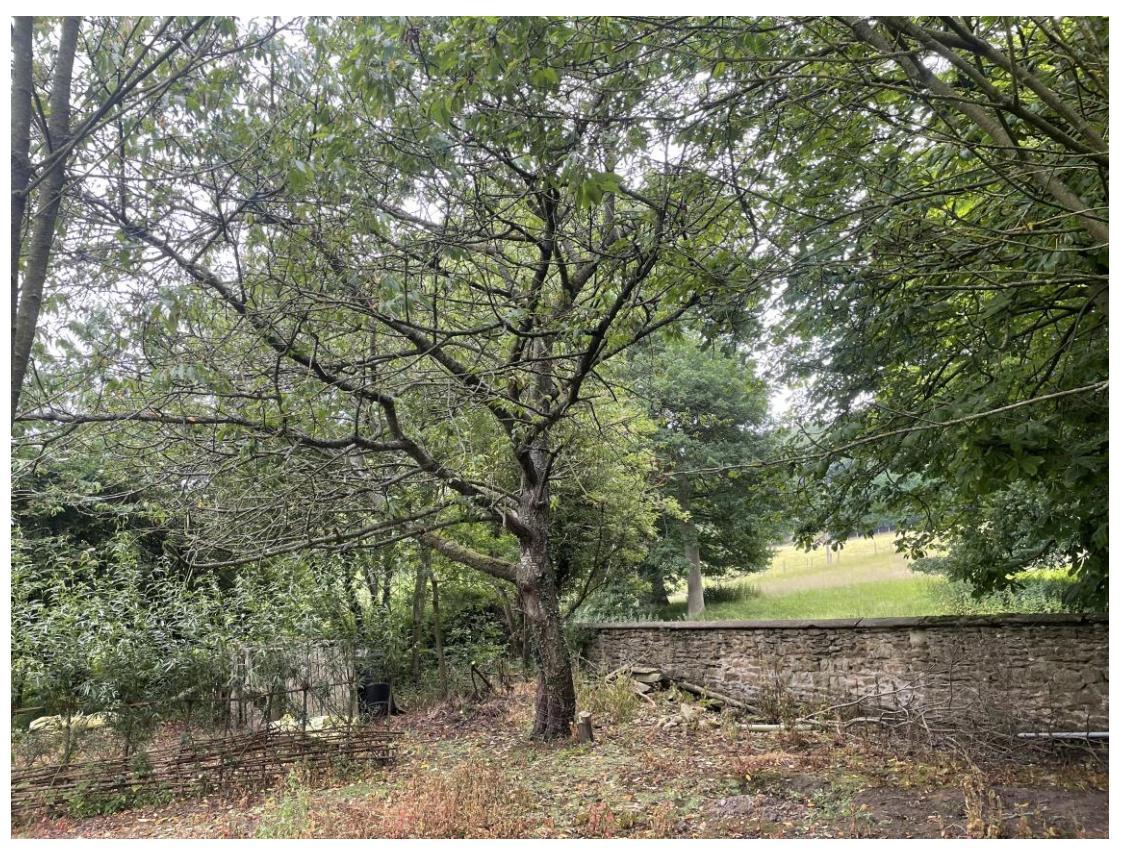
- 3.1.1.8 T3 is a mature cherry tree, the last of the three mature trees within the application area. The tree has good form but a sparse canopy with limited leaf cover. There is a moderate amount of deadwood throughout the lower and peripheral crown, the tree is thought to be dying back. It is assumed that the prolific amount of small cherry stems within the area including those of G2 are suckers from T3. Many of the cherry suckers are showing a similarly sparse canopy to T3 especially those closest to the parent tree. Both T3 and G2 are considered to be BS5837:2012 Category C2.

Image 4 – Looking north to T3, the sparse canopy can be seen.

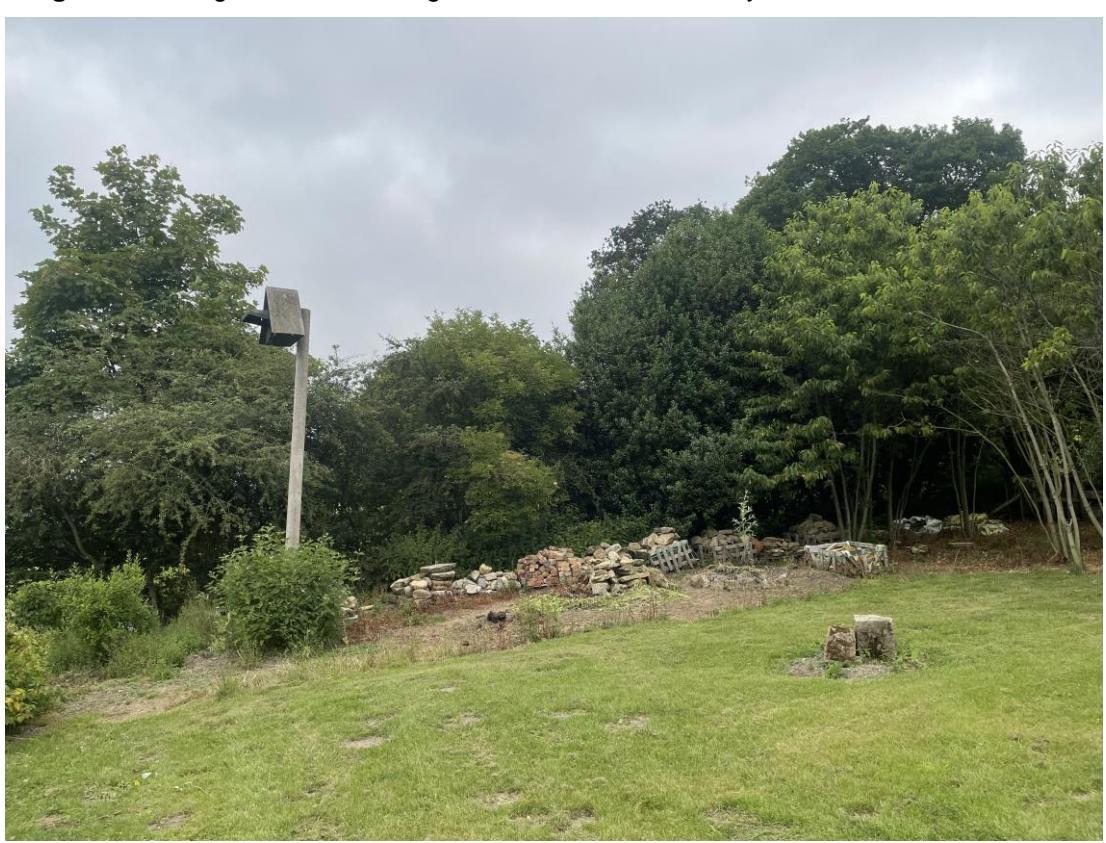
Image 5 – Looking north to G1 along the northern site boundary.

- 3.1.1.9 G1 accounts for a large amount of the canopy cover on site due to the continuous canopy it provides along the northern boundary of the application area. The group is a mixed species hedge which has been left unmaintained and so grown both laterally and in height and has many small cherry stems also thought to be from T3. The group is considered to be Category C2.
