## Design and Access Statement Householder – Repair (in a Conservation Area)

This application is for the replacement of the two lower south facing sash windows of the property (Millbrook, Chapel Street, Robin Hoods Bay) shown below, which are beyond repair due to rot which likely commenced before the current owners reinstated cast iron guttering under previous Listed Building Consent approximately ten years ago.

Millbrook cottage Robin Hood's Bay

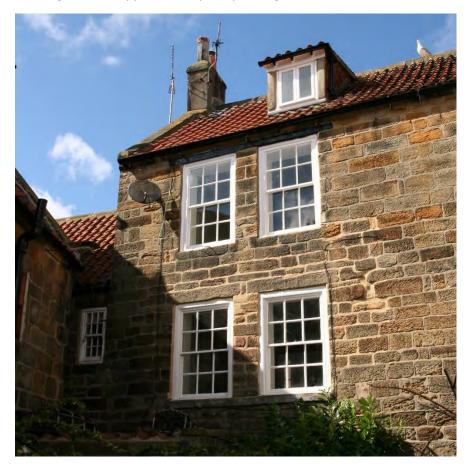
Image of south side of Millbrook

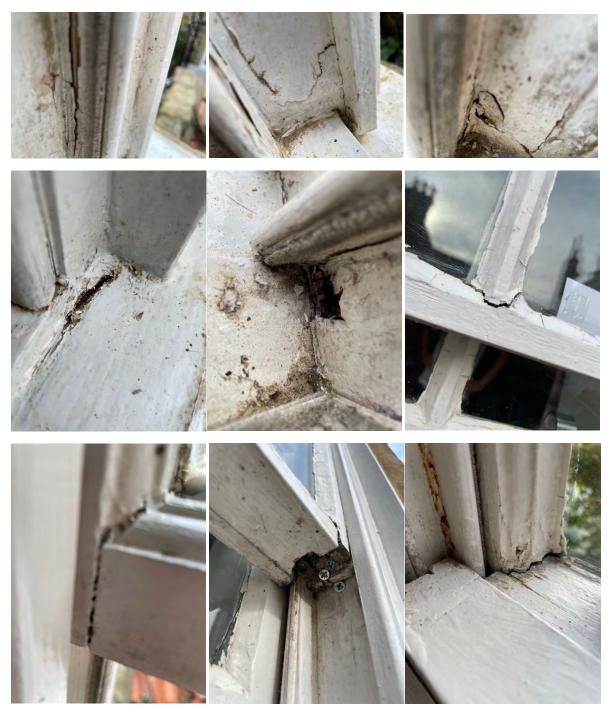
The windows to be replaced are the two lower ones shown in the image at the top of this document. Also shown here are several close ups detailing their current condition.

This window has had repairs to it at various times throughout its life, a replaced front edge to its cill, a lower sash bottom rail and numerous areas filled and painted, all these areas are now showing signs of deterioration and further decay.

In addition to these areas the bottom rail and side rails of the upper sash have rotted through and the joint has parted. (this is now screwed together and screwed shut to avoid complete collapse)

The lower sections of the outer and centre of the sash box have major decay and at some point in the past a cover strip of timber has been added to the outer box which appears to be covering further decay.

Again this window has seen multiple repairs throughout its life, to the cill and bottom rail of the lower sash.

It has had many areas of decay filled and painted which has now spread and is showing through these areas.

The lower portions of the boxes have extensive decay. The joints of the bottom rail of the upper sash are now visibly separating from the side rails .

The outer frame of the box has distorted joints at the point they meet, the boxes also have extensive decay in the lower areas where they meet the cill, the cill has extensive decay and is parting from a previous repair.

It is my opinion that this window isn't viable for repair and should be replaced with a like for like replacement.

It is my opinion that both these windows should be replaced with like for like replacements where all proportions and mouldings are matched exactly and where possible the original glass is re-used.
