TE Offices, Egton, Whitby, North Yorkshire.

Bat & Bird Scoping Survey

February 2022

Report reference	1674
Revision	01
Prepared by	Emily Hopkin
Approved by	Thomas McQuillan
Issue date	9 th February 2022

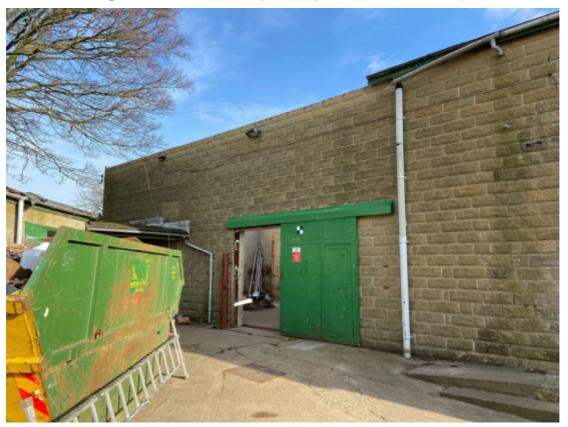
Photo 1. Building 1 – Western elevation (no roof present on this section).

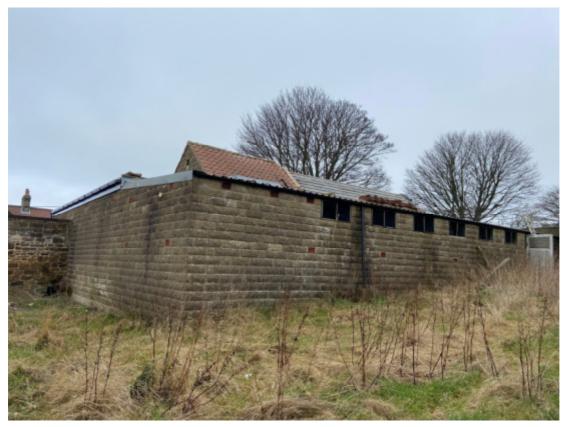
Photo 2. Building 1 – south and eastern elevations.

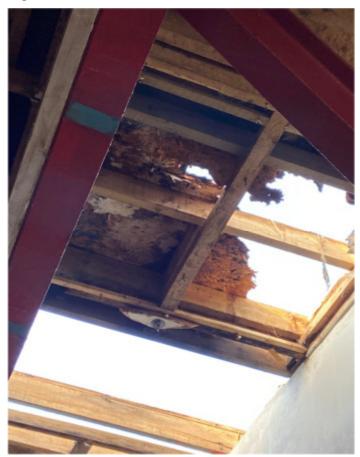
Photo 3. Building 1 – remaining roof sections within the main structure – showing the water ingress.

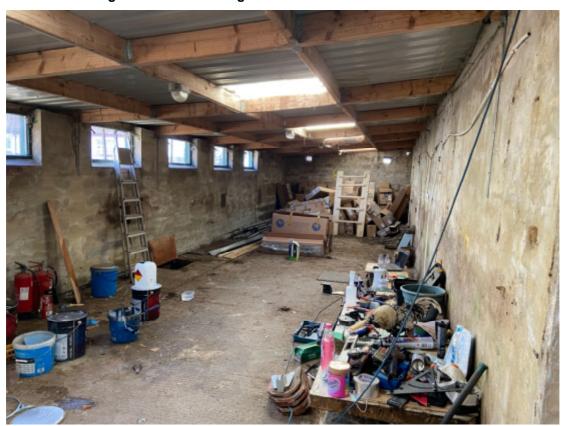
Photo 4. Building 1 – eastern building section.

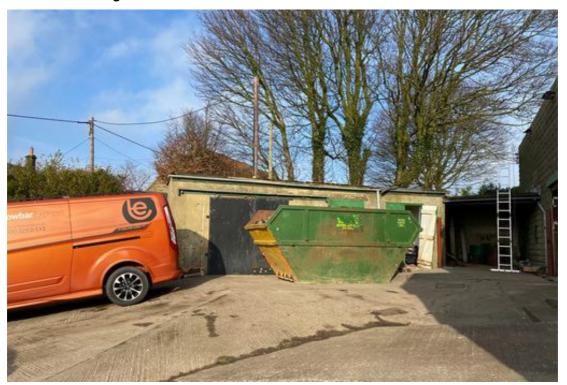
Photo 5. Building 2 – southern elevation.

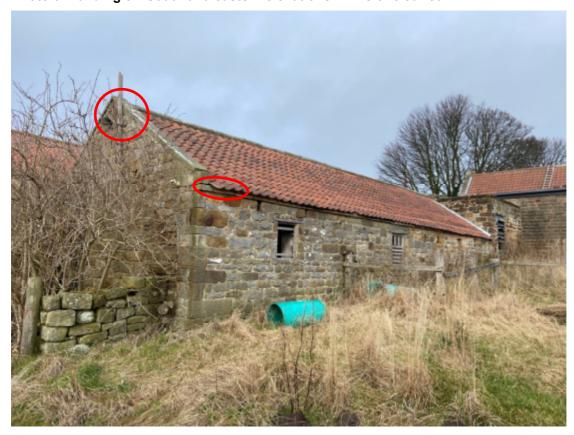
- 3.2.2.3 Building 3 offers several potential roosting features and was considered to hold features of <u>low-moderate bat roosting potential</u>. The following features were considered to be of potential value to roosting bats:

- Gaps and crevices in the stone work on the external and internal elevations of the barn (i.e.
 externally below the coping stones where mortar has failed on the southern elevation and
 internally between the stonework and roof timbers). These gaps would provide access into
 areas which would provide suitable roosting locations for crevice dwelling bats. Appendix 2:
 Photo 6.

Photo 6. Building 3 – south and eastern elevations. PRFs circled red.

4.2.1.2 At the time of writing the proposed developments will only include minor renovations to Building 3 (i.e. repair/replacement of doors) with no works planned for the features of potential value to roosting bats and no change of use proposed as the building will continue to be used for storage. Therefore no further surveys are recommended.

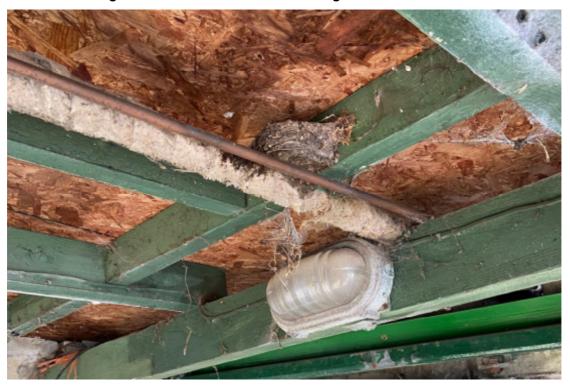
- 3.2.4.1 A single old barn swallow nest is located within the roof timbers in the north-east section of Building 2. There was no evidence (i.e. droppings below the nests) that these had been active in 2021.
- 3.2.4.2 Building 1 was considered to be suboptimal for nesting birds due to the present poor state of repair.
- 3.2.4.3 Building 3 was considered to be suitable for nesting birds, with several disused nests, likely to have been used by common species such as blackbird and wren, recorded within the internal rooms of the building.
- 3.2.4.4 No evidence of barn owl was recorded in the buildings.
- 3.2.4.5 It is not considered that the proposed works will impact great crested newts, otter, water vole, hedgehog, badger or reptile species.

Photo 7. Building 2 – swallow nest in the eastern region of the roof frame.

- 4.2.2.2 The development works should be completed outside of March to August (inclusive). Alternatively, if such work is required during the breeding bird season, a breeding bird survey check must be undertaken in order to confirm absence or presence of nest sites. If an active nest is found within the site, it must be avoided until the nest is no longer in use which may cause delays to the development.

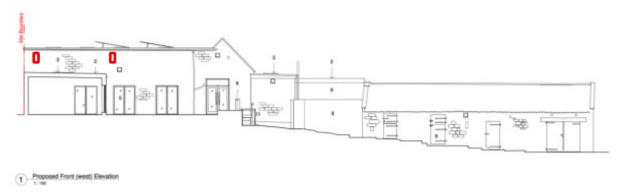
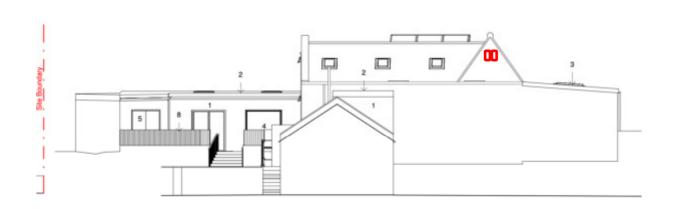
Photo 8. Location of four bat boxes proposed for Building 1 shown by red outlines.

4.2.1.3 As a biodiversity enhancement, four bat boxes are recommended to be installed on the southern elevation of Building 1 as shown in Appendix 2: Photo 8. Bat boxes provide permanence, unobtrusiveness and durability. Bat boxes can be purchased through a variety of web sources including http://www.wildcareshop.com & http://www.nhbs.com. The ecologist can provide guidance on the location and position for the two bat boxes.

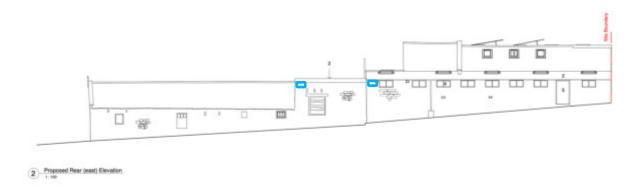
Photo 9. Location of two house sparrow terrace boxes proposed for Building 1 shown by blue outlines.

- 4.2.2.3 To compensate for the loss of bird nesting habitat it is recommend that two house sparrow terrace boxes be installed on site as part of the developments. As shown in Appendix 2: Photo these should be installed on the eastern elevation of the building.
