Proposed Conversion of outbuildings to form  
Garage and Holiday Cottage

Oak Tree House, Egton Bridge, Whitby, North Yorkshire, YO21 1XE

**STRUCTURAL CONDITION SURVEY  
of  
THE OUT BUILDINGS  
AT  
OAK TREE HOUSE  
EGTON BRIDGE  
WHITBY  
YO21 1XE  
prepared on behalf of  
J Money  
Project No P26\_22\_07.01**

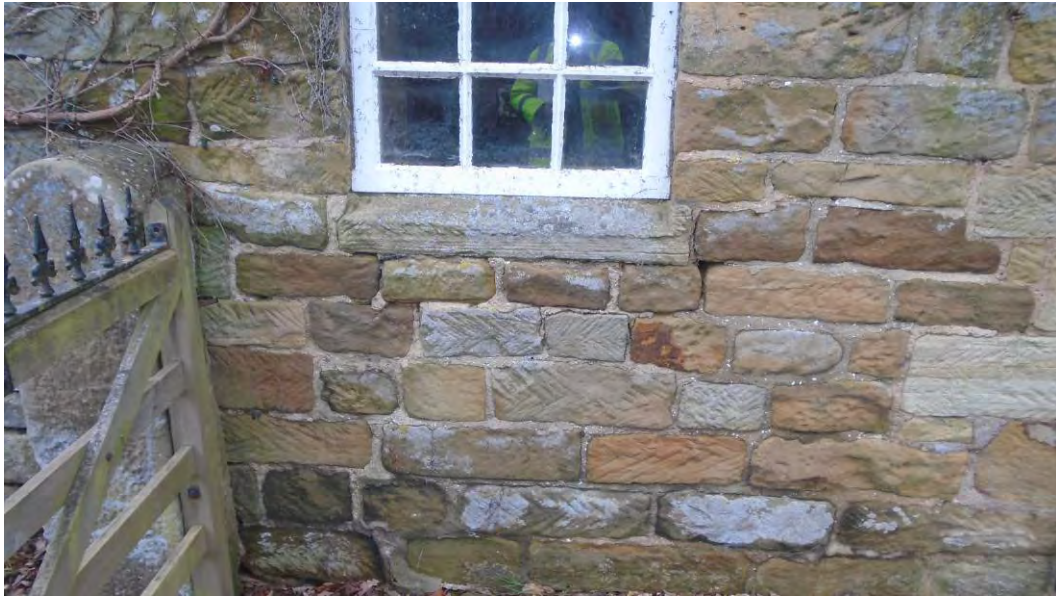
**Plate 9**

- b. The mortar on the gable end is showing signs of weathering (refer to Plate 9). These should be repaired with a suitable mortar that retains the historical content of the building

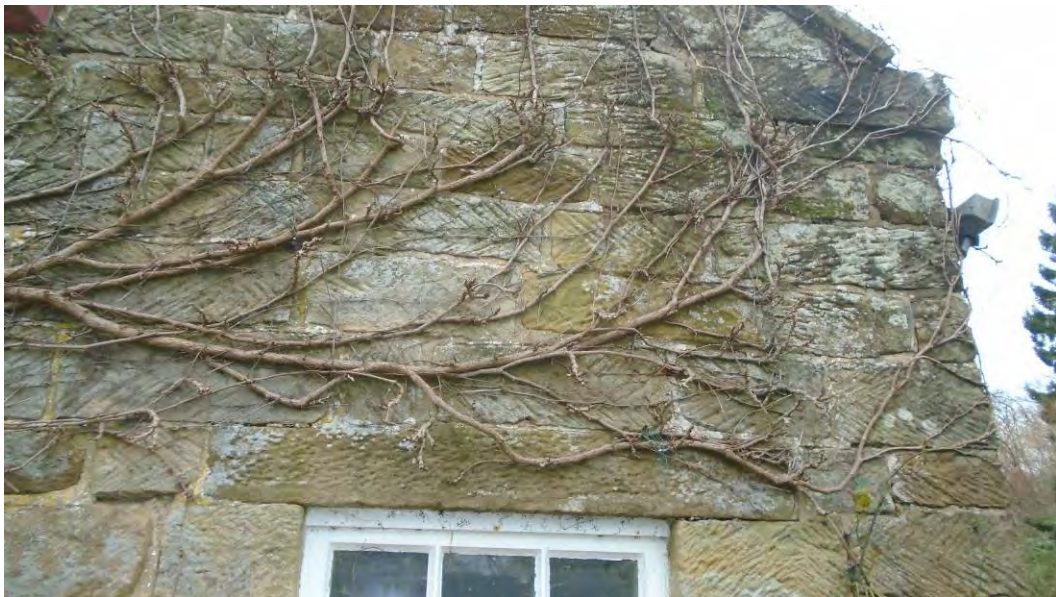
**Plate 10**

- c. There is a hairline crack above the ground floor window, on the northern side of the gable end (refer to Plate 10). It would be prudent to assess the load carrying capacity of the timber lintel internally to see if it needs upgrading before the crack is repaired

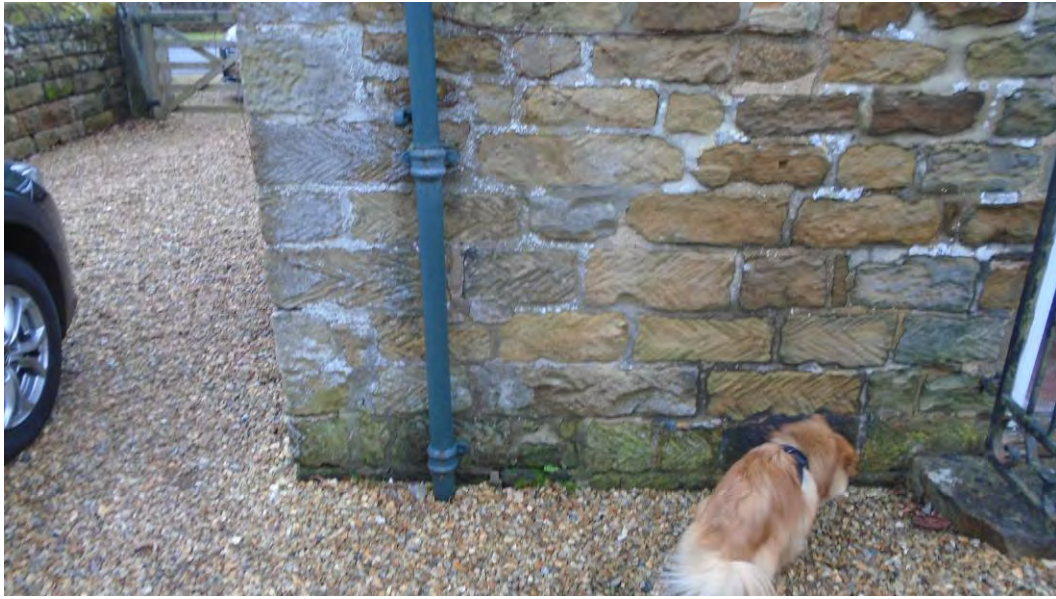
Plate 11

- d. A crack was recorded in the stone work on the north east corner of the rear elevation (refer to Plate 11). It would be prudent to undertake a CCTV of the below ground drains (for all 3 units and the house), then repair any defects within the drainage system. It may also be necessary to expose the foundation in this area to confirm it can support the load applied to it. This exposure should be undertaken in other areas just to confirm the foundations are adequate for the proposed alterations

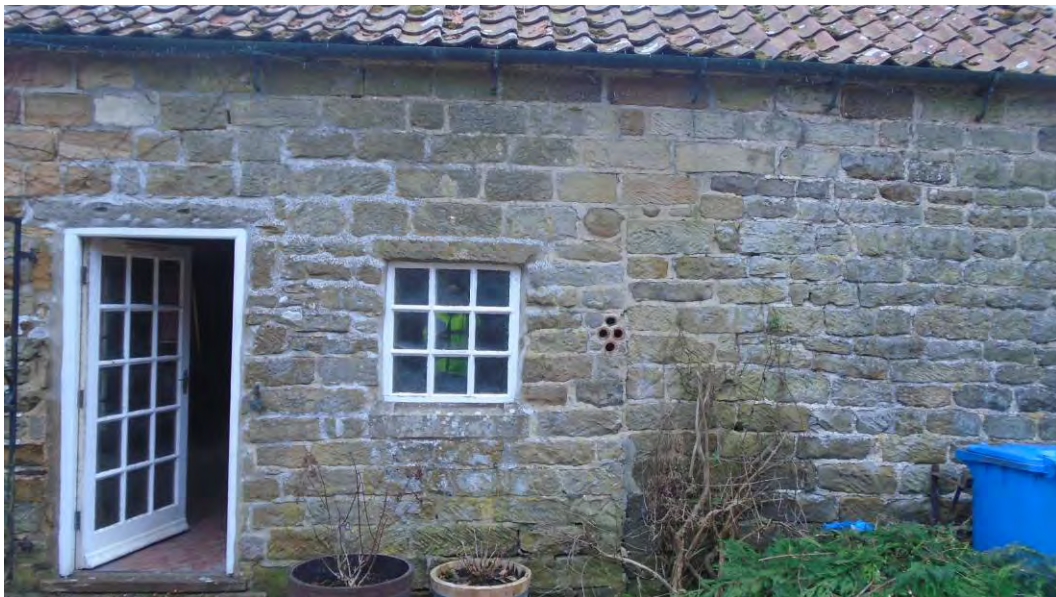
Plate 12

- e. There is a vertical crack in the stonework on the southern elevation at the junction between unit A and B (refer to Plate 12). The foundations should be exposed at this location before any tying of the stonework is undertaken

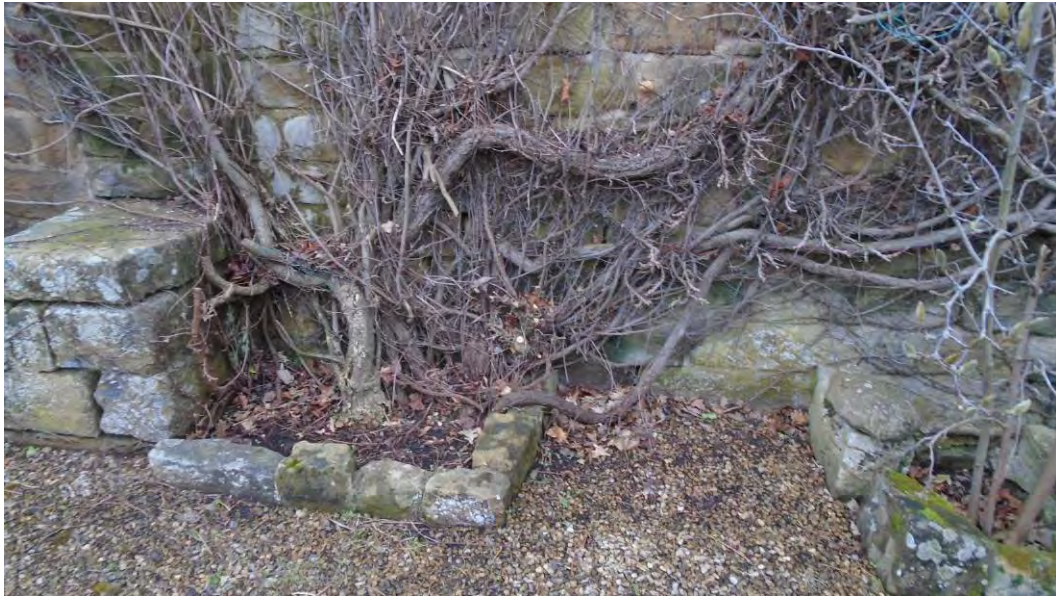
**Plate 13**

- f. There is a crack in the mortar on the front elevation (refer to Plate 13). This appears to be related to the roots from the vegetation near this defect. It would be prudent to monitor this cracking to see if it is related to a foundation issue before it is repaired

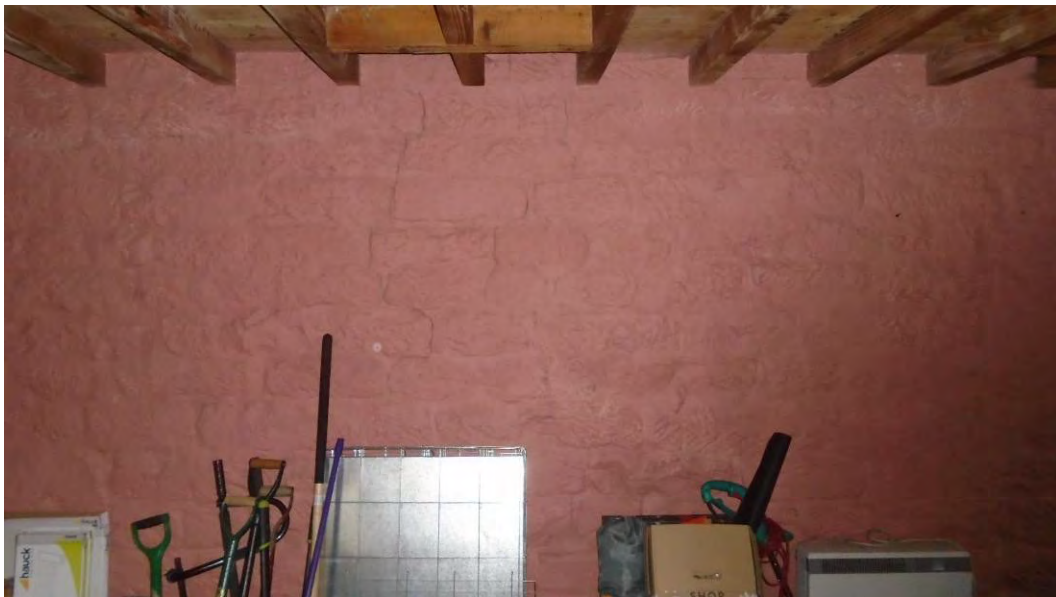
**Plate 14**

- g. There is a vertical crack in the stone work party wall at the eastern end of this unit (refer to Plate 14)
  - h. The lintel above the door opening on the rear elevation may need upgrading to accommodate the timber beam bearing near its support (refer to Plate 15)

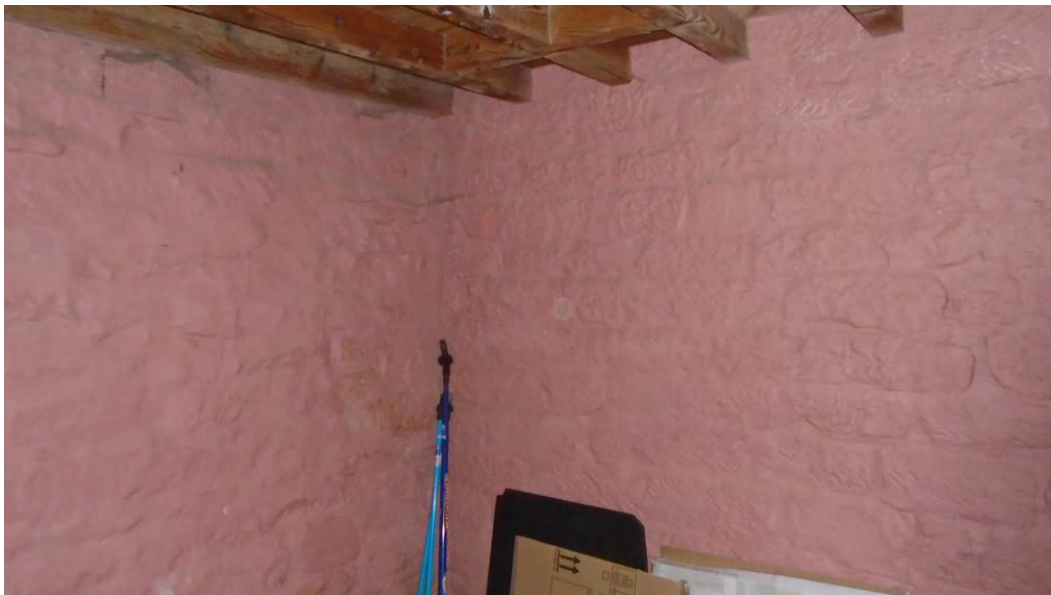
**Plate 16**

- i. There is an hairline crack in the south east corner of the stone work on the inner face of the party wall associated with Unit B (refer to Plate 16). This could also be related to the issues noted in item d above
- j. Access to the timber floor was limited. However, a number of boards were rotten (refer to Plate 17) and should be reviewed by a timber specialist

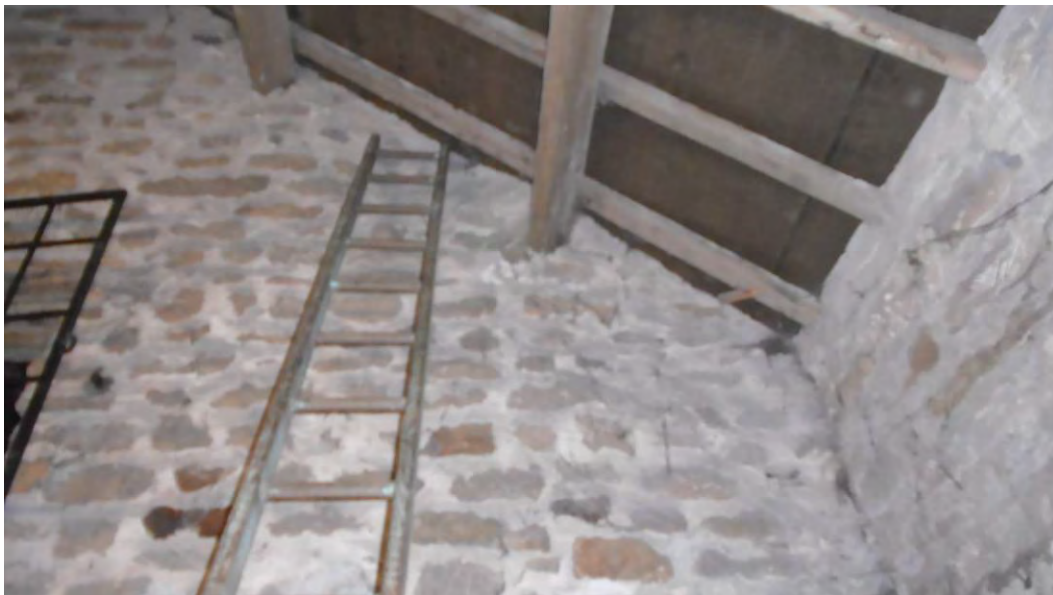
**Plate 18**

- a. A crack was recorded in the masonry party wall to unit A, below the purlin at the northern end of the wall (refer to Plate 18). It is likely that the purlin has locally overstressed the masonry

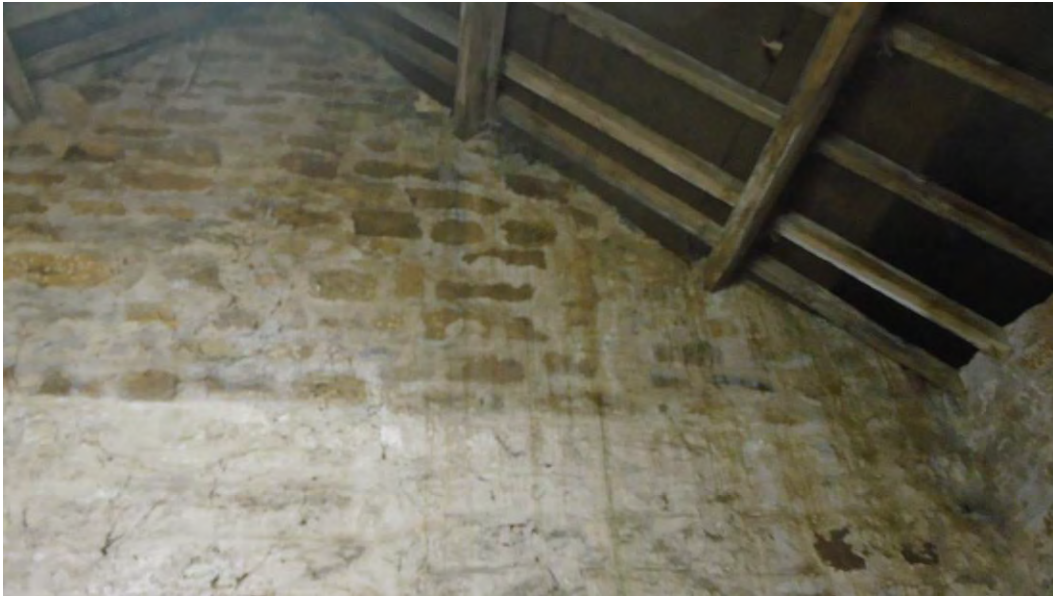
**Plate 19 - Typical**

- b. A number of cracks were recorded below the purlins (refer to Plate 19) on the party wall to unit C and above the access opening to unit C (refer to Plate 20). It is likely that the purlin has overstressed the masonry locally. It would be prudent to assess the load applied to the lintel, above the access opening, to review if it needs replacing before the crack is repaired

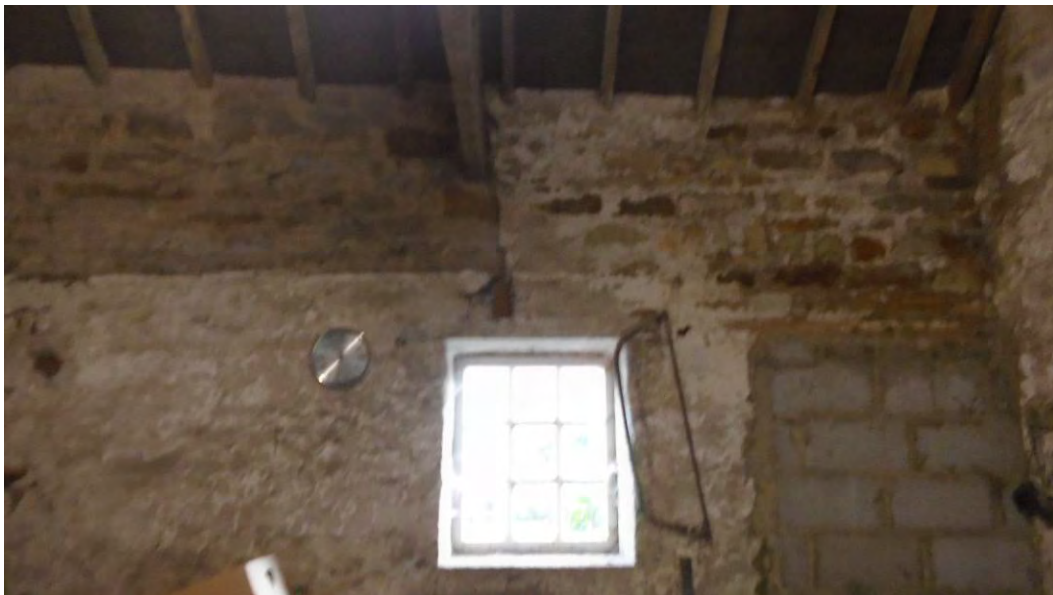
**Plate 22**

- d. The bearing end of the timber truss on the external wall is over a timber lintel (refer to Plate 22). The lintel should be assessed for the load applied to it and if necessary replaced with a suitably sized element

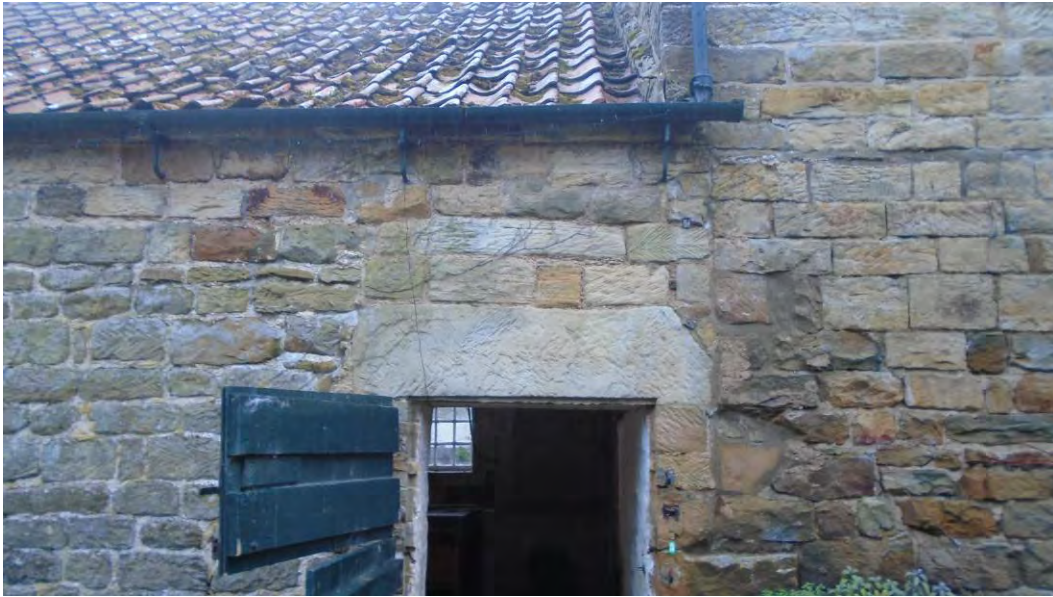
**Plate 23**

- e. As a general note the mortar on the external faces of the stonework needs re-pointing in a number of areas
- f. There is a crack above the door opening on the northern elevation (refer to Plate 23). It appears that the lintel above this opening has dropped on the eastern side of the doorway

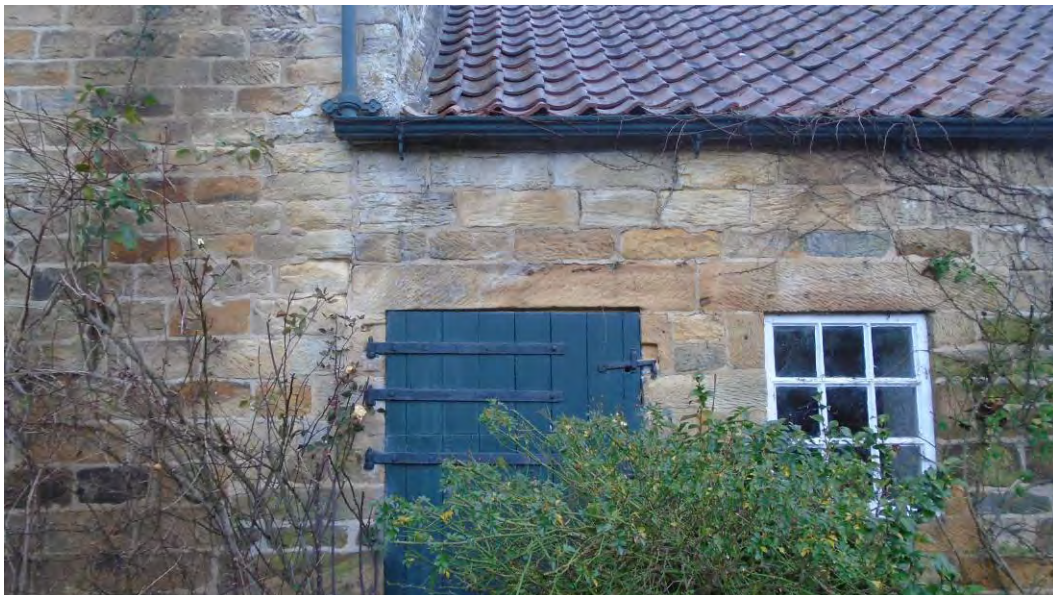
**Plate 24**

- g. There is a crack in the stonework above the door opening on the southern elevation (refer to Plate 24)

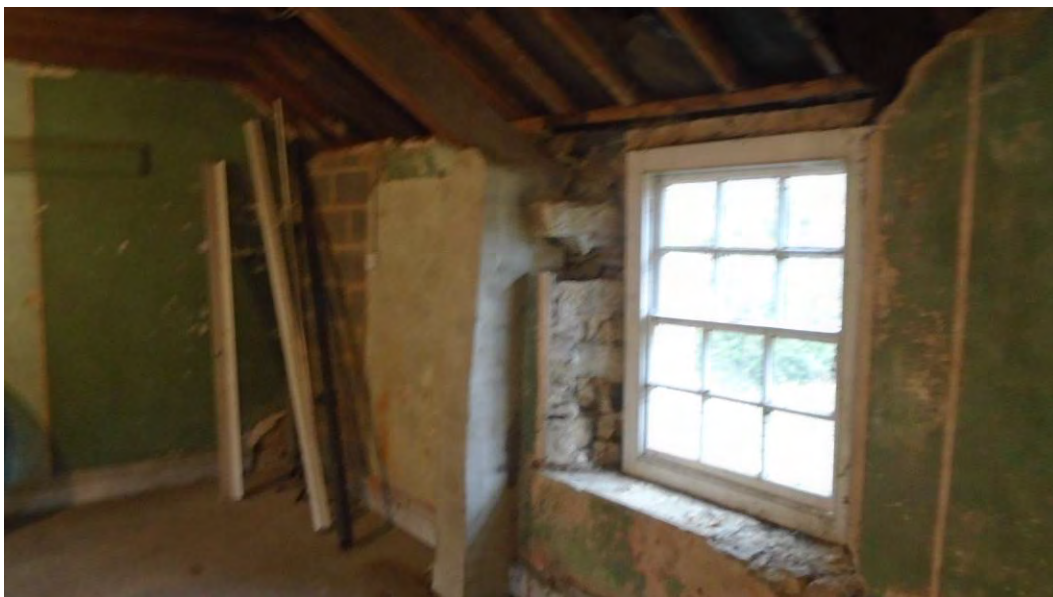
**Plate 26**

- b. The trusses at first floor level will need to be assessed for their load carrying capacity. The truss at the eastern end of the unit is supported on a pillar (refer to Plate 26). The pillar appears to have been introduced to support the rafter at this end of the truss, where it has decayed (refer to Plate 27), possibly from a leak in the fabric of the building. In addition to this the lintel above the window, near this area has been removed and the rafters are bearing on a deflected wall plate (refer to Plate 28). Furthermore, the timber floor has decayed locally (refer to Plate 29) and the pillar, that supports the truss has been poorly constructed and may not have a foundation. This area will need an overview from a structural perspective to strengthen the defective areas

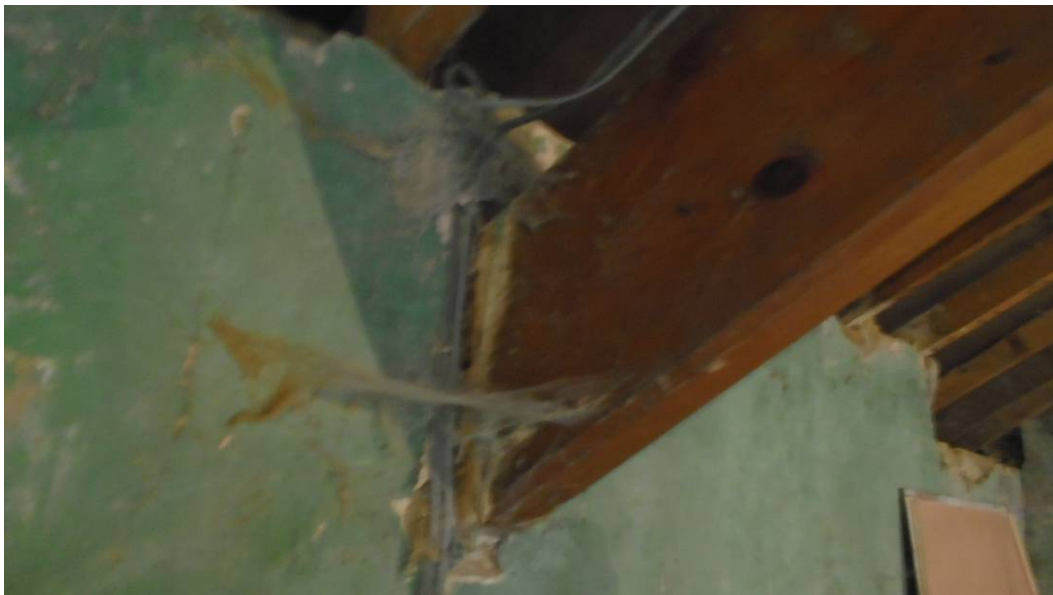
**Plate 30**

- c. The external wall in and around item b above, appears to be leaning outwards and has moved away from the truss at the western end of the unit (refer to Plate 30). The plumbness of the wall should be assessed internally and externally and remedial action taken as necessary. It is also noted that the trusses and rafters have a raised tie which maybe exacerbating the potential lateral spread at this location and possibly in other areas

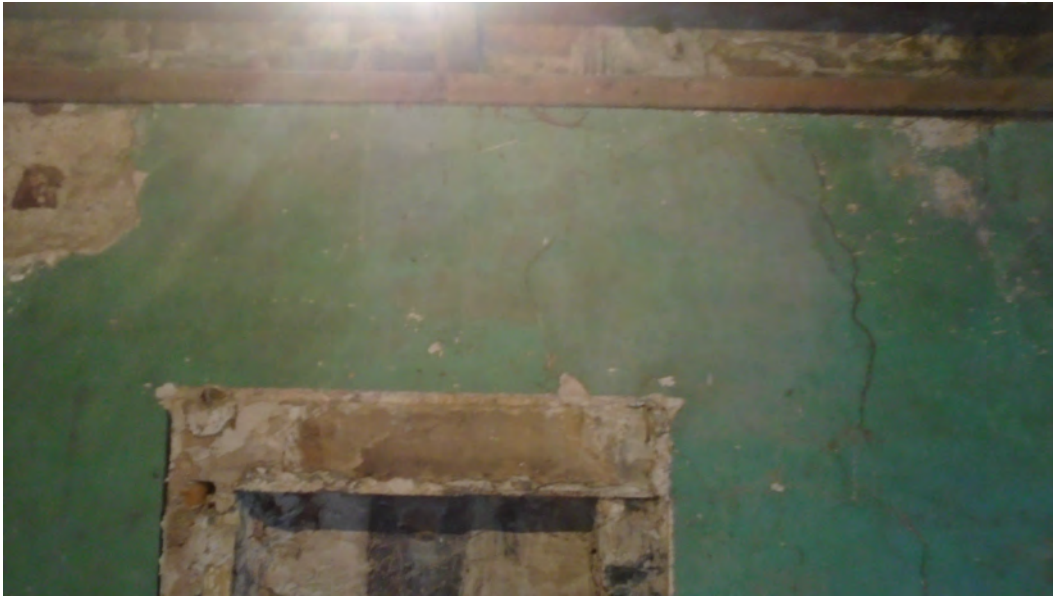
**Plate 31**

- d. There is a vertical crack above the fire place on the western party wall at first floor level (refer to Plate 31). This appears to be related to the heat applied to the stack as the crack follows the line of this element

- e. There is also a diagonal crack to the side of the fire place, noted in item d (refer to Plate 31). This appears to be related to the crack above the access opening noted in item 3.1.3 b. In addition to this the support above the fire place is formed from a stone lintel with a steel/iron plate below. The lintel has a short bearing onto the wall, the metal element has corroded and consideration should be given to rectifying this situation

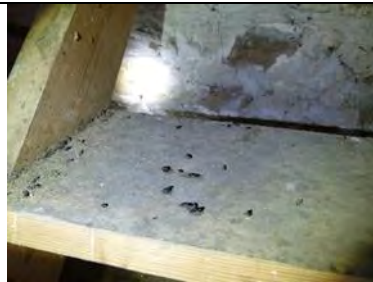
Bat droppings were found on the ladder leading up into the first floor (Photo 28).

Photo 28: Fresh bat droppings on wooden ladder to first floor
