Ladycross Caravan Park

Arb Impact Assessment

Drawing No: BA11372AIA

Title:
 Tree Survey & Constraints

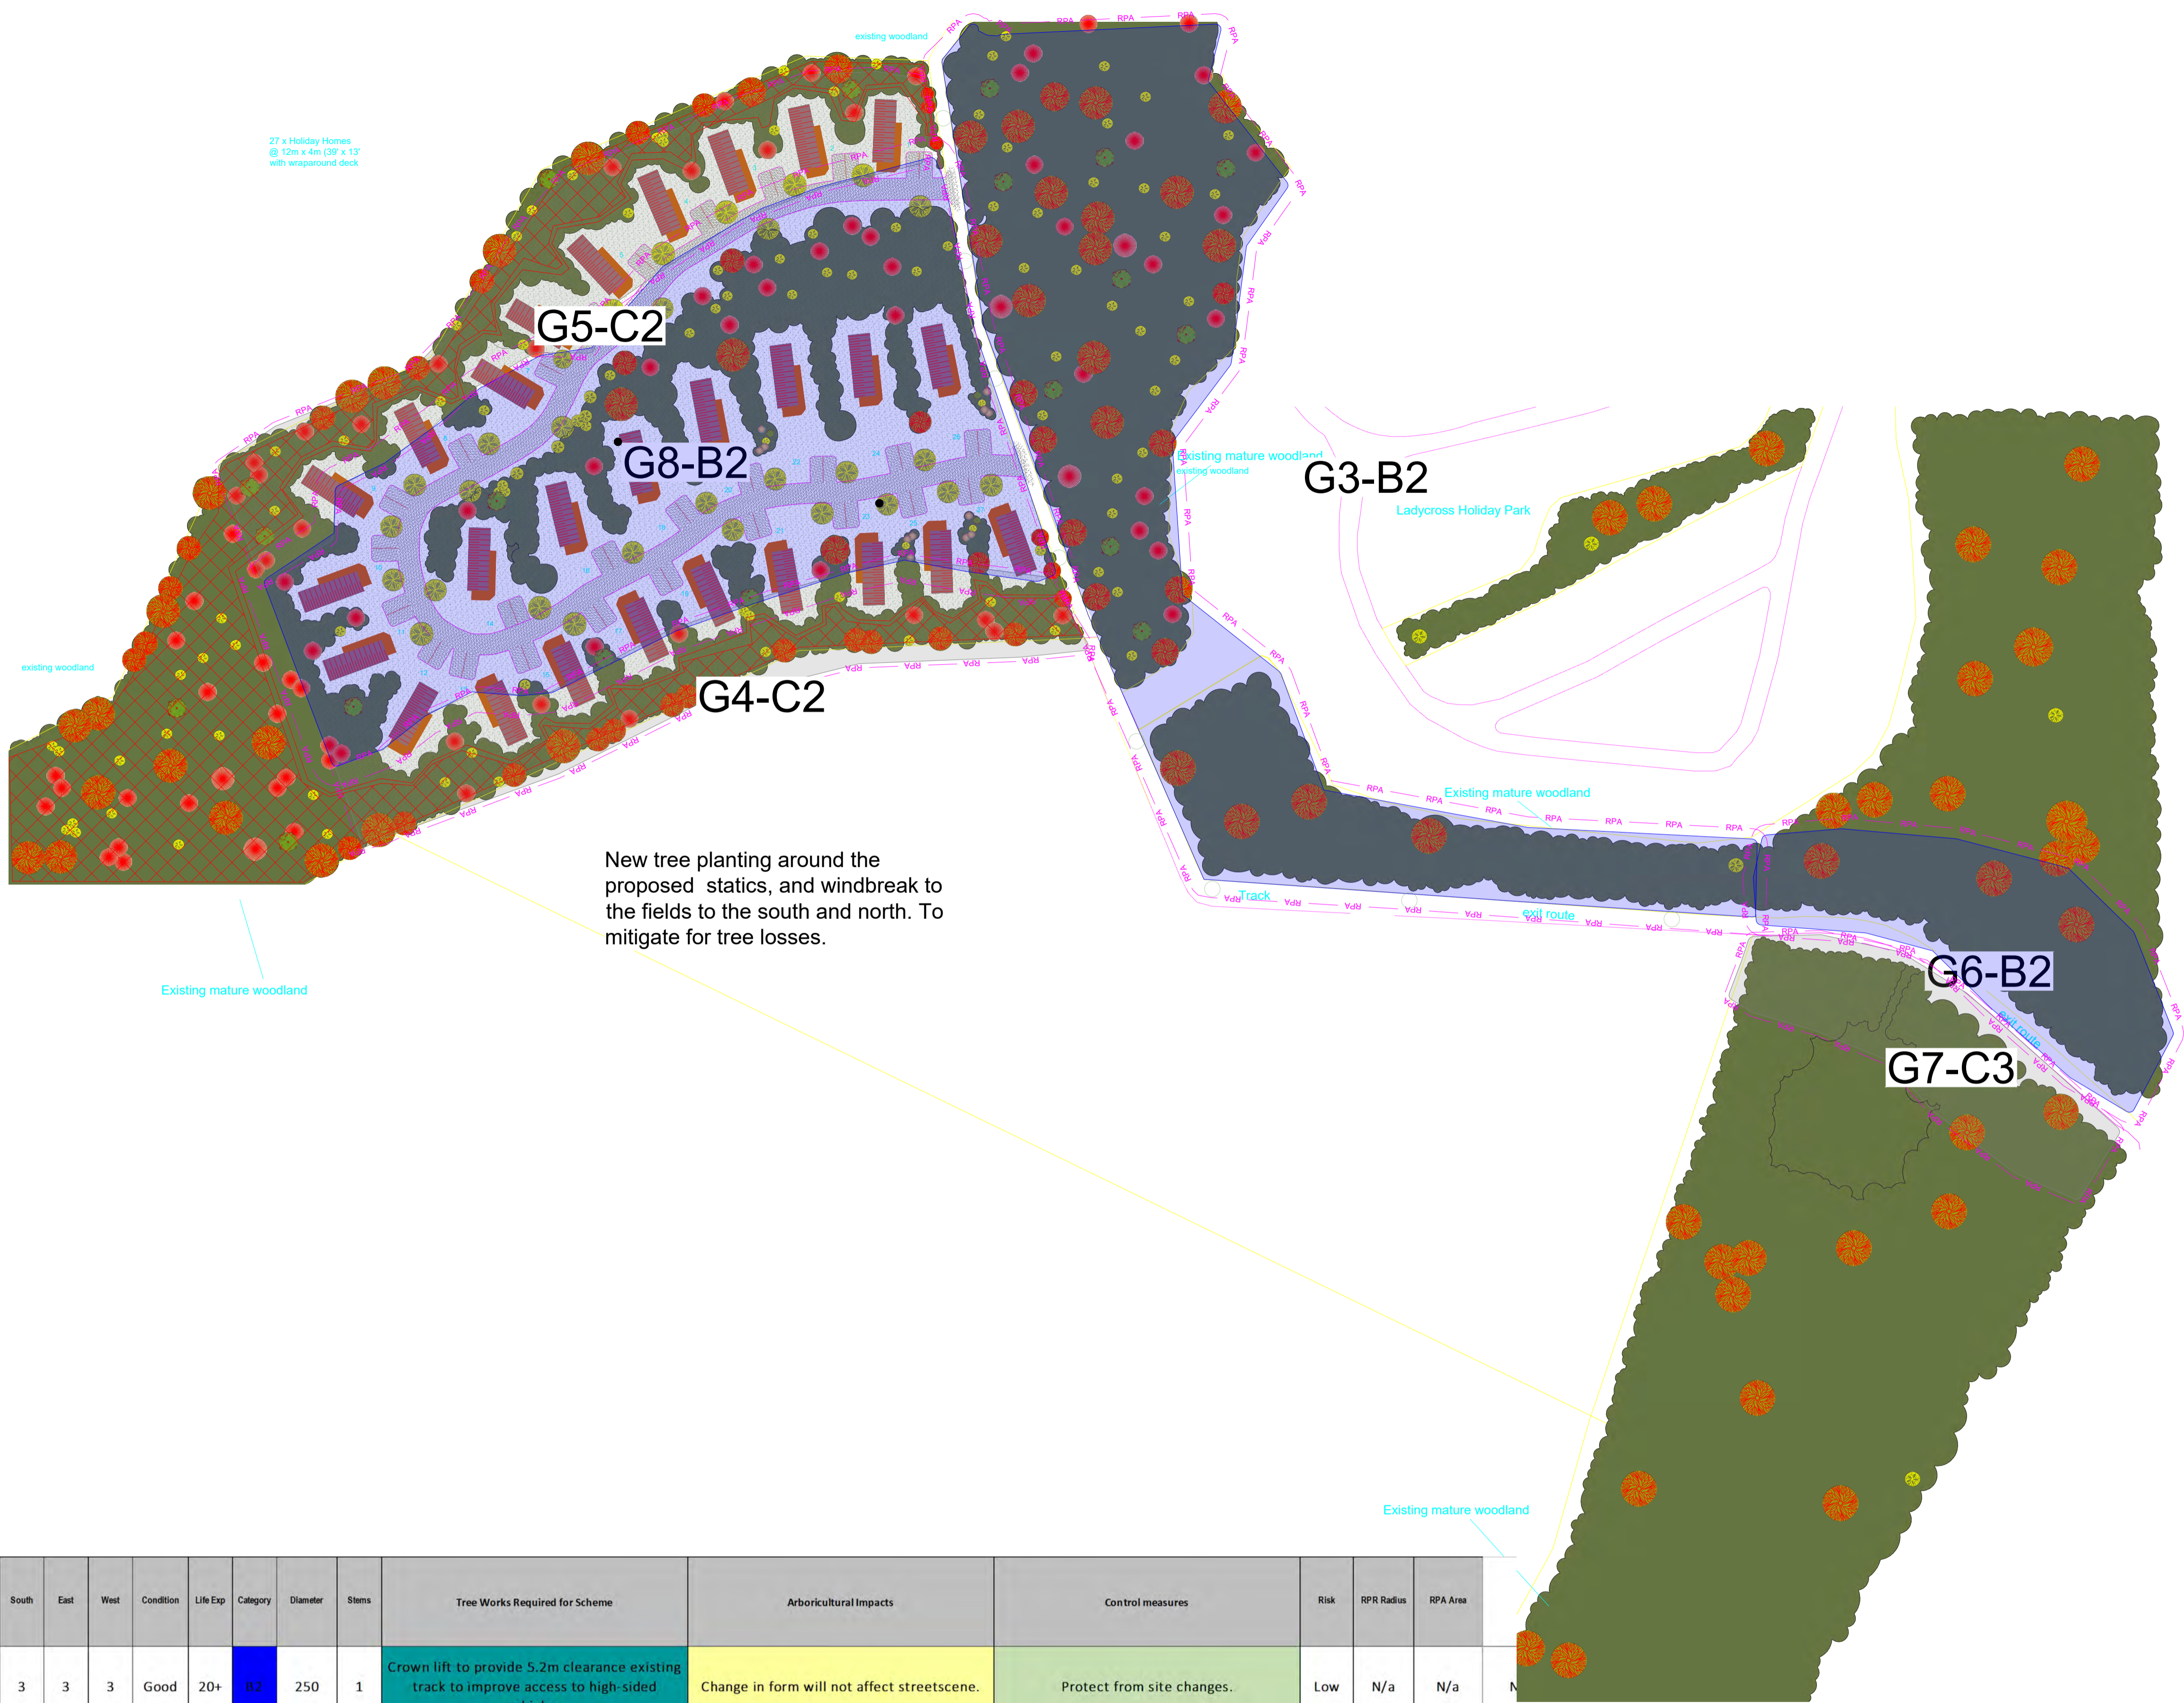
Est Pos	No.	Name	Age	Height	FSB	North	South	East	West	Condition	Life Exp	Category	Diameter	Stems	Tree Works Required for Scheme	Arboricultural Impacts	Control measures	Risk	RPR Radius	RPA Area
Est Group Numbers	G3	Scots Pine Goat Willow Silver Birch	EM	14	2	3	3	3	3	Good	20+	B2	250	1	Crown lift to provide 5.2m clearance existing track to improve access to high-sided vehicles.	Change in form will not affect streetscene.	Protect from site changes.	Low	N/a	N/a
Est Group Numbers	G4	Silver Birch Scots Pine	EM	6 to 12	1	4	4	4	4	Fair	10+	C2	75 to 200	1	Remove estimated 30 trees from the group	Partial loss of groups	Protect retained parts of the group with fencing and construction exclusion zones.	Low	2439	7
Est Group Numbers	G5	Silver Birch	EM	6 to 12	1	4	4	4	4	Fair	10+	C2	75 to 200	1	Remove estimated 30 trees from the group	Partial loss of groups	Protect retained parts of the group with fencing and construction exclusion zones.	Low	3012	9

Est Group	G6	Scots Pine Goat Willow Silver Birch	EM	6 to 14	2	3	3	3	3	Good	20+	B2	75 to 250	1	Crown lift to provide 5.2m clearance existing track to improve access to high-sided vehicles.	Change in form will not affect streetscene.	Protect from site changes.	Low	N/a	N/a
Est Group	G7	Scots Pine Goat Willow Silver Birch	EM	6 to 14	2	3	3	3	3	Good	20+	C3	75 to 150	1	Crown lift to provide 5.2m clearance existing track to improve access to high-sided vehicles.	Change in form will not affect streetscene.	Protect from site changes.	Low	N/a	N/a
Est Group Numbers	G8	Scots Pine, Silver Birch, Holly, Elder	EM	16 to 18	1	3	3	3	3	Good	20+	B2	150 to 400	1	Remove estimated 30 trees from the group	Partial loss of groups	Protect retained parts of the group with fencing and construction exclusion zones.	Low	8835	15

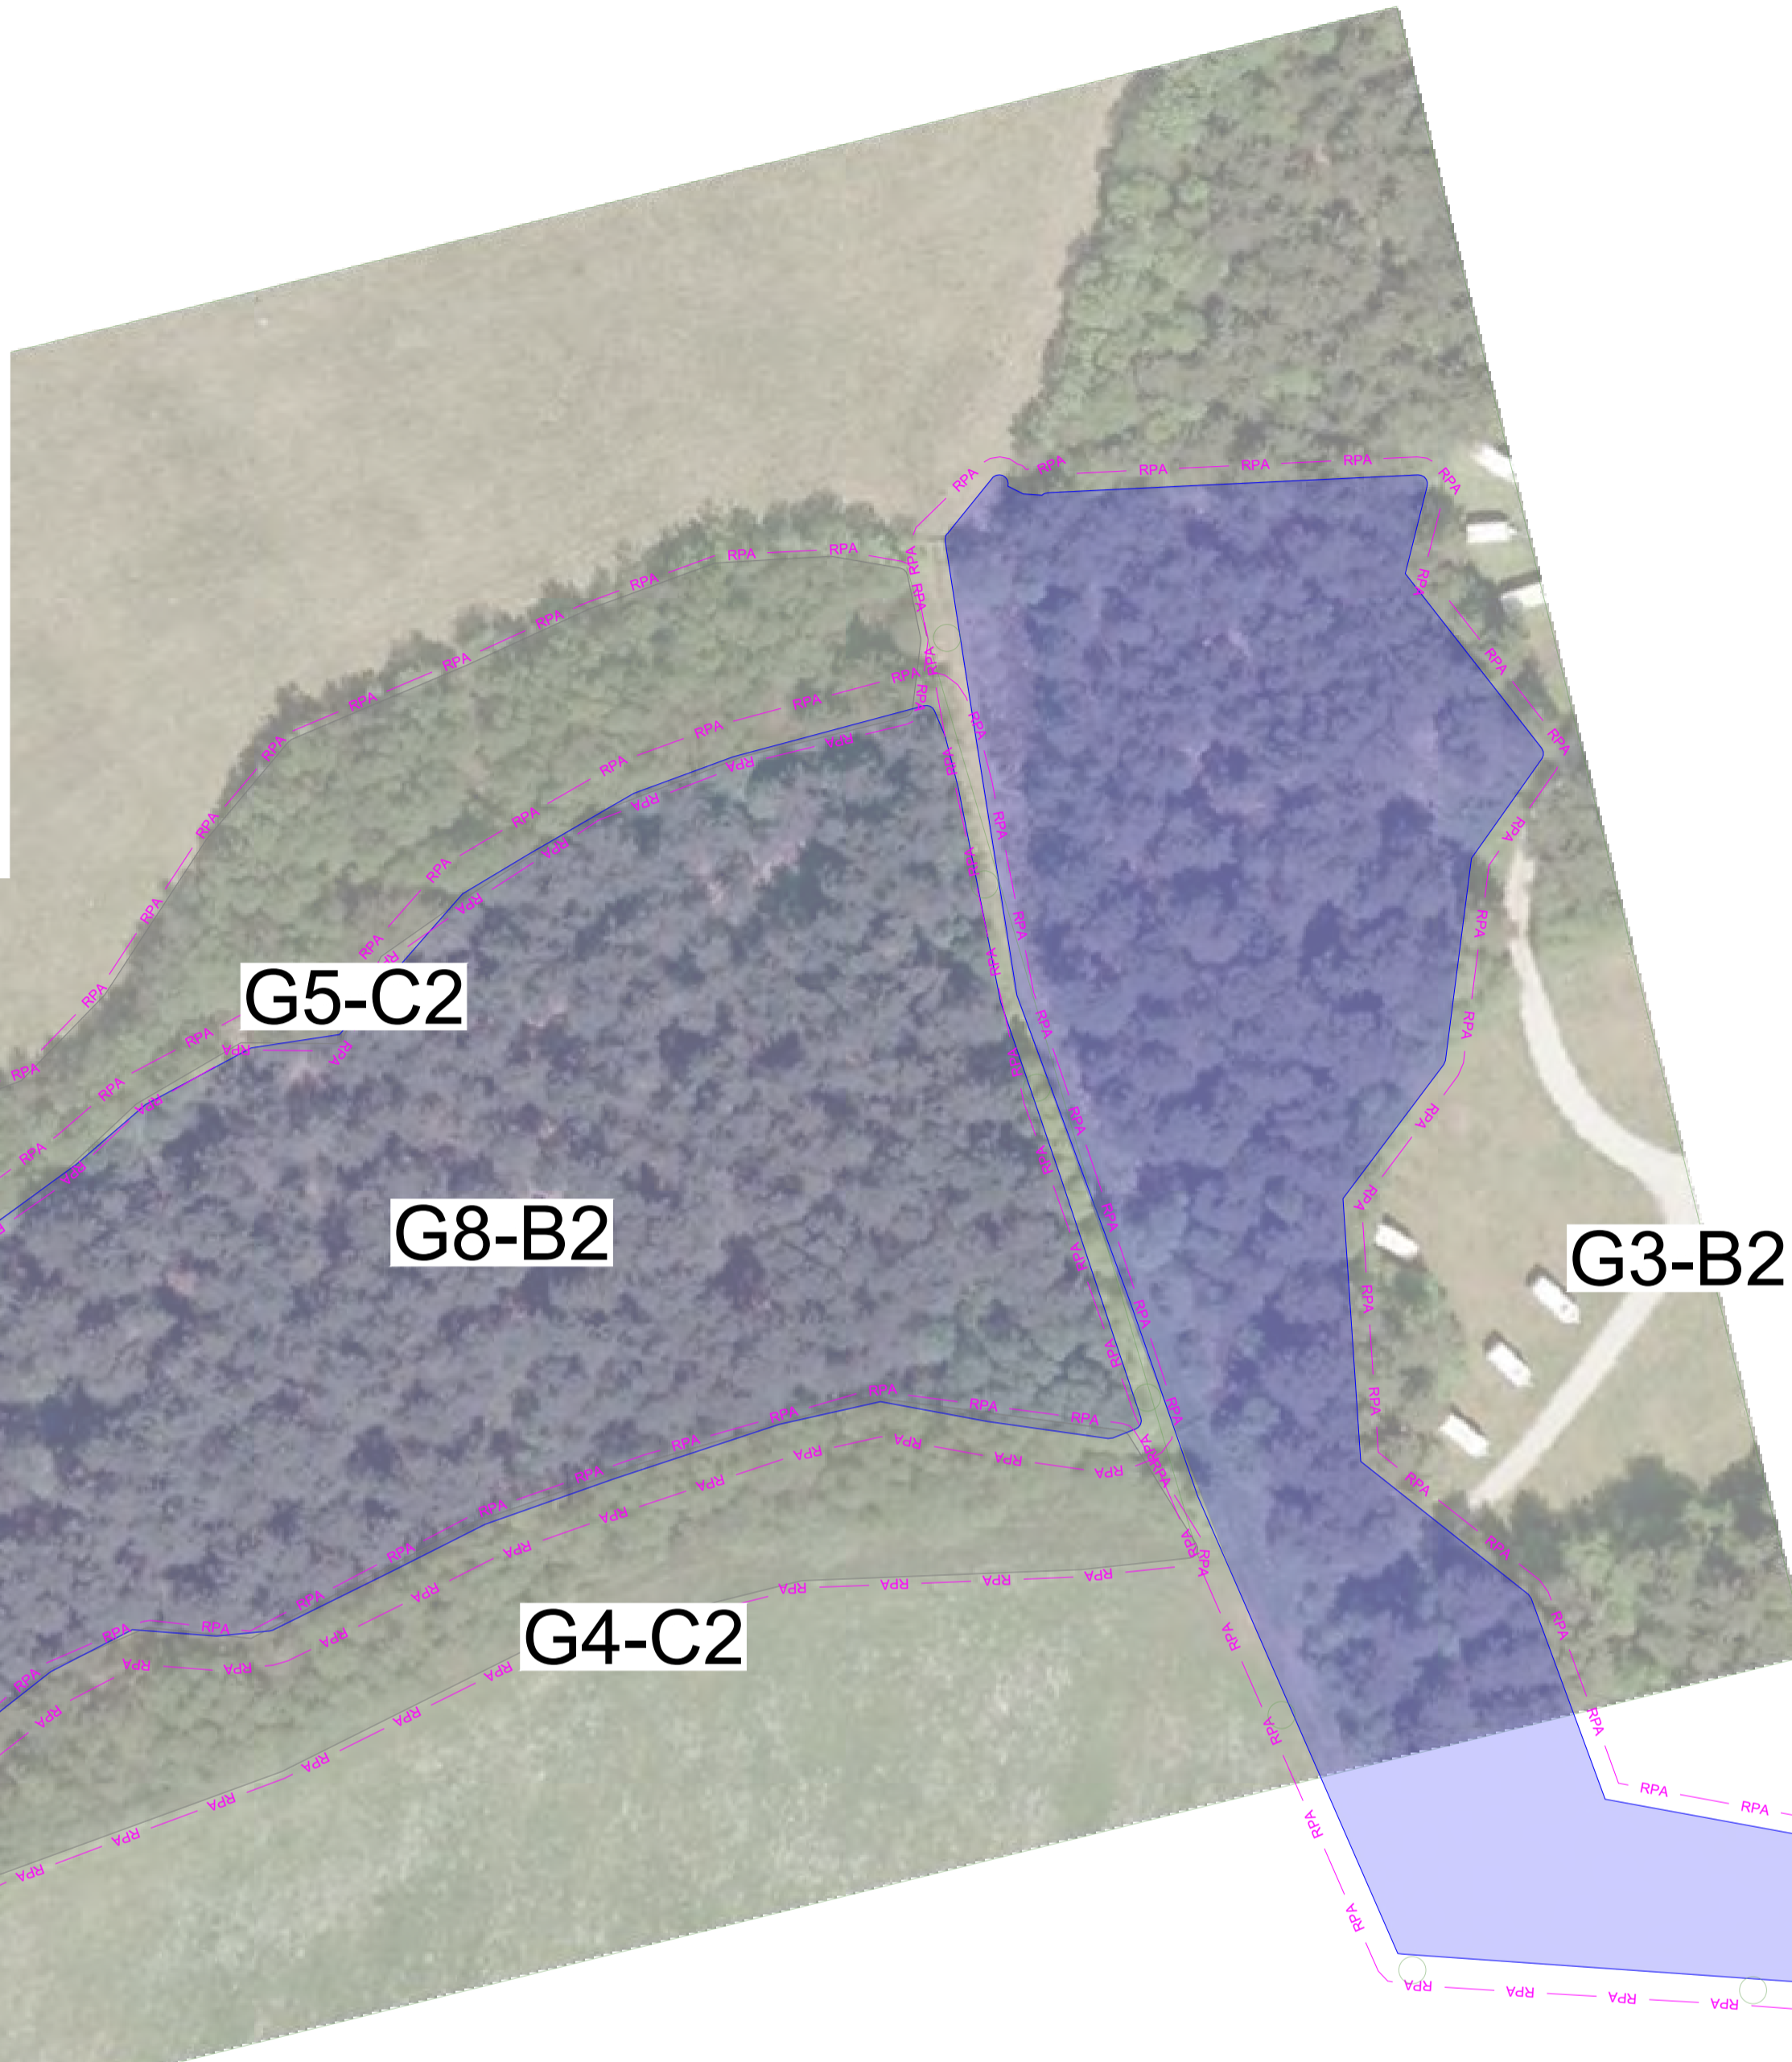
Est Group Numbers	Est Height	Est Spread	Est DBH	Species	Age	Health	Vitality	Safe Life	Canopy	Notes	Retain	Low	N/a	N/a	N/a	3	28.28									
G3				Scots Pine Goat Willow Silver Birch	EM	14	2	3	3	3	3	Good	20+	10	250	1	1	Growing as principally a pine woodland with a strip of mixed deciduous trees such as willow and birch on the western side at greater spacings. A typical semi managed woodland with all associated contributing factors.	None required.							
G4				Silver Birch Scots Pine	EM	6 to 12	1	4	4	4	4	Fair	10+	C2	75 to 200	1	1	Growing as edge trees of the pine plantation on the southern windward face. Typical form and condition of outer face trees. Some dead trees present.	In current usage and target occupancy, retain as natural.	Low	2439	7	170	1.8	10.18	
G5				Silver Birch	EM	6 to 12	1	4	4	4	4	Fair	10+	C2	75 to 200	1	1	Growing as edge trees of the pine plantation on the northern protected face. Typical form and condition of outer face trees. Some dead trees present.	In current usage and target occupancy, retain as natural.	Low	3012	9	271	1.8	10.18

G6				Scots Pine Goat Willow Silver Birch	EM	6 to 14	2	3	3	3	3	Good	20+	10	75 to 250	1	1	Growing as principally a pine woodland with a strip of mixed deciduous trees such as willow and birch on the southern side at greater spacings. A typical semi managed woodland with all associated contributing factors. Estimated distance to the pine racks is 5m.	Remove the weaker leaning trees over the track and highway.	Low	N/a	N/a	N/a	3	28.28	
G7				Scots Pine Goat Willow Silver Birch	EM	6 to 14	2	3	3	3	3	Good	20+	C3	75 to 150	1	1	A poorly developing group of low quality deciduous trees with small numbers of pine interspersed. Multiple level changes due to storage area for soil and timber. Overdeveloped of poor form trees growing towards the main highway which may require removal as part of general management.	Remove the weaker leaning trees over the track and highway.	Low	N/a	N/a	N/a	1.8	10.18	
G8				Scots Pine, Silver Birch, Holly, Elder	EM	16 to 18	1	3	3	3	3	Good	20+	10	150 to 400	1	1	Growing as part of a woodland. Monoculture of pine and birch. Southern wind bearing pines on average 400mm diameter with trees becoming slender to the north of the group to an average of 200mm. The woodland appears to have had very little management and no evidence of past thinning.	In current usage and target occupancy, retain as natural.	Low	8835	15	1325	4.8	72.39
