Bat, Breeding Bird and Barn Owl Scoping Survey
Mill Inn, Harwood Dale

February 2023

Mill Inn
Harwood Dale
Scarborough
YO13 0LA

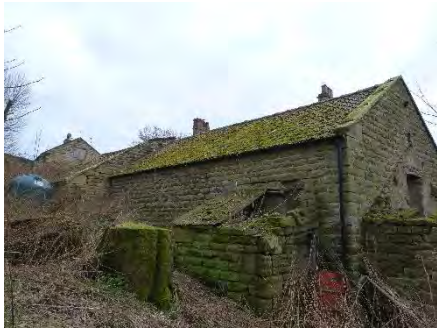
<p>Photo 1. Southern aspect</p>	<p>Photo 2. Masonry crevices under window ledge on southern aspect</p>	<p>Photo 3. Toilet block on eastern aspect – roof degraded</p>

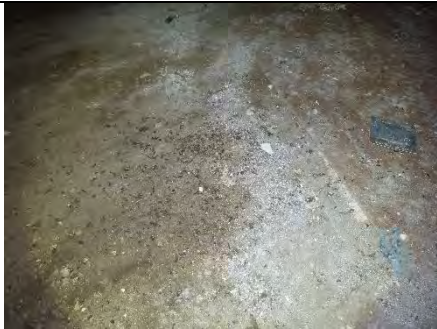
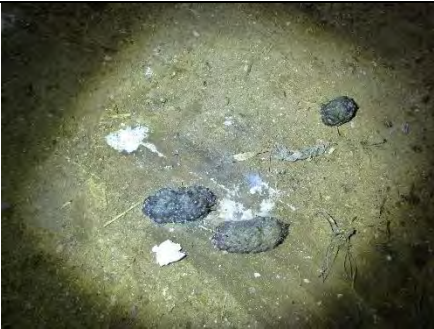
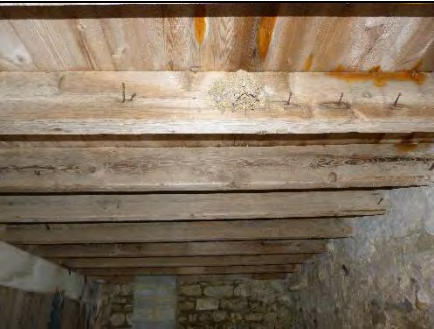
<p>the first floor. Few barn owl pellets (≤ 5) were also identified, likely old – no sign of barn owl nesting identified.</p> <p>The ground floor has some internal masonry crevices and barn swallow nests along the wooden beams.</p>	
	<p>Photo 7. Accumulated bat droppings under ridge beam</p>	<p>Photo 8. Barn owl pellets, likely old</p>	<p>Photo 9. Ground floor – swallow nesting on beams</p>

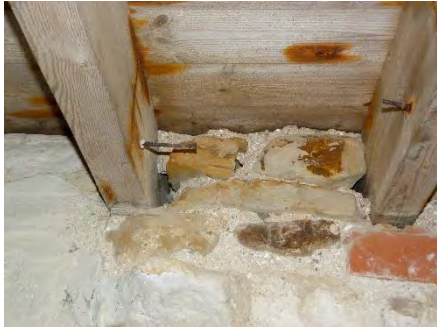
<p>Photo 10. Internal masonry crevices, ground floor</p>
