Planning Statement

Property: Prospect House Farm, Suffield, Scarborough, YO13 0BH

Proposal: Conversion and Change of Use of Agricultural Outbuildings into Holiday Letting Accommodation

Structural Condition Report

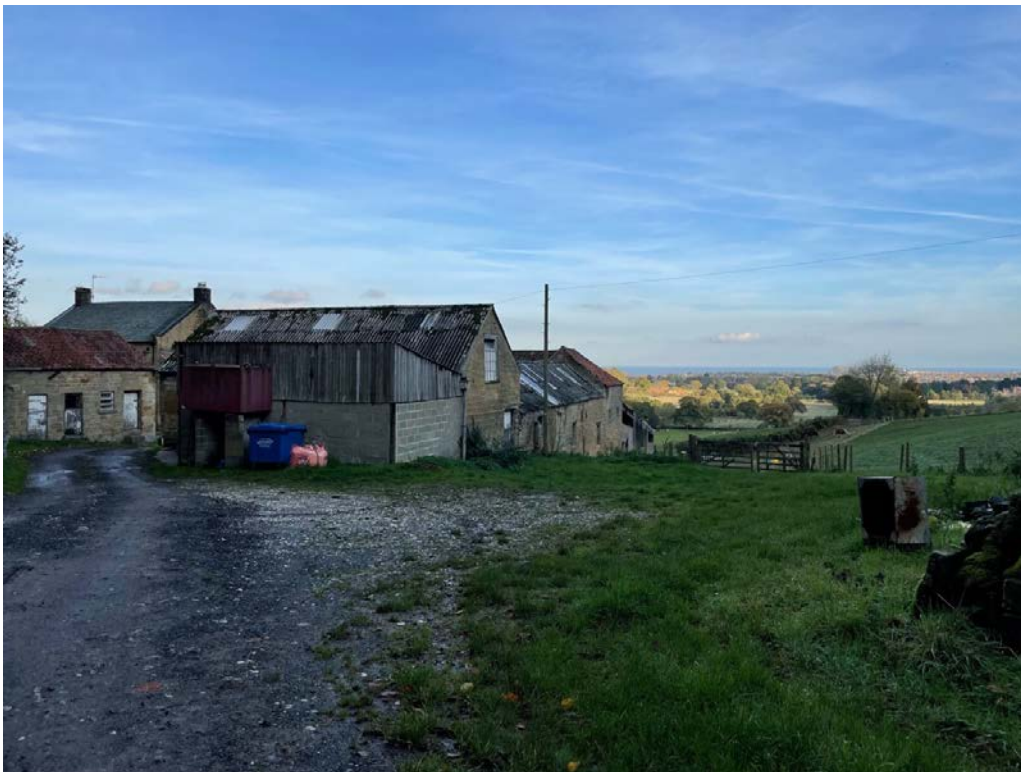
Elevations B & F with modern outbuilding in foreground (to be demolished leaving 3 car spaces for holiday guests)

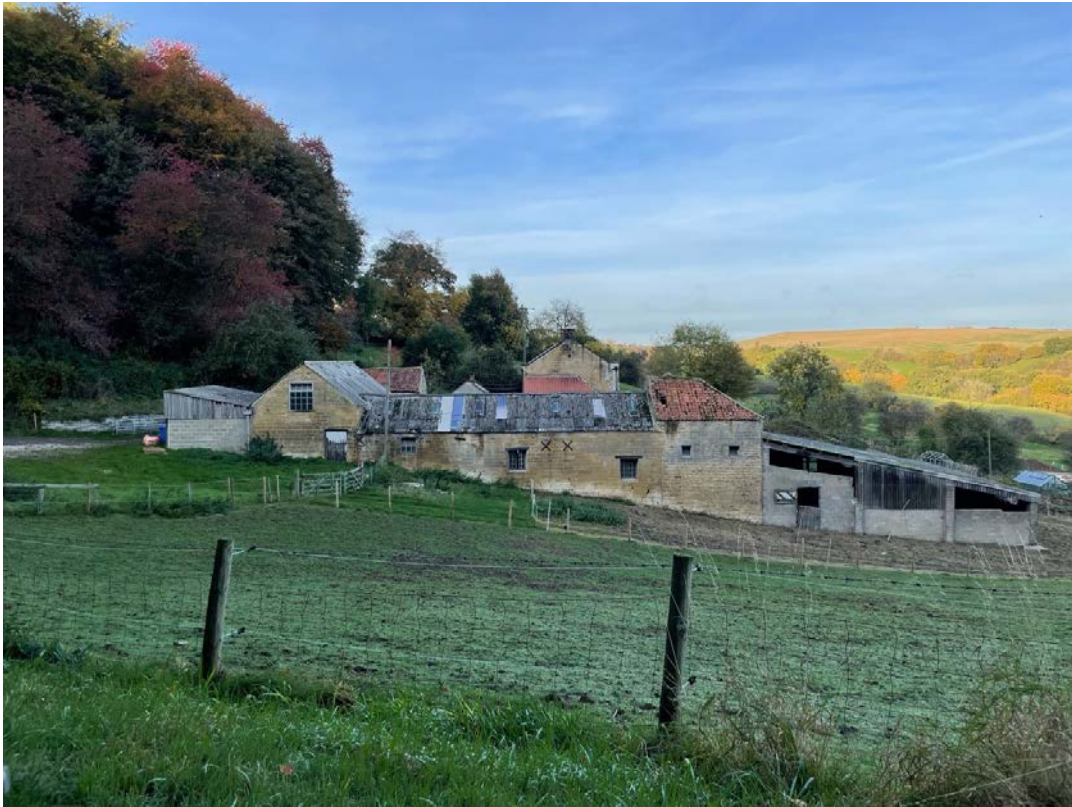
Elevation B showing stone outbuildings centrally flanked by relatively modern concrete block walled buildings to west and east that it is proposed are demolished

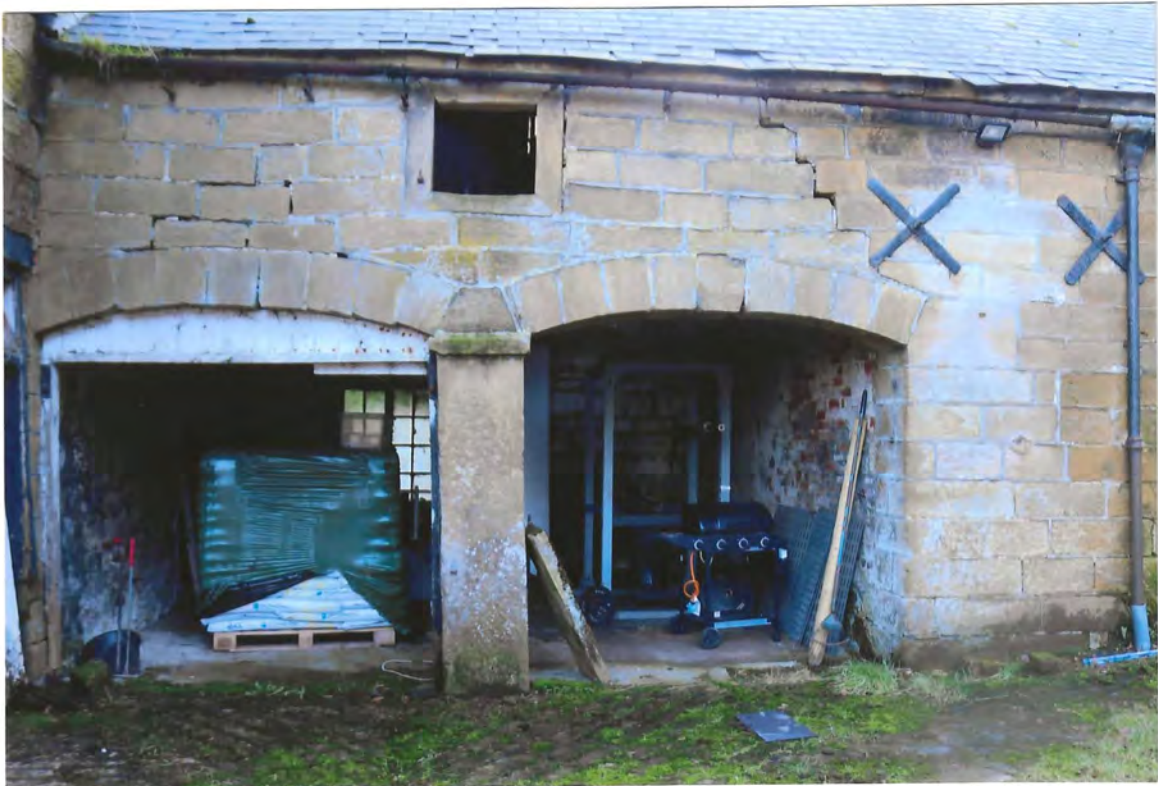
- (vii) The two stone arches on the north wall to Unit 2 have moved/dropped over time such that severe cracking of the supported stonework above has occurred and the central stone support pillar is significantly out of plumb.

8. STONE ARCHES TO UNIT 2

- (v) Carefully take down and rebuild the two 'dropped' stone arches and supporting pillar. Provide a new foundation for the pillar.
- (vi) Subject to advice from an experienced Stonemason take down and rebuild the external section of wall to Unit 1 where it over-sails (due to previous horizontal movements), Unit 2 wall.

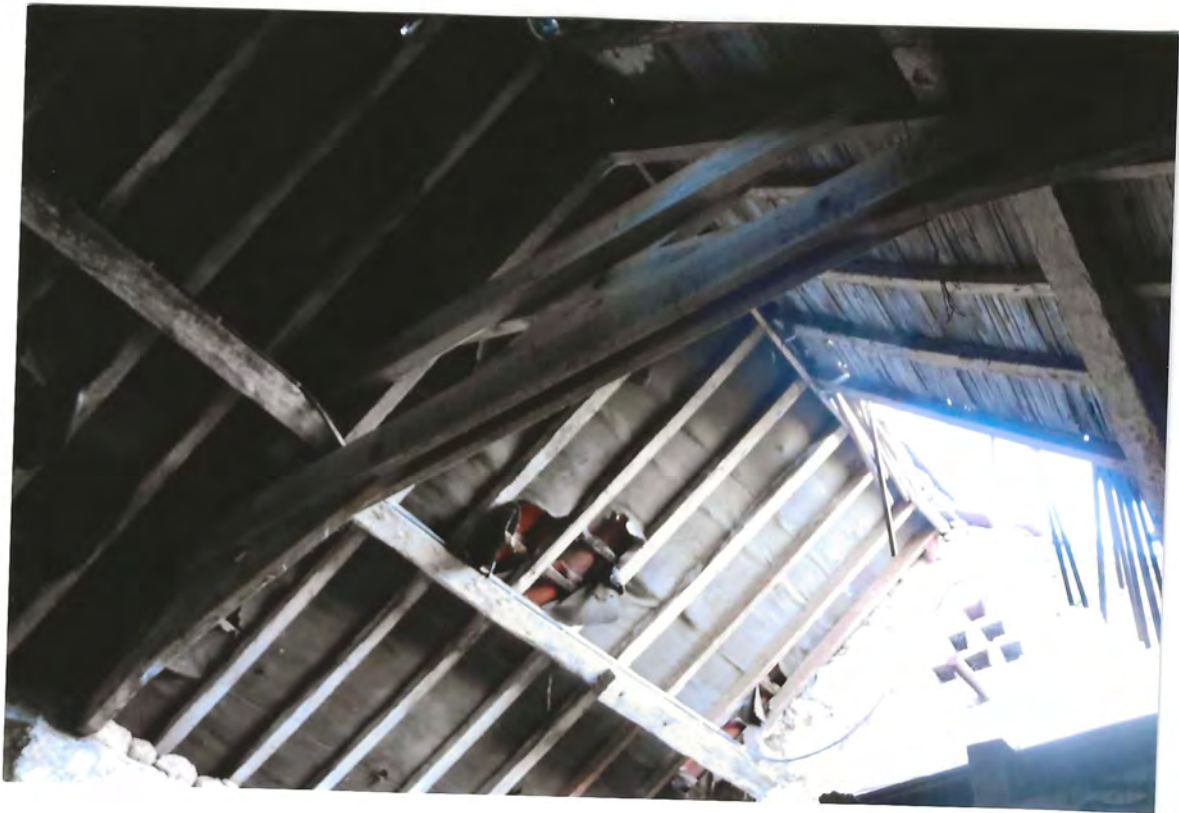
Noted that sections of the roof in Unit 3 have previously collapsed.

14. ROOF DETAIL . UNIT 3

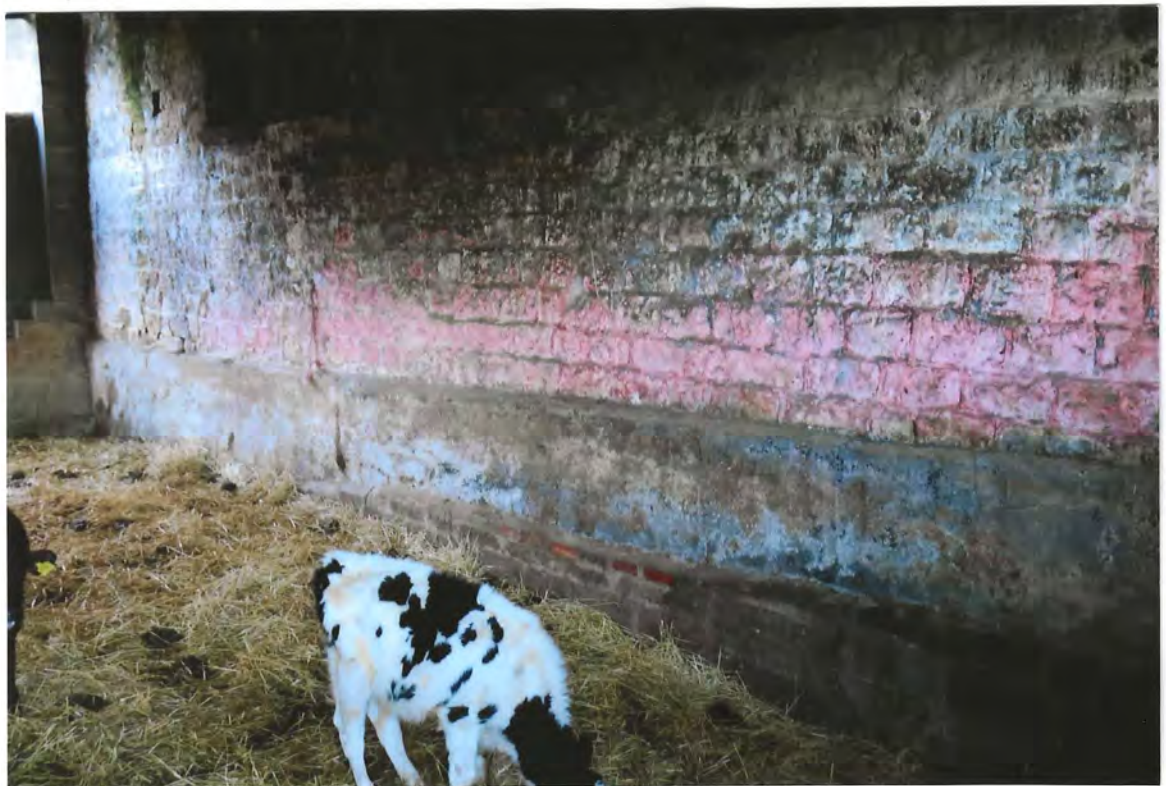
- (x) There is a mixture of stone, timber, and rusty steel (Unit 2) lintels above existing door and window openings.
- (xi) The east wall of Unit 3, abutting the modern farm building, (to be demolished) appears to have been extended downwards due to the differences in level (approx. 1.5m) between the two. Details of how this

was done are not clear at this stage. Viewed from a short distance no obvious signs of movements or cracking were observed in this 'retaining wall'.

16. LOWER EXTERNAL WALL TO UNIT 3
EXISTING FORD YARD TO BE DEMOLISHED

- (vii) Investigate further the 'retaining wall' at the eastern end of Unit 3. Following demolition of the modern farm building provide at least two lines of lateral natural stone walls in existing field to provide gradual decreases in ground levels and therefore reduce the retained height of the existing wall
