Planning Statement

Property: Prospect House Farm, Suffield, Scarborough, YO13 0BH

Proposal: Conversion and Change of Use of Agricultural Outbuildings into Holiday Letting Accommodation

Structural Condition Report

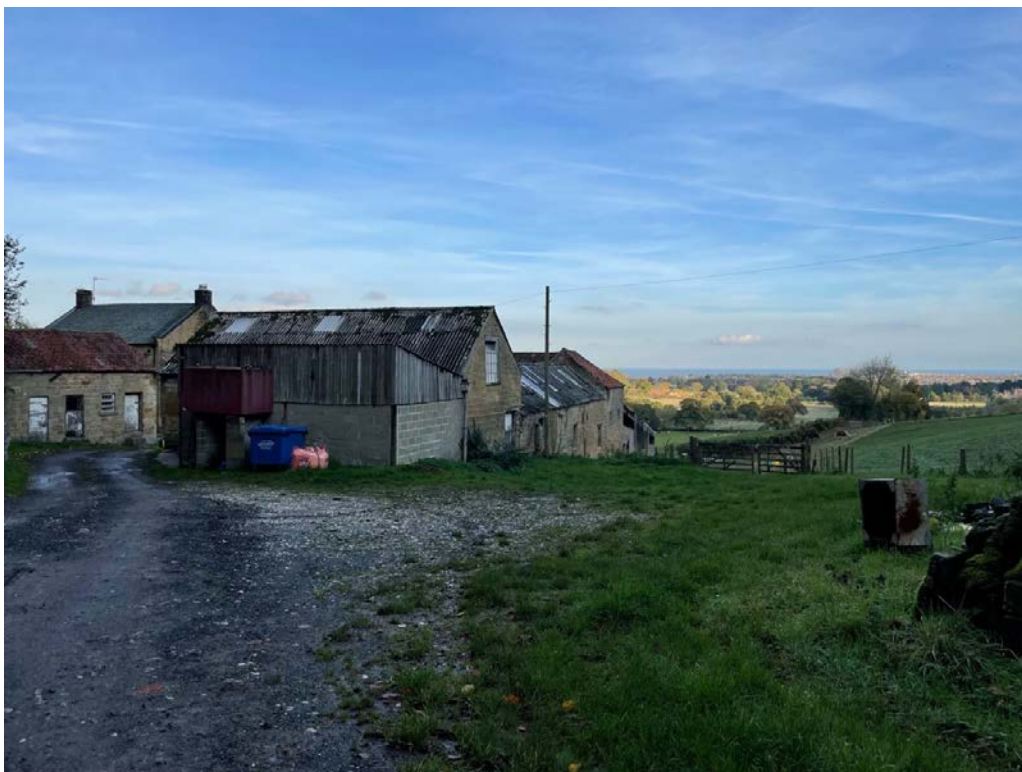
Elevations B & F with modern outbuilding in foreground (to be demolished leaving 3 car spaces for holiday guests)

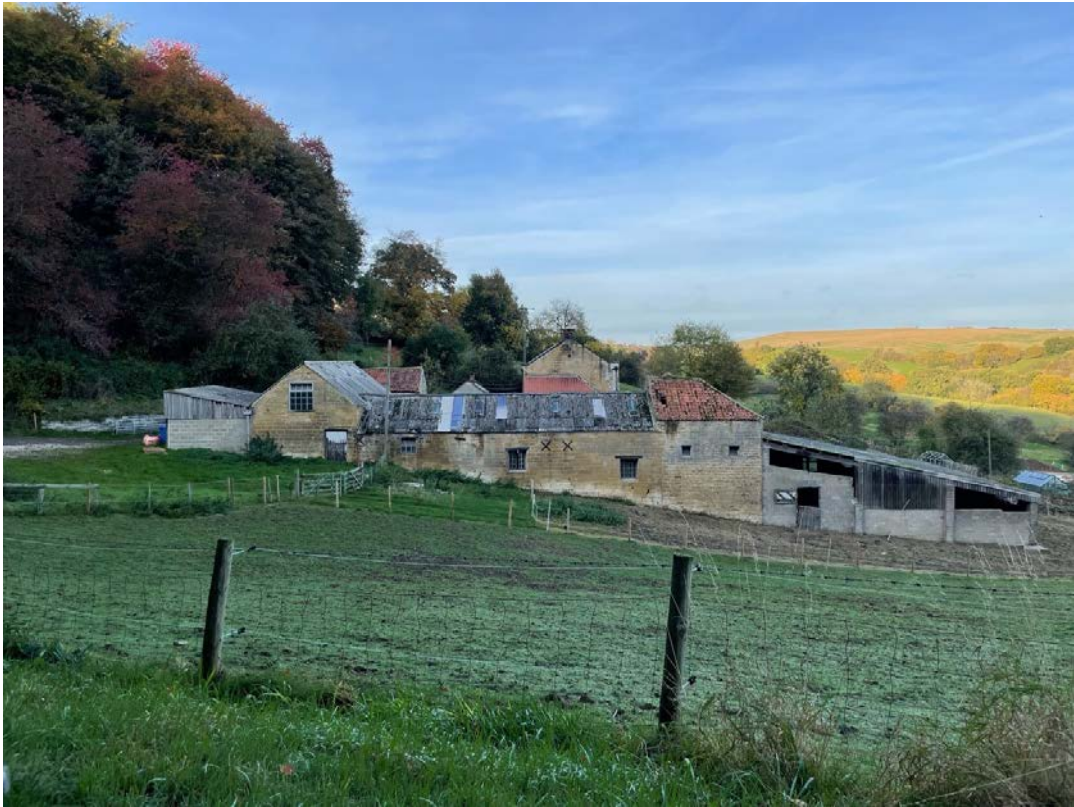
Elevation B showing stone outbuildings centrally flanked by relatively modern concrete block walled buildings to west and east that it is proposed are demolished

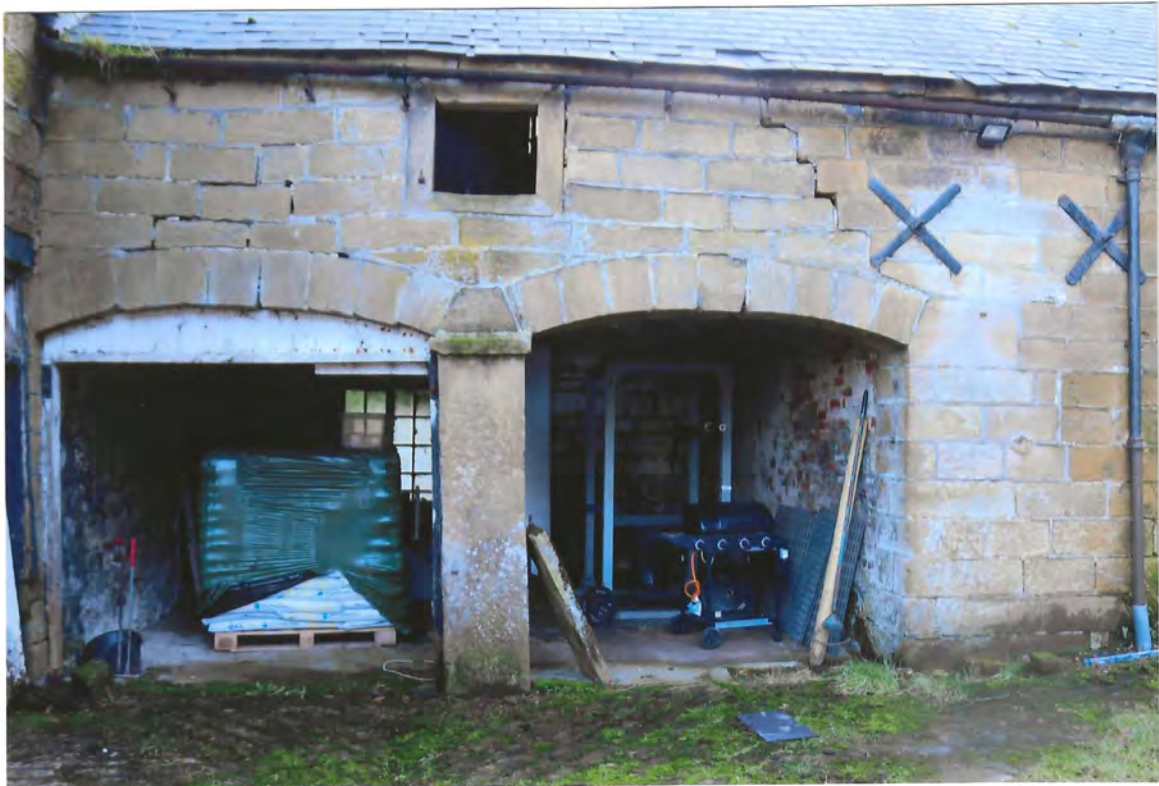
8. STONE ARCHES TO UNIT 2

- (vii) The two stone arches on the north wall to Unit 2 have moved/dropped over time such that severe cracking of the supported stonework above has occurred and the central stone support pillar is significantly out of plumb.

- (v) Carefully take down and rebuild the two 'dropped' stone arches and supporting pillar. Provide a new foundation for the pillar.
- (vi) Subject to advice from an experienced Stonemason take down and rebuild the external section of wall to Unit 1 where it over-sails (due to previous horizontal movements), Unit 2 wall.

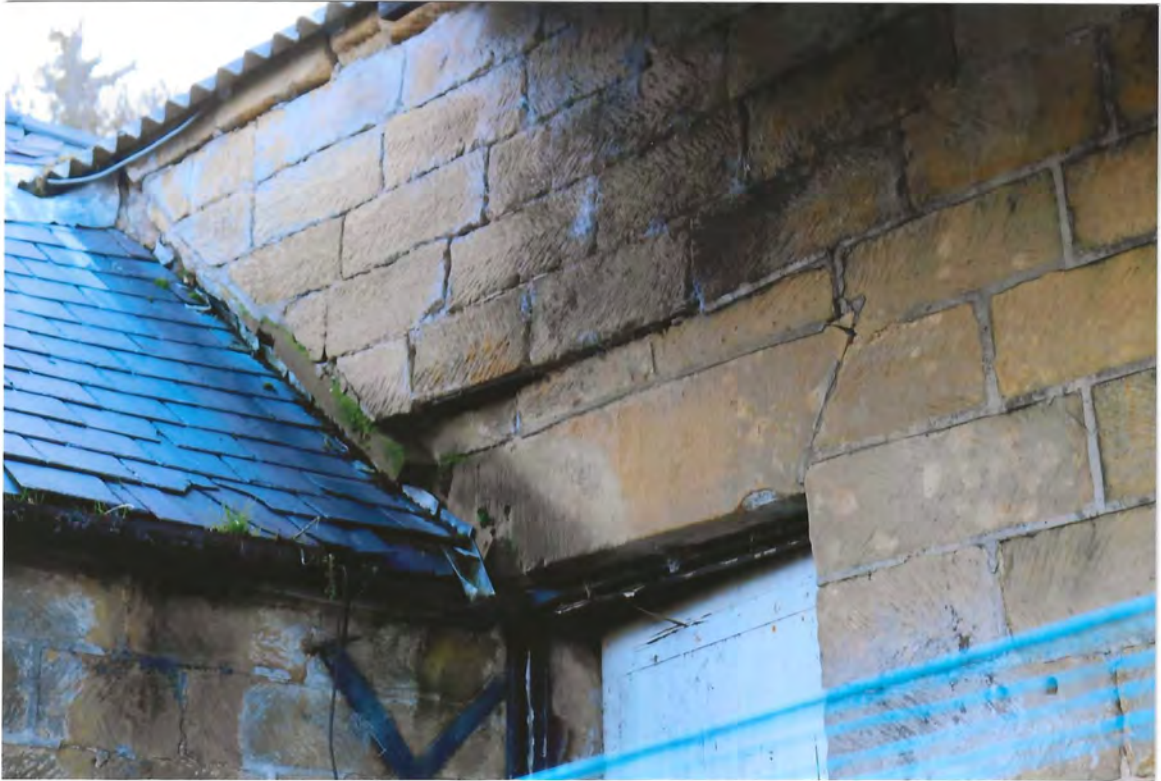
11. HORIZONTAL MOVEMENT - UNIT 1

- (vi) At eaves level at the junction of the external walls to Units 1 & 2, there is significant horizontal, 'sliding displacement of the Unit 1 sandstone wall over the Unit 2 wall, over a length of about 2 -3m, again due to horizontal thrust movements from the Unit 1 roof on the wall below.

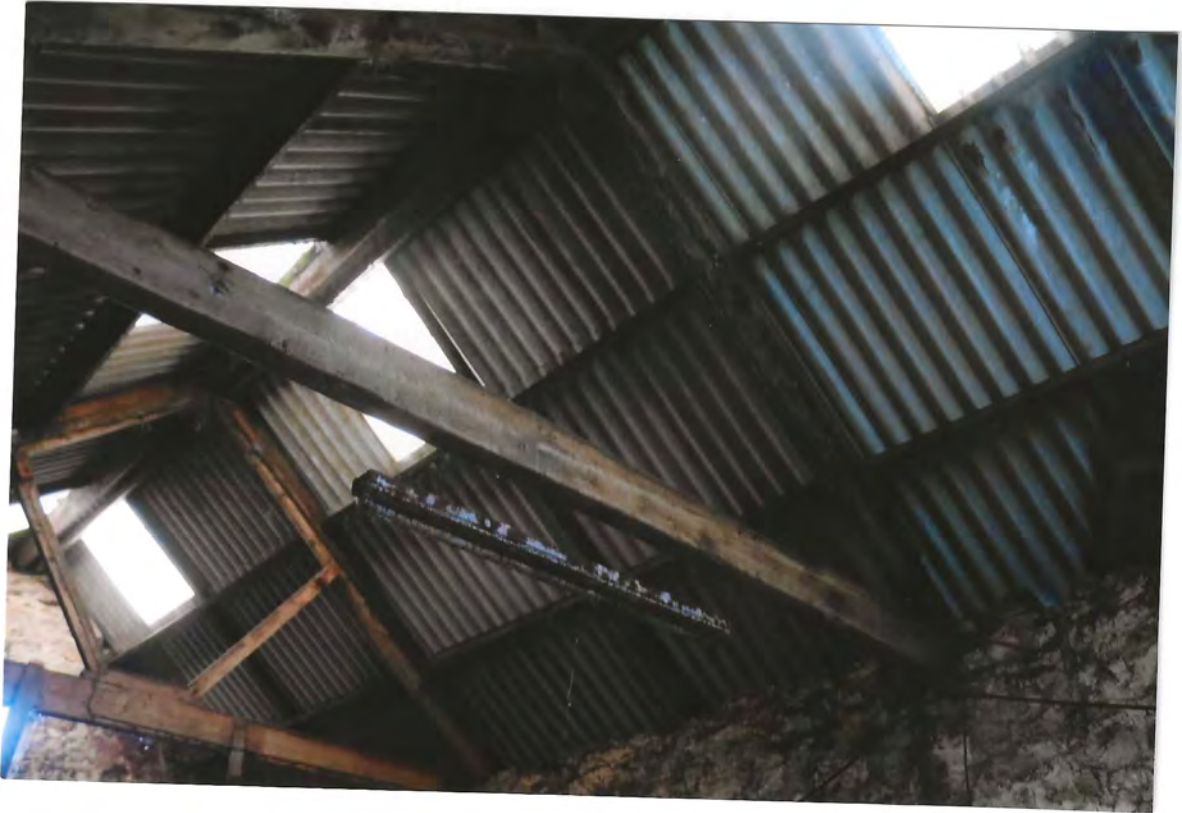
13. ROOF DETAILS - UNIT 1

Unit 1; Corrugated asbestos sheets on timber rafters, purlins and intermediate timber 'trusses'.

General; The ridges to all units are noticeably undulating, due to long term movements from potential under sizing /degradation of the timber roof structures and outward bulging of supporting walls. Rainwater gutters are either non- existent or non- functional on all Units.

- (xiii) Dependent upon the roof timbers survey results retain /strengthen the existing roof trusses/purlins/rafters or add new strengthening timbers alongside. Compliance with Building Regulations will be required. Provide new roof slate or pantile coverings, to reflect the current situation, new tiling lathes, under felt and insulation.

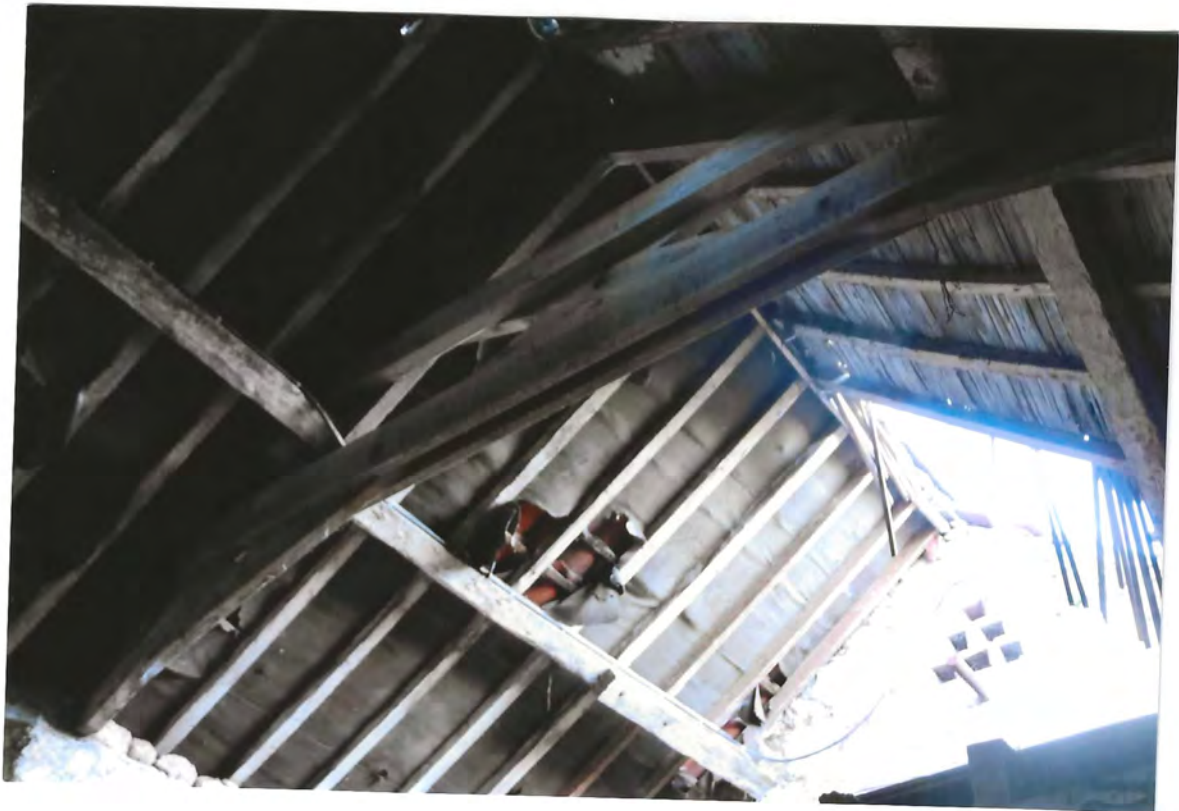
14. ROOF DETAIL . UNIT 3

Unit 3; Pantiles on timber rafters, purlins and trusses. The roof is hipped at the southern side.

Noted that sections of the roof in Unit 3 have previously collapsed.

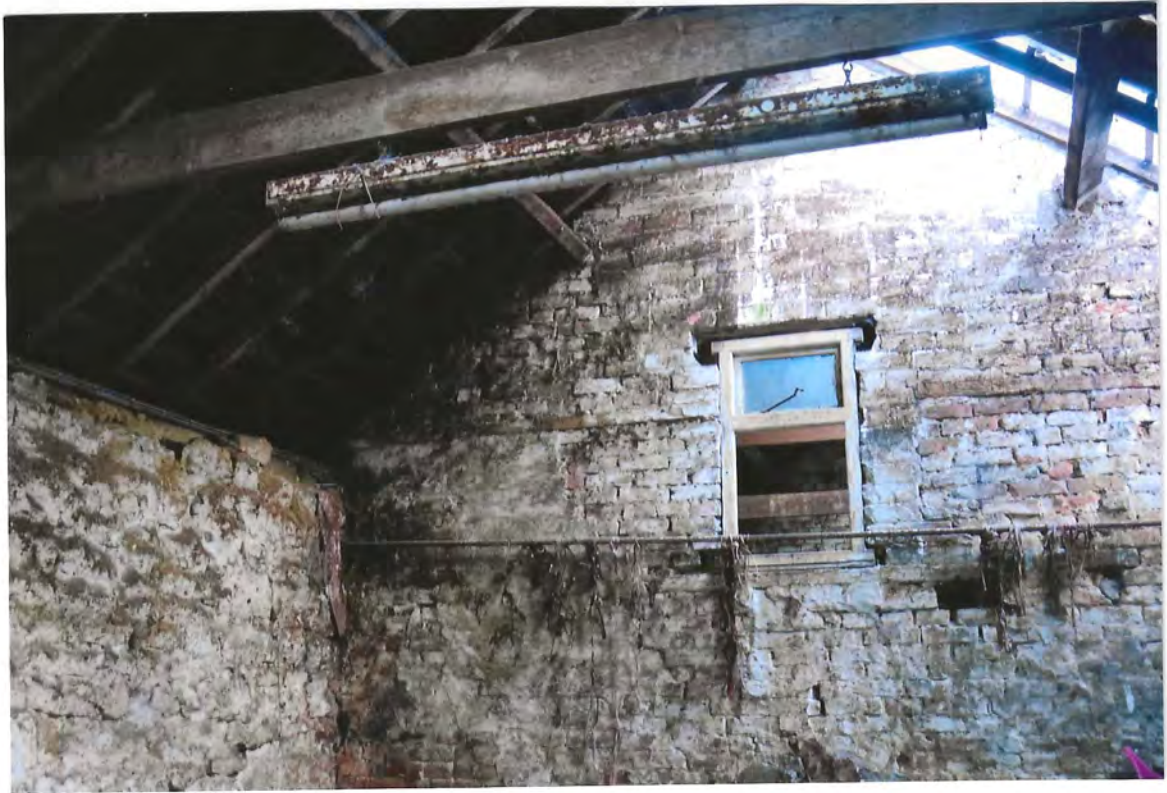
15. INTERNAL CROSS WALL - UNIT 2

- (viii) The north west external corner of Unit 1 has suffered localised low level vehicle impact damage in the past.
- (ix) Two cross walls in Unit 2 are constructed in 100mm thick brick and appear, subject to further cleaning down for better inspection, to be in a questionable condition. Again, these cross walls appear to be not tied or bonded to abutting external walls.

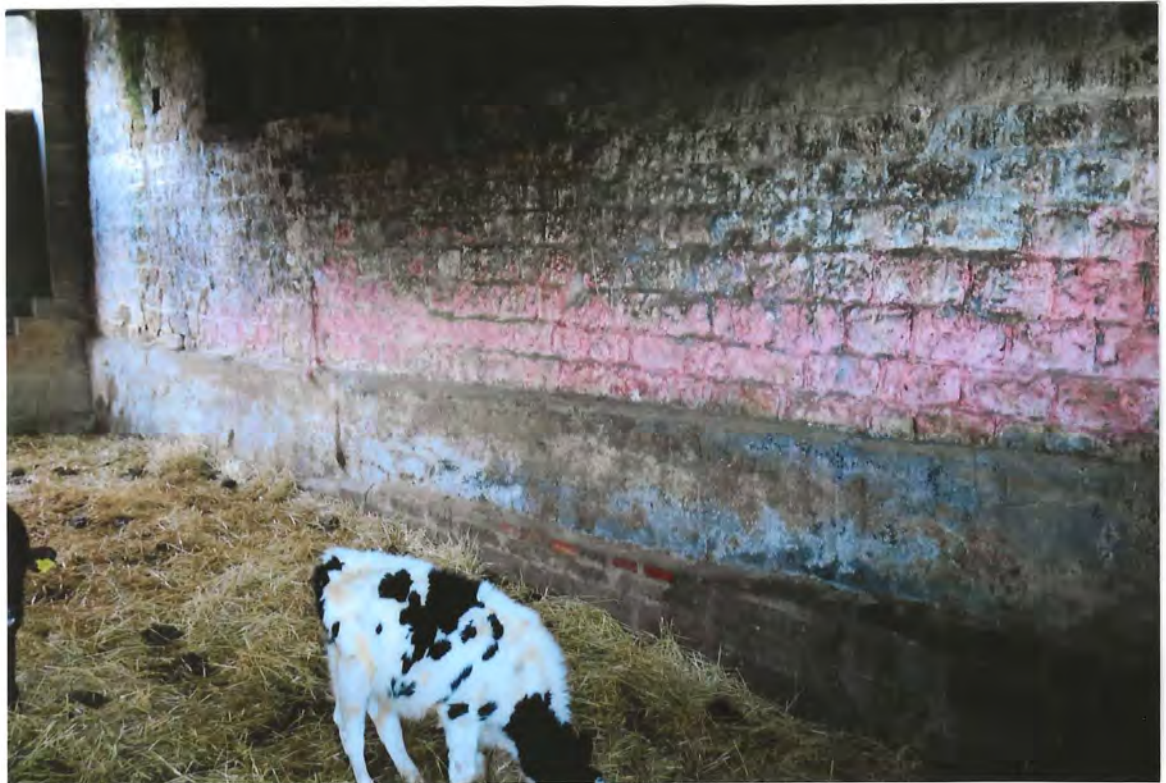
16. LOWER EXTERNAL WALL TO UNIT 3
EXISTING FORD YARD TO BE DEMOLISHED

- (x) There is a mixture of stone, timber, and rusty steel (Unit 2) lintels above existing door and window openings.
- (xi) The east wall of Unit 3, abutting the modern farm building, (to be demolished) appears to have been extended downwards due to the differences in level (approx. 1.5m) between the two. Details of how this

was done are not clear at this stage. Viewed from a short distance no obvious signs of movements or cracking were observed in this 'retaining wall'.

- (vii) Investigate further the 'retaining wall' at the eastern end of Unit 3. Following demolition of the modern farm building provide at least two lines of lateral natural stone walls in existing field to provide gradual decreases in ground levels and therefore reduce the retained height of the existing wall
