PROPOSED ROOF WORKS, INSTALLATION OF SOLAR PV PANELS, REPLACEMENT OF RAINWATER GOODS AND REPLACEMENT OF EXISTING EXTERNAL TERRACE COVERING

HERITAGE STATEMENT

Thorpe Hall
Church Lane
Fylingthorpe
Whitby

Stone + Associates

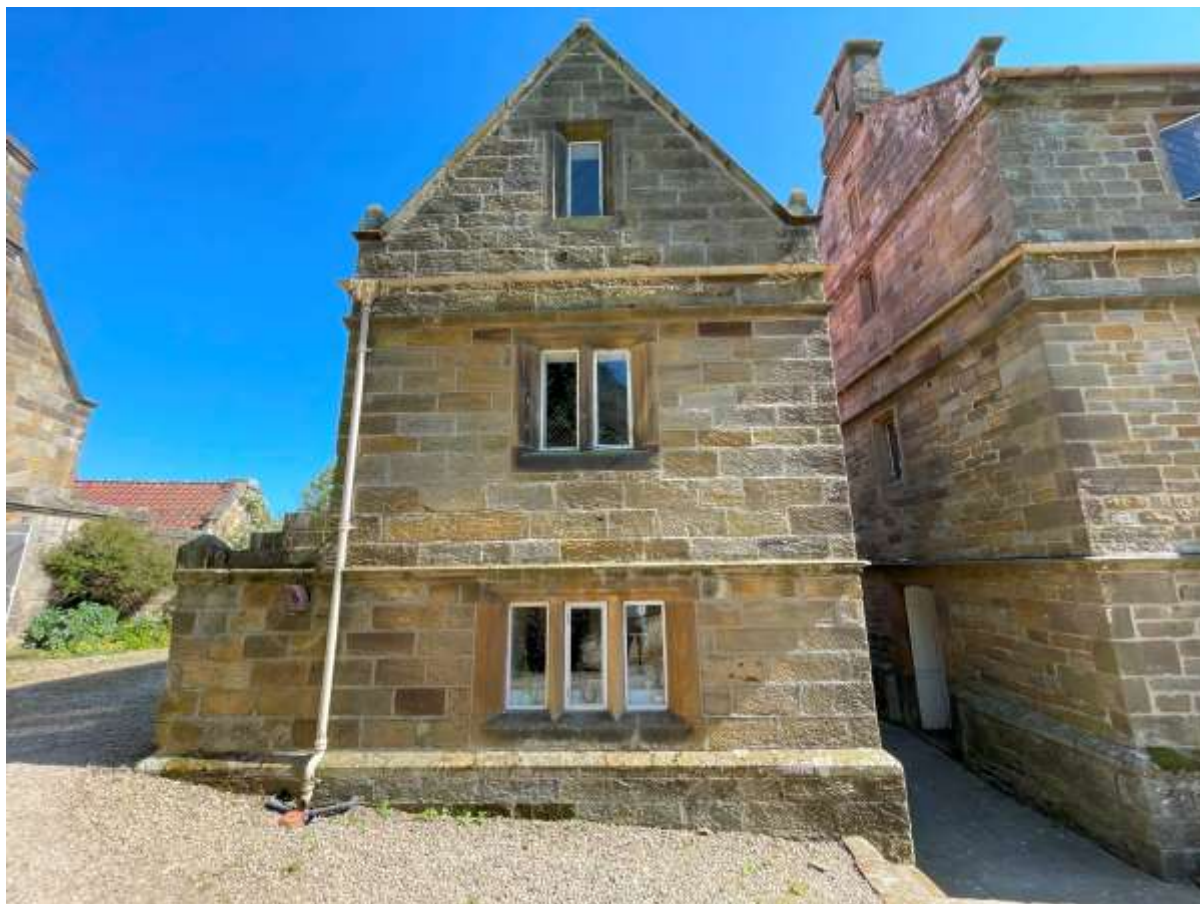
Figure 13 - Northwest Facing Gable (c.1844). Horizontal Gutter at first floor level to be removed. Downpipe to be renewed.

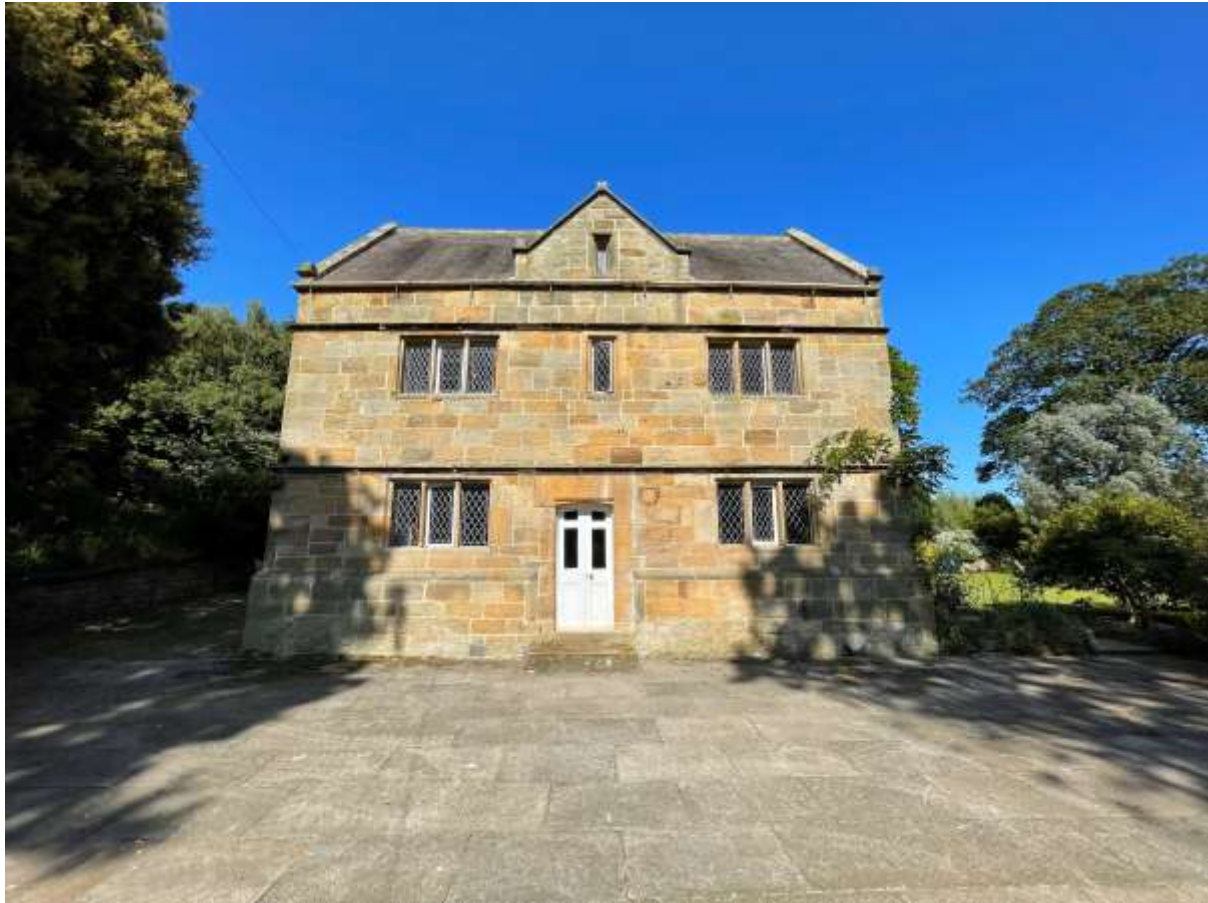
Figure 18 - Southwest facing elevation of 'Original House'. Terrace to be renewed. Existing guttering to be removed and replaced with new profile guttering running towards new downpipe.

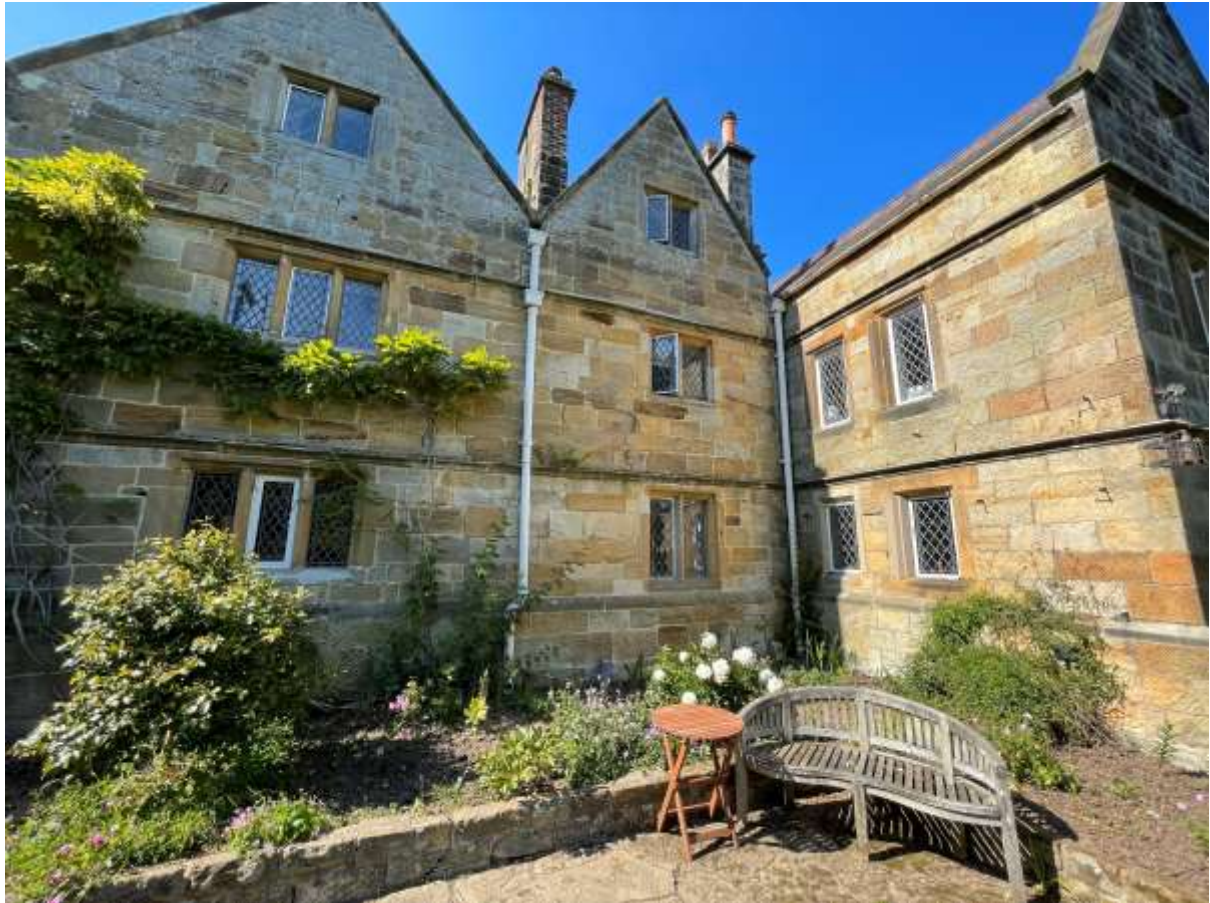
Figure 19 - Southeast facing elevation of 'Original House' and Southwest side elevation of 1835 extension. Valley downpipes to be removed and replaced with new, including hoppers. Guttering to 1835 extension to be renewed with new profile cast iron guttering.
