PROPOSED ROOF WORKS, INSTALLATION OF
SOLAR PV PANELS, REPLACEMENT OF
RAINWATER GOODS AND REPLACEMENT OF
EXISTING EXTERNAL TERRACE COVERING

DESIGN, ACCESS AND HERITAGE STATEMENT

Thorpe Hall

Stone + Associates

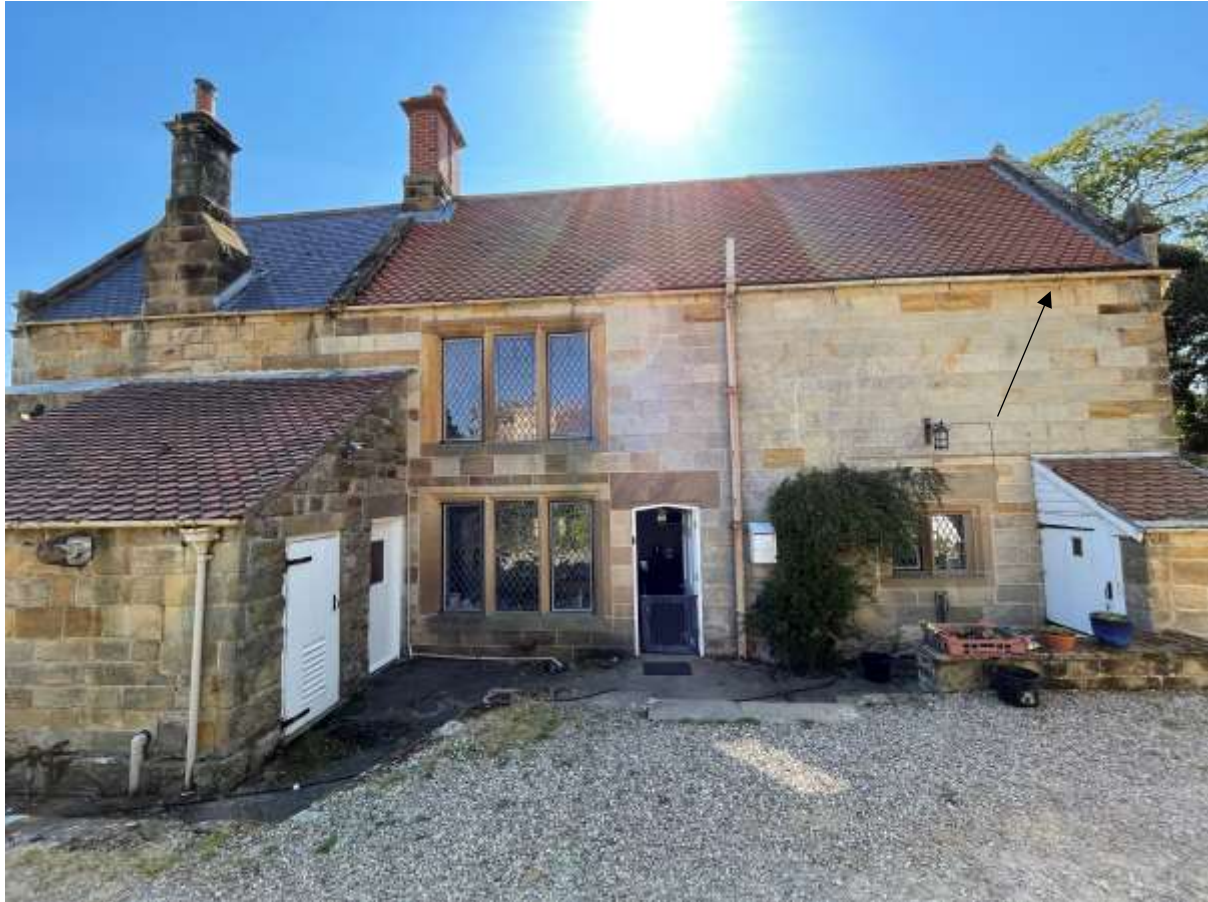
- 5.9. It is proposed that the existing rainwater goods are replaced with new rainwater goods throughout. The replacement of the existing is due to several factors. The existing, non original guttering, is of half round profile which is not of historical significance and is installed in a fashion which detracts from the character of the existing building. Details of this can be seen in Figure 10 In addition this profile of gutter, and the way to which this has been installed, means that the system cannot adequately cope the amount of rainwater captured by the existing roofs. This therefore leads to regular overtopping of the guttering and in turn causing harm to the dwelling house.

Figure 12 - Northeast Facing Elevation (c.1844) – Guttering arrangement to be renewed. Please note the distance between the roof eaves and the guttering on the RHS of this picture. There is a significant gap between the two which leads to the rainwater shooting over and missing the guttering. This is due to the selected half round profile which does not allow for a significant amount of water within the profile and must be laid at a greater fall, leading to large gaps as the gutter run extends.

- 5.10. It is proposed to alter the current gutter arrangement, to ensure that the drainage runs are more logical and remove the horizontal stretches of guttering which span across elevations. The revised guttering layout is shown on drawing W5001_PL20_01_Proposed Gutter and PV layout.

- 5.11. To ensure the guttering system works as designed, it is proposed that the gutter profile is altered to a cast iron Hargreaves G46 profile (or similar) in 5 or 6" width depending on the application. This will ensure that the guttering system can capture and hold sufficient water to prevent overtopping and subsequent harm to the dwelling house. A sample of this gutter profile is submitted with this application. It should also be noted that this more decorative gutter with enhance the character of the existing building, by drawing influence from the drip mouldings around the property.

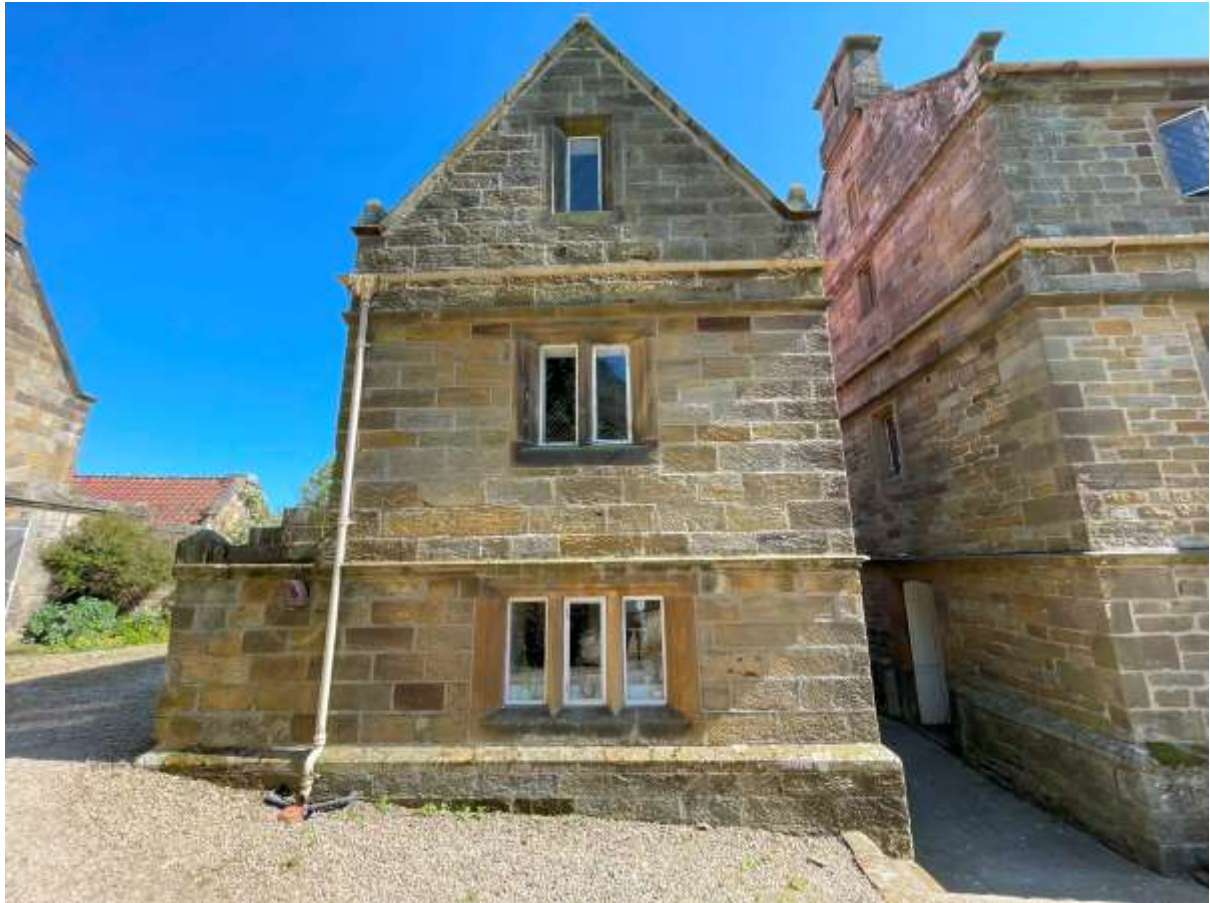
Figure 13 - Northwest Facing Gable (c.1844). Horizontal Gutter at first floor level to be removed. Downpipe to be renewed.

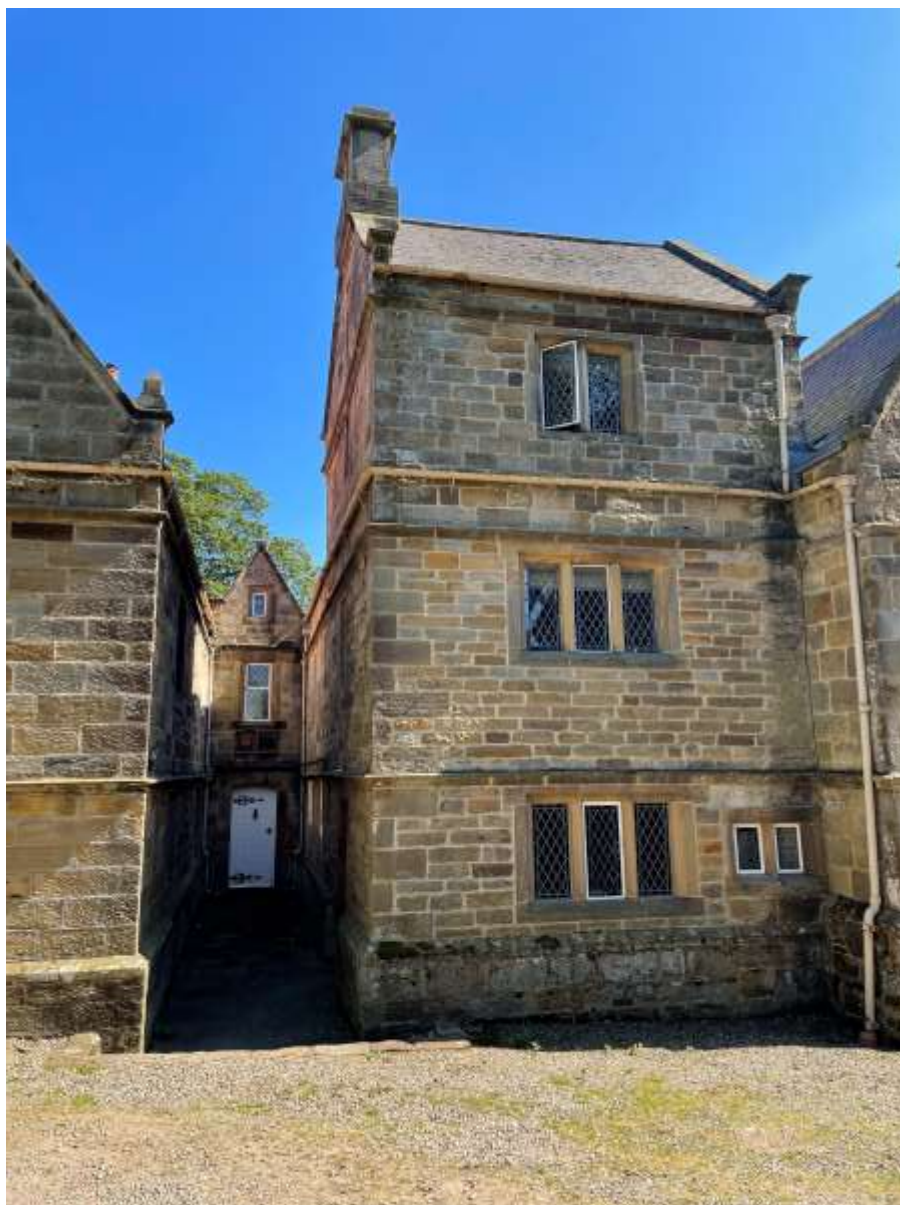
5.7 As part of this application permission is sought to undertaken roof works to the storeyed porch. At present the current fixings have failed to their proximity to the coast and the effect his has had on them through corrosion. This has led to several slates being disturbed. The age of this roof is also starting to show. It is therefore proposed to strip the slates from both the north and south faces, back to the timber rafters. These rafters in turn would be repaired as far as possible and then recovered with a modern breathable membrane to allow for the release of moisture from the attic space. Tile battens would be installed over the rafters and membrane the roof would then be re-slatted using the existing slates, where possible, and where not possible, slates would be installed on a like for like basis.

Figure 14 - Northwest Elevation - Storeyed Porch - Horizontal gutter at first floor to be removed. Downpipe and gutter to roof to be renewed. Downpipe to side of 'Original House' to be renewed with new box hopper at top to fix the existing water ingress problems. Please also take note of the roof covering to the storeyed porch. It is proposed this roof is replaced on a like for like basis.

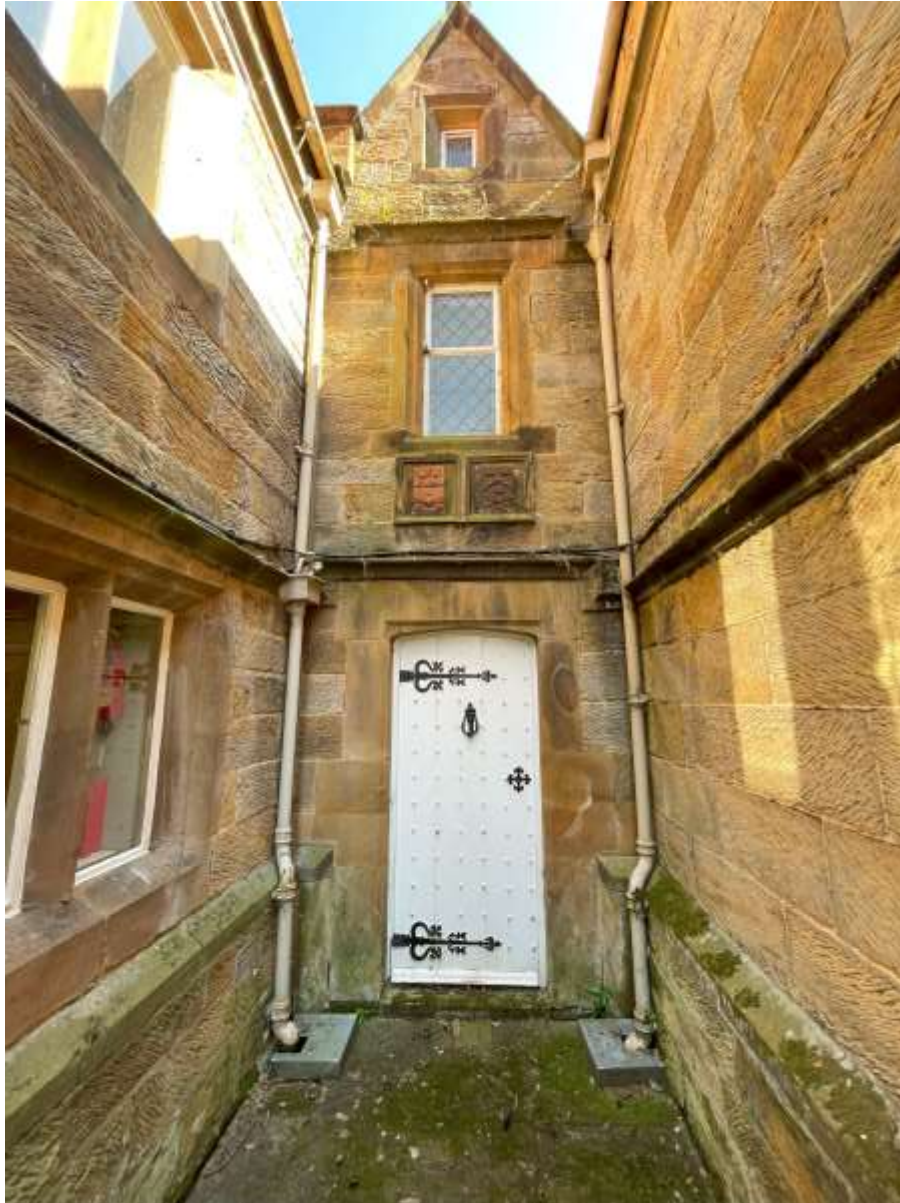
Figure 15 - Northwest elevation of 'Link' building. Downpipes to both sides to be replaced with new. Guttering over to be replaced with new profile. Gulley's and underground drainage to be renewed.

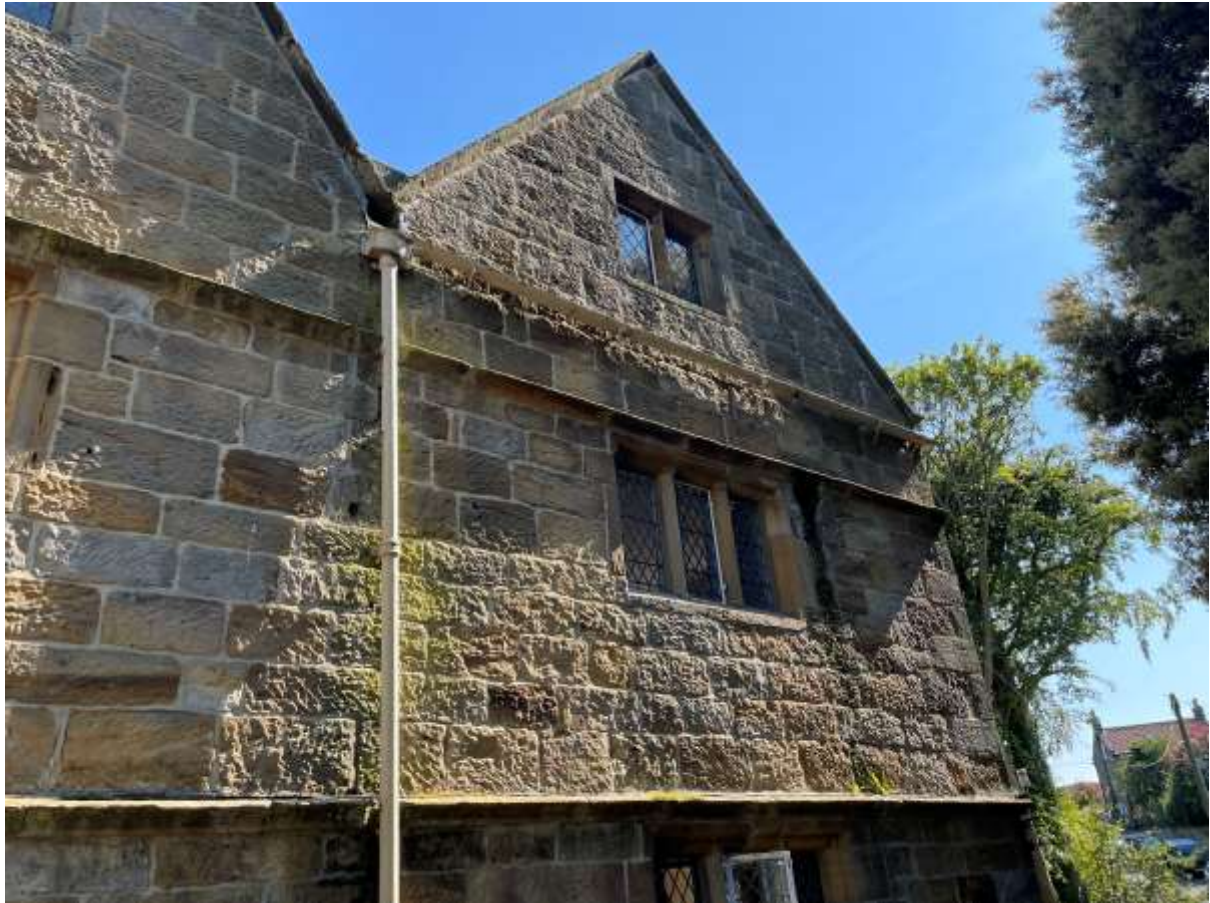
Figure 16 -Northwest Elevation of 'Original House'. Horizontal guttering above first floor level to be removed with new downpipe installed to northwest / southwest corner. Existing valley downpipe to be renewed.

- 5.12. To ensure that the system is free from defect, it is proposed to renew several existing downpipes, again as shown on plan. It is only proposed to provide 1 additional downpipe, shown to the northwest corner. This removes the need for guttering to span across the northwest elevation of the 'original house' leading to a more attractive aesthetic.

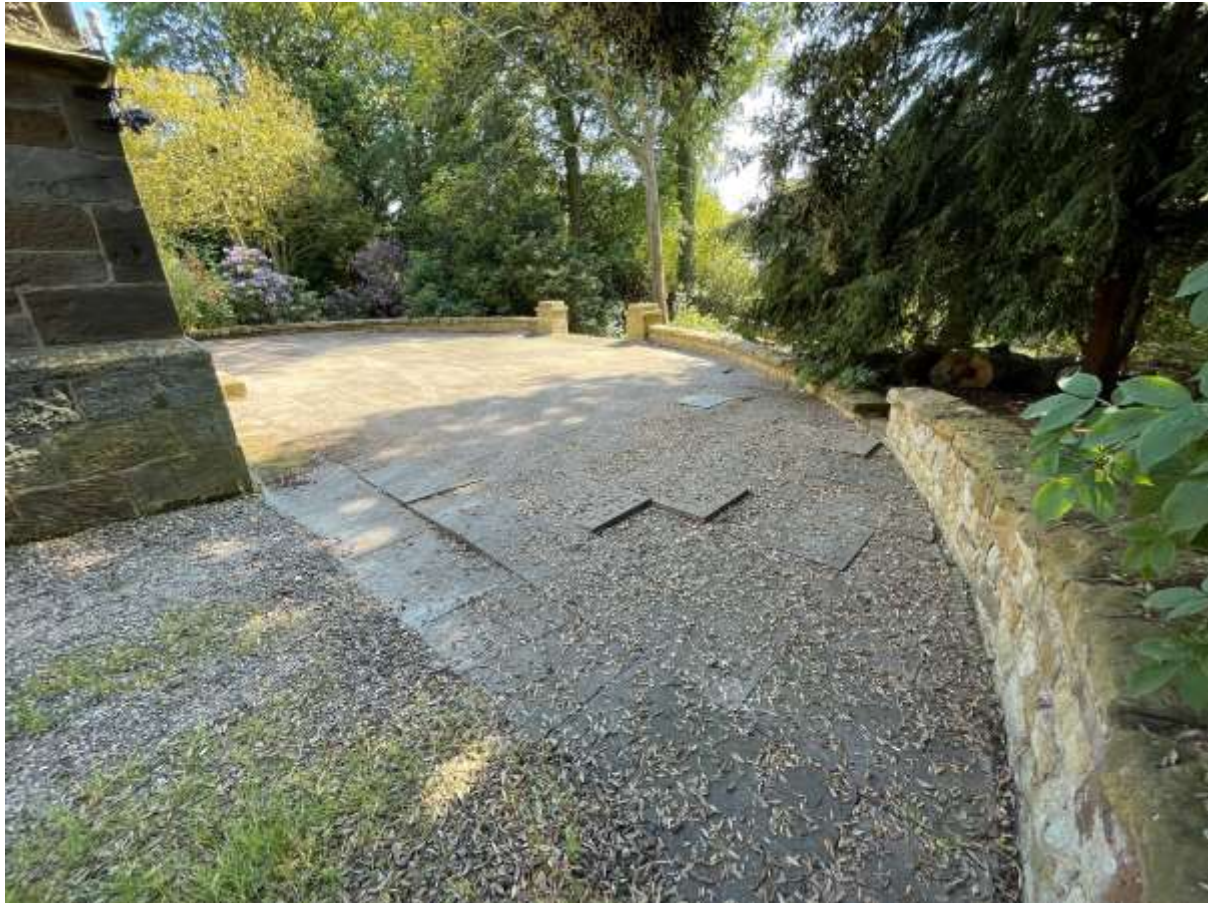
- 5.14. Existing southwest terrace**
- 5.15. This application seeks to renew the existing terrace material found to the southwest of Thorpe Hall.
- 5.16. The existing covering is a mix of broken concrete pavers and gravel, which is not fit for purpose nor particularly enhances the dwellings aesthetics. The covering is significantly damaged due to subsidence and as such poses a health and safety risk.

Figure 17 - Existing terrace to South West Elevation. Existing concrete pavers shown. Paving to be removed and replaced with yorkstone flagstones or bonded gravel.

- 5.17. It is therefore proposed to remove the existing material and install a more sympathetic material. This application seeks to apply for permission to utilise either a Yorkstone Flagstone or self binding gravel as a decorative finish. This is to be confirmed by condition should the planning authority agree to this. Both finishes would allow for a more aesthetically pleasing finish enhancing the dwelling house. However, it is to be understood that the cost of Yorkstone could be prohibitive.

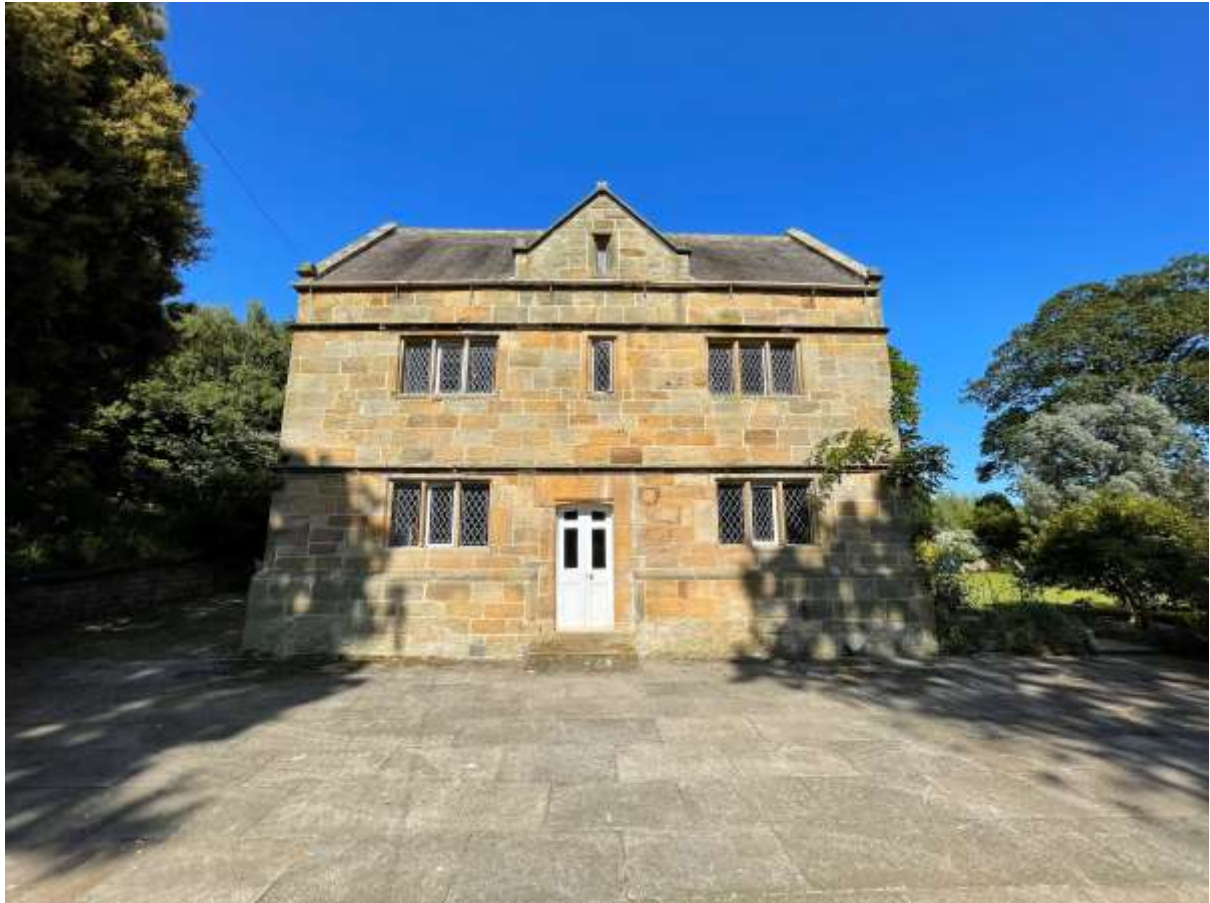
Figure 18 - Southwest facing elevation of 'Original House'. Terrace to be renewed. Existing guttering to be removed and replaced with new profile guttering running towards new downpipe.

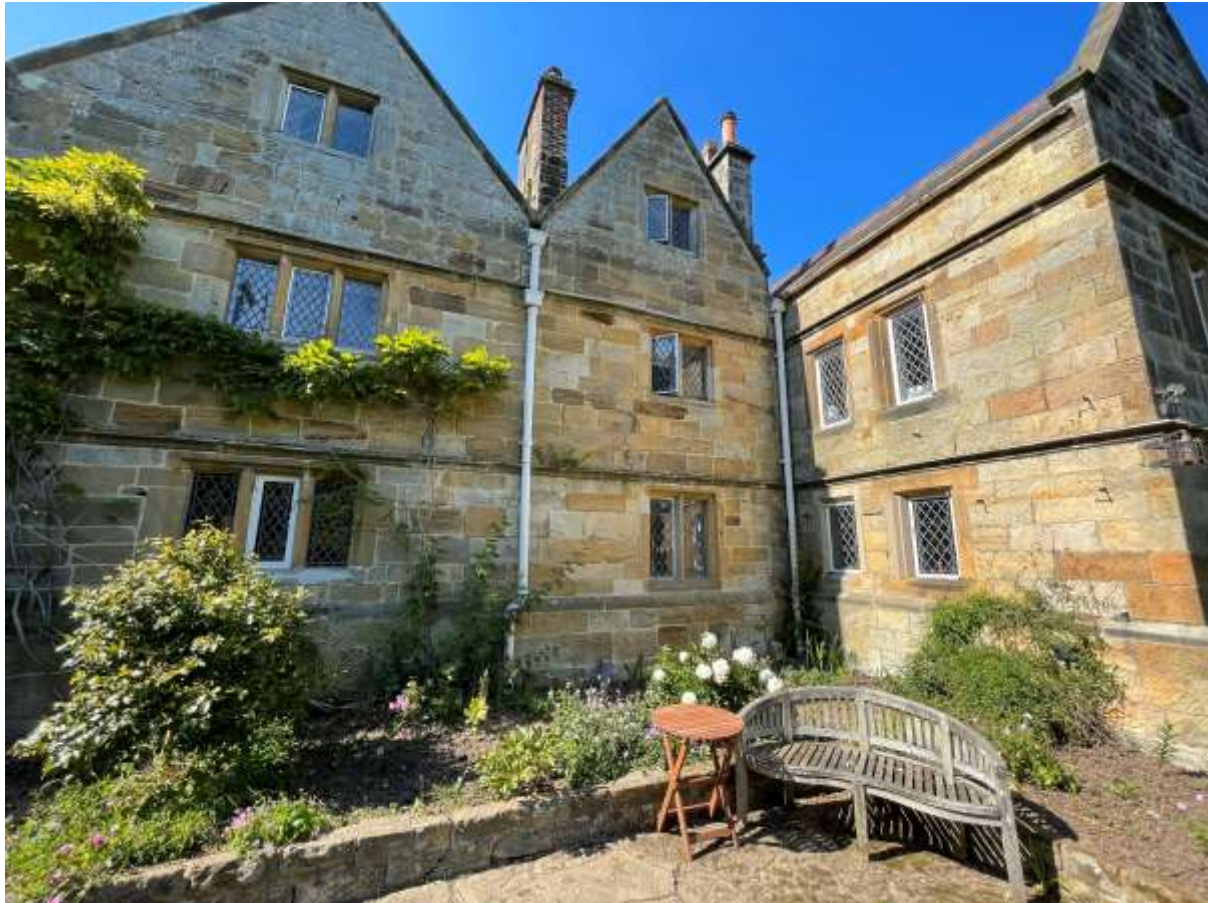
Figure 19 - Southeast facing elevation of 'Original House' and Southwest side elevation of 1835 extension. Valley downpipes to be removed and replaced with new, including hoppers. Guttering to 1835 extension to be renewed with new profile cast iron guttering.

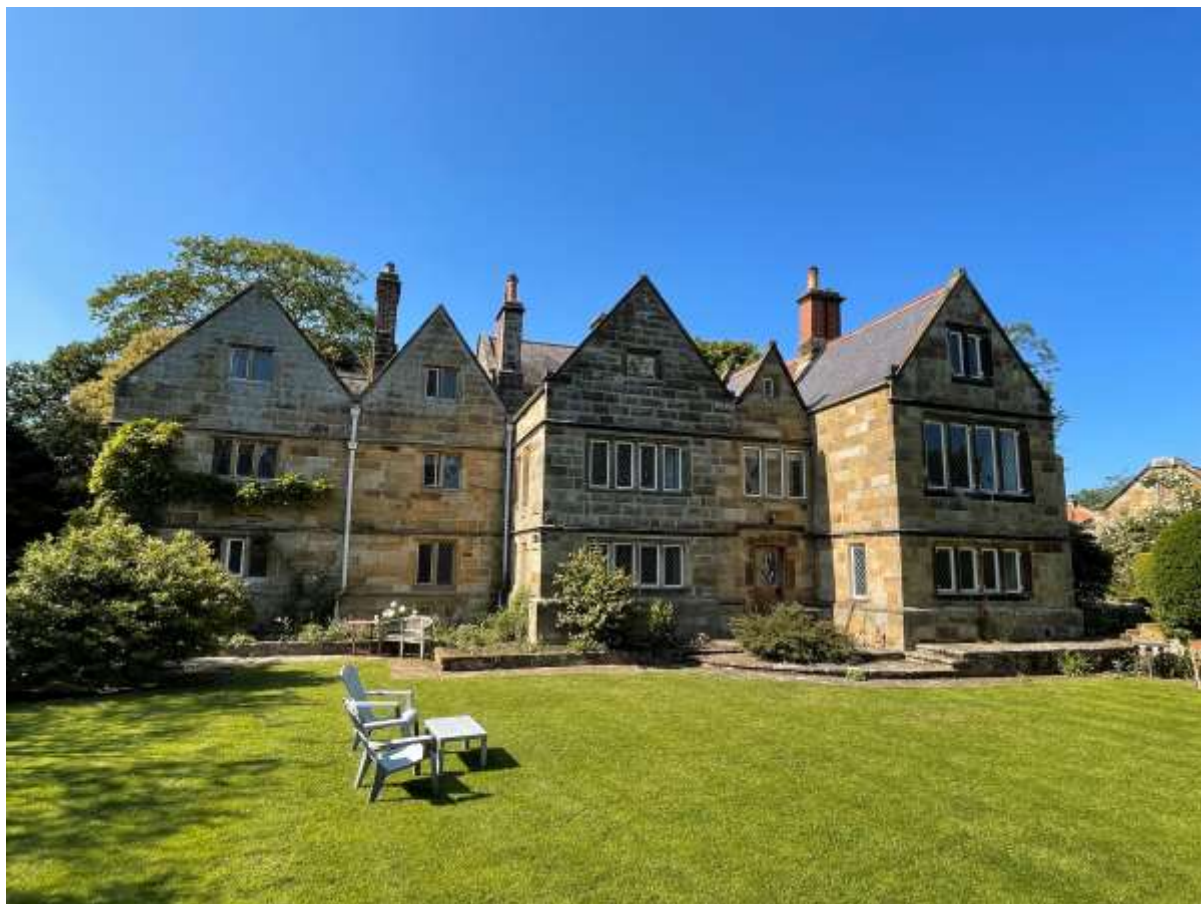
Figure 20 - Southeast facing elevation of 'Original House', 1835 addition, link building, 1844 incorporated building and south roof slope of Storeyed porch. Southern roof to be utilised for Solar PV.

5.3 It is proposed that a new solar photovoltaic array is to be installed, using an over roof bracket system, onto the South facing roof of the storeyed porch.
