# Arboricultural Implication Assessment

## The Blacksmiths

Hawsker

# Arboricultural Method Statement The Blacksmiths

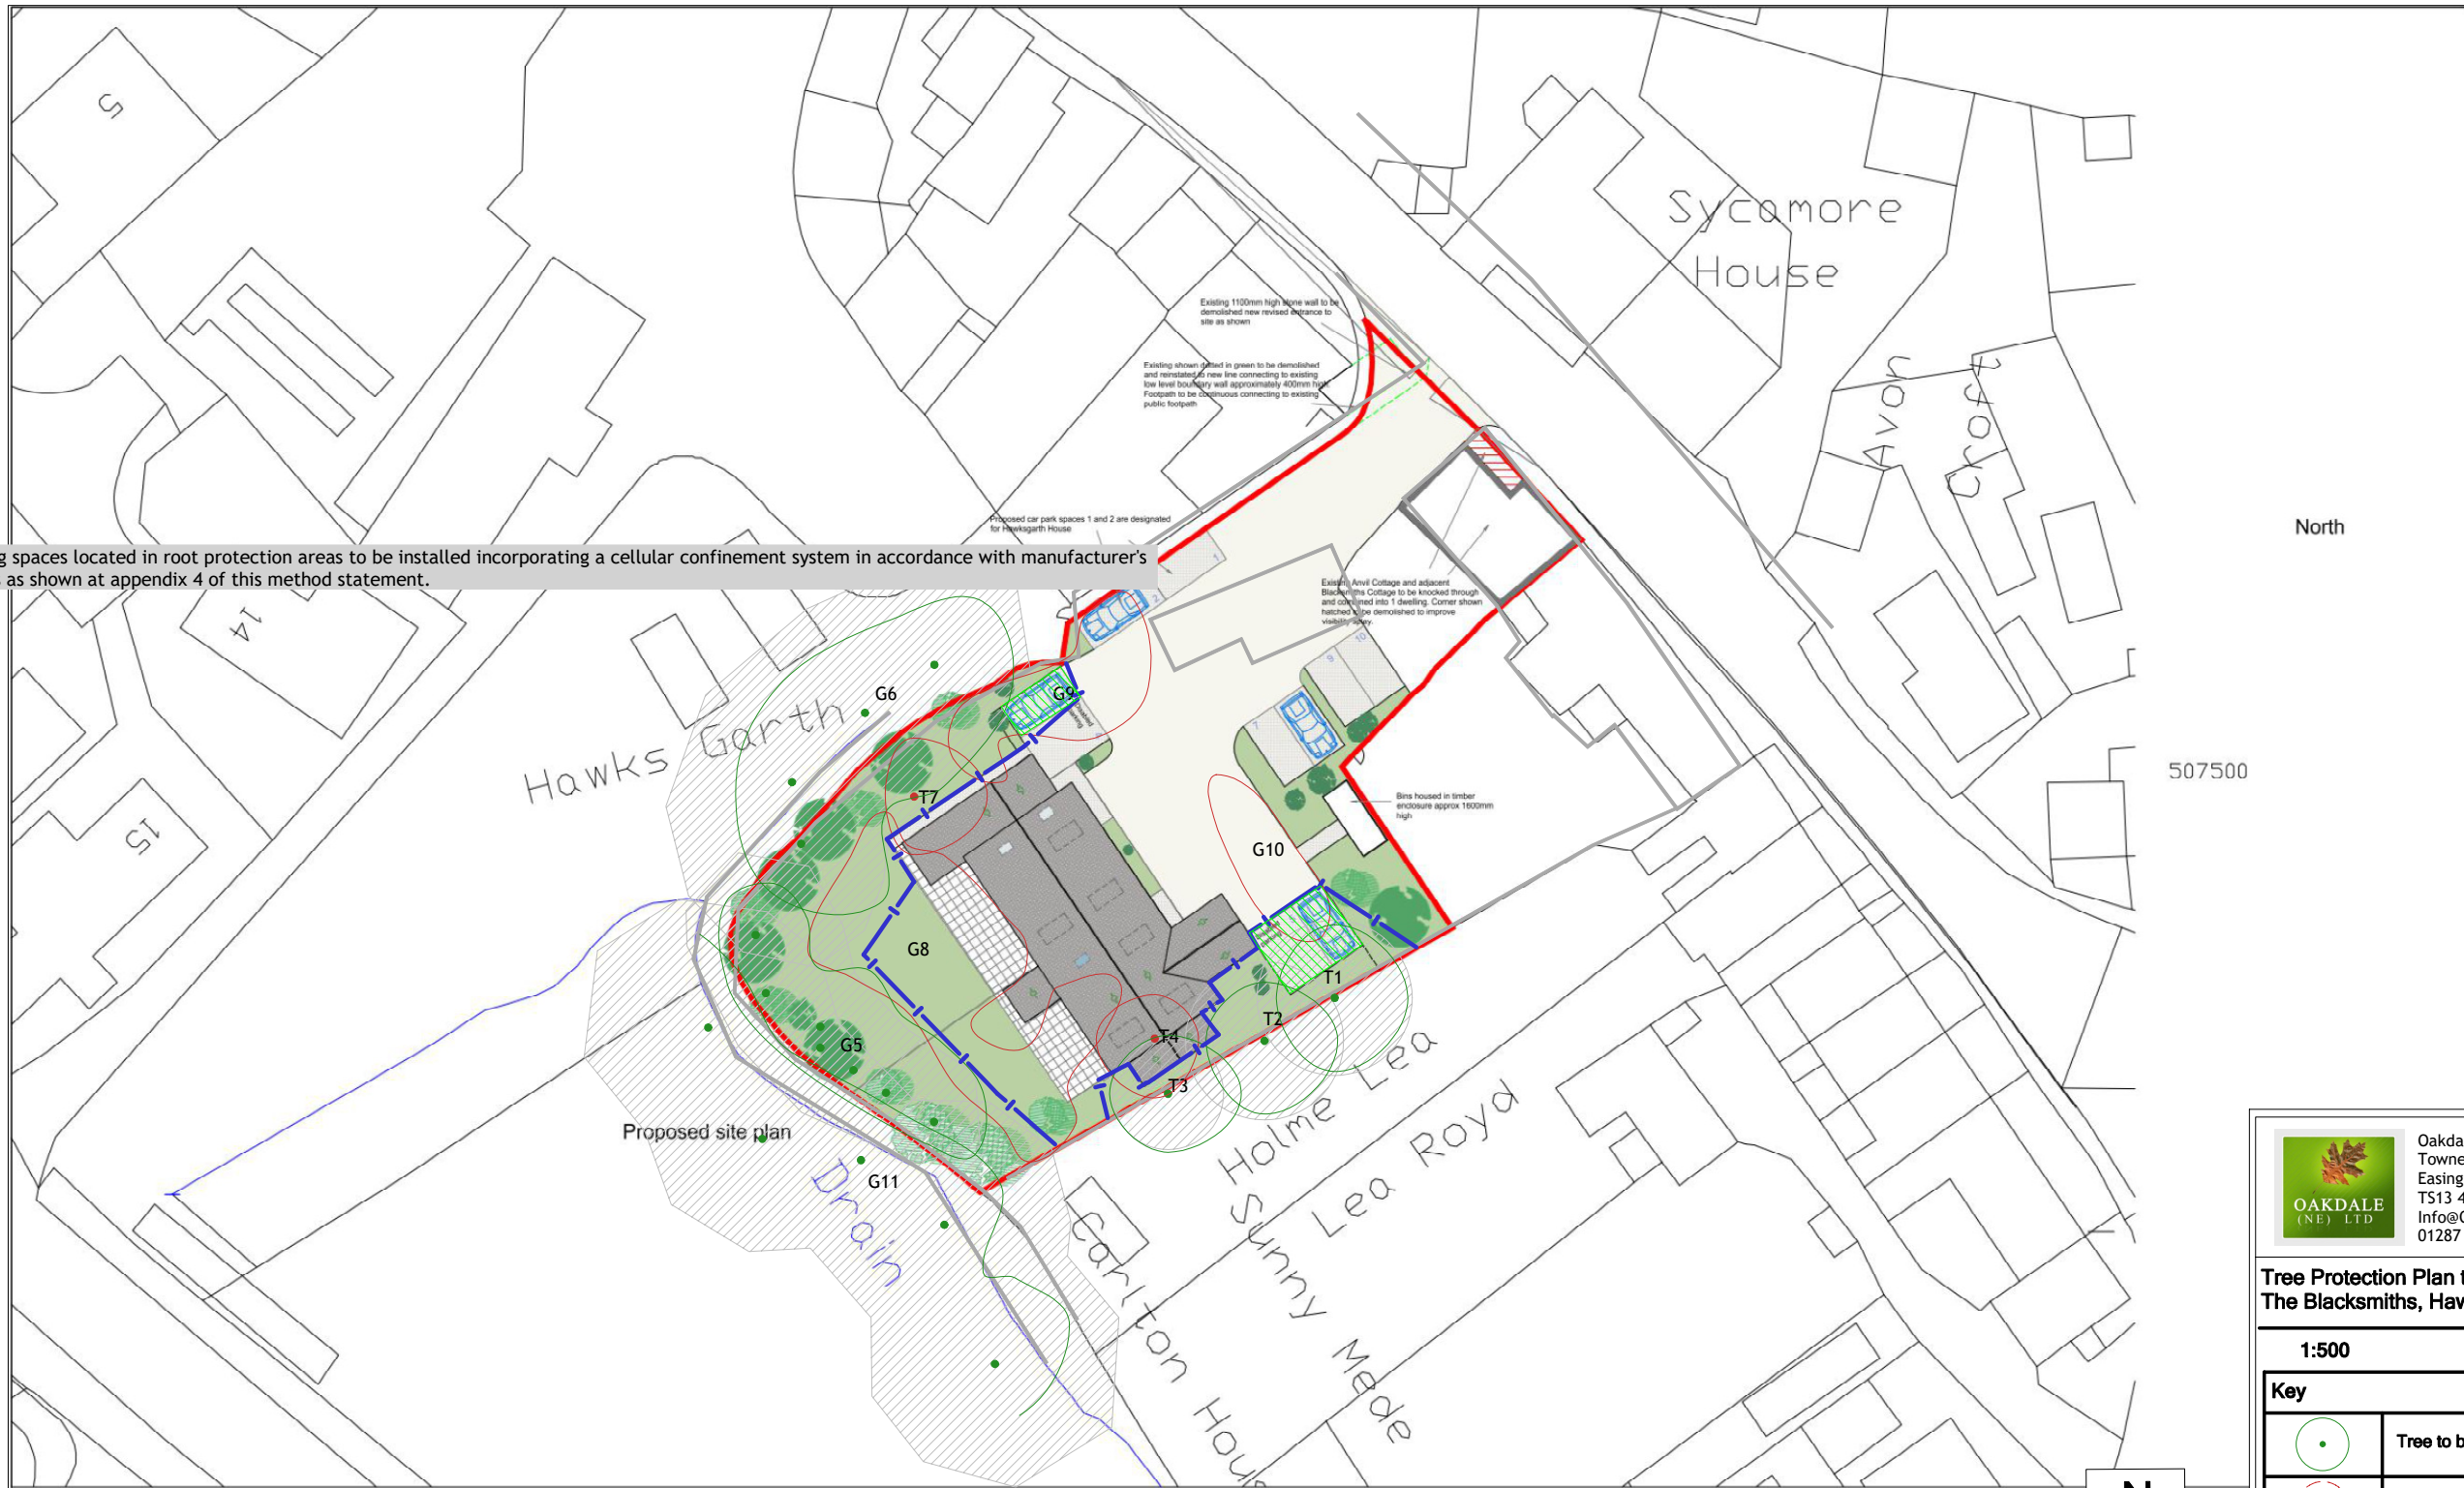
**Tree Protection Plan to BS5837:2012 at:  
The Blacksmiths, Hawsker**

New parking spaces located in root protection areas to be installed incorporating a cellular confinement system in accordance with manufacturer's instructions as shown at appendix 4 of this method statement.

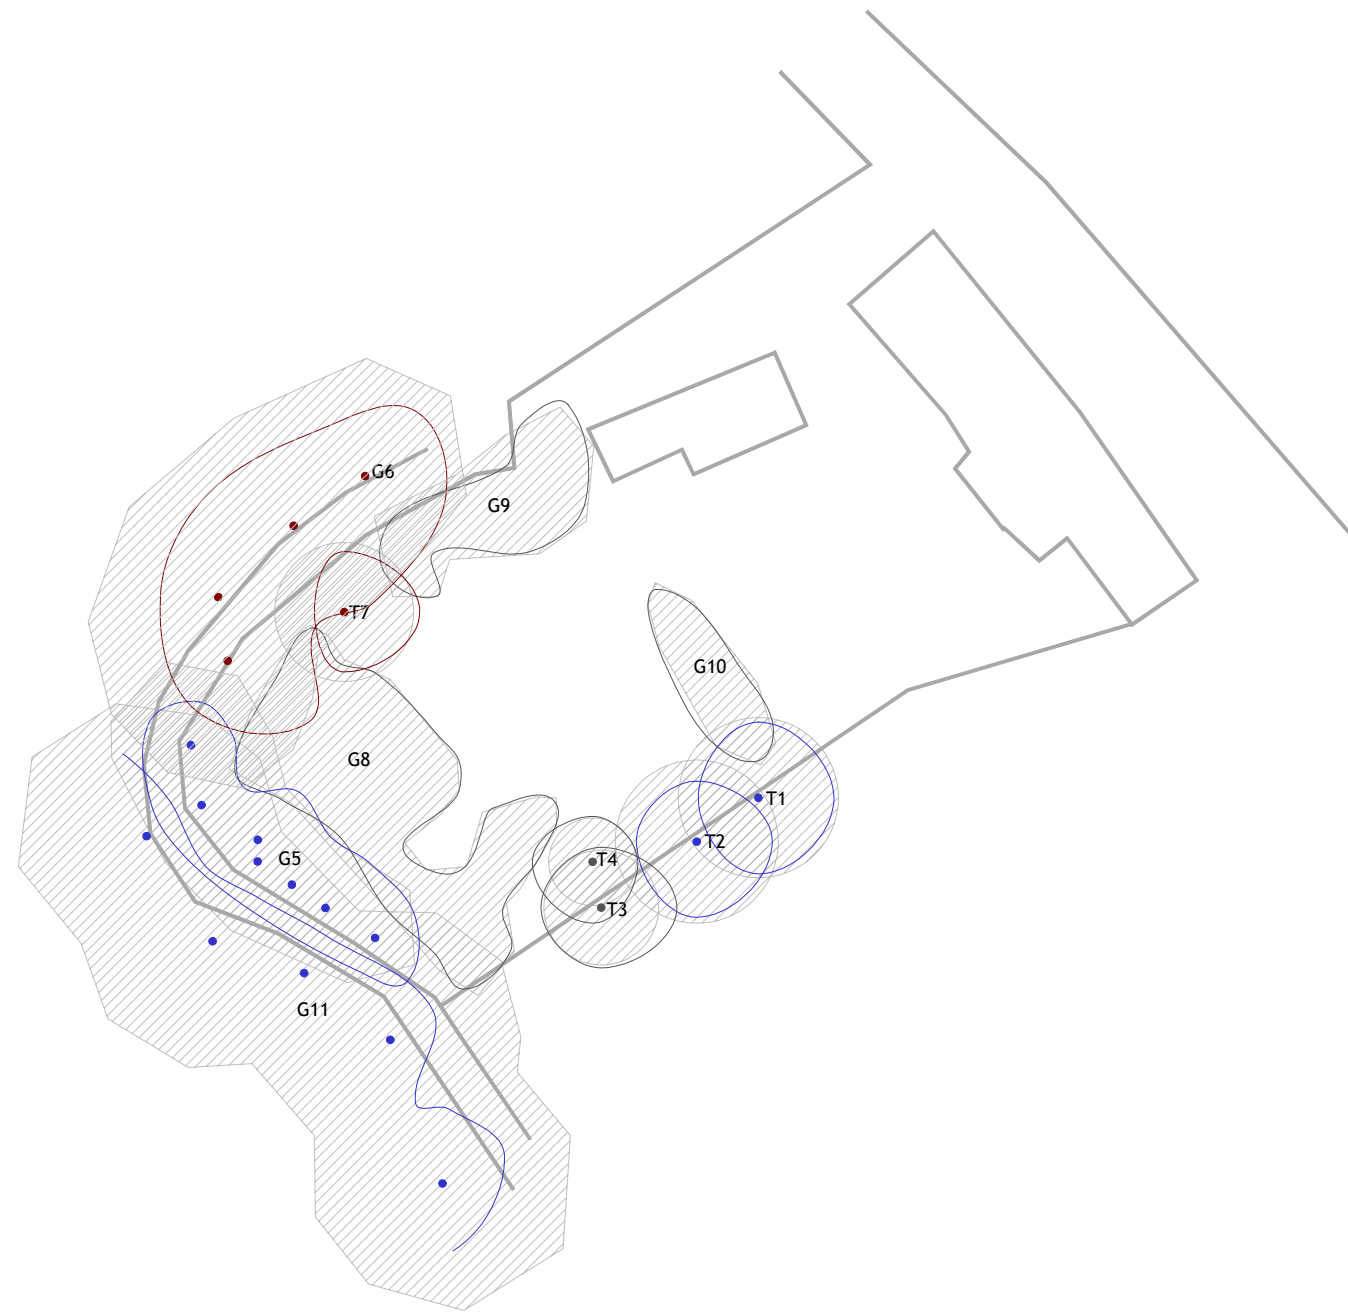
# Appendix 2: Plans

Trees T1, T2, G5, and G11 are of medium value, and appear to be in reasonable condition to be retained. They have been allocated a category B.

Trees G6 and T7 are hazardous trees and have been allocated a category U, these trees should be removed or heavily pruned for safety reasons.
