**Condition Verification Check of Condition 01 and Condition 06 of Planning Approval NYM/2010/0551/FL at Stoupe Brow Farm, Browside, Ravenscar**

REPORT ON A  
STRUCTURAL INSPECTION AND APPRAISAL  
OUTBUILDING/FORMER BARN - STOUPE BROW FARM

26 August 2010

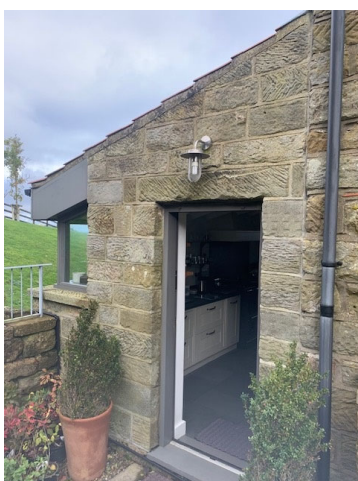
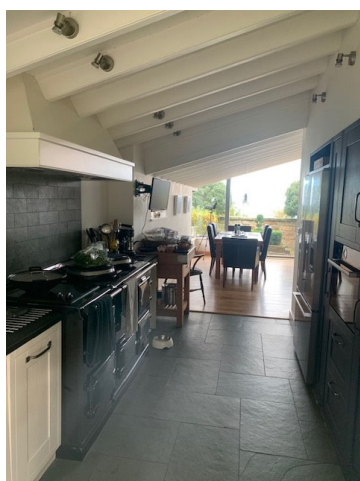
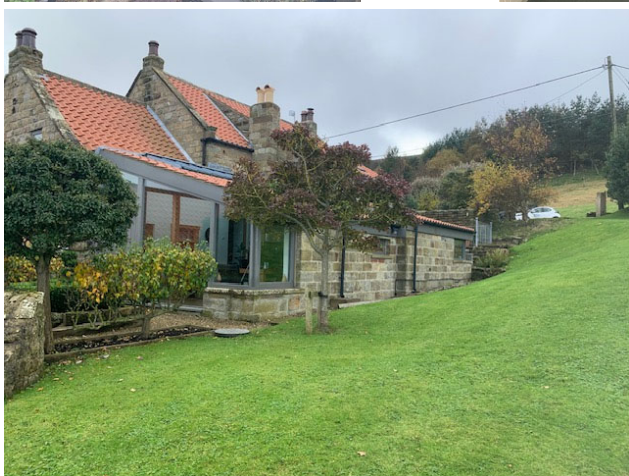
Figs 1 - Fig 3. – Photograph of completed single storey extension to dwelling.

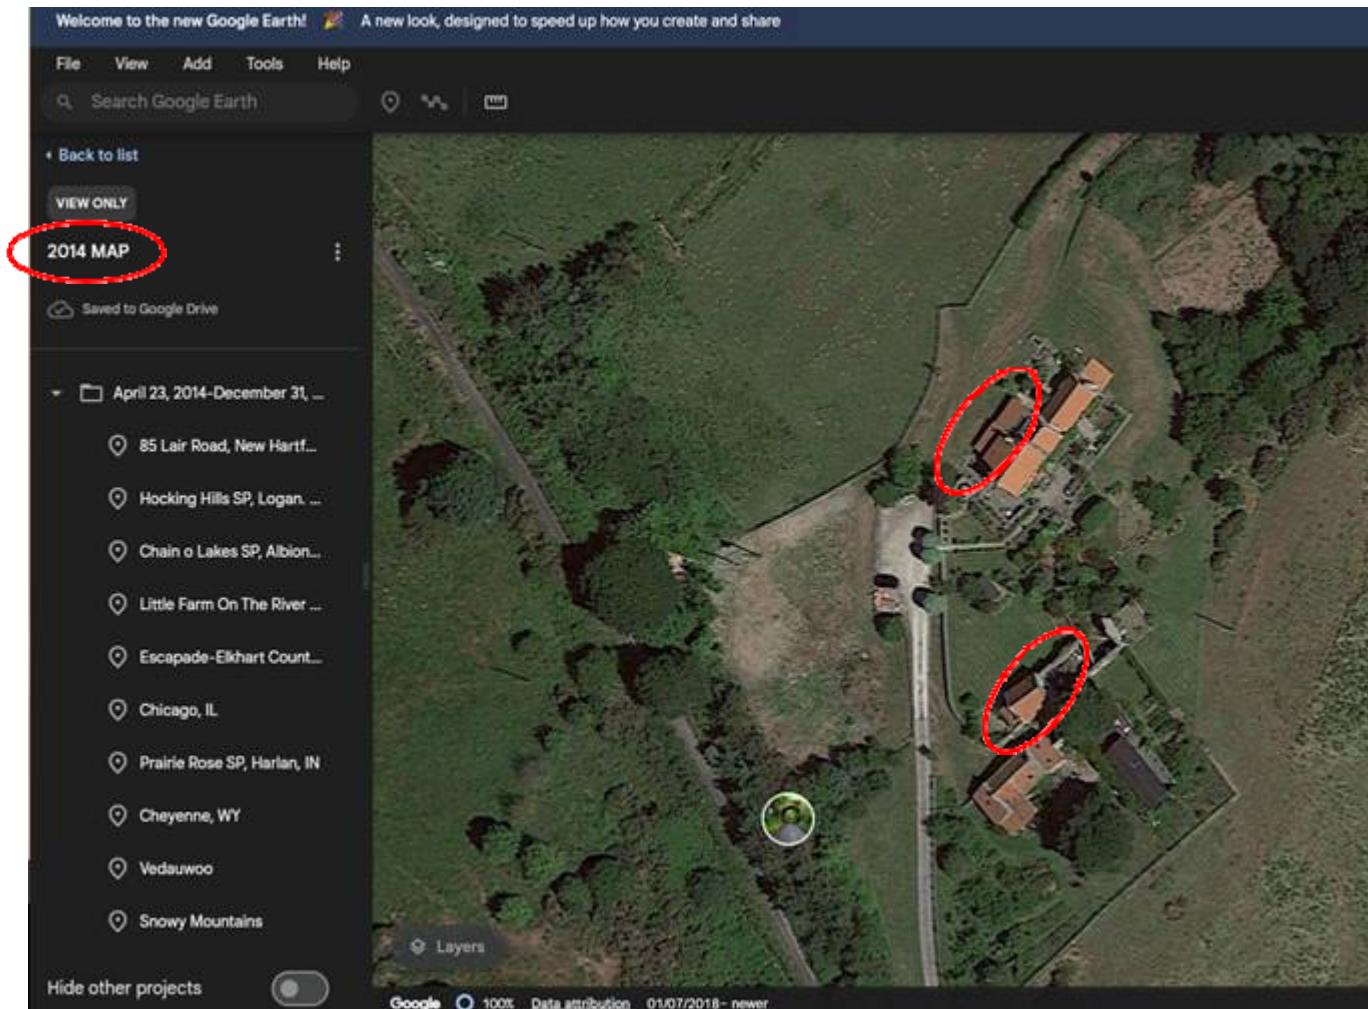
Fig 4. – Google earth (2014) showing the completed extension and barn where works have taken place to install drainage.

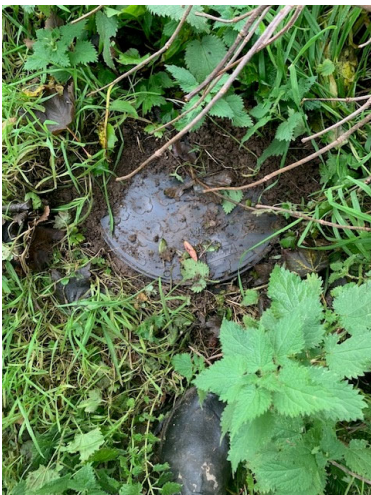
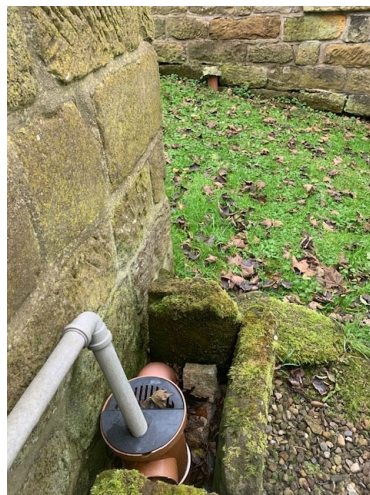
Figs 5 and 6. - New drainage (waste) pipes to Barn 1 associated with the same planning permission.
