3.0 HISTORY OF CLIFF HOUSE

Mason Clark Associates (MCA) was commissioned by Shaw & Jagger Architects, on behalf of the property owner, to provide an initial structural opinion relating to the proposal to construct a two-storey extension at the rear (east elevation) of the property.

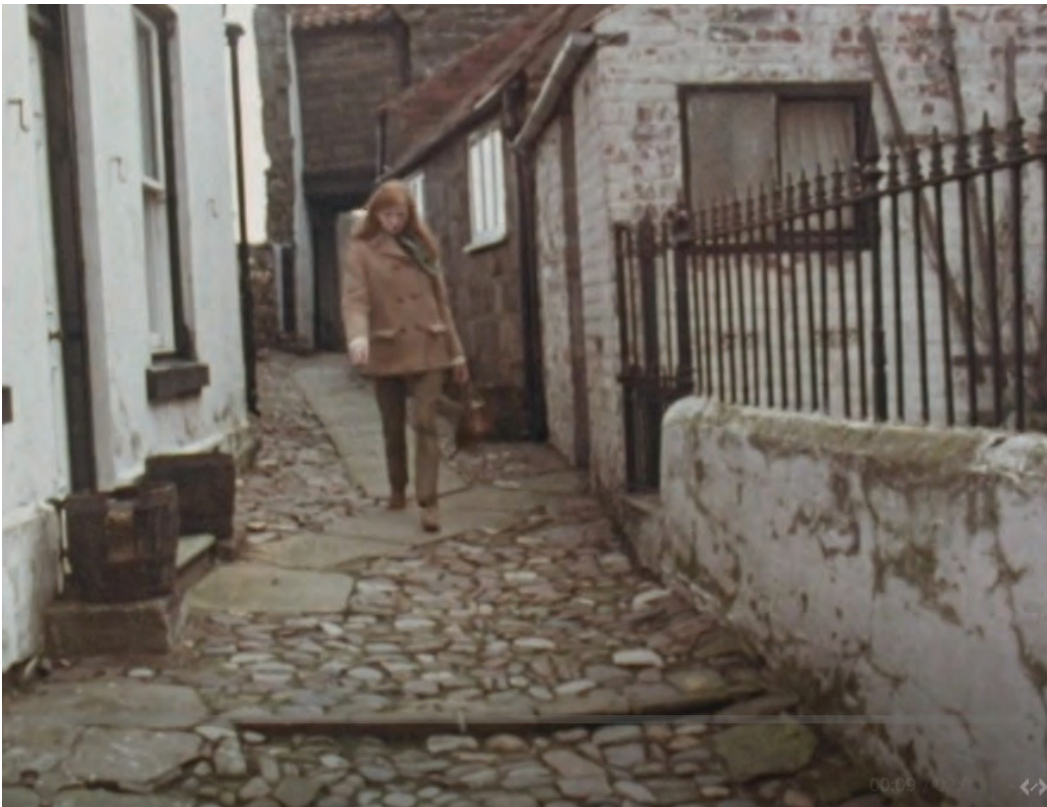
A still taken from the 1970s BBC documentary showing Cliff House. The adjoining building has since been demolished. The door to the workshop opposite is now blocked up.

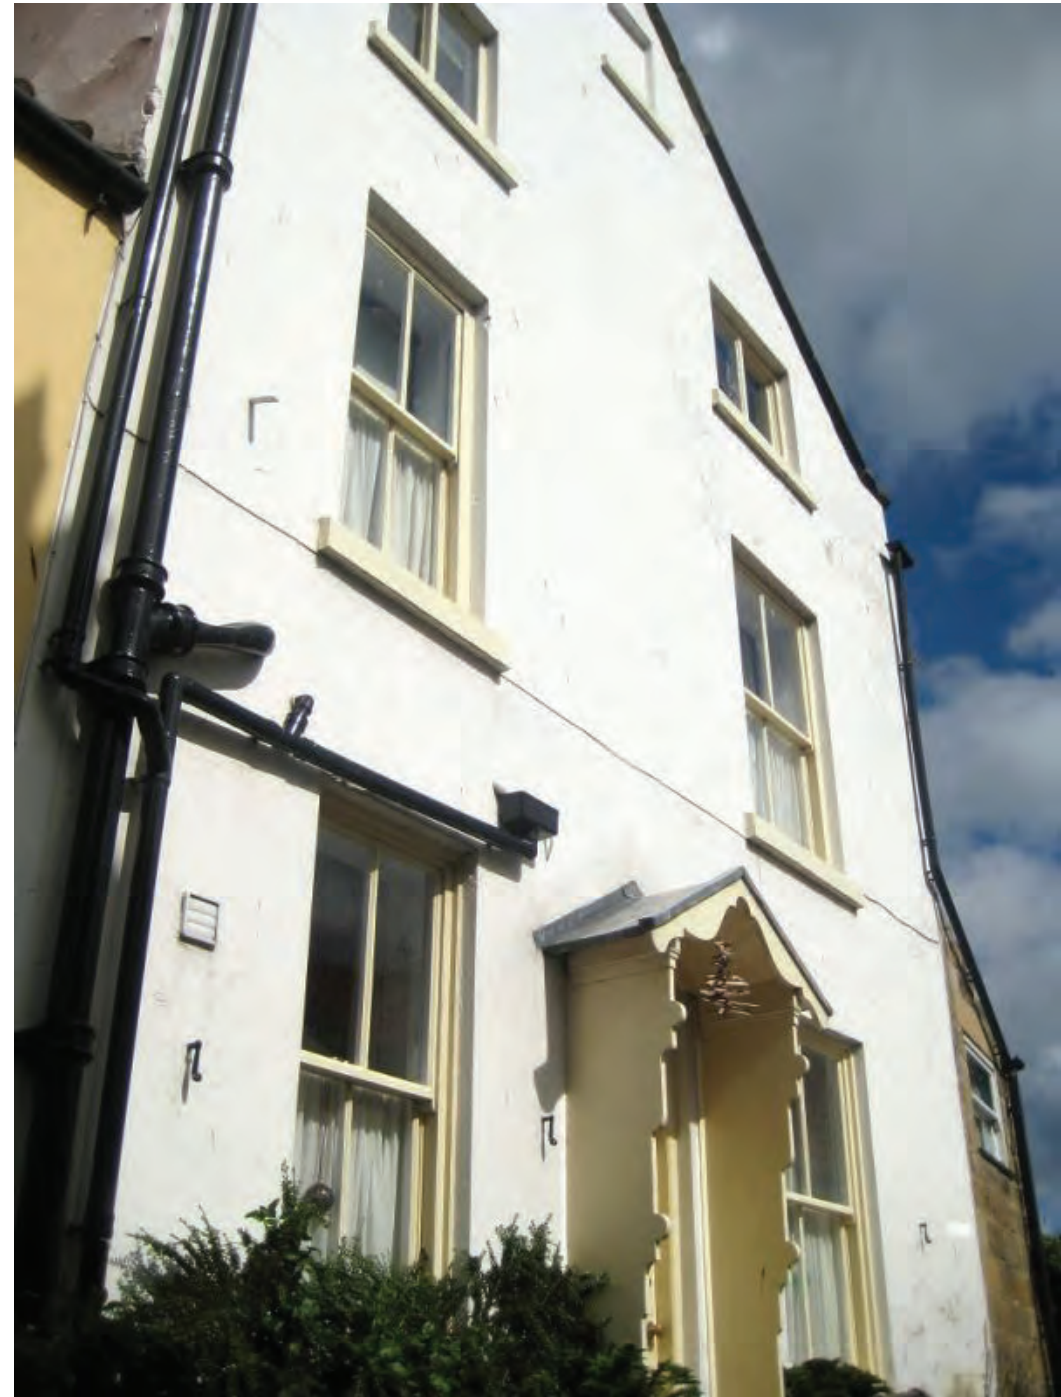
Cliff House in 2001 with the render still present.

The building was rendered in the Victorian period when it was restored and this can be seen in a photograph in the 1920s; this render still existed in 2001 but has since been removed and re-pointed throughout to the street front and is in good condition. The Victorian face and stonework is in good condition.

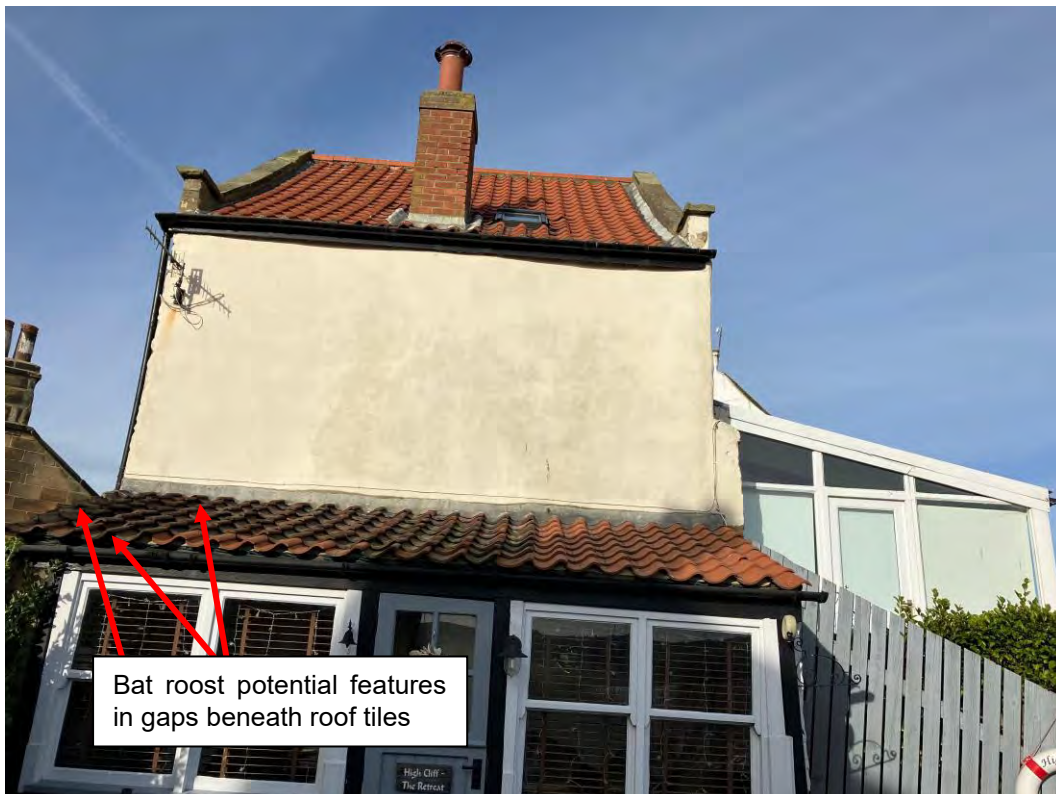
- 3.2.2.2 The main building at the site (Cliff House) was assessed as having low bat roost potential based on a small number of identified bat roost potential features. The masonry is generally well sealed and looks to be in good condition. Bat roost potential features are present in gaps at the eaves on the north elevation; gaps at the eaves on the southern elevation behind soffits where mortar has crumbled; gaps within a vertical crack between the main building and south elevation extension; gaps under roof tiles on the main roof and south elevation extension roof, a small number of gaps in the masonry on the east elevation and gaps under lead flashing.

Photo 2. Eastern elevation of Cliff House – view west.

4.2.1.1 In order to ensure legal compliance and in accordance with current guidelines⁴, prior to any work affecting the roof, eaves, flashing or masonry gaps on the main building at the site (Cliff House), it is recommended that a minimum of 1x dusk emergence or dawn return bat survey should be undertaken during the optimal survey period of 1st May to 31st August inclusive.

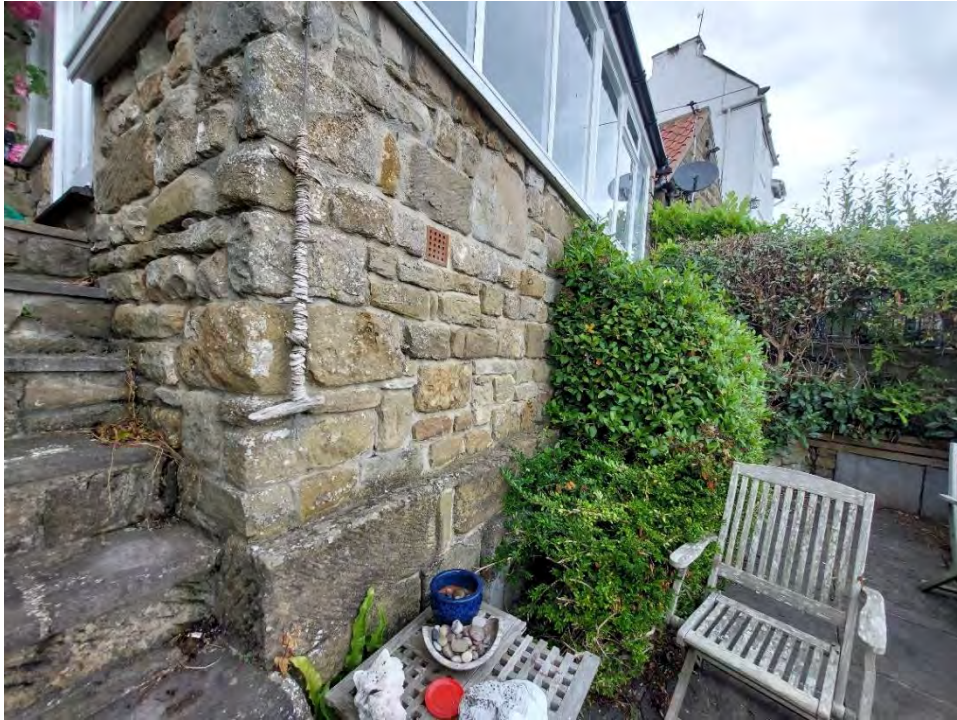
01 East elevation - view of the conservatory support wall and lower patio.

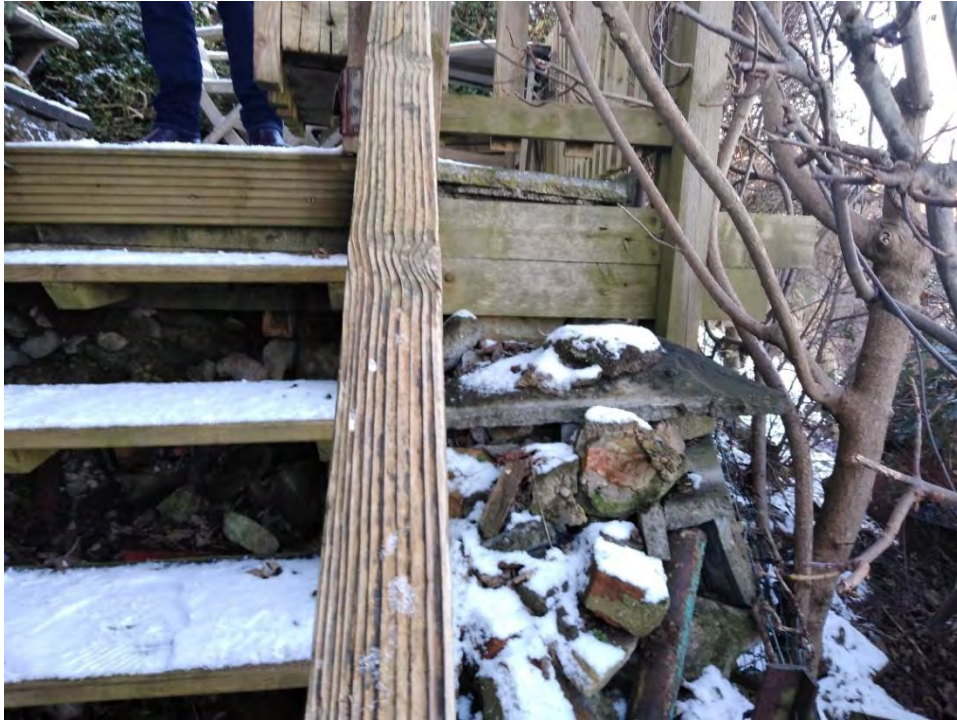
03 View of lower patio showing ad hoc rubble support.

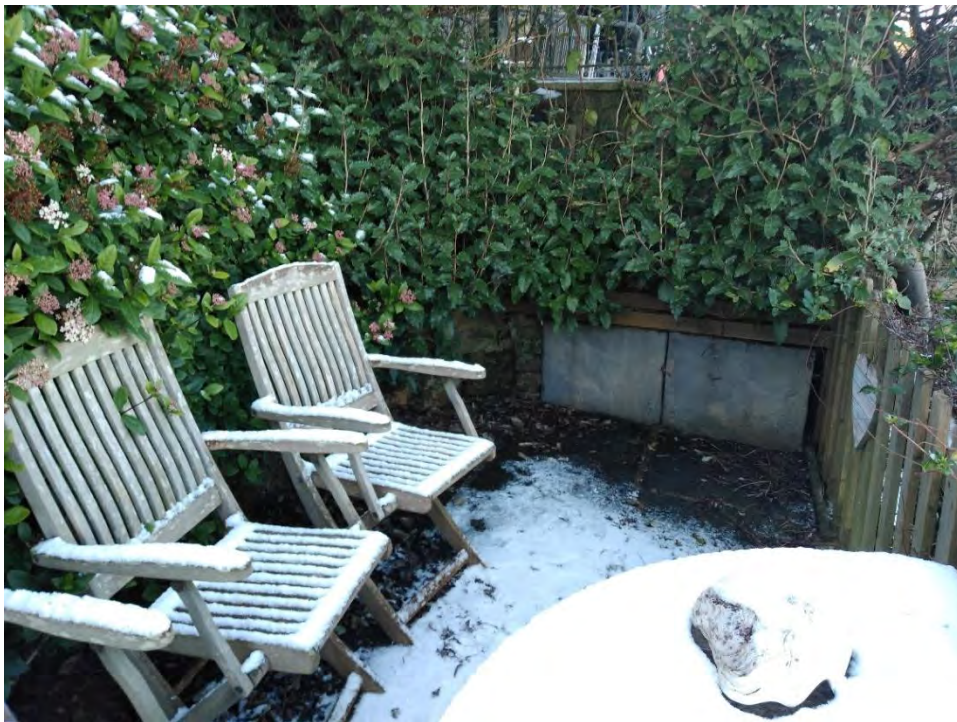
04 View across lower patio looking north towards the adjacent higher - level patio. Concrete wall hidden behind the vegetation.

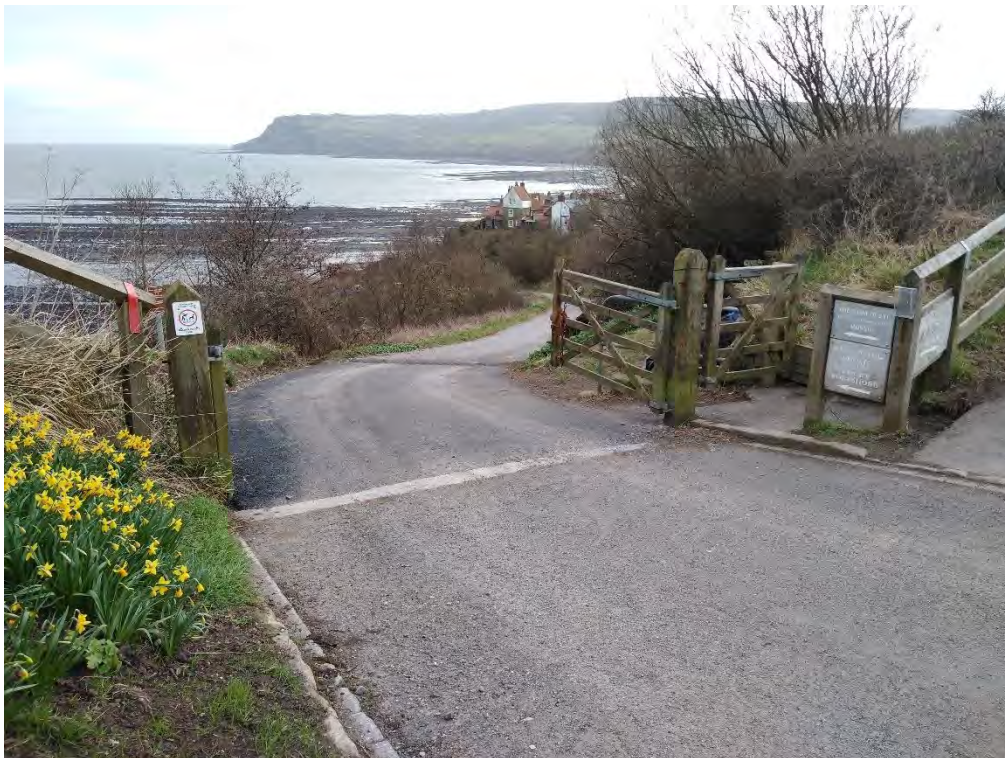
05 View from top of the coastal slope. Vegetation screening to lower patio. Ad hoc supports stabilising surface of the bank.
