Proposed:  
ALTERATIONS to  
YORK HOUSE  
KING STREET  
ROBIN HOODS BAY

Drawing:  
EXISTING  
ELEVATIONS I

Drawing No. 193/12a  
Date: DECEMBER 2017  
Scale: 1/50

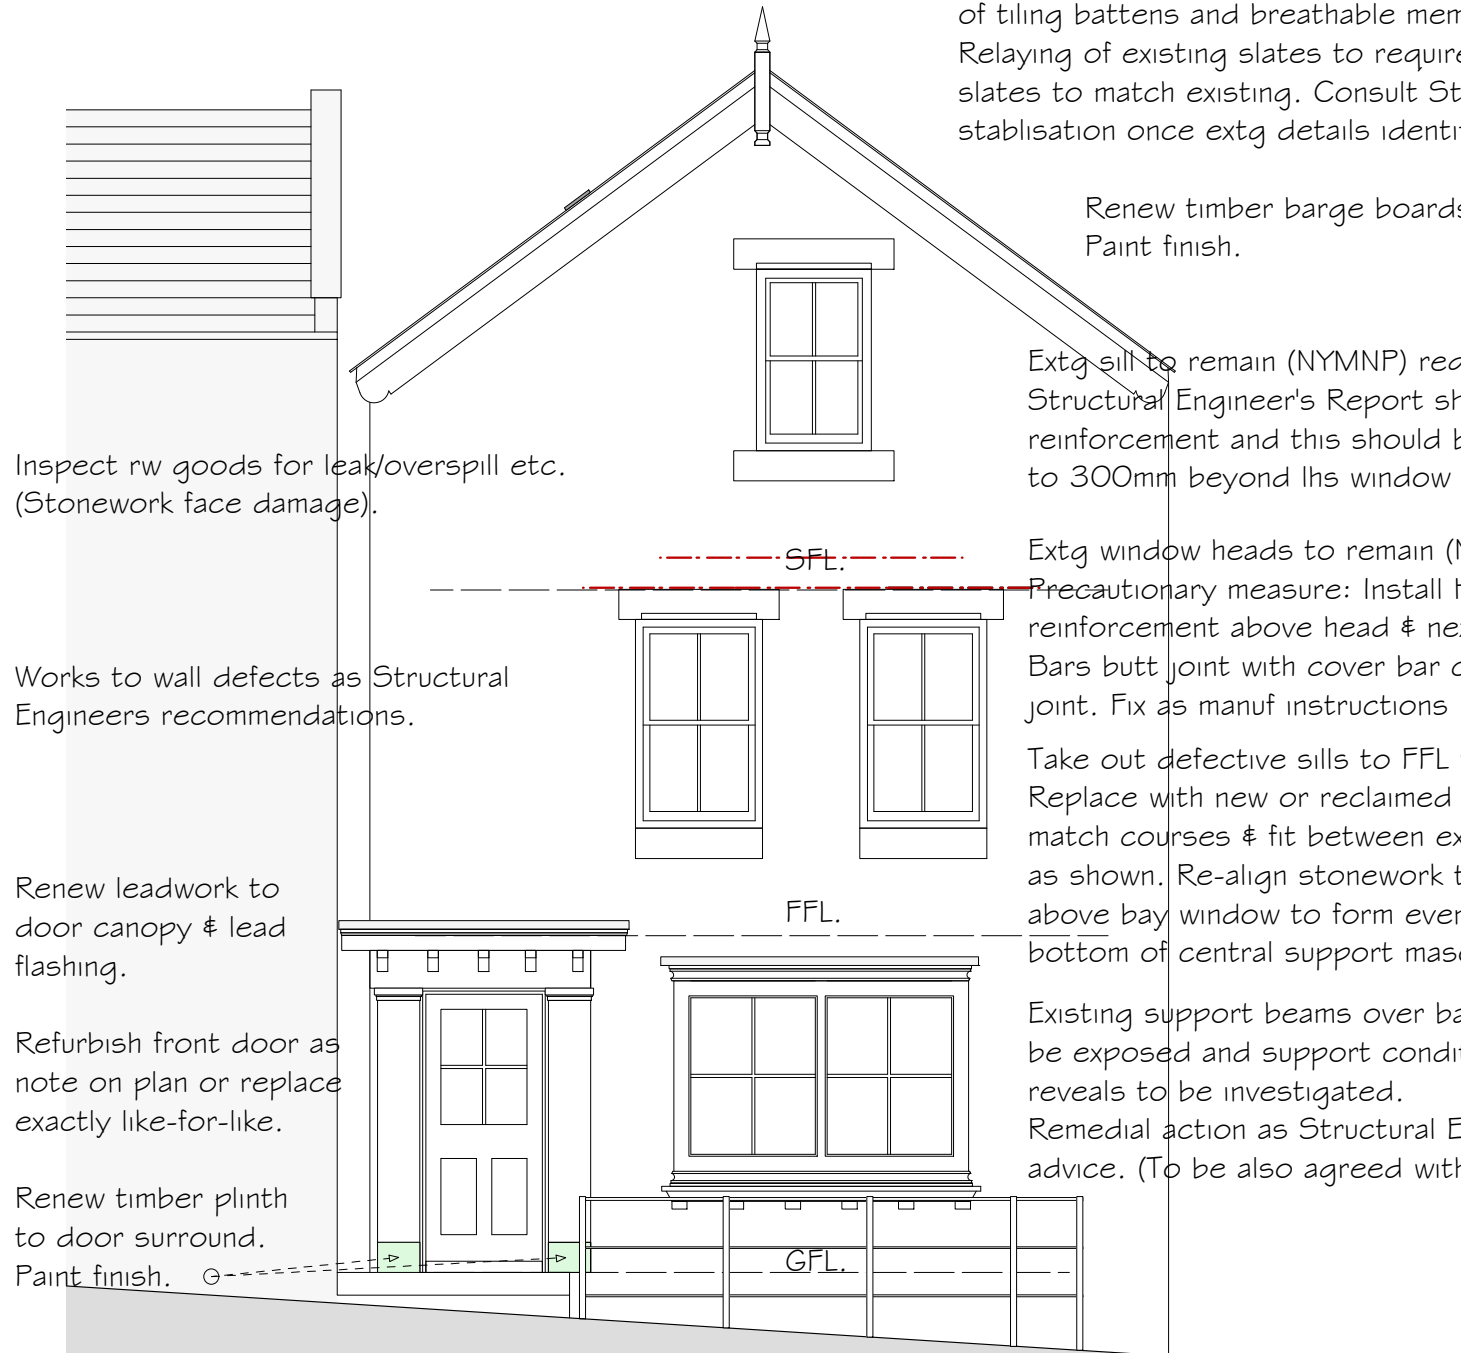
S O U T H E L E V A T I O N

Main roof of house to be inspected by specialist roofing contractor. Areas of uneven slating, patching, broken & missing slates, & yawning, give the impression that a complete overhaul may be required. It is anticipated that the slates will require removal and the replacement of tiling battens and breathable membrane underlay will be necessary. Relaying of existing slates to required gauge and lap & any supplementary slates to match existing. Consult Structural Engineer on roof structure stabilisation once extg details identified in engineer's report are known.

Structural:  
Settlement has clearly occurred in the front wall of the building generally emanating from the head of the bay window and rising up the entire facade. There is evidence that work has been carried out in the past however there are obvious problems which remain to be addressed. Refer to Structural Engineer's report.

Renew timber barge boards & verge timber details. Paint finish.

Extg sill to remain (NYMNP) requirement. Structural Engineer's Report shows crack reinforcement and this should be extended to 300mm beyond lhs window opening.

Extg window heads to remain (NYMNP). Precautionary measure: Install Helifix joint reinforcement above head & next course over. Bars butt joint with cover bar centrally over joint. Fix as manuf instructions in 50 mm groove. Take out defective sills to FFL window openings. Replace with new or reclaimed sills section to match courses & fit between extg historic masonry as shown. Re-align stonework to 3no courses above bay window to form even panel incl. quirk bottom of central support masonry.

Existing support beams over bay window to be exposed and support conditions at jambs/ reveals to be investigated. Remedial action as Structural Engineer's advice. (To be also agreed with NYMNP).

NB. SEE STRUCTURAL ENGINEER'S REPORT FOR OTHER SPECIFIC CRACK REINFORCEMENT WORKS USING HELIFIX BARS.

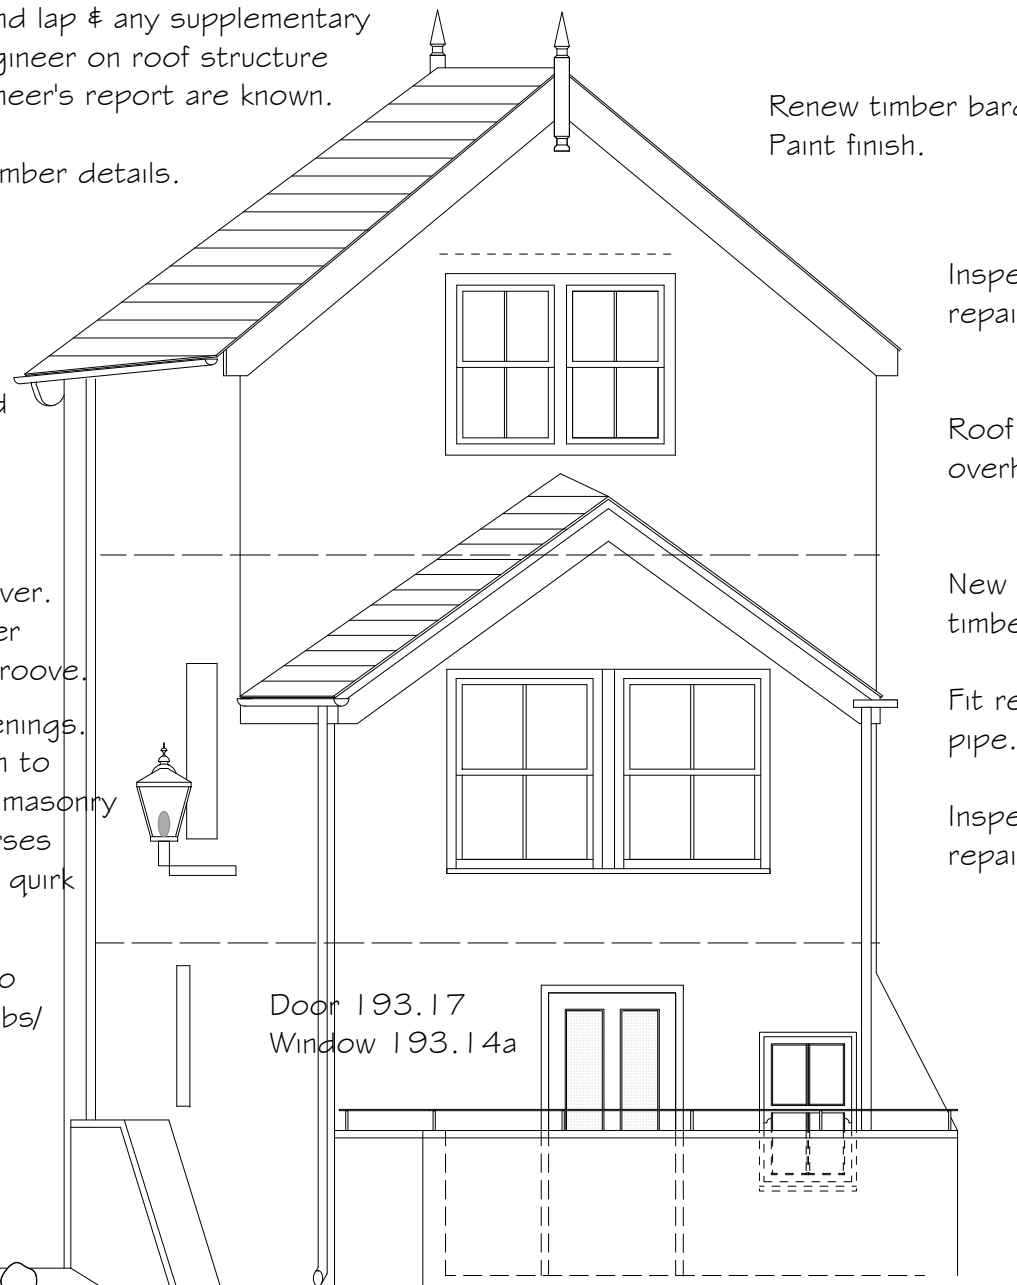
N O R T H E L E V A T I O N

Roof to first floor extension to be overhauled as notes on plan drawing.

Renew timber barge boards & verge timber details. Paint finish.

Inspect timber to window frame & repair as required. Paint finish.

New timber barge boards & verge timber details. Paint finish.

Fit return to rw gutter & 50mm fall pipe. Discharge to current location.

Inspect timber to window frame & repair as necessary. Paint finish.
