**CONVERSION OF SUNNY BANK BARN, BROXA LANE, HACKNESS
SCARBOROUGH YO13 OJW TO SINGLE DWELLING**

**Conversion of Sunny Bank Barn
to single dwelling including
alterations to the existing access**

TREE REPORT

SUPPLEMENTRY TREE REPORT

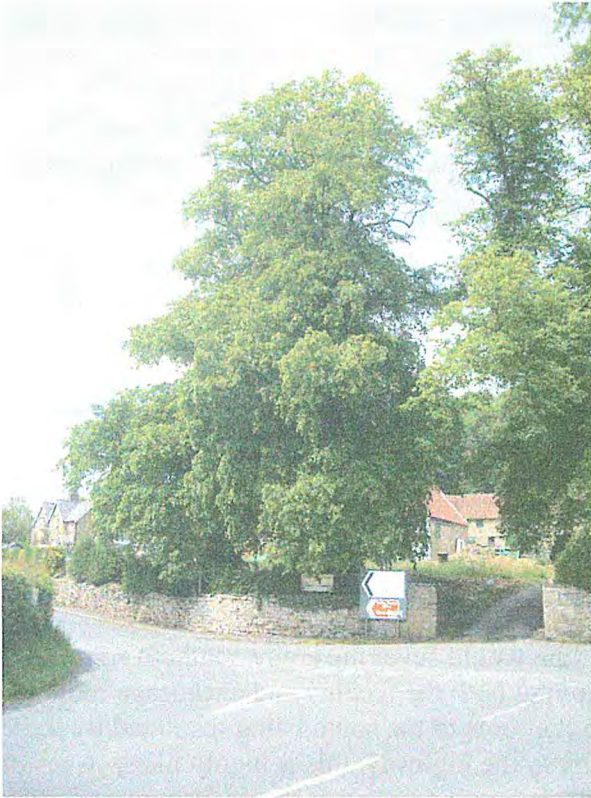
Fig 3 Tree T1 and T2

A pair of mature Limes growing approximately three meters apart and having integrated crown. In terms of visual impact the trees are considered as a group along with a third mature lime on the opposite side of the entrance within the adjacent property.

The overlapping crown of T1 and T2 has resulted in reduced spread for both trees which would be left with unbalanced and poorly shaped crown should either one be removed.

T1 appears to have grown from two leaders which have conjoined . there is a distinct joint ridge on the east and west side of the tree. The dominant lead to the north has a distinct lean to the north. the southern branch has been previously cut back due to overhanging of the highway, this has left a stub with much suckering and several pegs.

There are several short pegs left from previous pruning, most showing dieback, numerous minor healed and healing lesions from minor limb removal.

The trees are located within 1.5- 2 m of a retaining wall which form as a sharp change of level of sum 1.3m. There is no sign of heave or root damage to this wall and the roots appear to have established to accommodate the level change.

There was slight late leafing out towards the top of the tree on the northern side but other than this no major issues observed there is moderate to light suckering at the base. Aphid residue is present as expected for the species but there are no signs of gall might or fungal disease
Trees 1 and 2 are in good to excellent condition.

The cutting back of the retaining wall to the extent of the sight line would sever the entire southern rooting plate to within 0.75m of the bowl of both trees T1 and T2 removing both the feeding and anchorage roots of both trees over approximately 30% of the rooting area. Despite the roots to the south being restricted by the retaining wall and cutting back of the crown to prevent overhang to the highway, this is highly likely to result in stability issues particularly when the northward lean of T1 is taken into account. It would also potentially affect the long term viability of the both trees.

Minor works to T1 to remove or balance the reduced limb to the south
 reduction in the height of the wall and rebuilding to ensure retention capability and stability

Sightlines be accommodates by changes to ground profile

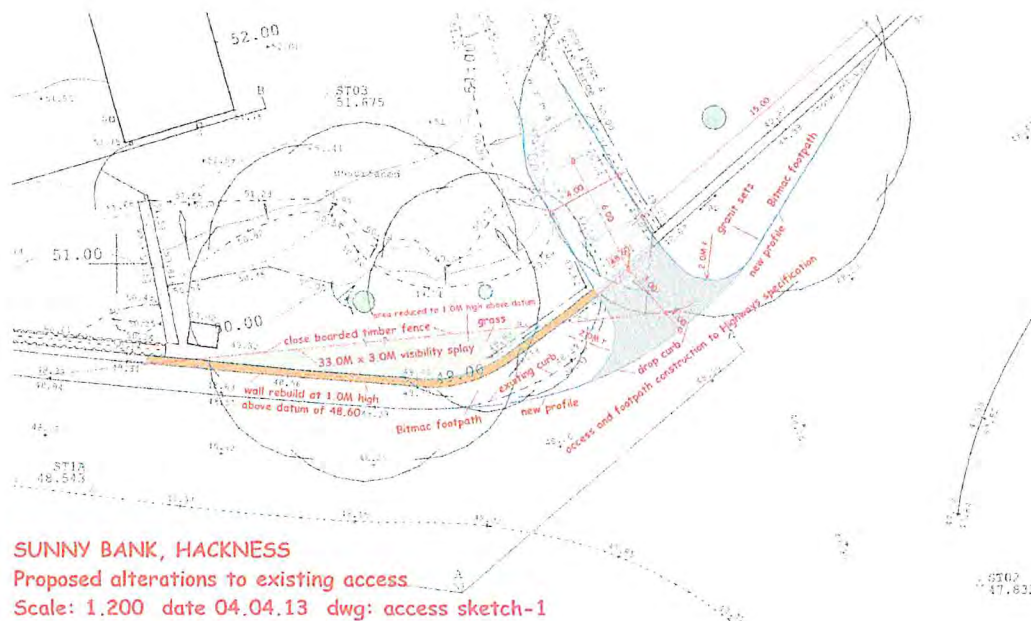
Fig 4: extent of the proposed works

Cutting back of the retaining wall to accommodate sightline to ground level would result in the loss of the trees and is considered unacceptable.

The sightline can be accommodated by careful hand grading of the ground profile to reduce the level to accommodate a sightline at 1.0m

The works can be successfully accommodated without detrimental effect to the trees surveyed by reducing the height of the wall and the ground level in a small section of the land to the south of the trees. as indicated in Fig 4 The extent of the proposed works

It is recommended that the wall be taken down and rebuilt in sections **on the line of the existing** wall to avoid any issues with stability of the retained soil and trees.

The reduction in ground profile to be limited to the areas required by the sightline and to be evenly graded back to the tree bowl. All regarding works to be completed by hand and monitored for root position and damage.

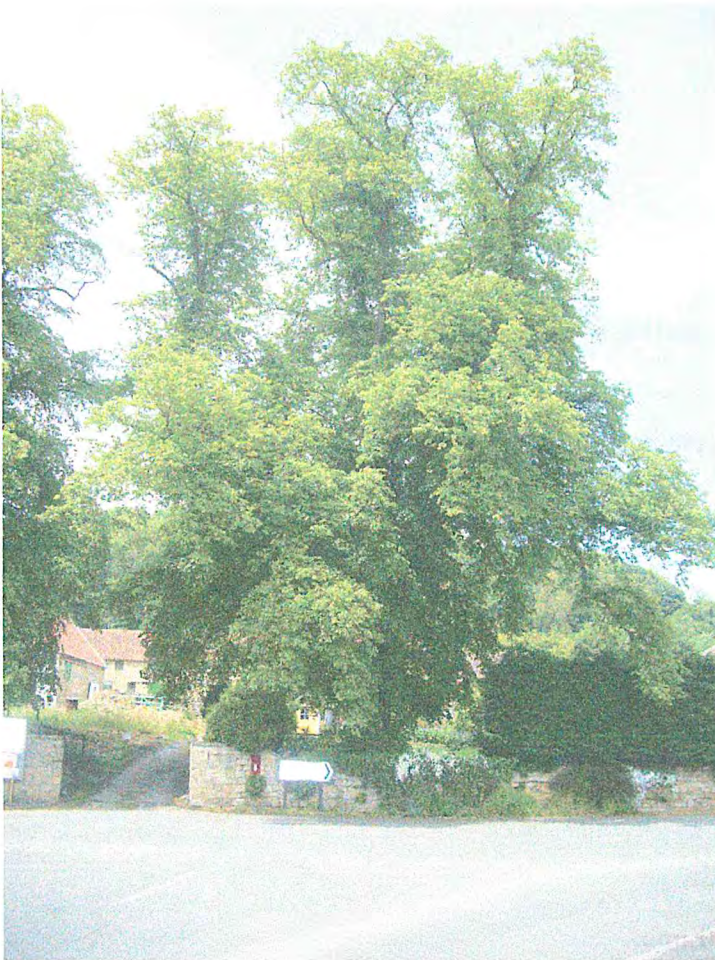
Fig 5: T3

The tree has an unbalanced crown with a large limb extending almost right-angled to the south, and three distinct leaders.

The tree showed signs of late leafing and early leaf drop. There was also minor crown dieback on all three stems. The tree is showing signs of stress but as no obvious cause can be found and the stress response is general and uniform it is likely to be from age or water table or climatic issues rather than mechanical root damage. The lack of corresponding stress in the trees at Sunny Bank make environmental factors unlikely. The tree is currently in fair condition but this condition can be expected to deteriorate in the near the medium future.

This tree is not affected by the works

Its condition rules out any proposal that the loss of the trees at Sunny Bank would be mitigated by the retention of this tree.

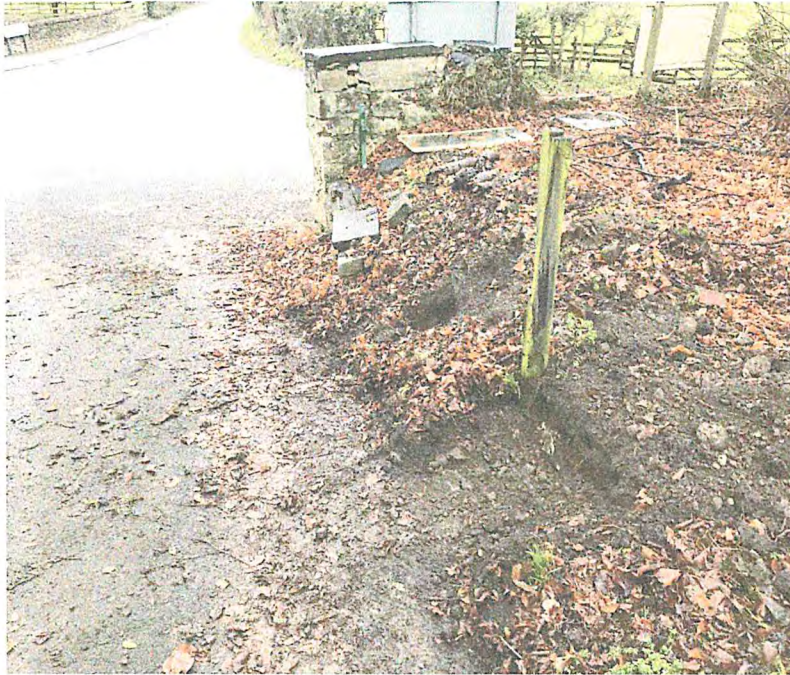
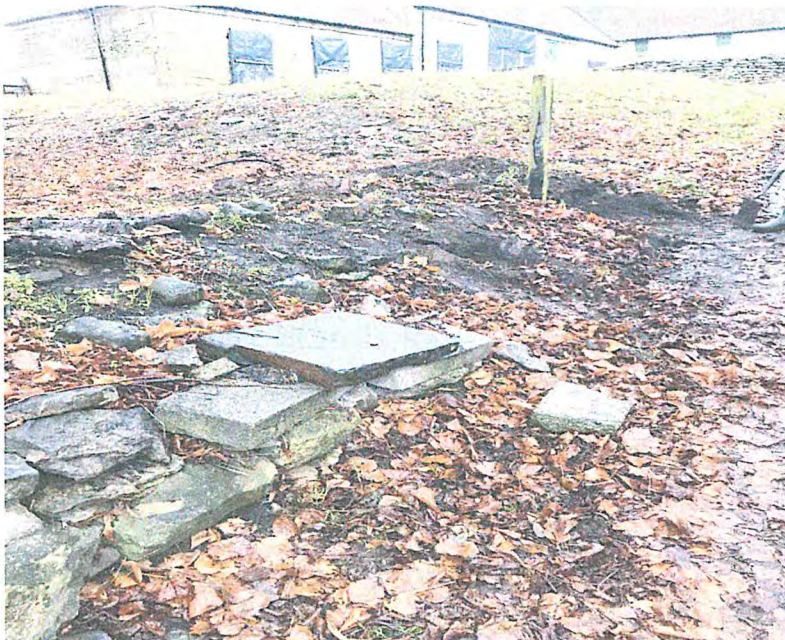
Photo 2 - General view of access driveway

This will require the removal of approx 400mm deep x 400mm wide of spoil from the area shown in pictures two and three and extending 6.0M, from the front boundary wall, up the driveway.

Photo 3 - General view of area which needs to be excavated

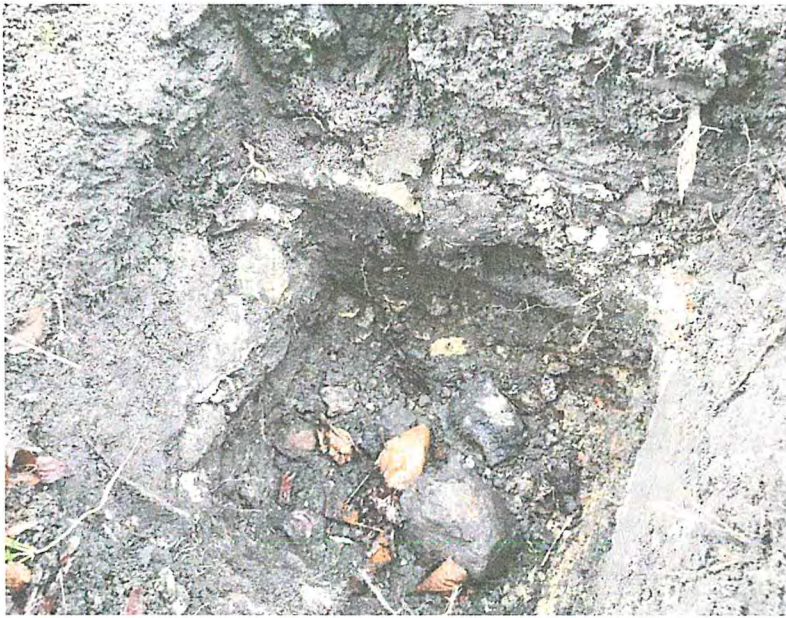
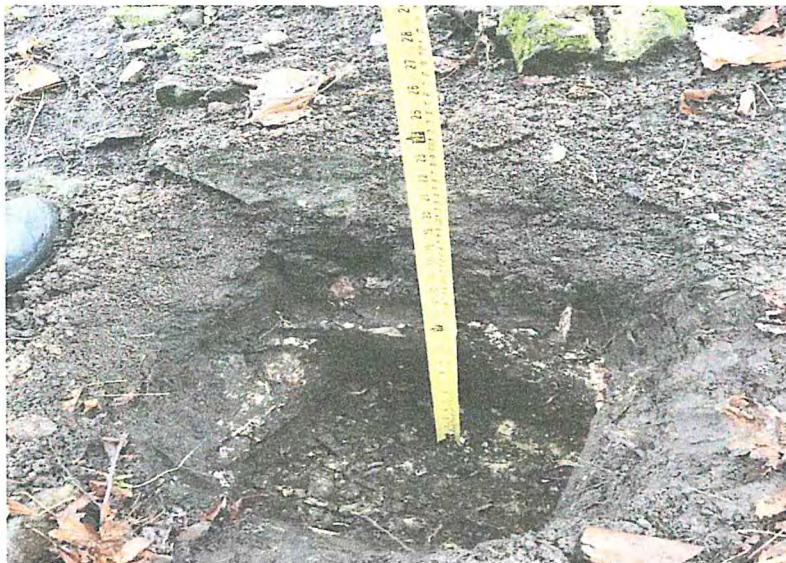
Photo 4 - Test excavation hole on access driveway

The driveway itself is tarmac and has been in situ for many years. There is evidence of some basic arrangement of stones to fashion a retaining wall.

Photo 5 - Test excavation with tape for reference

Two 300mm square test holes were excavated to a depth of 600mm along the proposed excavation area to assess the founding material and the presence of any root material from the trees.
