GRIBDALE STABLES DIKES LANE, GREAT AYTON, TS9 6HA

**Conversion of redundant equestrian building to provide
habitable holiday accommodation, a cycle hire shop and cafe.**

Design and Access Statement

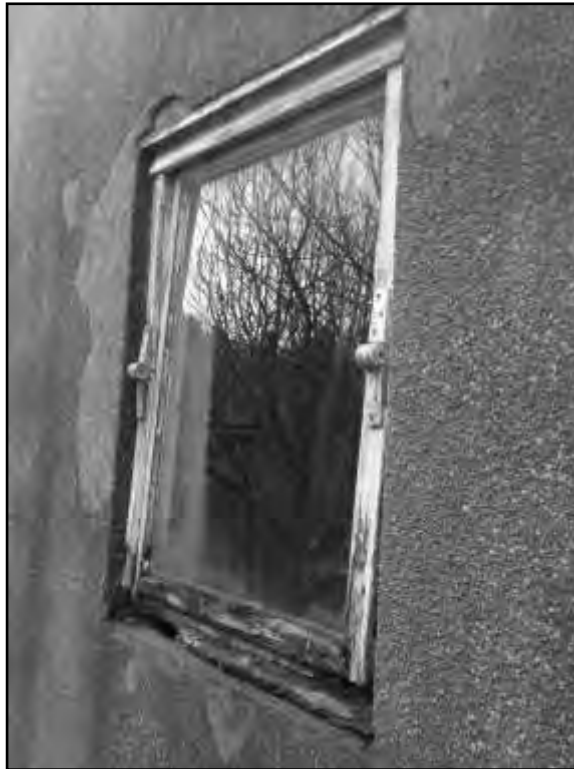
Figure 20. Window frames are rotten and in a poor state of repair

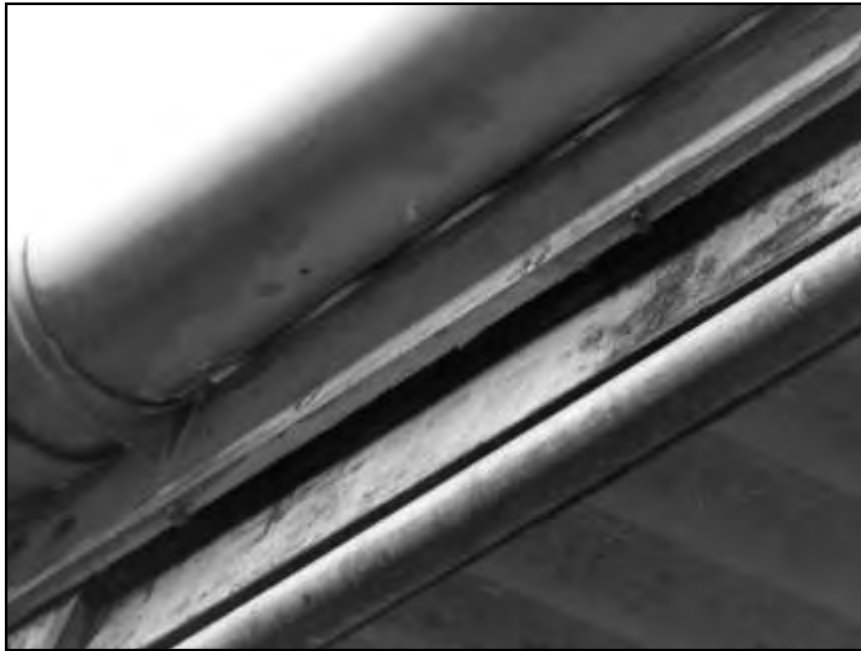
Figure 22. Gap behind fascia board on south eastern elevation

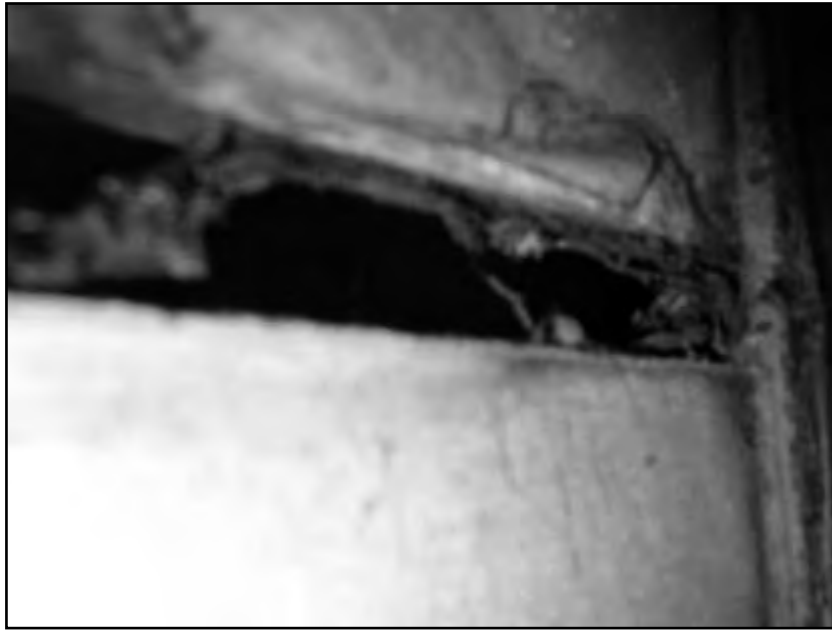
Figure 28. Gaps present in the ceiling below the asbestos sheeting

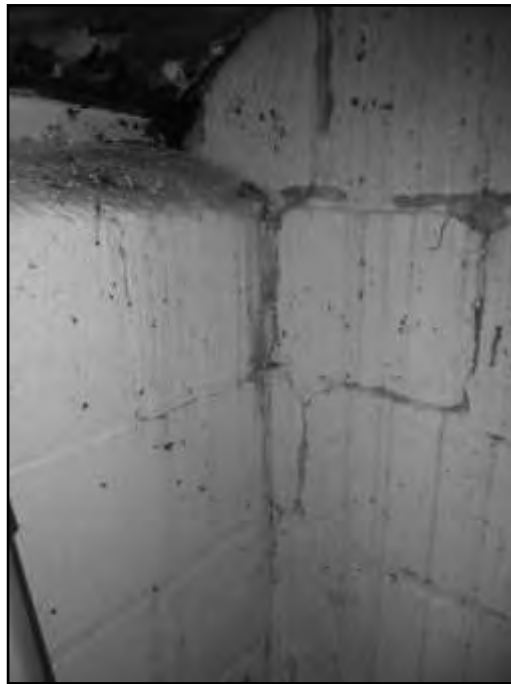
Figure 31. Bat droppings scattered across the first floor – on the floor, walls and wall tops

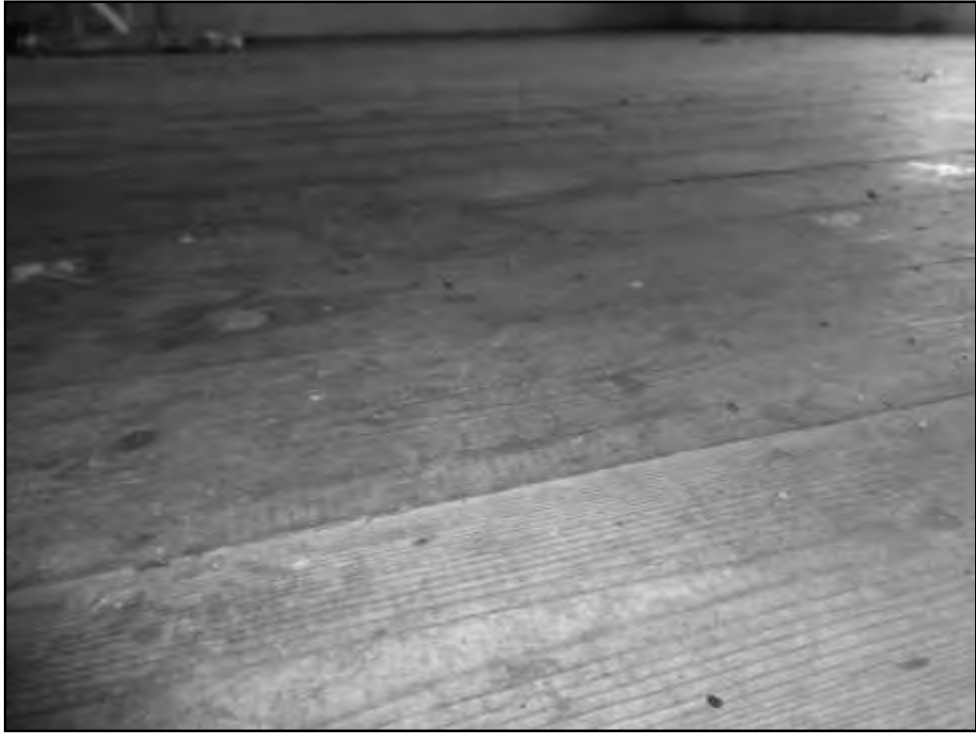
Figure 32. Figure 31. Bat droppings scattered across the first floor – on the floor, walls and wall tops

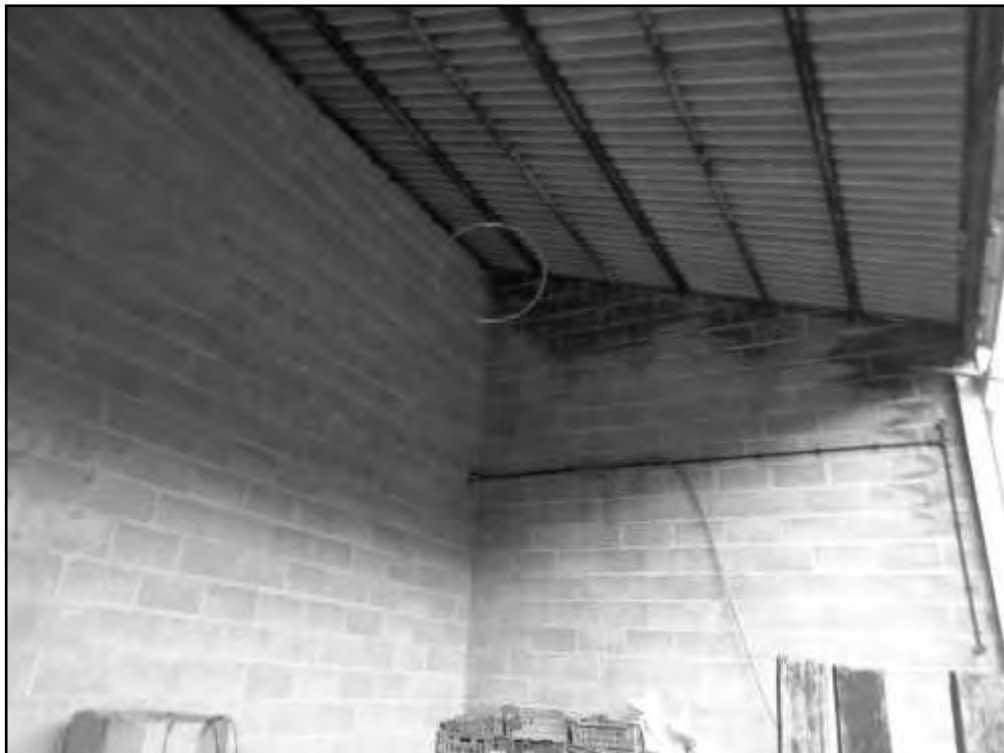
Figure 33. Open barn on south eastern elevation. Remnant bird's nest and potential bat roost entrance marked

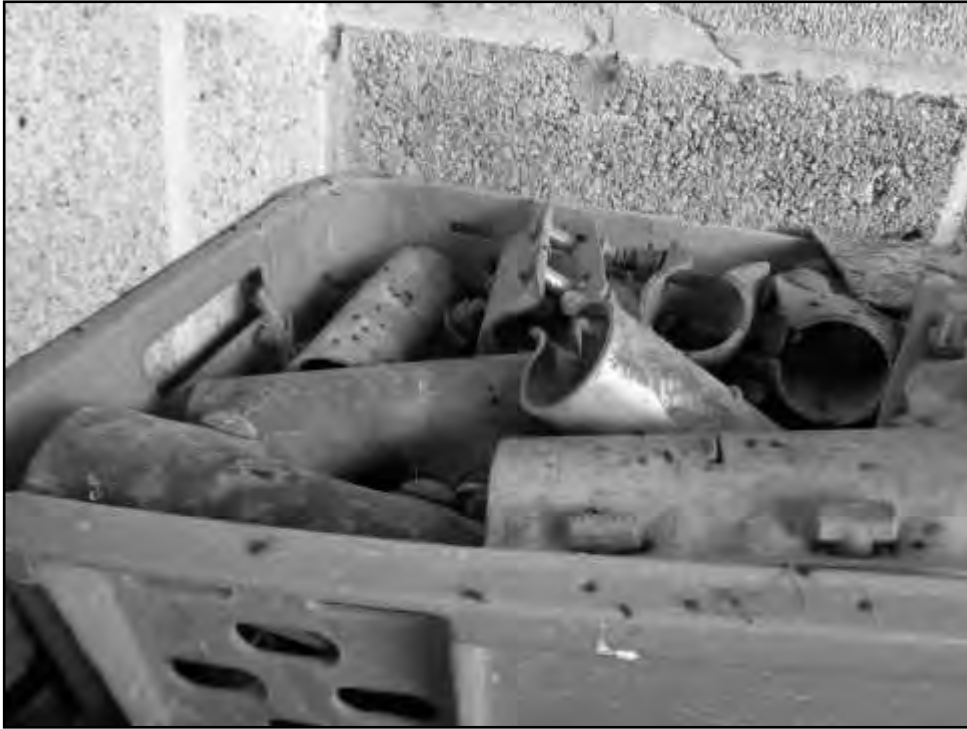
Figure 36. Bat droppings scattered in corner of south eastern barn below possible roost entrance

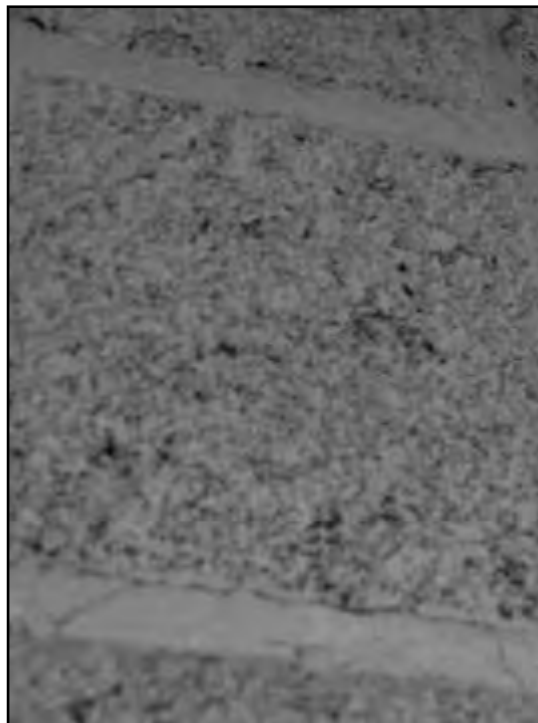
Figure 37. Bat droppings across walls in the corner of south eastern barn below possible roost entrance

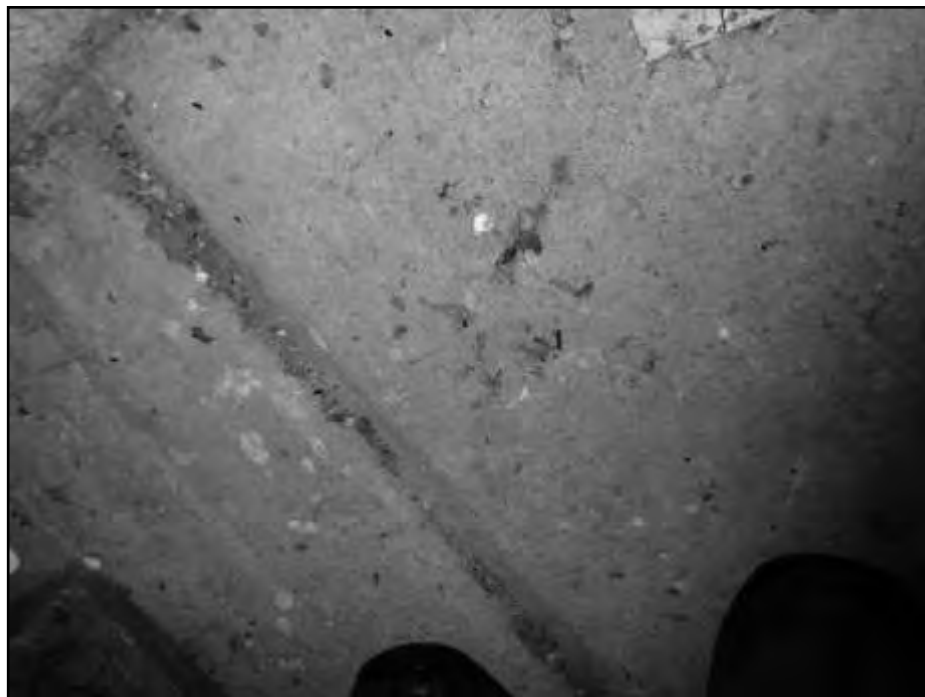
Figure 41. Bat droppings present on the ground floor
