DESIGN, HERITAGE AND ACCESS STATEMENT

PROPOSED BARN CONVERSION TO HOLIDAY COTTAGES

THIRLEY COTES FARM, HARWOOD DALE, NORTH YORKSHIRE

STRUCTURAL SURVEY

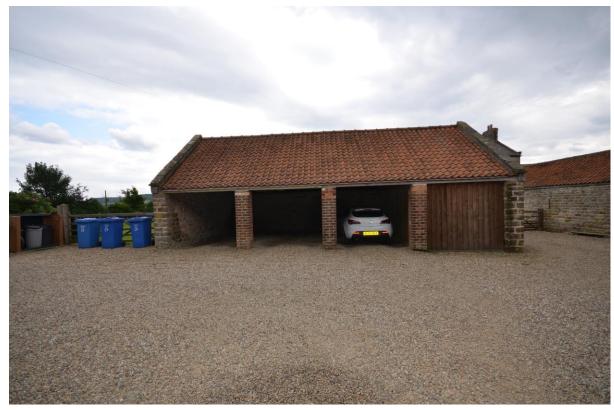
- 1. North elevation of Pear Tree Barn. This building has been re-roofed and refurbished in the last few years.
- 2. North elevation of Pear Tree Barn.

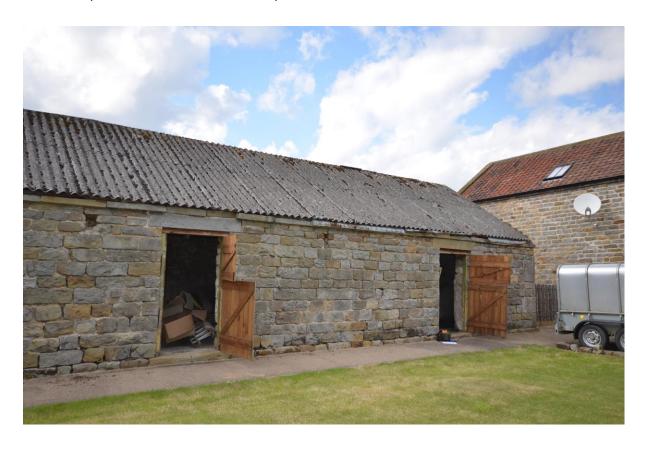
The roof finish to Mulberry Barn in the main is asbestos sheet which probably replaced pantiles in the 1960's. This is probably a chrysotile form of asbestos which is not notifiable but clearly it would be sensible to remove it to a registered tip.

- 3. East elevation of Mulberry Barn, an asbestos roof was fitted probably in the 1960's.
- 4. West elevation of Mulberry Barn with an asbestos roof and a pantiled lean-to.

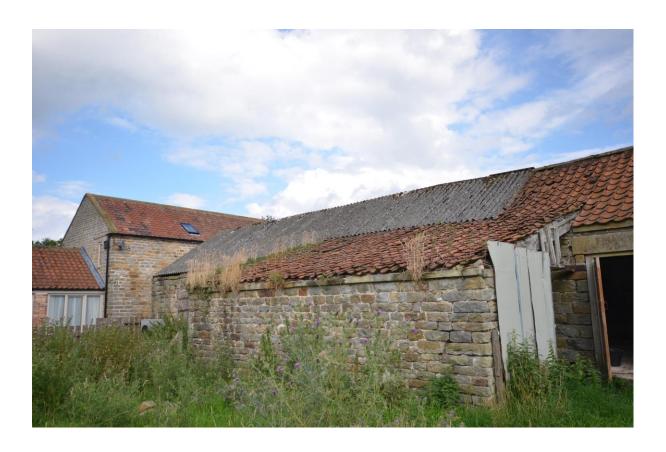
There is a lean-to projection to the west of the building which again may not be original. This has a lean-to rafter roof finished in pantiles; the roof is clearly in need of replacement although this is not structurally imminent.

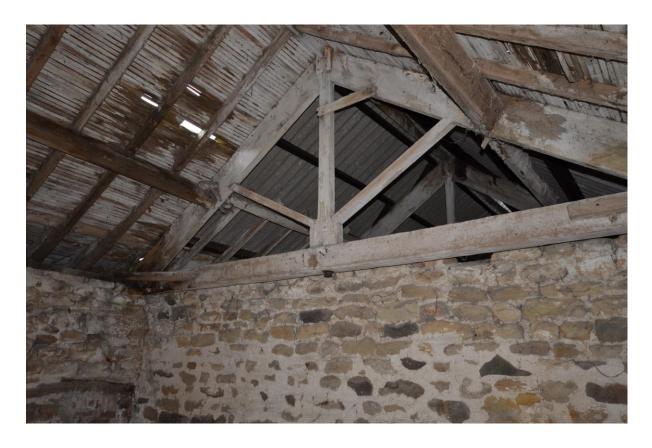
The roof is constructed with king post trusses with purlins. These are in reasonably sound condition but may need attention to localised rot where damp penetration has occurred.

- 5. Internal view at the junction between Mulberry Barn and Walnut Barn showing the existing king post trusses which are generally in sound condition although there is evidence of damp penetration.
- 6. General view across the courtyard to Walnut Barn and Mulberry Barn.

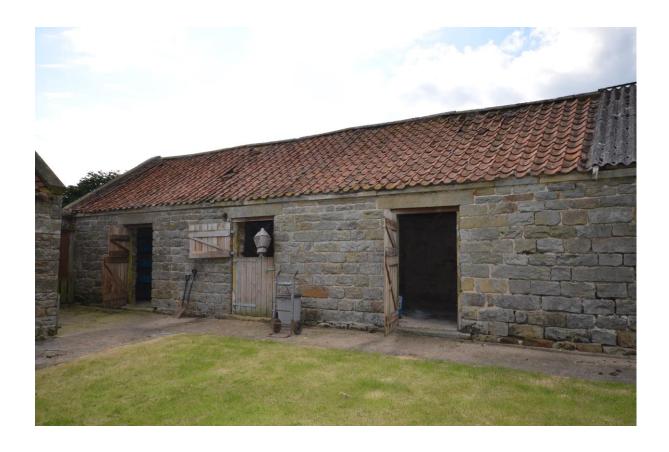
- 7. View of the eastern elevation of a section of Walnut Barn.
- 8. View of part of Walnut Barn with the north elevation of the southern range of courtyard buildings.

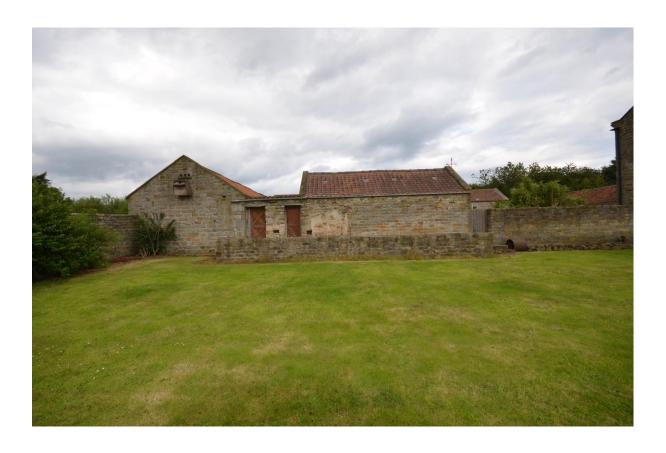
9. South elevation of Walnut Barn, a greenhouse has been removed in the past leaving a plinth wall.
