# Heritage, Design and Access Statement

For outbuildings at Troutdale Mill,  
Snainton, North Yorkshire, for Mr & Mrs M. Milner

Anthony David Robinson, B.A, M.C.D, M.A(Conservation),  
M.R.T.P.I., M.I.H.B.C.

August 2016

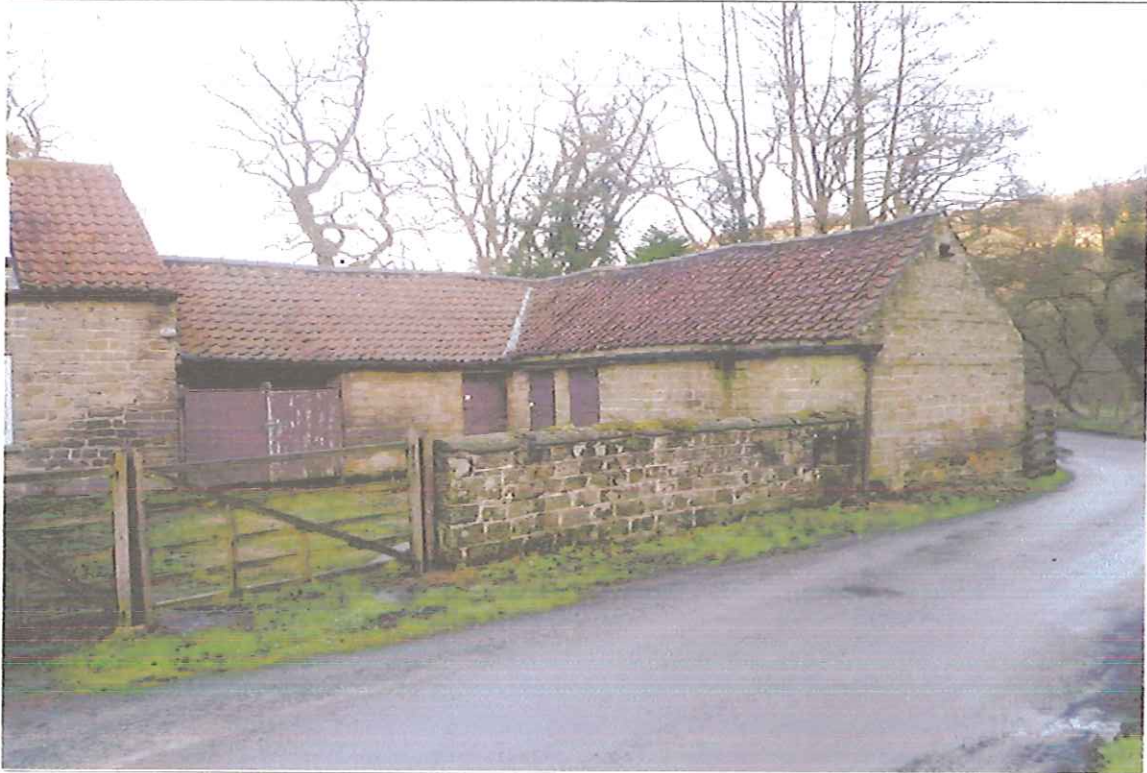
1. Troutsdale Mill. View of attached farm buildings from south west.

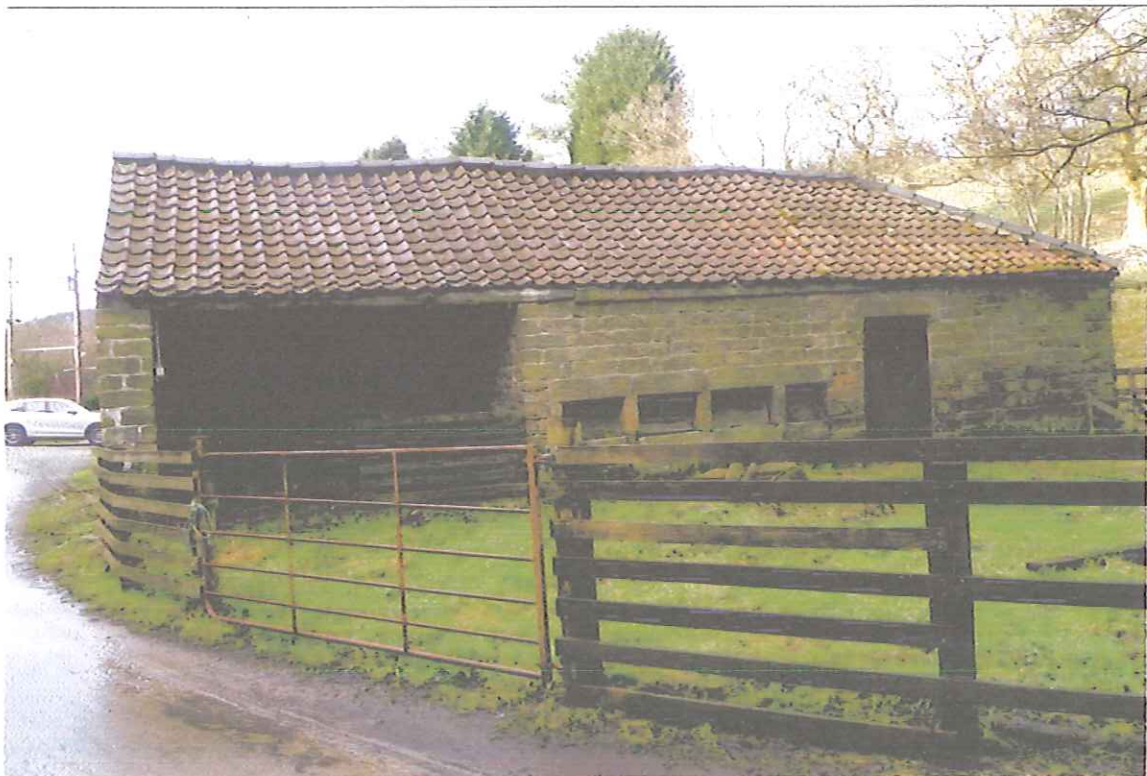
2. Troutsdale Mill. South-east elevation of south wing of farm buildings, showing cart shed and pig sty feeders.

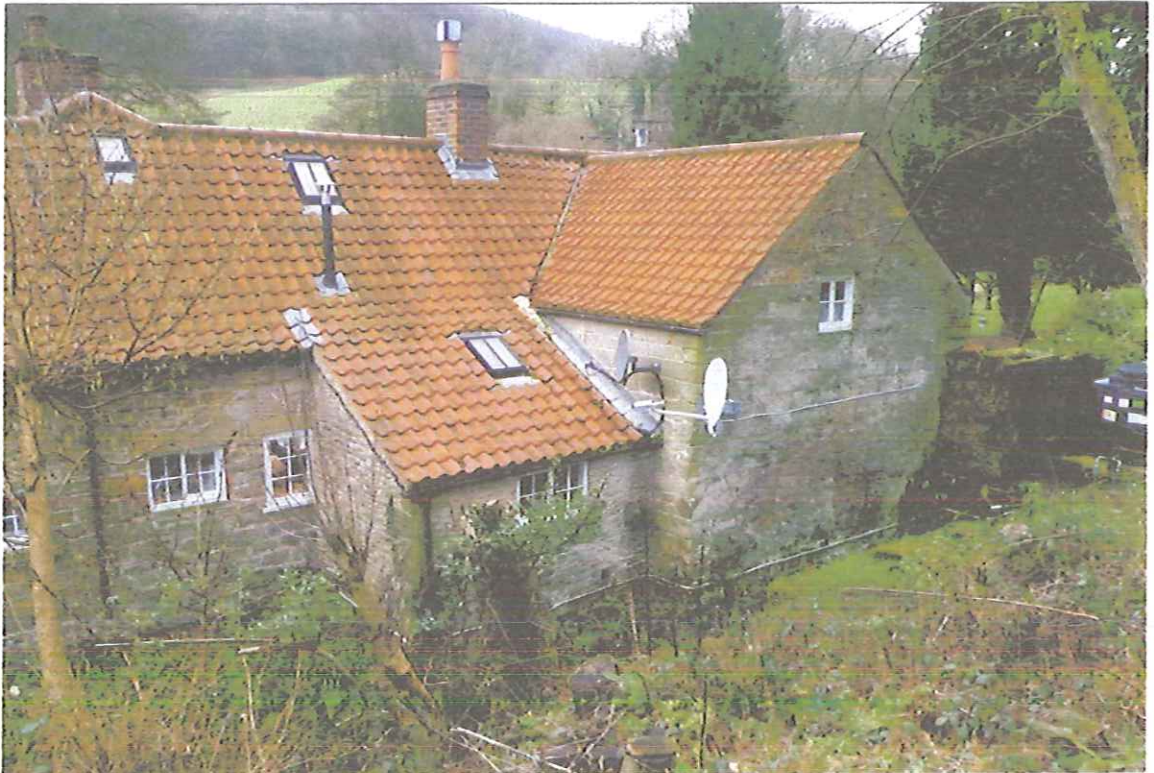
3. Troutdale Mill. North-east elevation of the mill house, with mill to the right. The stonework which supported the leat which fed the overshot wheel is to the right.

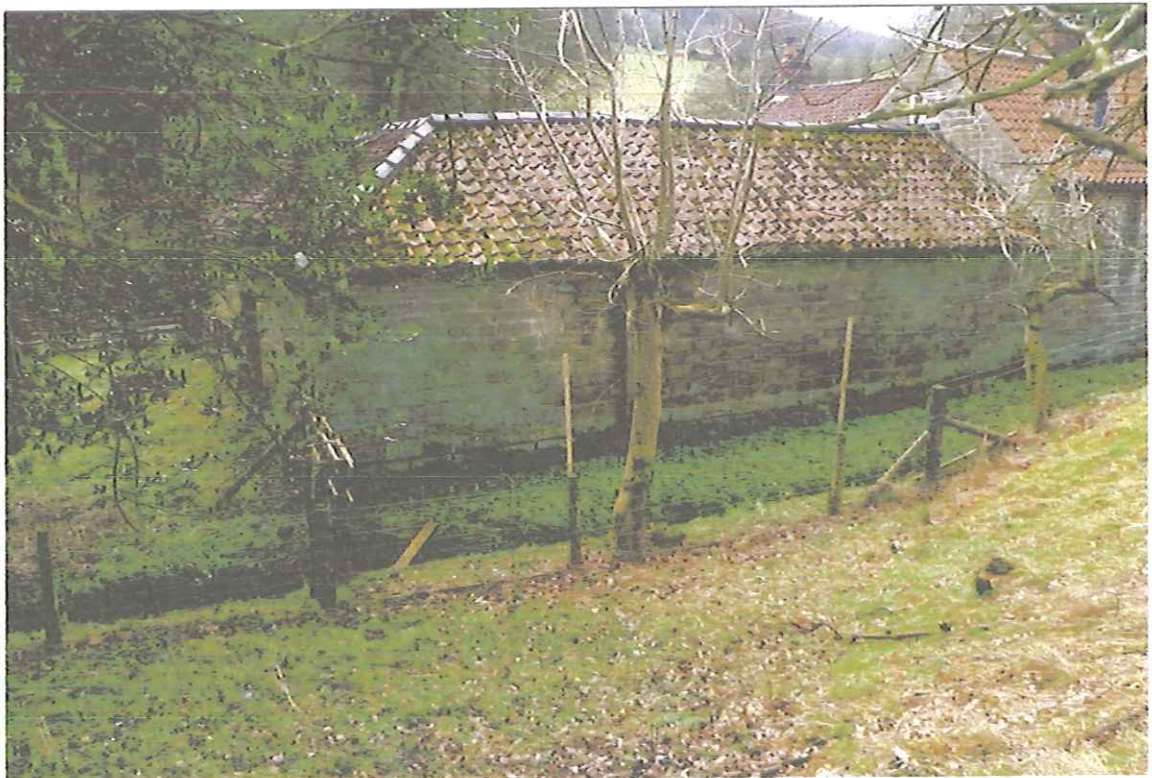
4. Troutdale Mill. North-east elevation of attached farm buildings.

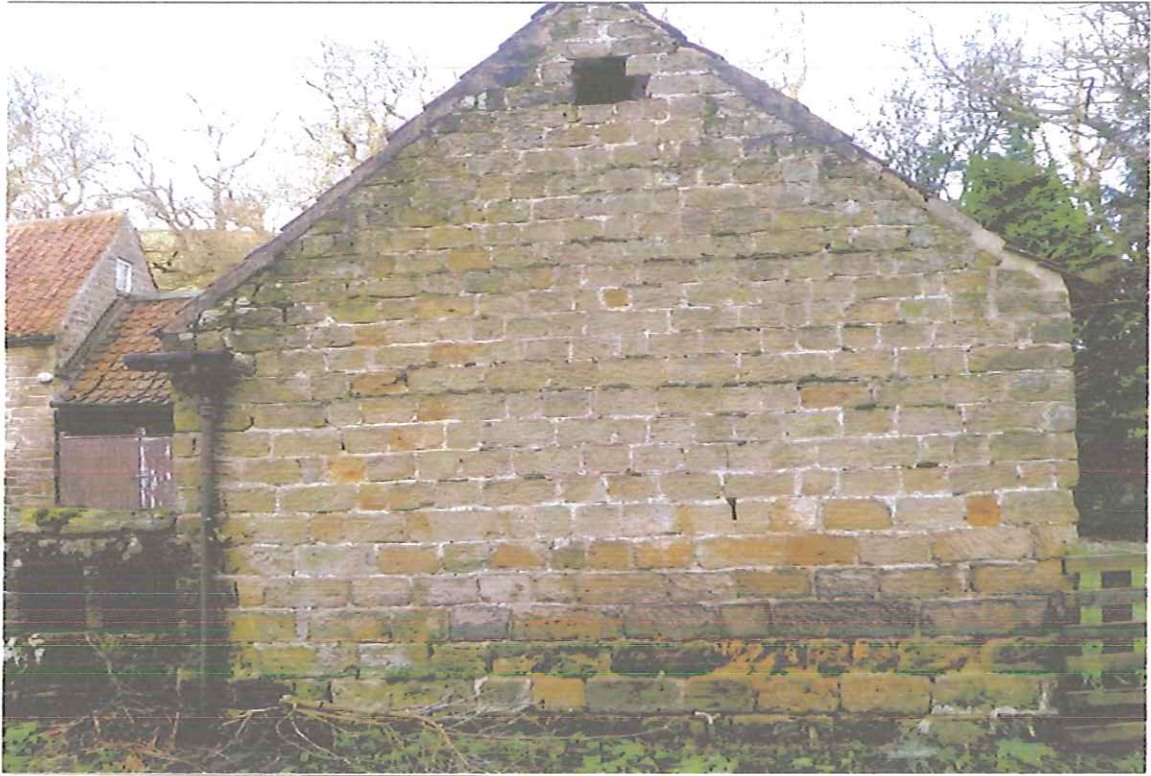
The south gable end abutting the road has a plinth, and a small square opening in the gable apex, possibly an owl hole.

5. Troutsdale Mill. South gable end showing probable owl hole.

The south gable onto the road has a small high level opening which will be repaired and glazed. The yard wall is in poor condition and will be rebuilt, retaining the feed hoppers at the eastern end.

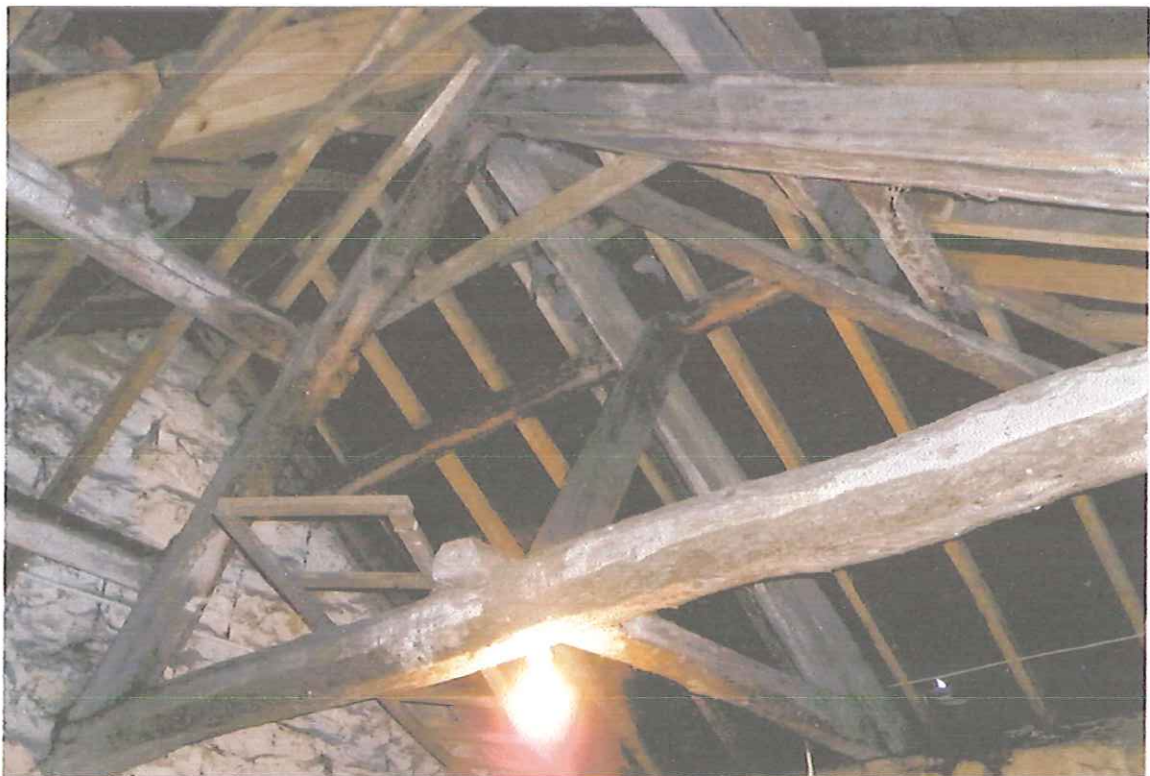
The hip end roof is formed from a single "A" frame truss, comprising a tie beam with the principal rafters jointed into it and jointed at the ridge. A half "A" truss joins the main truss at right angles, the tie beam resting on the tie beam of the full truss. Although the truss members are roughly finished the tie beams are well bedded into the walls and well jointed.

6. Troutsdale Mill. Collared roof truss in the half-hipped roof over Store 3, the old milking parlour.

It is proposed to convert store 3 into a kitchen and shower room, with a through passage along the south side from the back door. Clearly, this is a fairly radical change from its former use as a milking parlour. However, it may be possible to retain the "A" frame full and half trusses within the rebuilt roof structure in order to keep an important element of the agrarian character of these buildings.

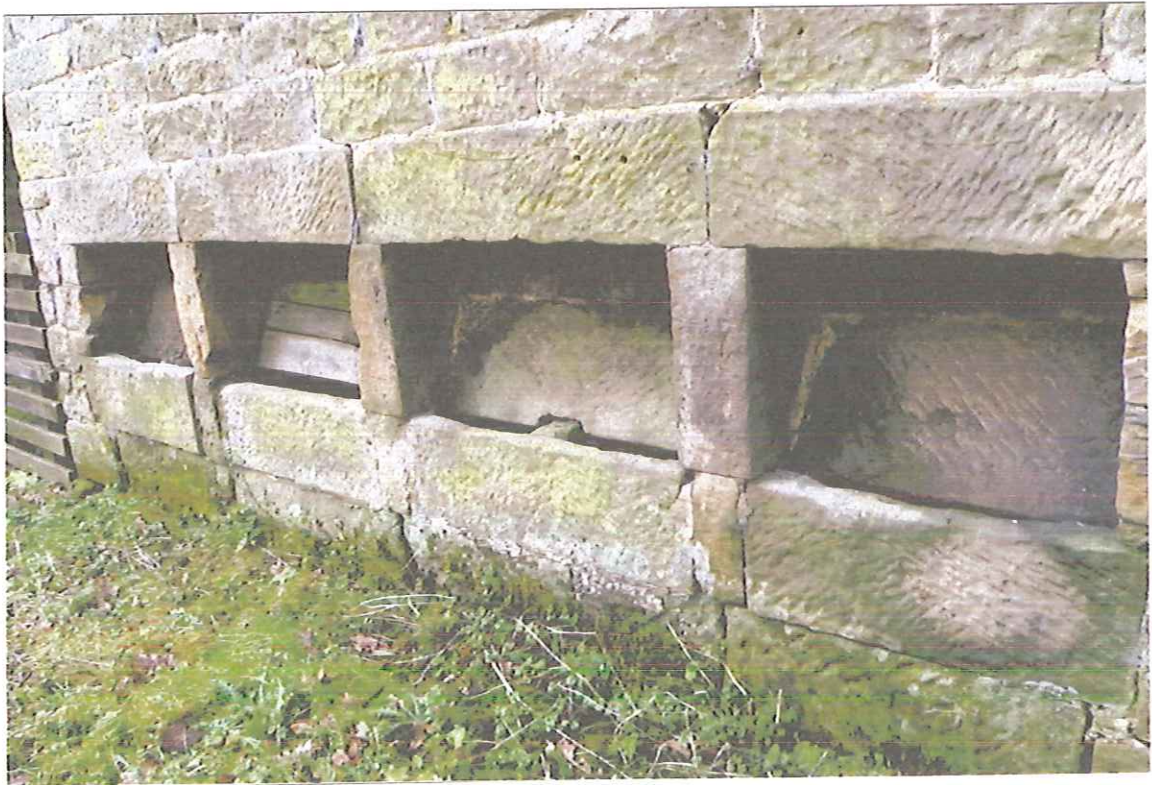
7. Troutdale Mill. Stone pig feeders in the south-east elevation.

Parts of the east wing and much of the roof will require rebuilding. Localised areas of the walls, namely the upper courses of the west wall and the east wall above the four feeders of the east wing are bowing and will require partial rebuilding. It is proposed to retain the feed hoppers in the east elevation as part of the rebuilding, so that this feature will still be visible externally

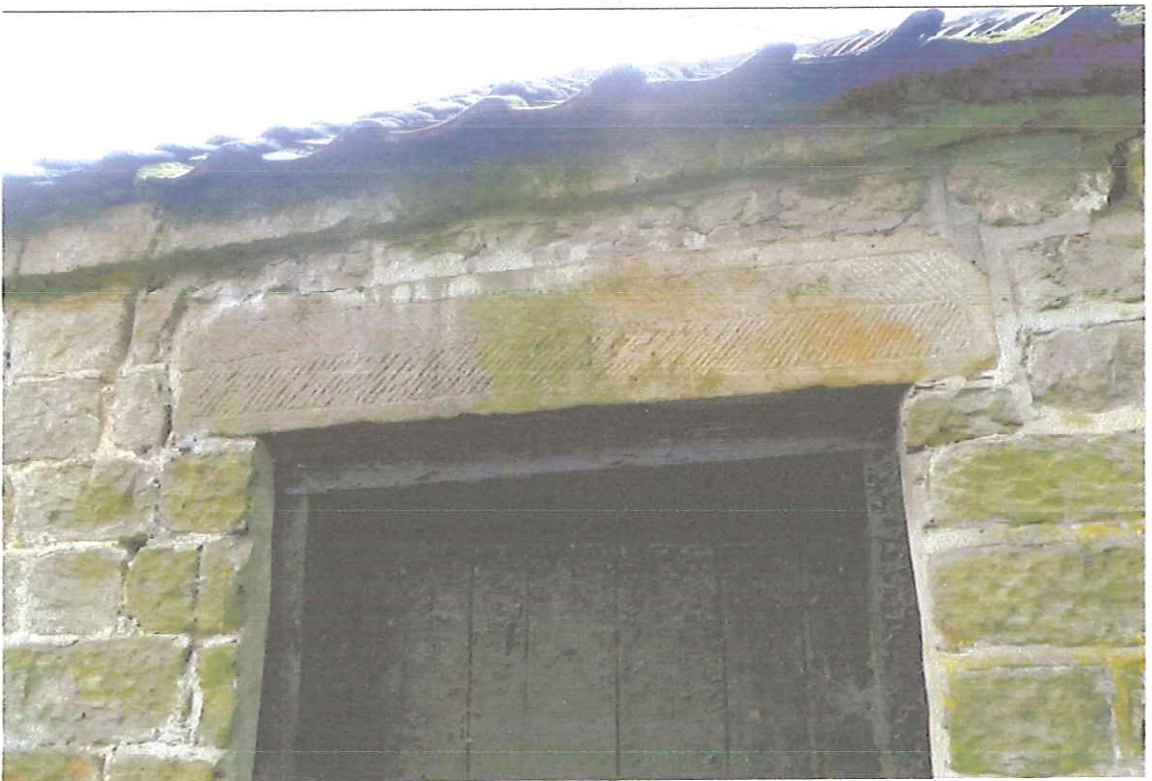
The doorway in the east elevation has a deep stone lintel made from a single piece of dressed and squared stone, with a plain margin to each edge, with diagonal tooling to each side of a centre line forming a herringbone pattern.

8. Troutdale Mill. Herringbone tooled lintel over door in south-east elevation.

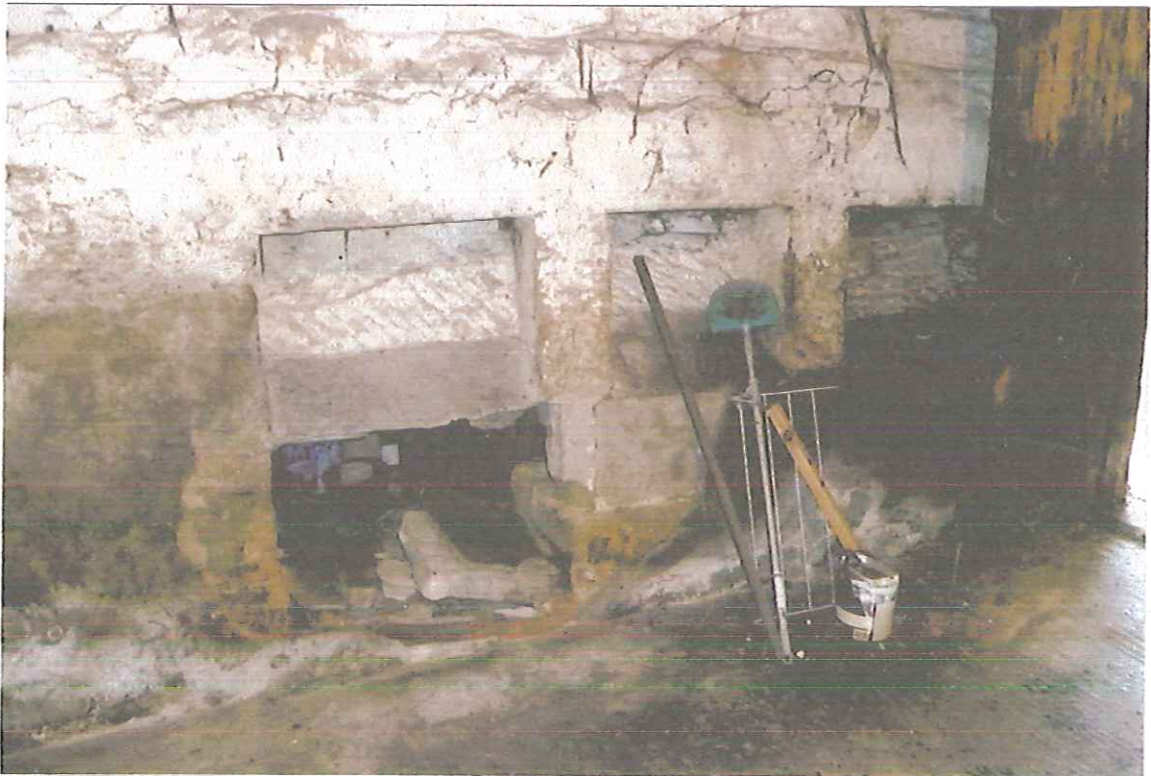
Each set of feeders is constructed from dressed sandstone blocks with scutched tooling, with a single squared and tooled lintel over each opening. An angled sandstone baffle sits over each feed trough. The three feeders between stores 3 and 4 are in poor condition, with two of the troughs removed.

Store 3 was latterly used as a milking parlour and retains a modern concrete central wall, creating two stalls, with a central drain channel in the concrete floor. Store 4 was used as a byre, with a central drainage channel in the concrete floor. The wall between these two rooms has extensive vertical cracking and will require remedial work. This wall has three feed hoppers, two of which have lost their feed troughs.

9. Troutsdale Mill. Stone pig feeders in the south wall of Store 3, the old milking parlour.

It may be possible to retain the group of three feed hoppers between stores three and four (proposed kitchen and bedroom), as a feature in the wall of the kitchen, although they may need to be hidden behind the proposed corridor wall linings. The proposed corridor linking bedrooms 1 and 2 (Stores 4 and 5) will require the making of new doorways in the north walls of these rooms. These works will not require

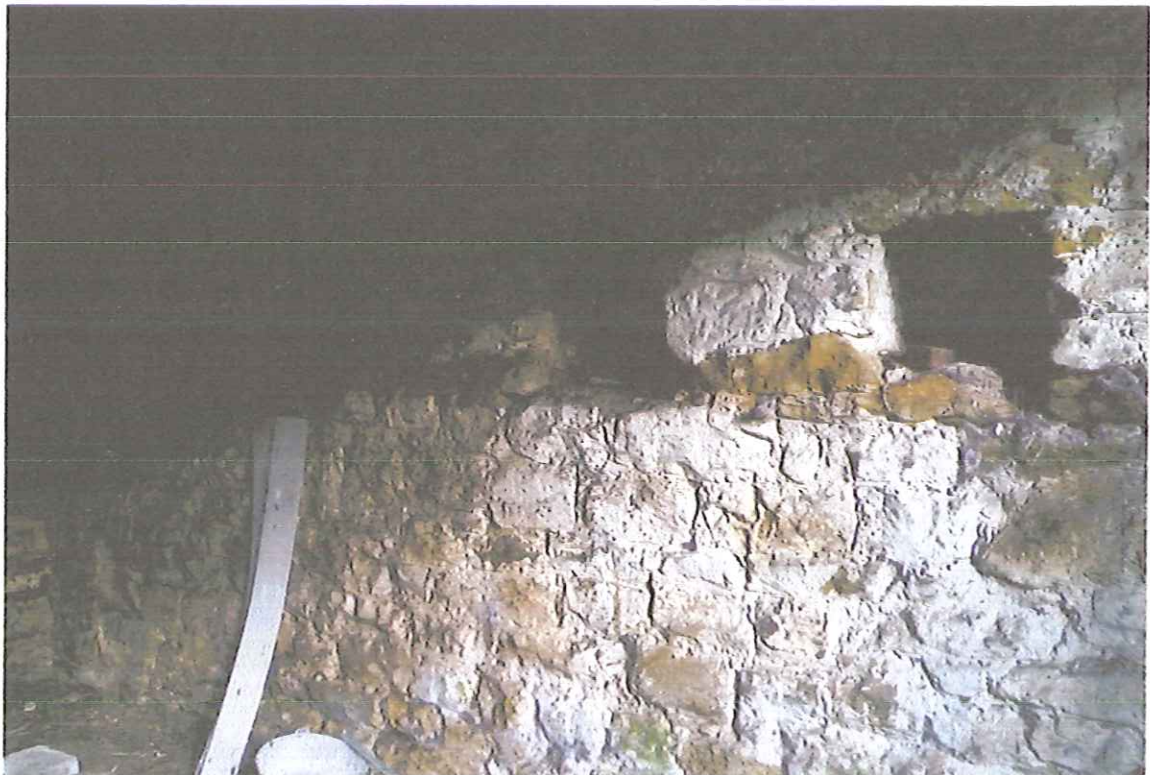
The roof of the cartshed next to the house is of purlin rafter construction, with round timber poles used as purlins and sawn or split poles used as rafters, these being reinforced by modern sawn rafters. There is a thin modern timber ridge. The wall separating the cartshed from the byre has four square alcoves (30x32x35cm deep) at 1.3 metres above the floor, purpose unknown.

10. Troutsdale Mill. Niches in the south-east wall of Store 1, cart shed.
