Tree Survey and Arboricultural Impact Statement.

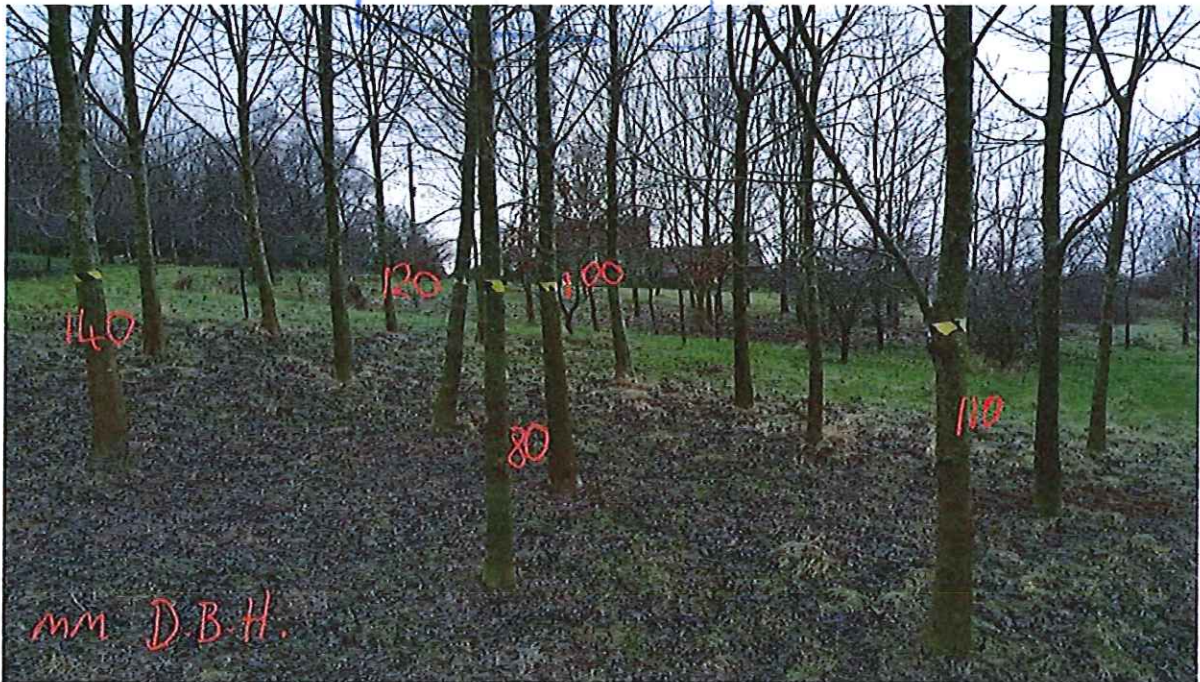
The location of the Glamping Pod in this woodland will require the removal of five trees all of which are Ash and are in the centre of the woodland. The removal of these trees will not adversely affect the overall crown of the area as due to the current density of planting it would be difficult to identify them from distance.

As noted in Picture 1 the trees to be removed are marked with tape and annotated with DBH in mm showing a range of 80 to 140 mm DBH (1.5m from ground)

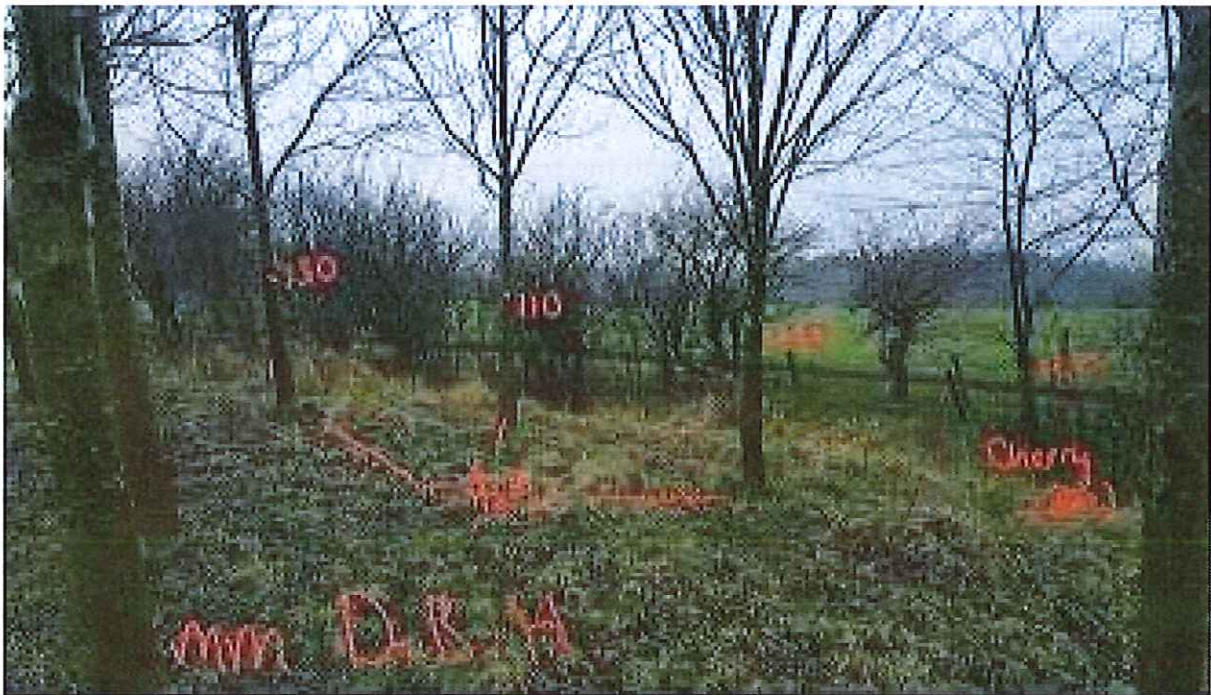
There are three Ash trees as seen in the Picture 2 that will require removal to allow the parking area to be constructed. They are 110, 120 and 130mm DBH (1.5m from ground). Whilst these trees are on the outer edge of the woodland planting they form part of the greater crown area and when viewed from outside the property the overall shape and size of the entire woodland crown area will largely be un-affected as the trees behind them will become more prominent.
