Location:
**Thirley Cotes Farm
Harwood Dale**

Report Type:
**Arboricultural Survey
Arboricultural Impact Assessment
Arboricultural Method Statement
Tree Protection Plan**

Ref:
ARB/AE/1671

Date:
October 2017

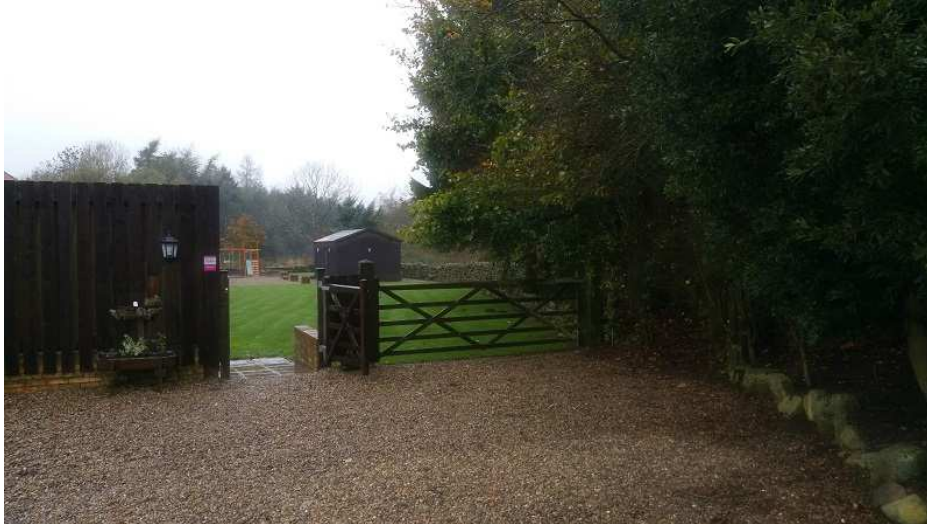
Figure 1: Looking west towards rear garden – note end of access driveway.

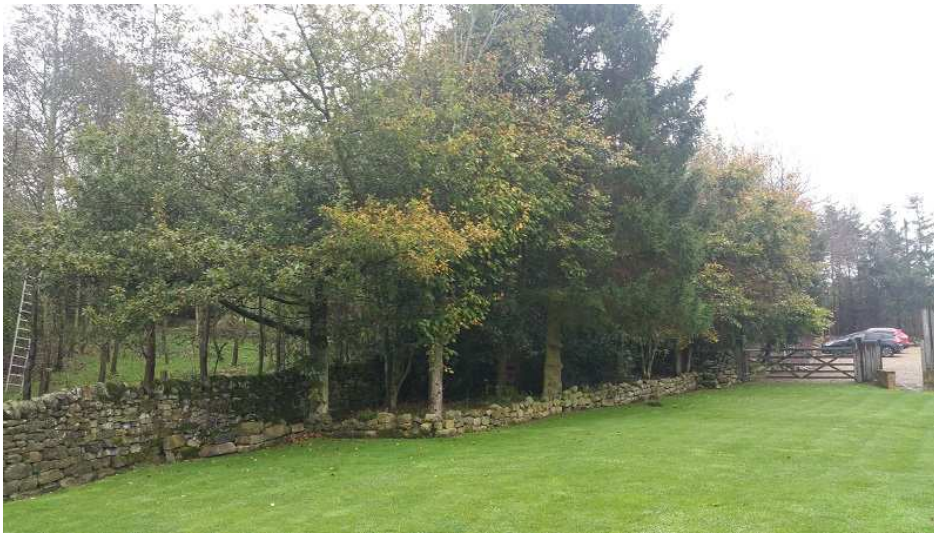
The location of the access driveway and parking bays is close to, and within, the Root Protection Areas (RPA's) of Trees 1, 2, 4, & 7 and damage could occur to any underlying root tissue, and / or overhanging branches during construction.

Figure 2: Looking east towards Trees 1-7 – area for proposed access drive and parking.

Mitigation / Countermeasure: The encroachments into the RPA's as shown on plan are considered minimal, and as the trees are so young and vigorous, and the proposals so relatively lightweight in nature and extent, it is not expected that any significant detrimental long-term impacts will be experienced by the trees. Prior to construction of the access and parking bays overhanging branch tissue from Trees 1-7 will be crown-lifted to 2.5-3m to allow vehicular clearance, following this protective fencing will be installed prior to construction as shown within Appendix 7.

- 5.1 Refer to Appendix 3 for stage specific tasks.
- 5.2 Prior to any further site works the trees (1-7) require crown-lifting to allow vehicular access - this work must be undertaken by a suitably experienced Arborist and be in accordance with BS3998 'Tree works – Recommendations' 2010. Following which tree protection barriers need to be erected in order to protect the trees from damage; this must remain in situ during the entire build process. The fencing needs to be erected according to the locations found on the Tree Protection Plan (Appendix 7). The fence should conform to the specification within Appendix 5, unless a similarly immovable alternative is agreed with the Local Planning Authority. All weather notices should be attached to the fencing marked with the following: '*Construction Exclusion Zone - Keep Out*' (a notice is provided within Appendix 4).

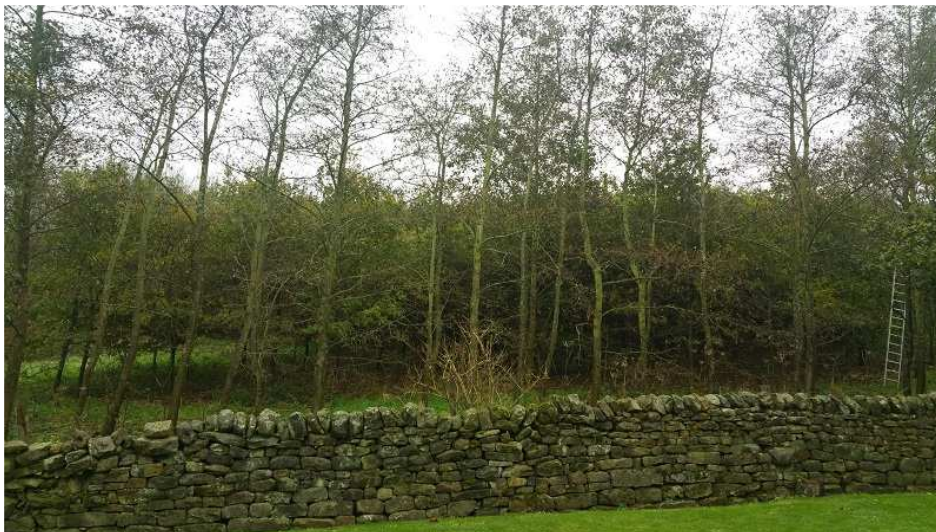
Figure 3: Group 2.

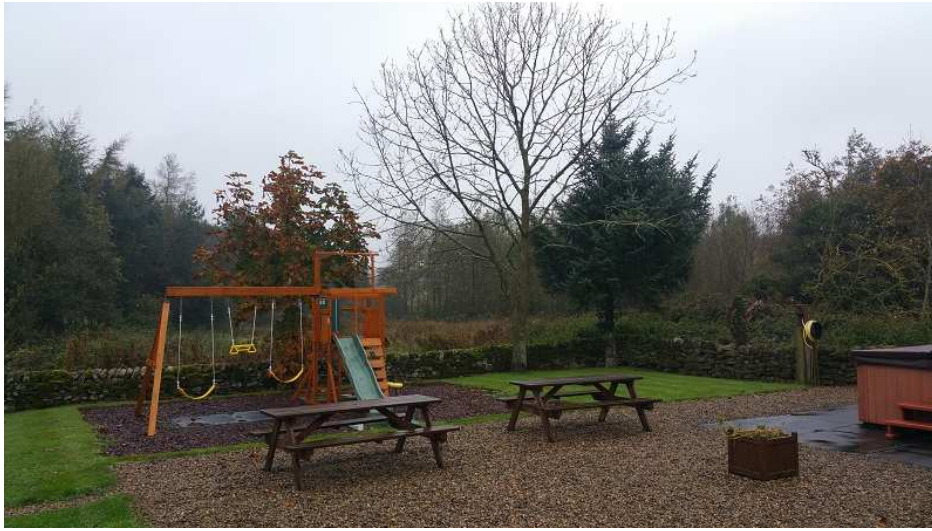
10	Blue Spruce	SM	21	1	6	3	3	3	3	1.5	N	Minor crown suppression by Tree 9.	40+	B1	No work required

Figure 4: Trees 8-10 (l to r)

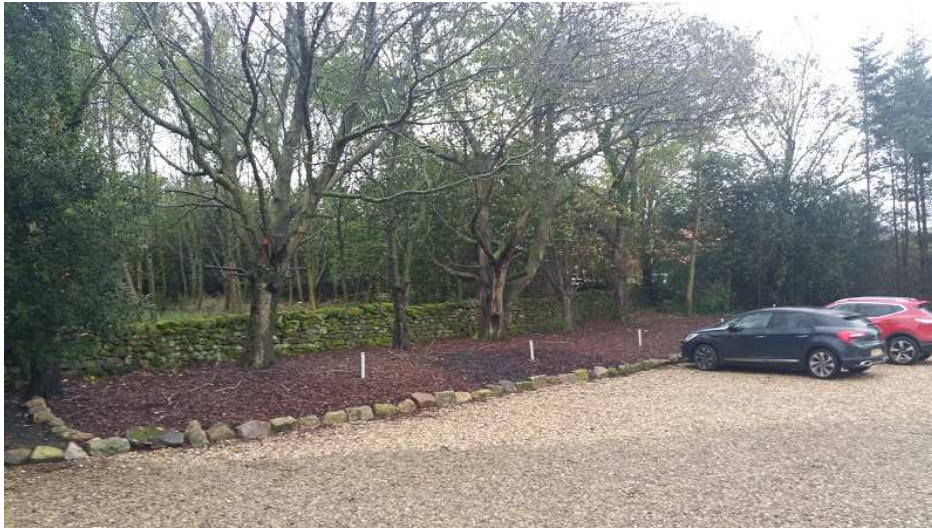
Figure 5: Trees within Group 3 - new parking bays

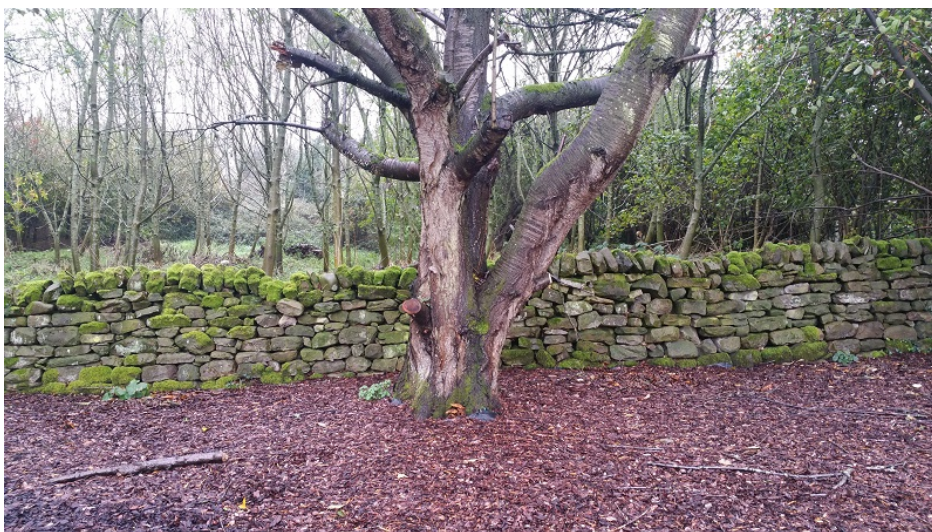
Group Number	Dominant Species	Lesser Species	DBH	Average Height	Age	Average Spread	Condition/Comments	Recommendations	EstCont	BS Cat
1	Holly Whitebeam Spruce spp		20	10	SM	2	Small group of trees in corner of garden. This group includes Trees 1-7 which are the dominant / front row of the group - these were all detailed individually. Generally low value individual trees but with some group screening value / function.	No work required	20+	B2
2	Common Alder		12	10	SM	2	3 lines of trees 4m off wall. Beyond these lines appears to be a young mixed broad-leaved plantation.	No work required	40+	C2
3	Cherry spp Holly	Spruce spp Oak spp	30	10	SM	3	Line of x6 Cherry - cleared under / bark chipped - with screening trees to each side. New parking bays recently installed. Young woodland beyond. Central Cherry - largest of the group - has fungi - <i>pholiota squarrosa</i> - infection (decay causing organism).	Consider removal of central diseased Cherry	40+	B2

Figure 6: Central Cherry in Group 3 - note fungal fruiting bodies at base
