MICHAEL MILLER BA. (Hons) ARCH. MCIAT  
Architectural Consultant

HERITAGE STATEMENT for LISTED BUILDING CONSENT  
PROPOSED ALTERATIONS at  
SHIRLEY HOUSE, SUNNY PLACE, ROBIN HOODS BAY.

1.0. HERITAGE STATEMENT.

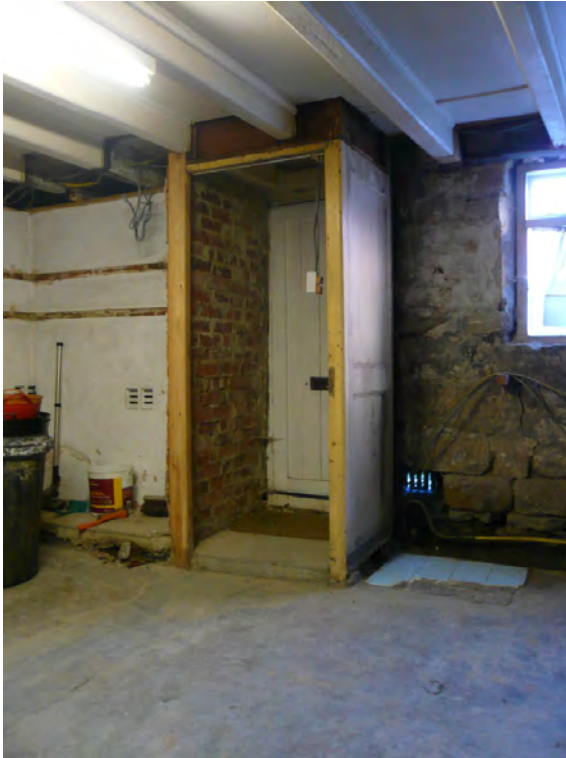
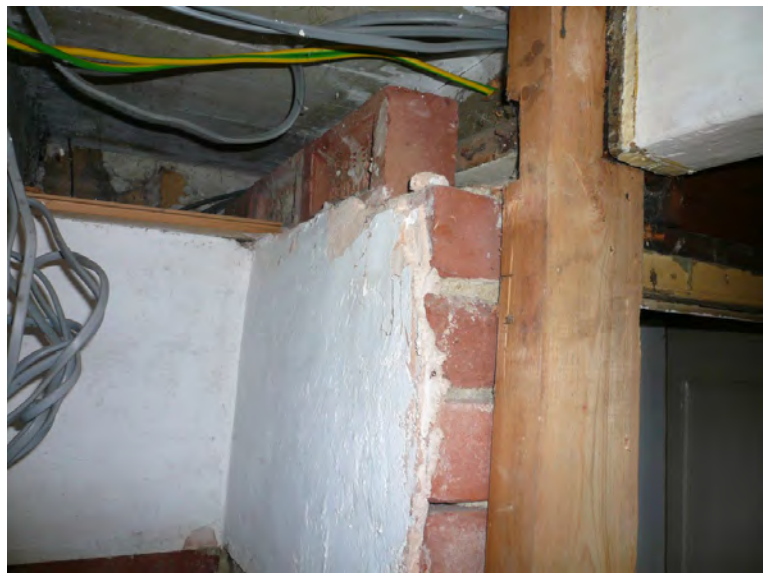
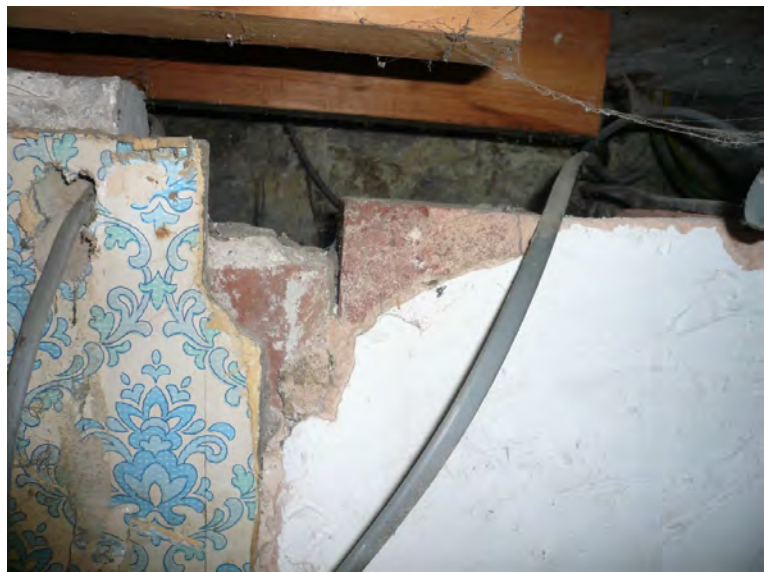
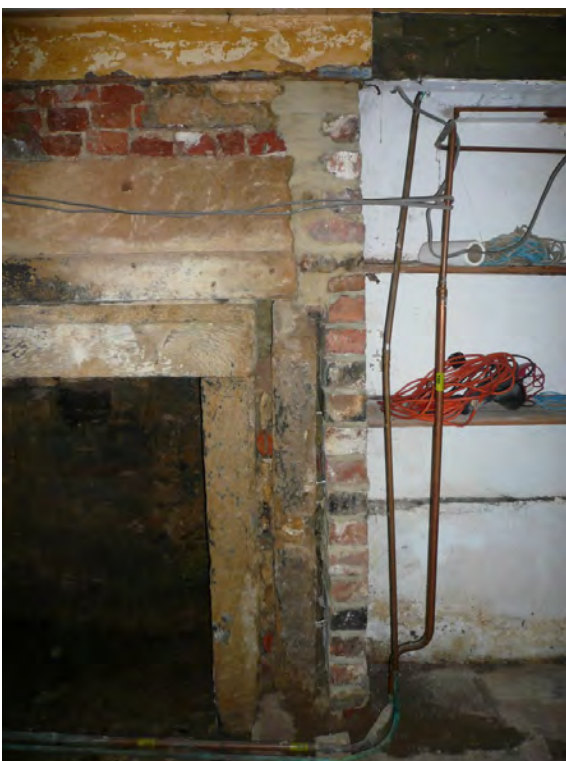
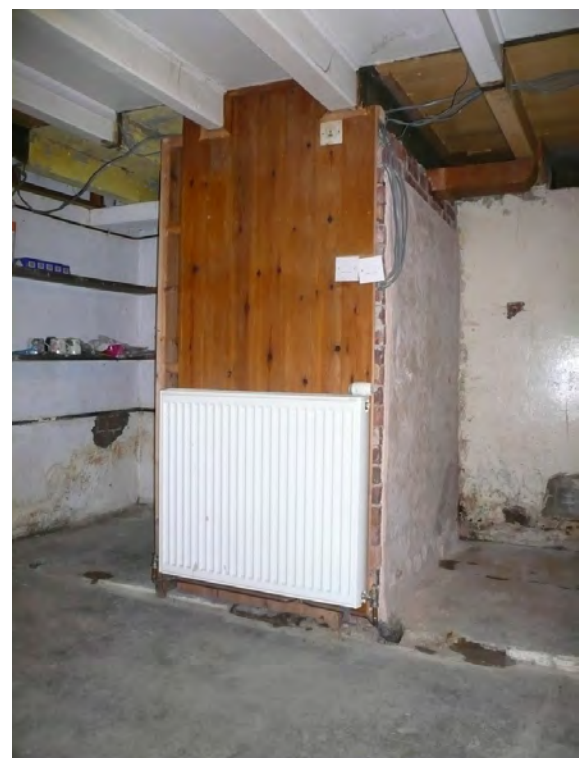
APPENDIX A  
Basement brickwork lining walls.

The external walls in the Basement have been lined with brickwork and a cavity construction has been created.

It is considered this to be a 20<sup>th</sup> century addition and this appears to have been an attempt to stem the ingress of ground water and to make the basement habitable, which it has not. Evidence of this is clear where dampness has affected plaster finishes on the walls and timber has rotted.

It is a necessity to address this problem as the continued ingress of moisture will only serve to accelerate the deterioration of the fabric of the building, historic or not. Modern living exacerbates the problem by the introduction of heating systems and the capability of the internal volume of air to take up moisture vapour. Under certain conditions, the resulting problem is the formation of condensation on uninsulated construction. Photographs show various aspects of the Basement in order to confirm this claim. Appendix A

The intended solution is to remove the brickwork lining walls and install a Sovereign 'Sovdrain' cavity drainage system as shown in the attached trade literature. Appendix. The system has a pedigree of being used in historic buildings, evidence of installations in Grade I Listed can be found, as it does not rely upon an adhesive fix which penetrates the host fabric, but a mechanical means of fixing which is ultimately capable of reversal. The proposed construction includes insulation which is intended to combat the opportunity for condensation to form.

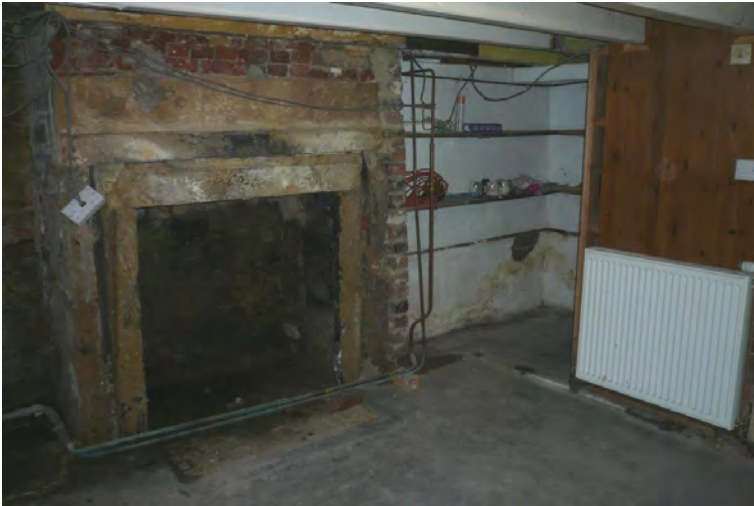
Fireplace recess

The left hand side of the chimney breast structure has been variously re-built; concrete blockwork and the brickwork beneath should be removed. See photographs Appendix B. The structure should be re-constructed using natural stone which is to be tied into the adjacent structure to create a sound and homogenous structure. A sawn stone lintol will be required to be built in in order to support the rear edge of the proposed hearth stone. Detail drawing 190.xx

The reason that this aspect of work is necessary is the as a component of the structure of the chimney, possible total weight of 20-30 tons, the support here is relatively slender and definitely in a poor state of repair.

The remedial work will ensure the integrity of the structure and its ability to perform its function in future.

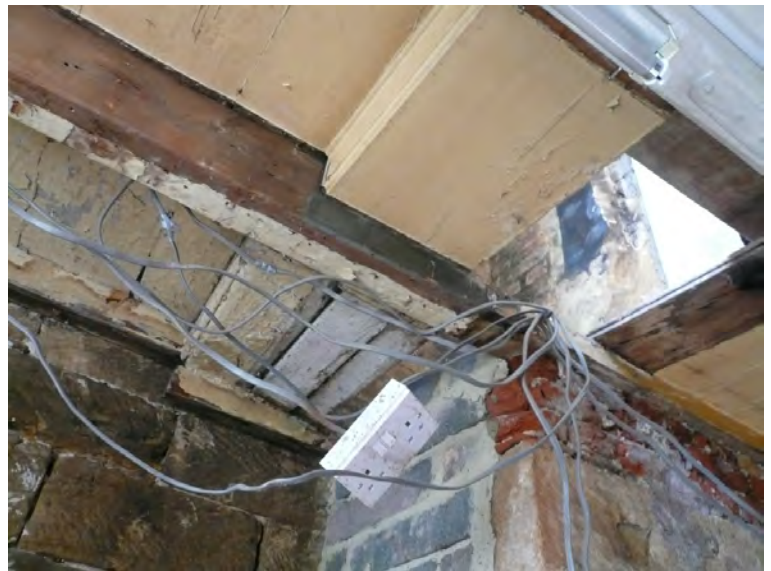
At high level the floor joist has been (historically) cut to accommodate the fireplace hearth above and a knot, which has dried and dropped out, have together contributed to an unacceptable reduction in section at the point of bearing where the requirement for reaction to shear is paramount. See photograph. To exacerbate this problem, the same joist supports timber beams which in turn support the chimney/fireplace structure at Ground Floor Level. See photograph Appendix B.

LHS fire place recess. Timber beams support masonry over.

In order to remedy the problem it is considered that the offending joist should be supported by a new timber post (see Structural Report) and detail drawing 190.16 Basement Support Post. The timber beams which support the masonry above should be carefully revealed and consequently replaced due to the obvious amount of timber decay in this location. Following the reinstatement of this structure, a new stone hearth may be installed.

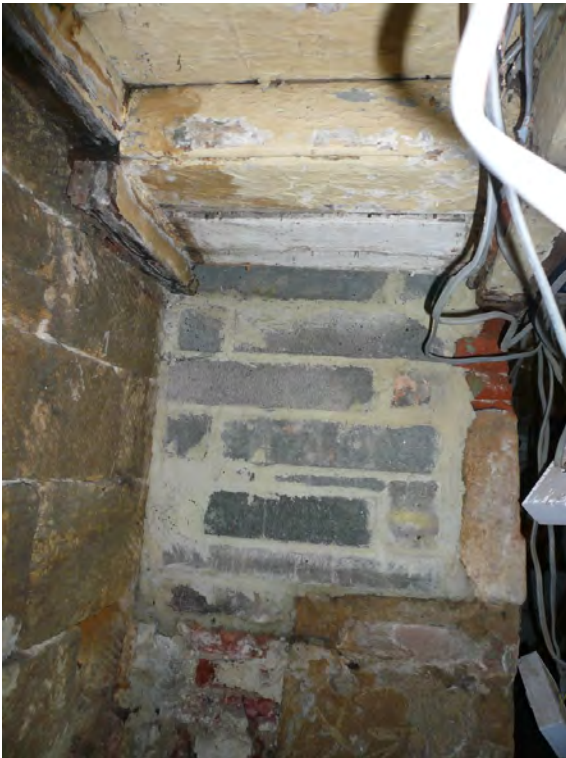
LHS chimney breast & masonry support beams.

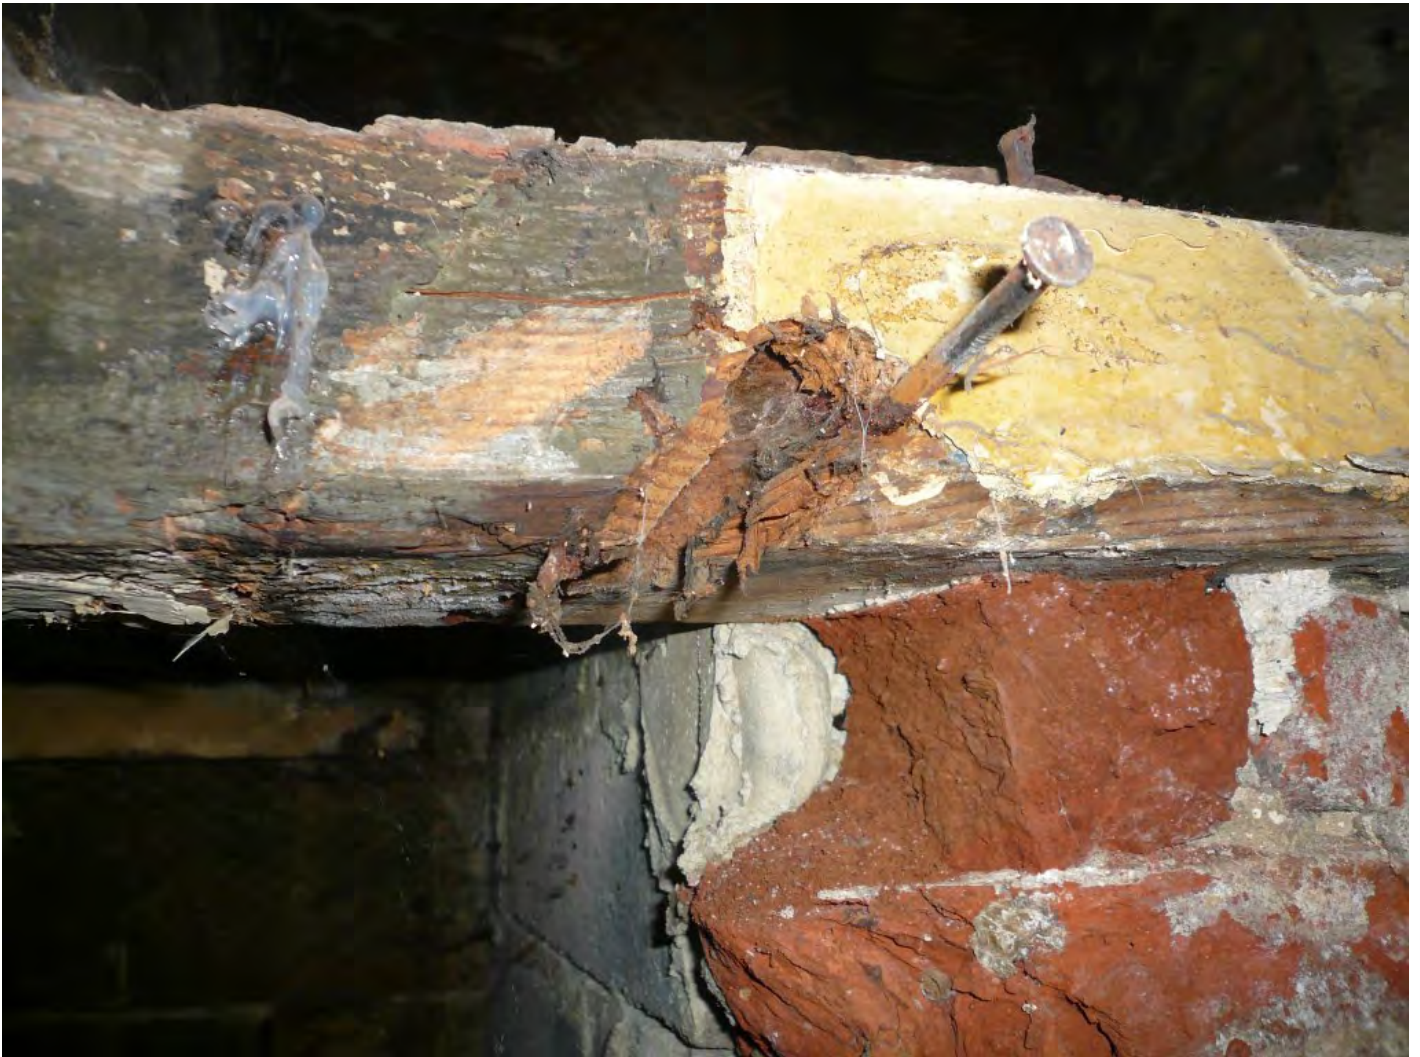
APPENDIX C  
JOIST SUPPORT to HEARTH/CHIMNEY BREAST.

Subject of section 2.07. paragraph 3.

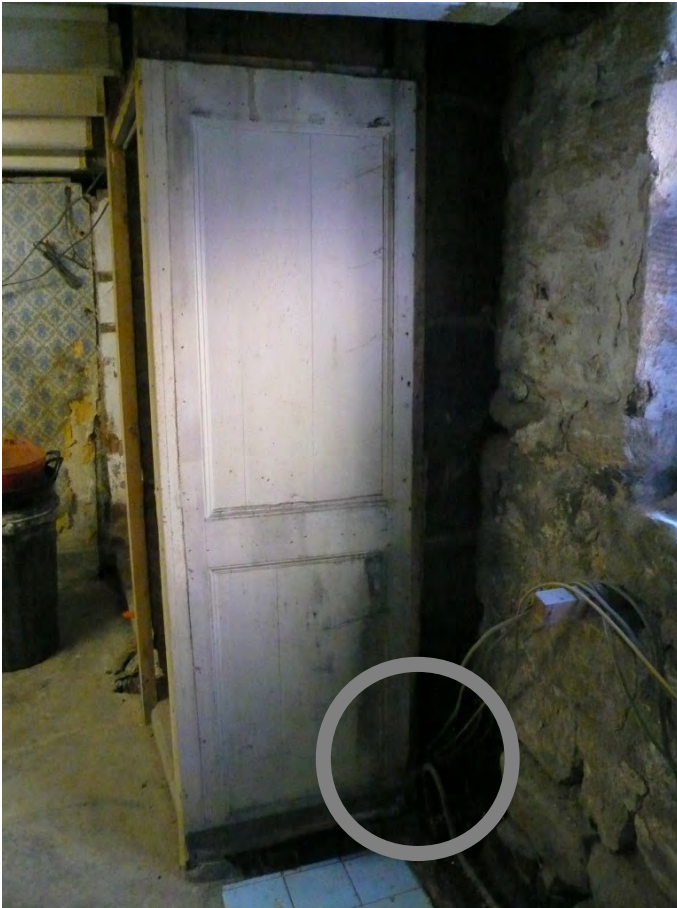
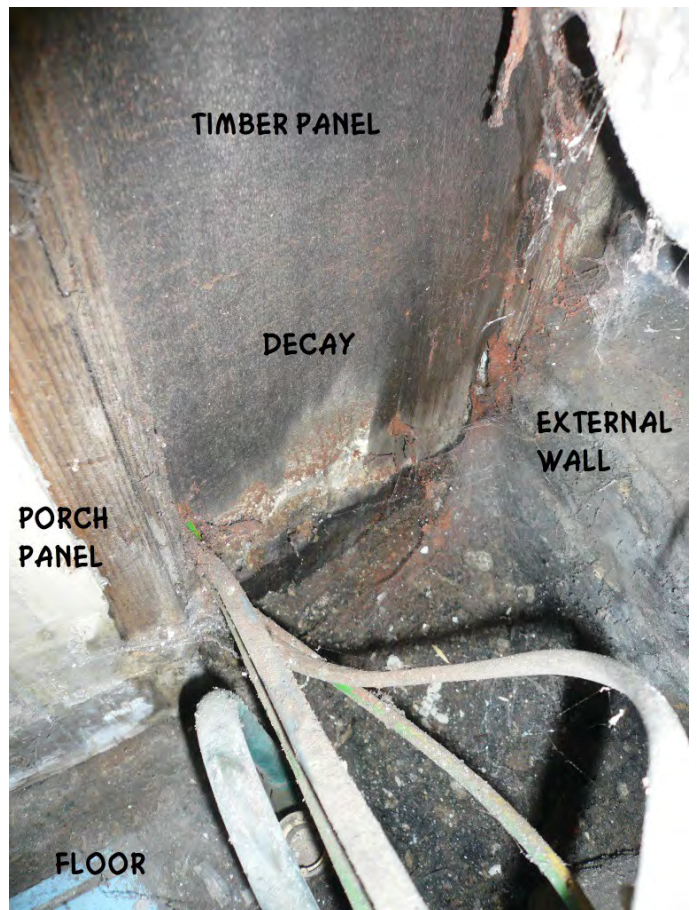
APPENDIX D.

It will be necessary to repair the connection panel between the main panel and the door opening as this has suffered decay. See photograph Appendix D.

Basement Porch. Screen to wall – panel.

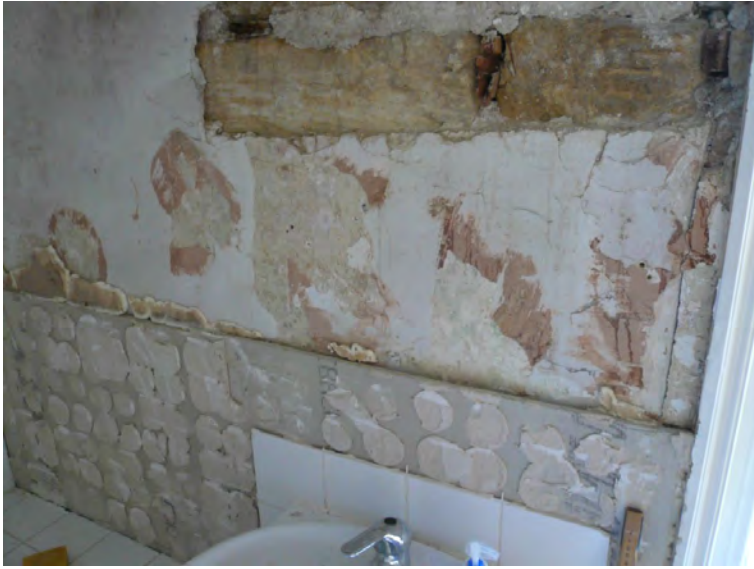
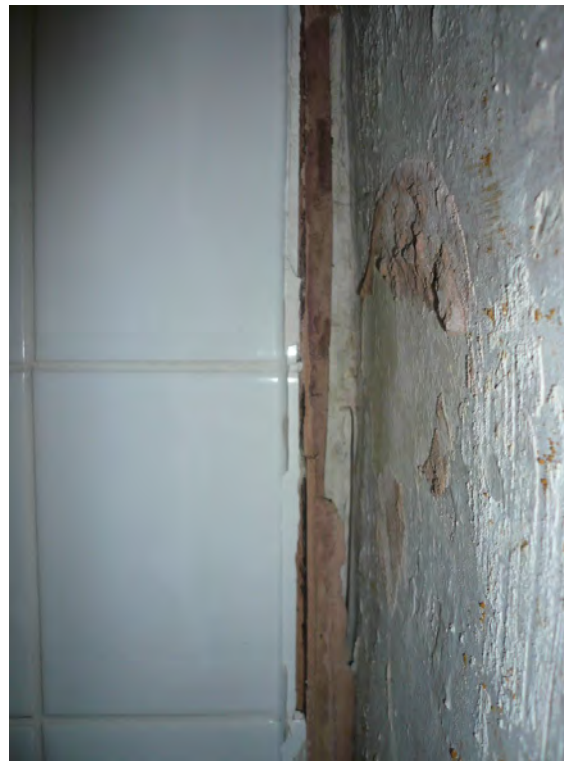
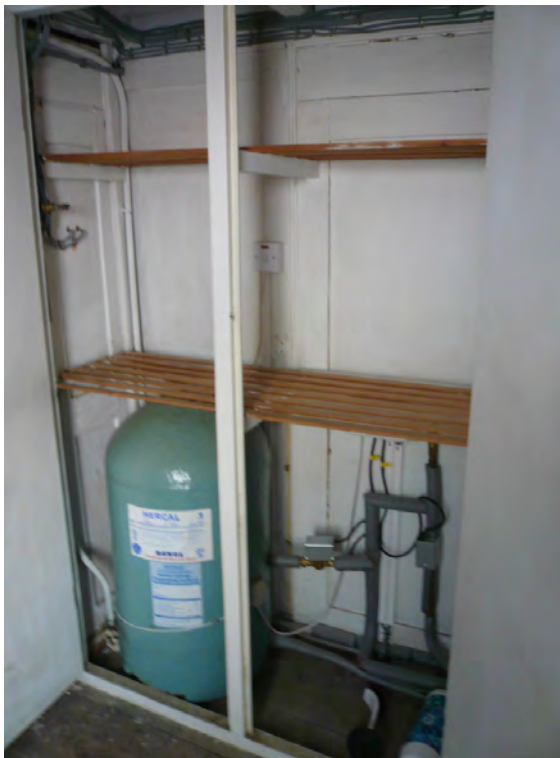
APPENDIX F.  
FIRST FLOOR LEVEL BATHROOM

Ceramic tiles on 'Hardie' tile backer board fixed to existing lime plastered walls with expanding foam.

Shown:  
Stonework to external wall  
Plaster coat finish  
Tile backer board  
Ceramic tiles.

View of party wall face showing tiling and backer board behind.

Proposed finishes: Full height tiling around bath. Tiles on new partition wall. Tiles to Bathroom?Bedroom wall on existing boarded wall (to be proven adequate). Tiling to party wall on extended tile backer board.

Remainder of Bathroom. Remove tile backer board & reinstate lime plaster wall finish. Fit wide board timber panel dado to 3/4 wall height. On battens to provide ventilation space behind.

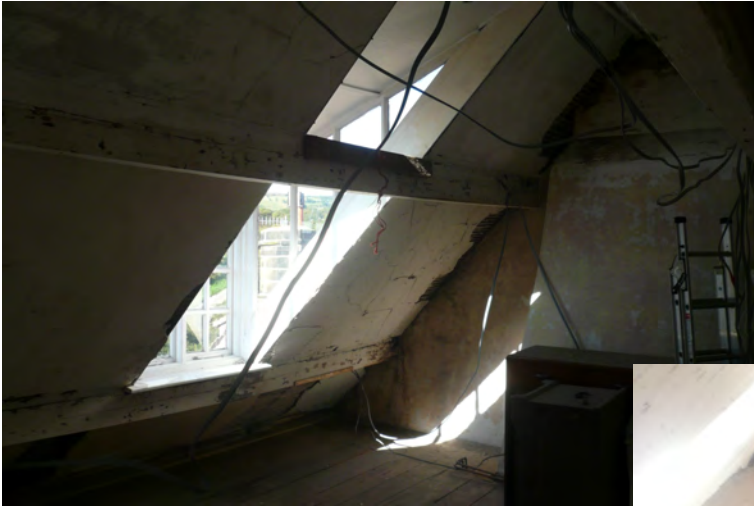
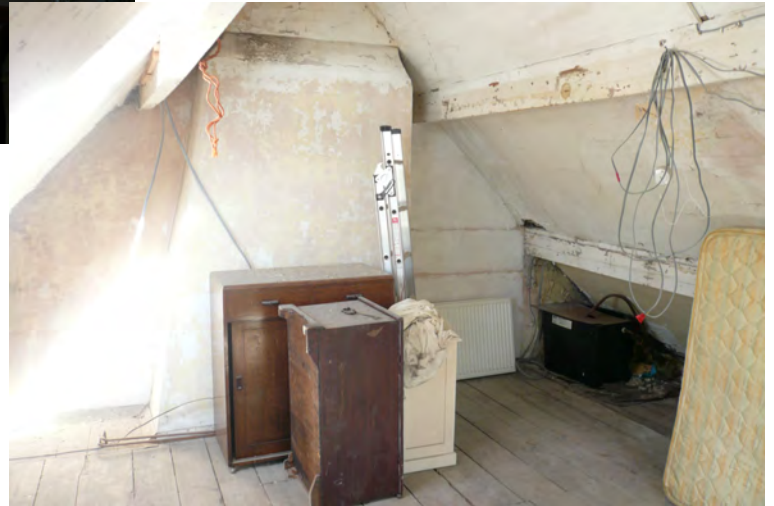
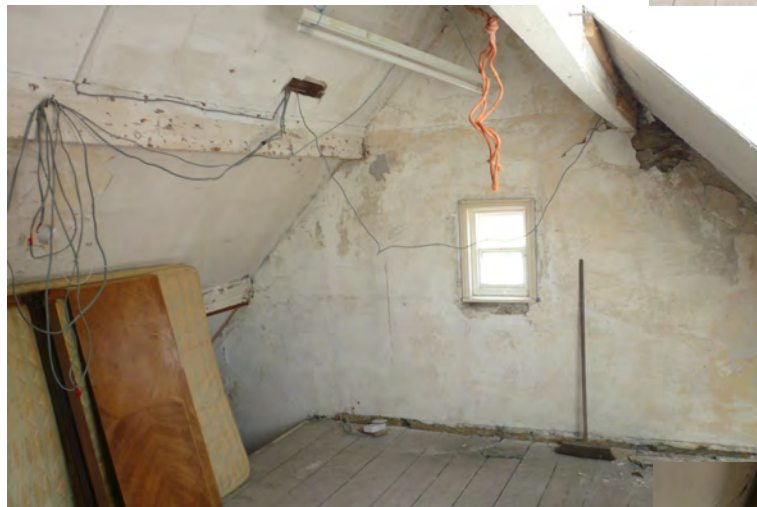
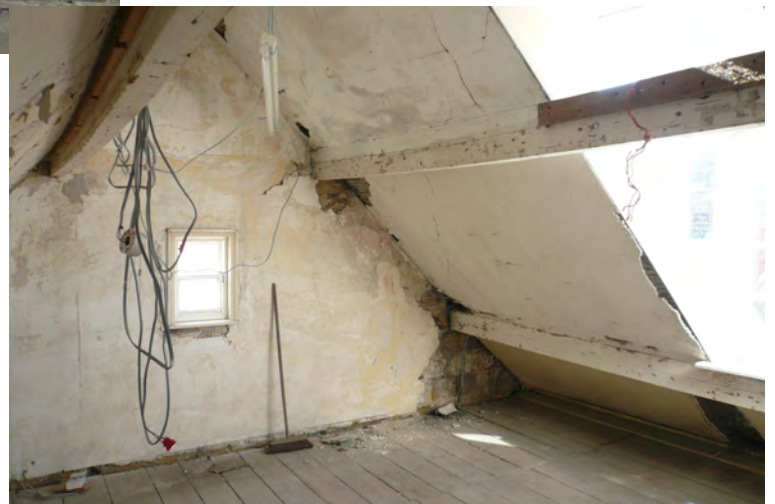
APPENDIX G.  
ATTIC ROOM

The lath and plaster ceiling shows undoubted effects of age related defects and decay. There are many loose patches and areas where the plaster has become friable. The only realistic outcome is to take this part of the construction down.

The existing lime plaster coating to existing walls is to be removed as it has perished due to age.

Between the existing rafters it is intended that Rockwool insulation is fitted between the rafters and a wood fibre board soffit lining finished with thin coat lime plaster as specified on the drawing 190/11.

Where lime plaster has been removed, it is to be replaced on a like-for-like basis.

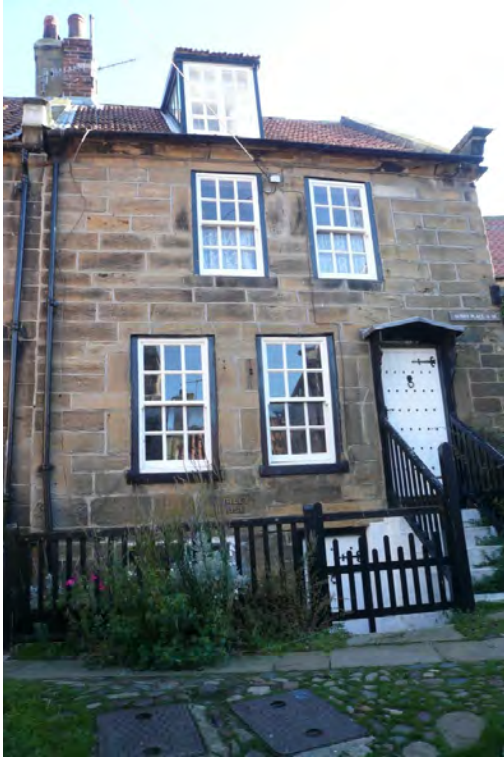
Front Elevation

2.22. Inappropriate materials and methods have been used for pointing the external wall joints in stonework. It is necessary to replace this work in order to protect the longevity of the stonework and also in order to maintain the appearance of the asset in a historic manner.

There has been some movement in the stonework detail, the cause of which is not evident from ground level inspection. The issue will be inspected from scaffolding and repair works carried out as necessary.

The work will be carried out by removal of pointing and raking out of mortar joints using hand tools. Re-pointing in 1 : 2½ Lime/sand mix, sand 50/50 sieved sharp sand/builders sand.
