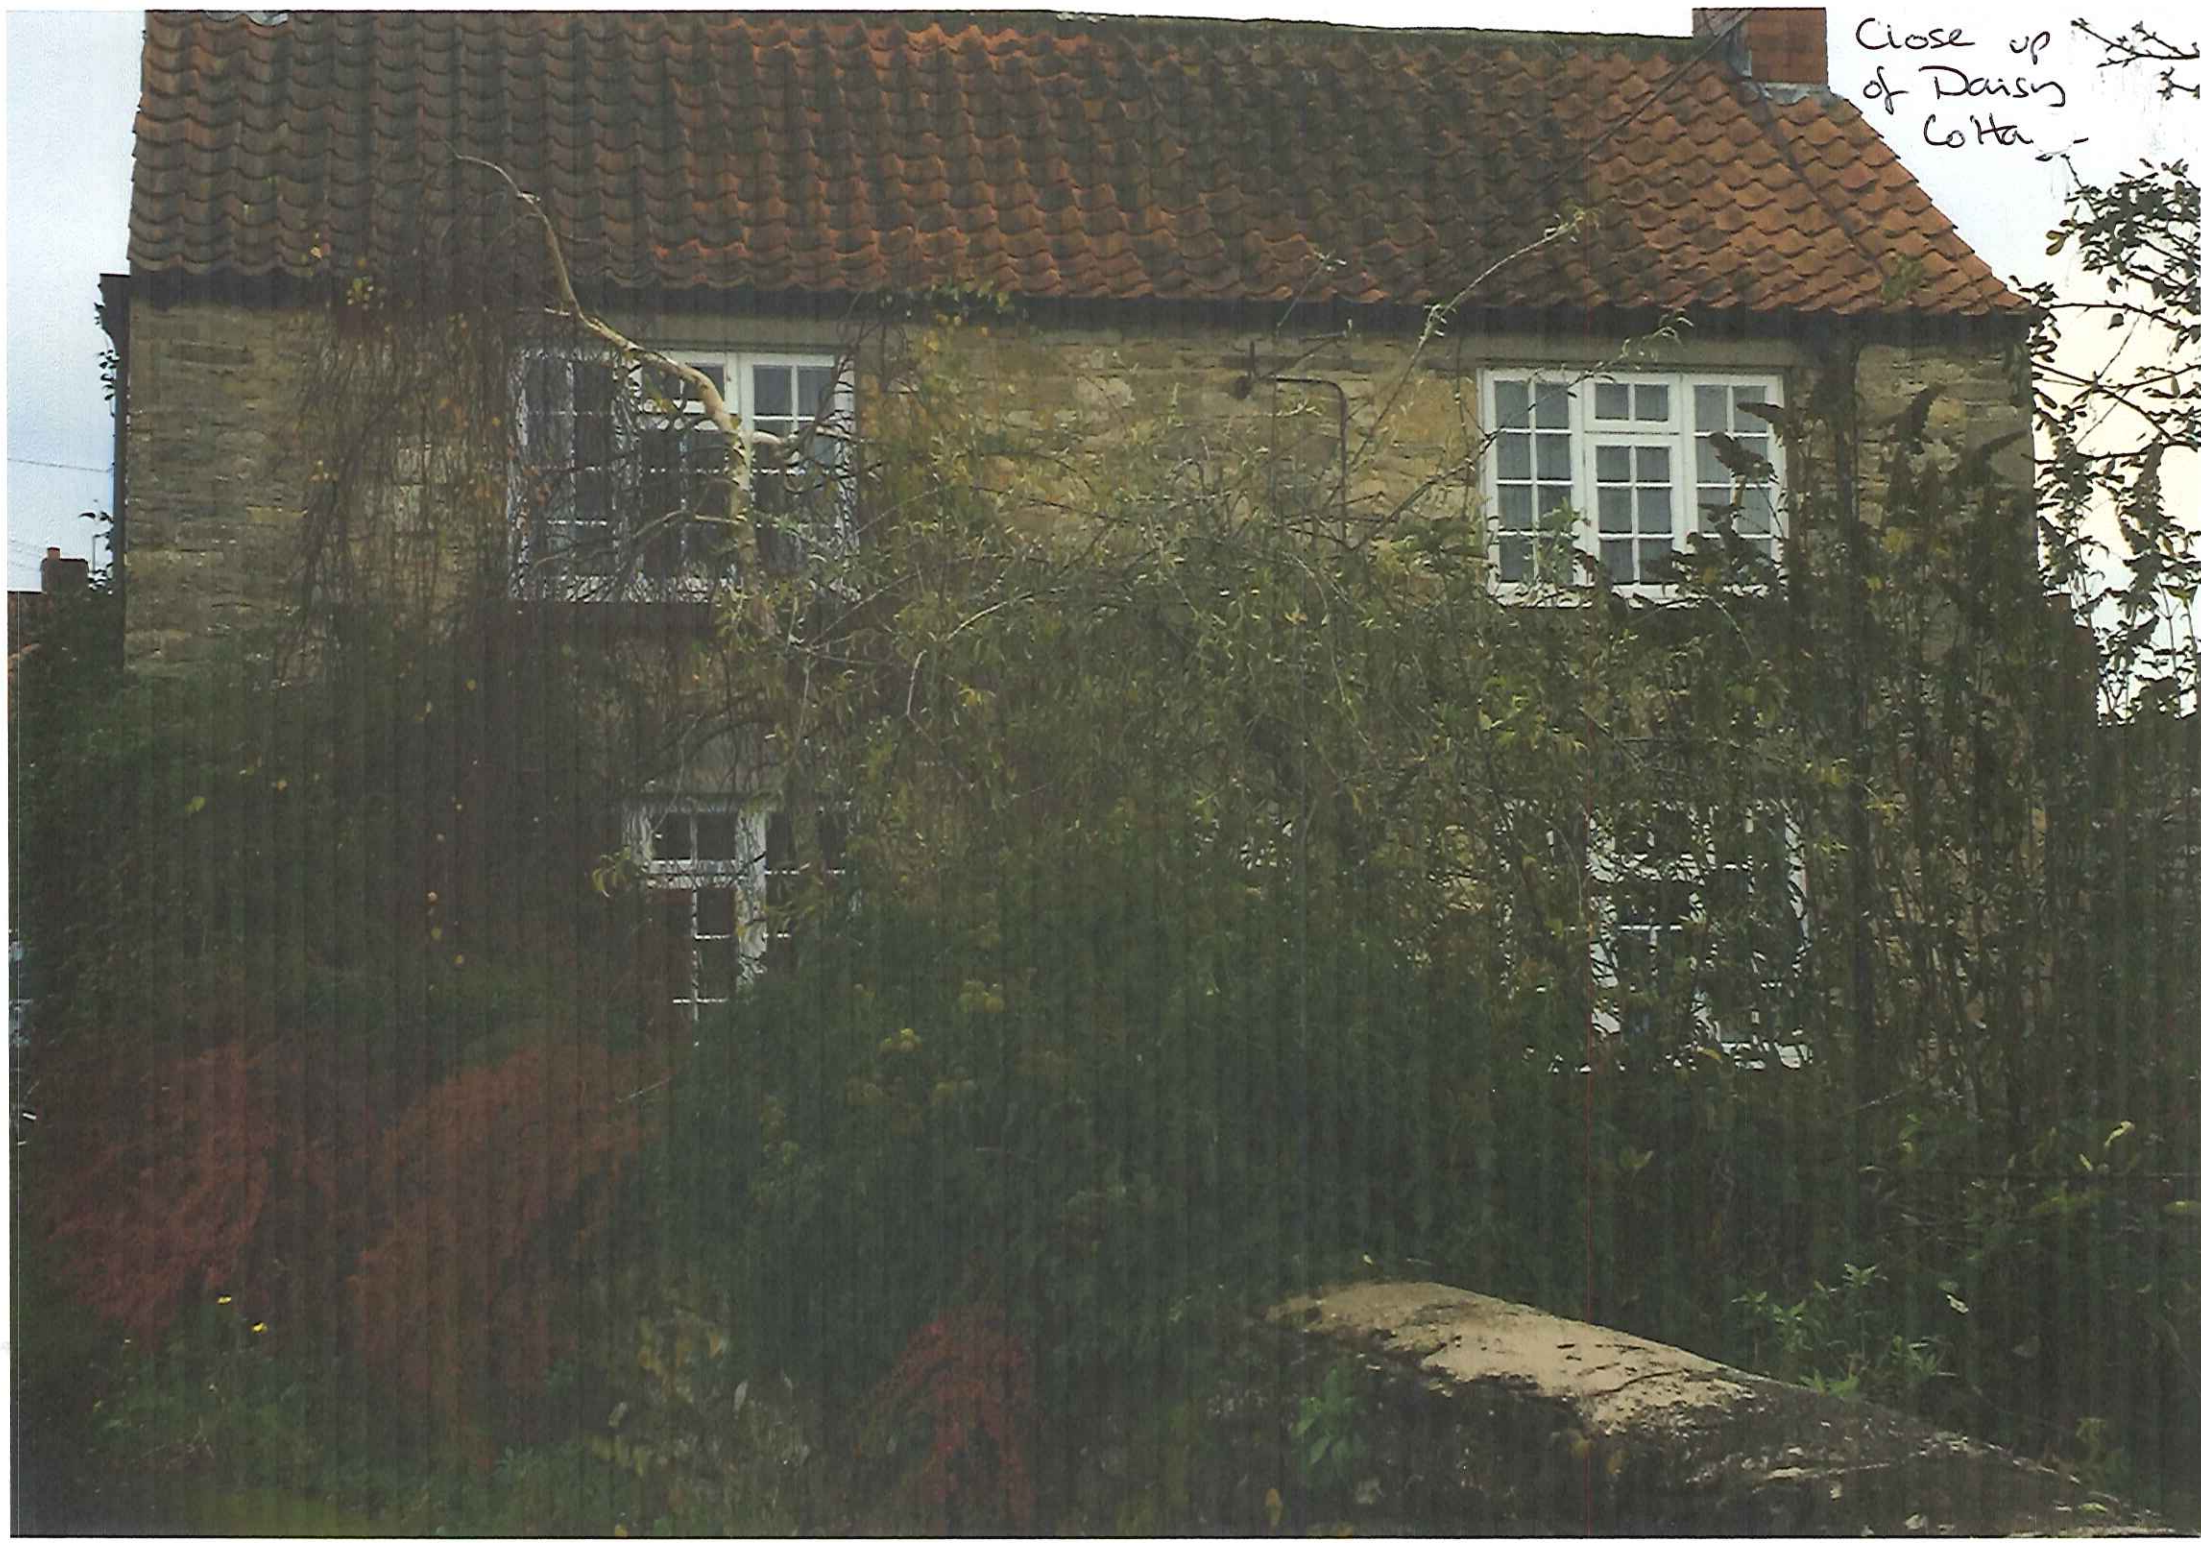
Close up
of Daisy
Cotta

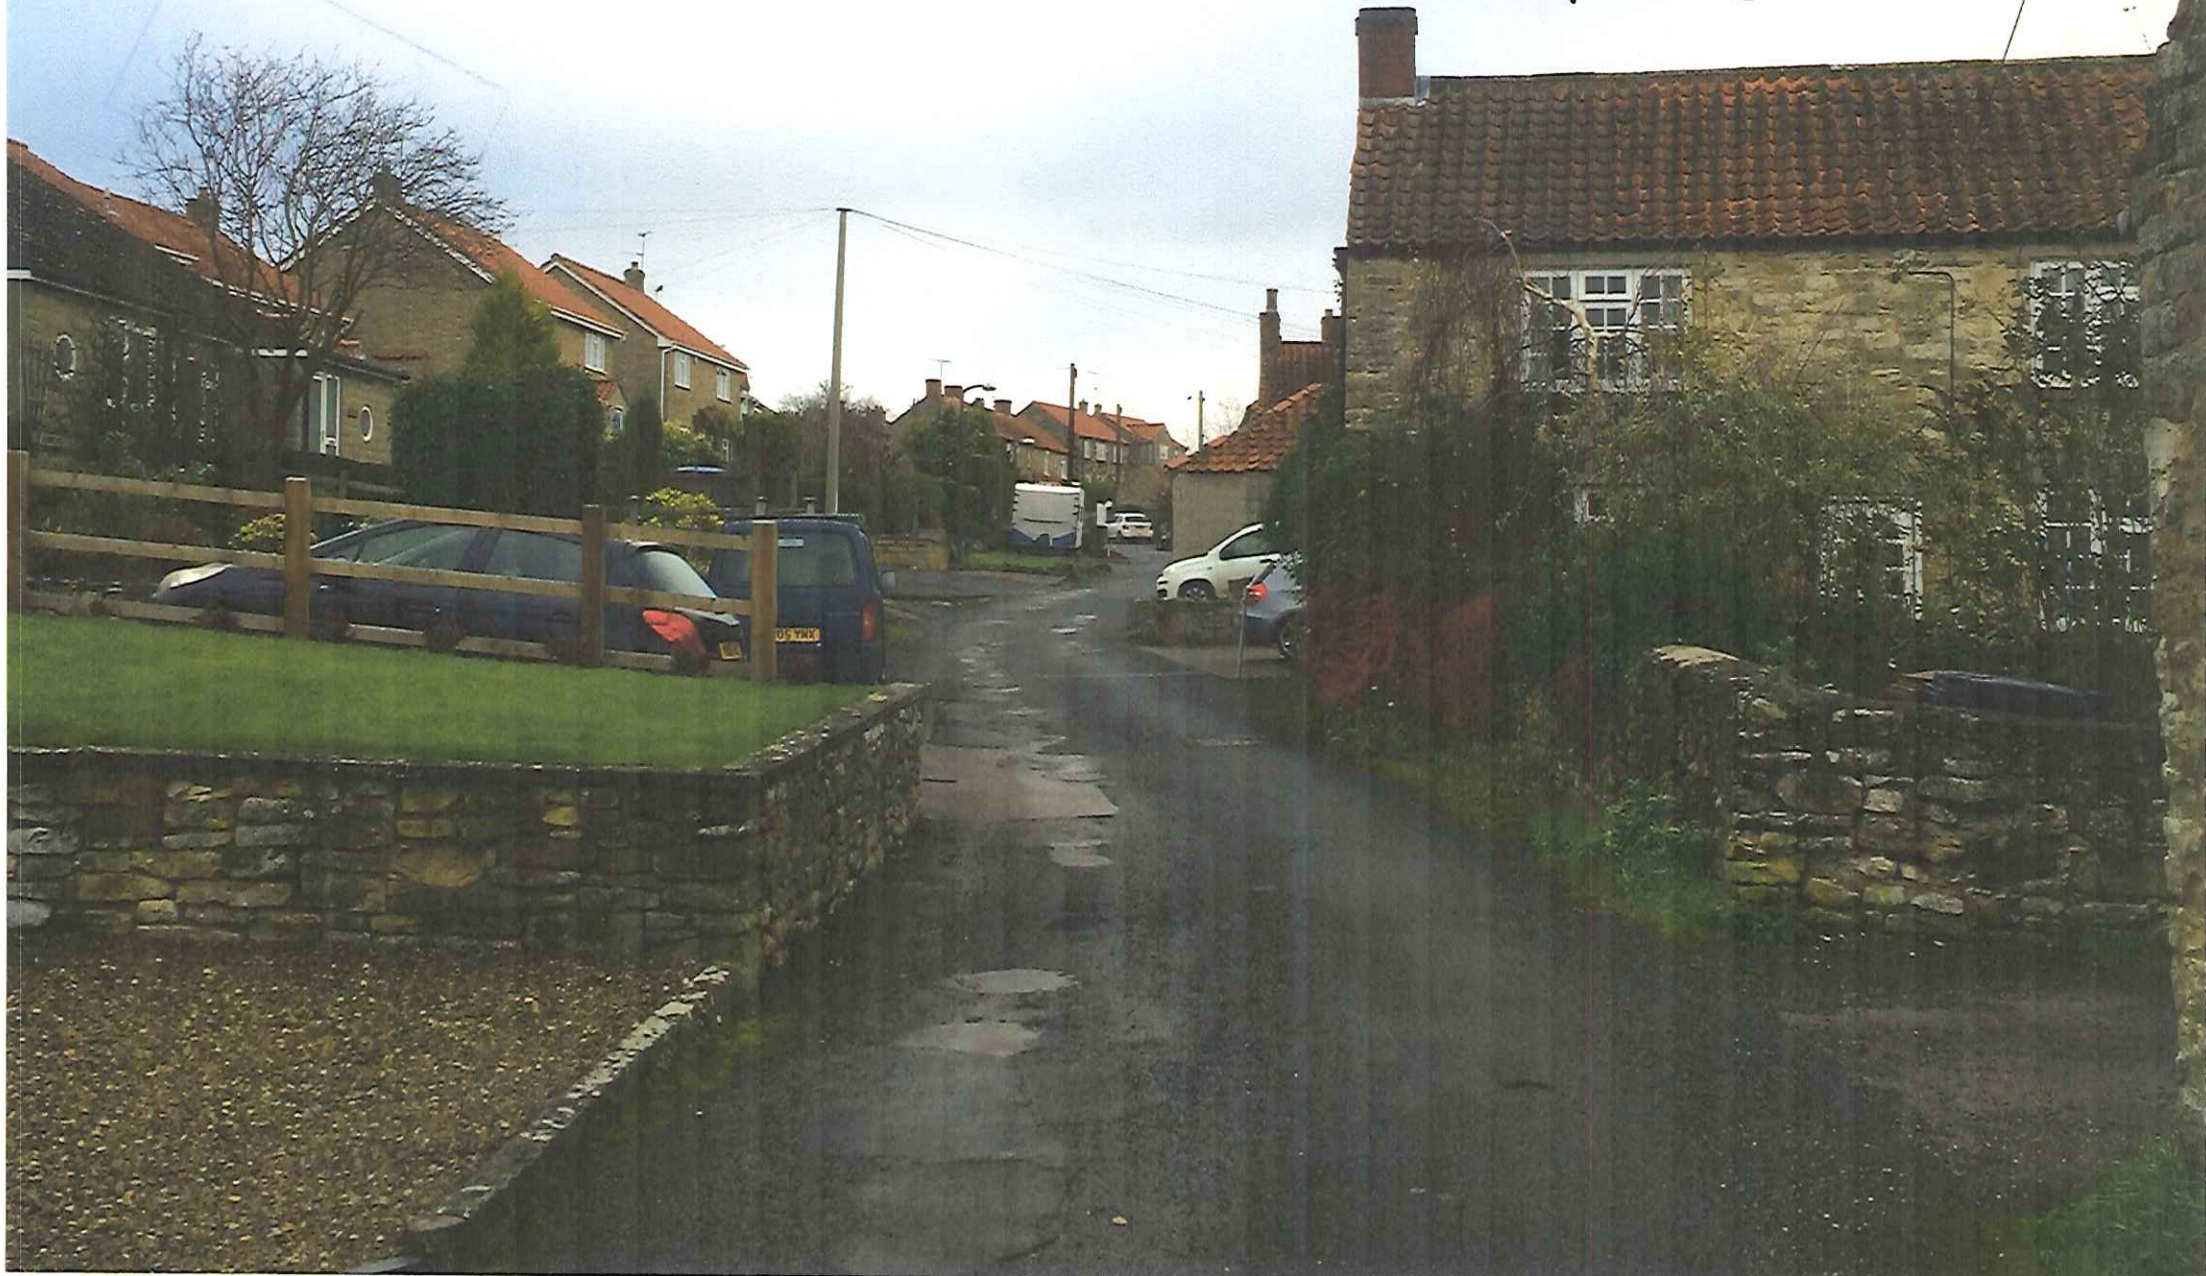
Daisy Cottage very much obscured by trees. Especially in summer.

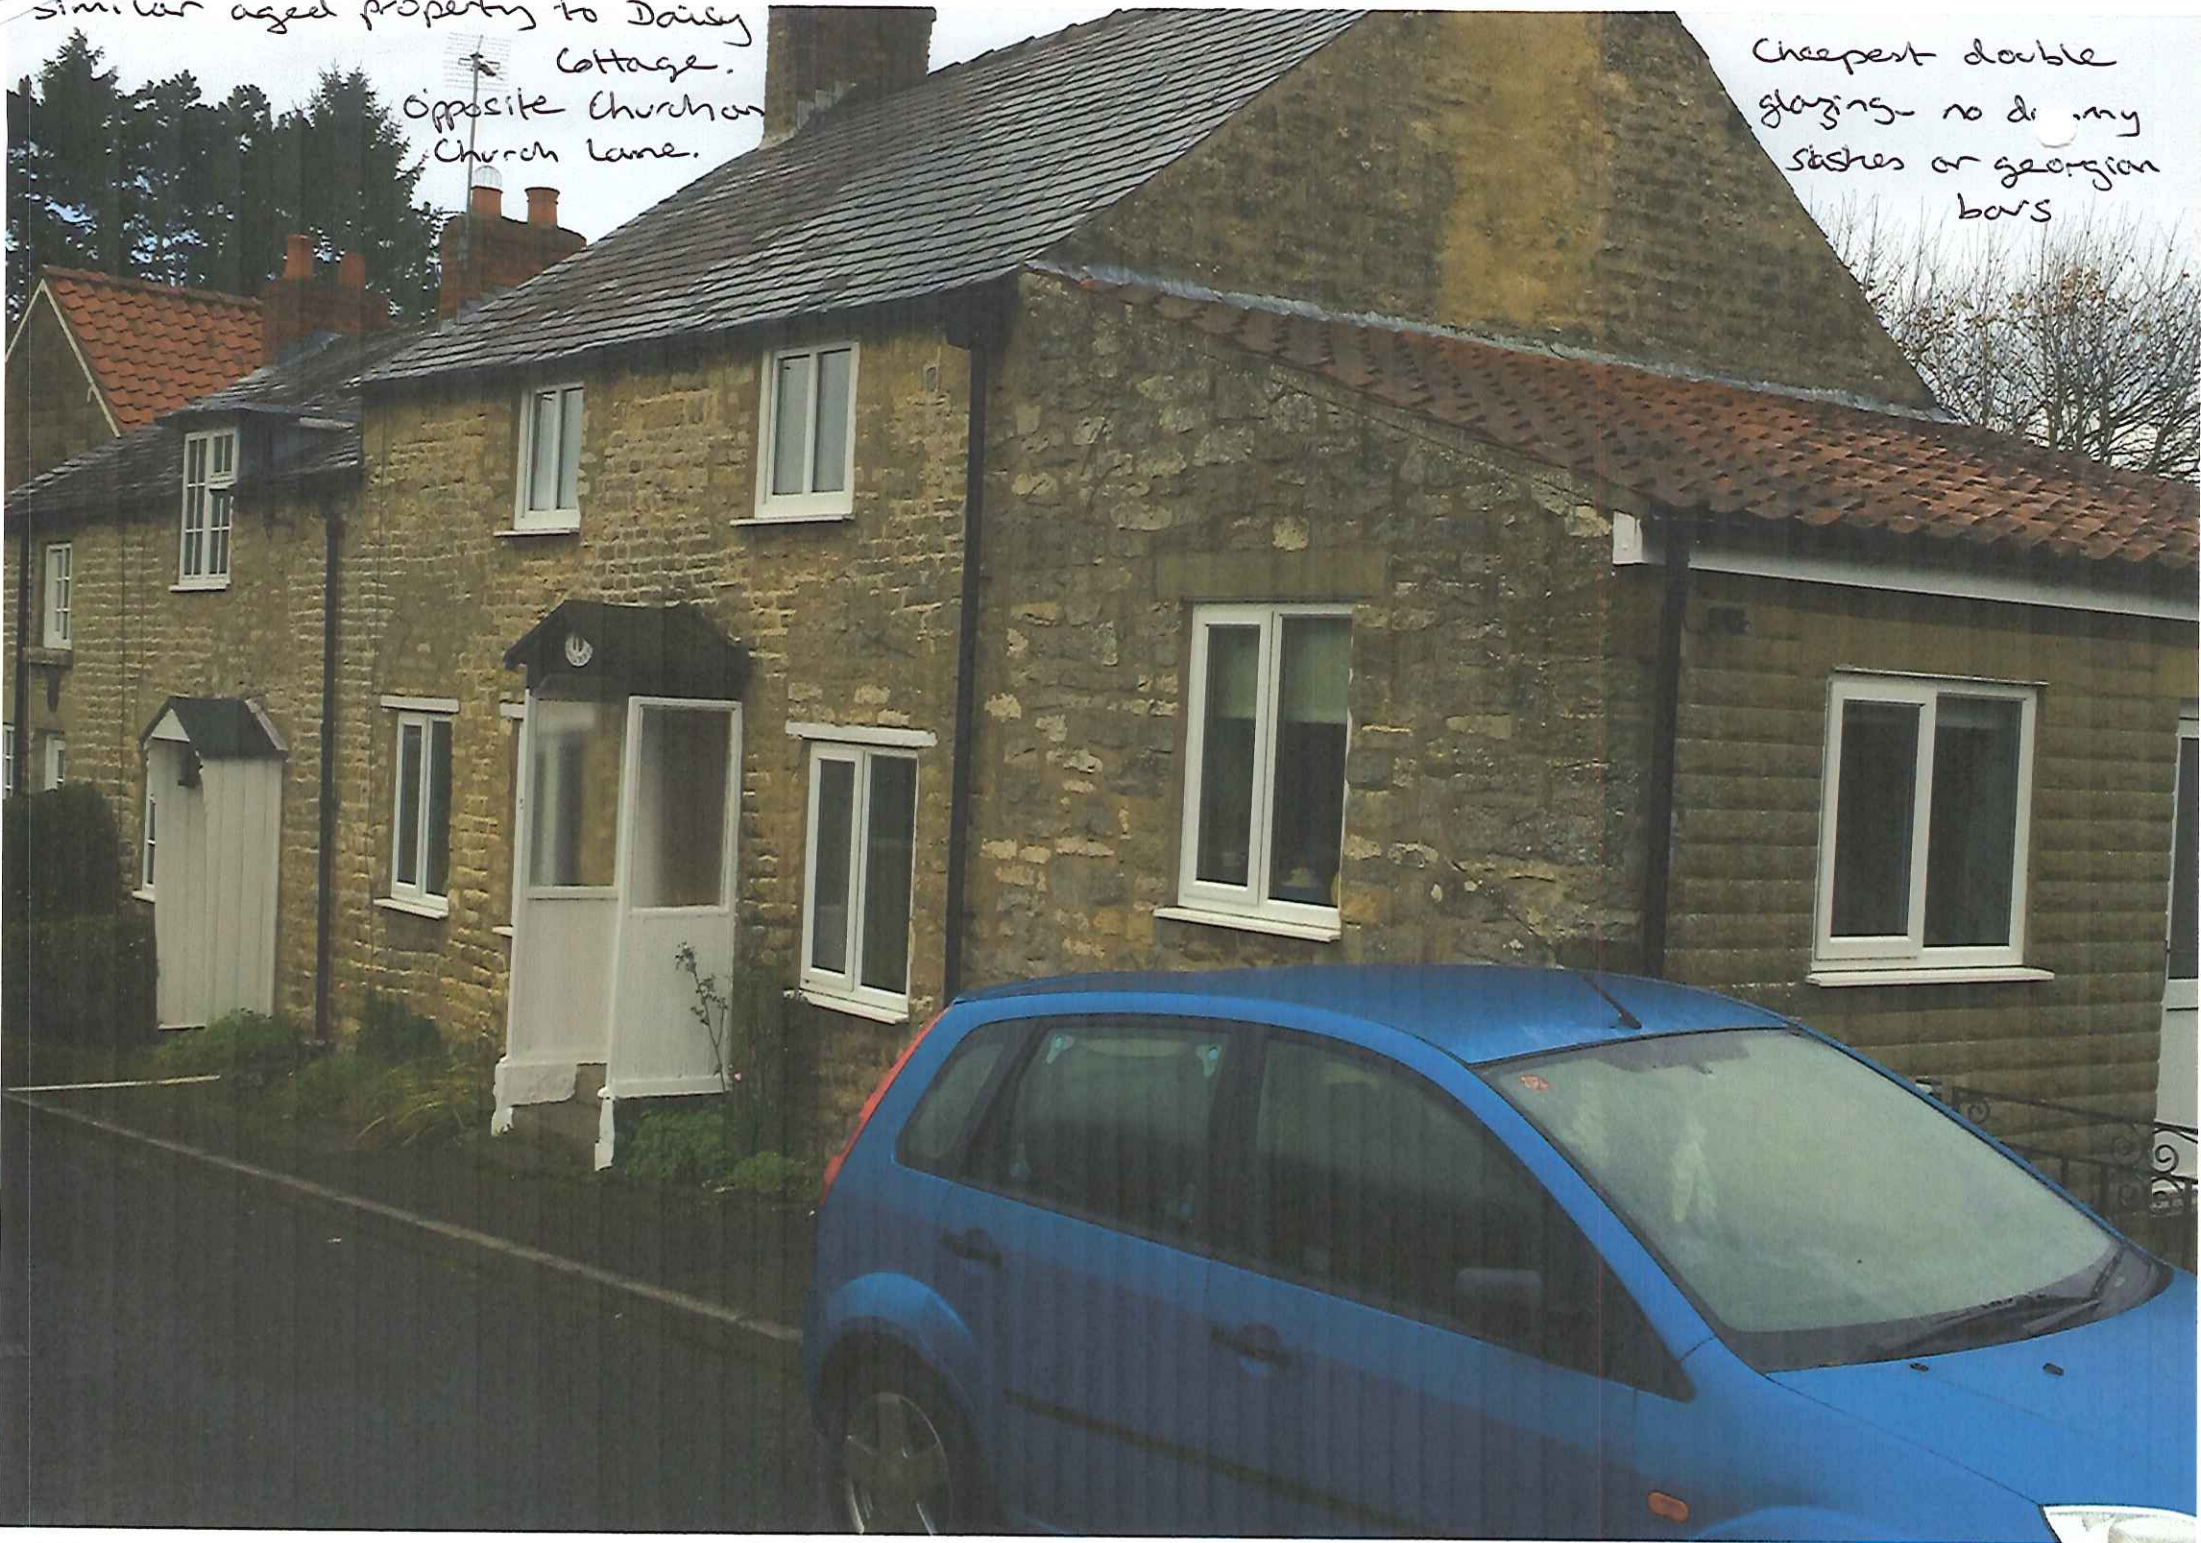
similar aged property to Daisy
Cottage.
Opposite Church on
Church Lane.

Cheapest double
glazing - no dr. my
sashes or georgian
bars

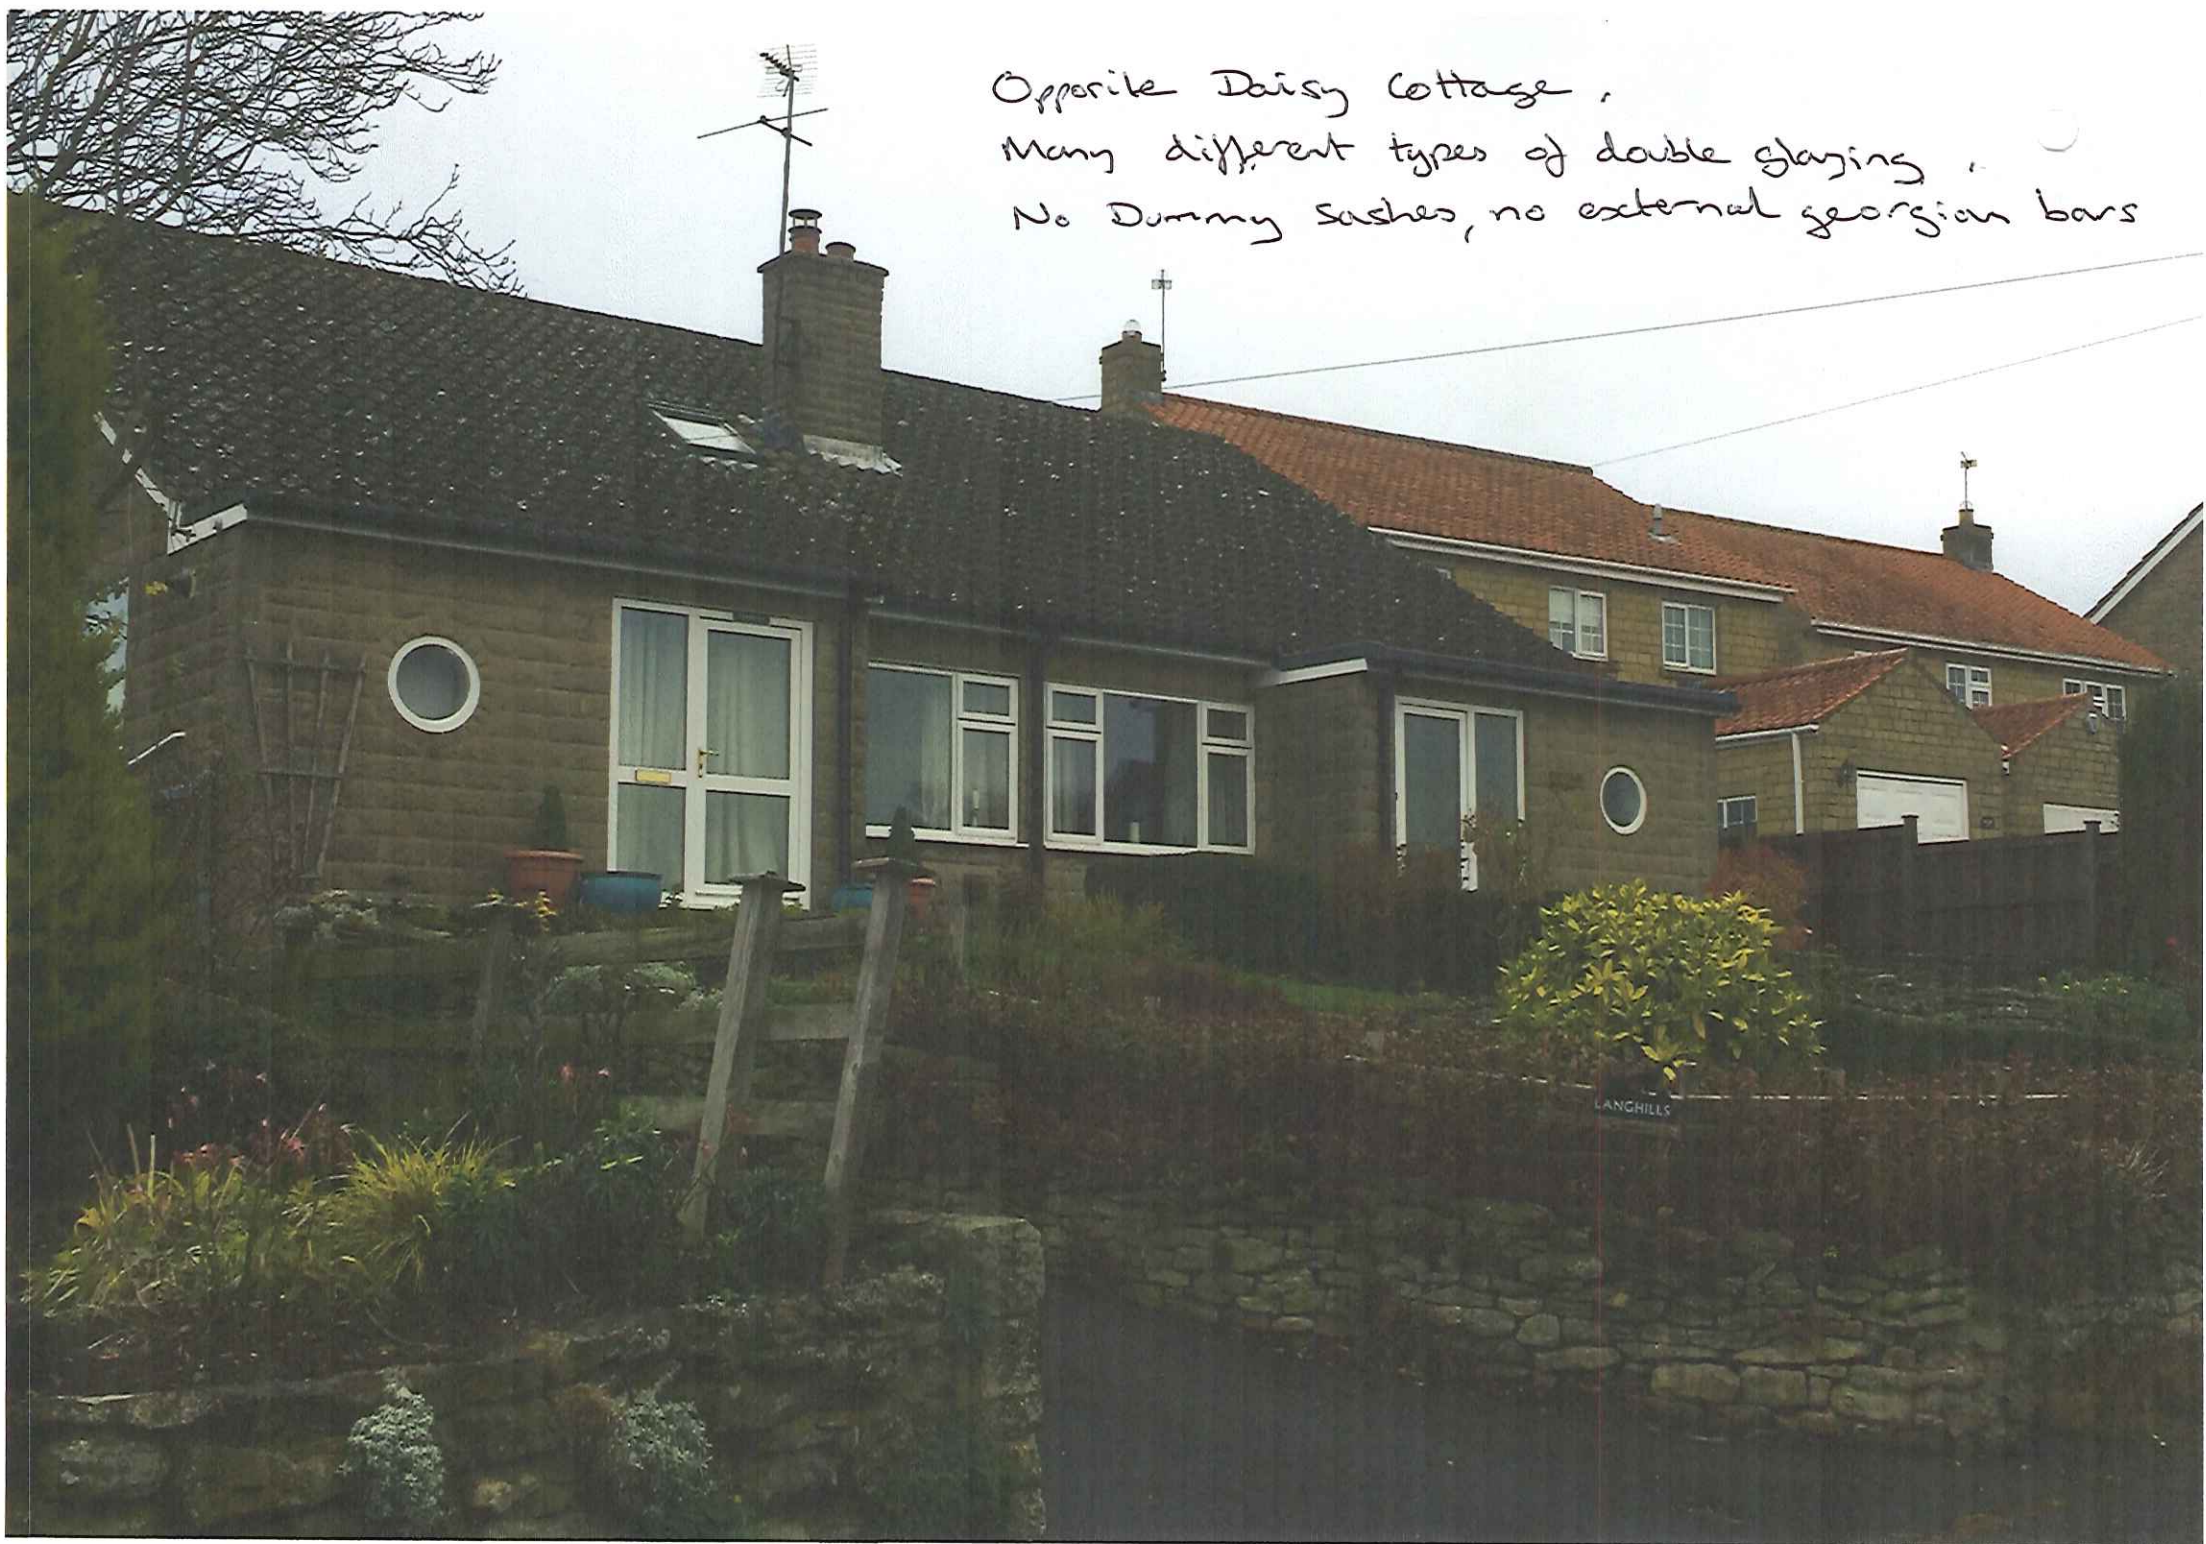
Opposite Daisy Cottage,
Many different types of double glazing,
No Dummy sashes, no external georgian bars

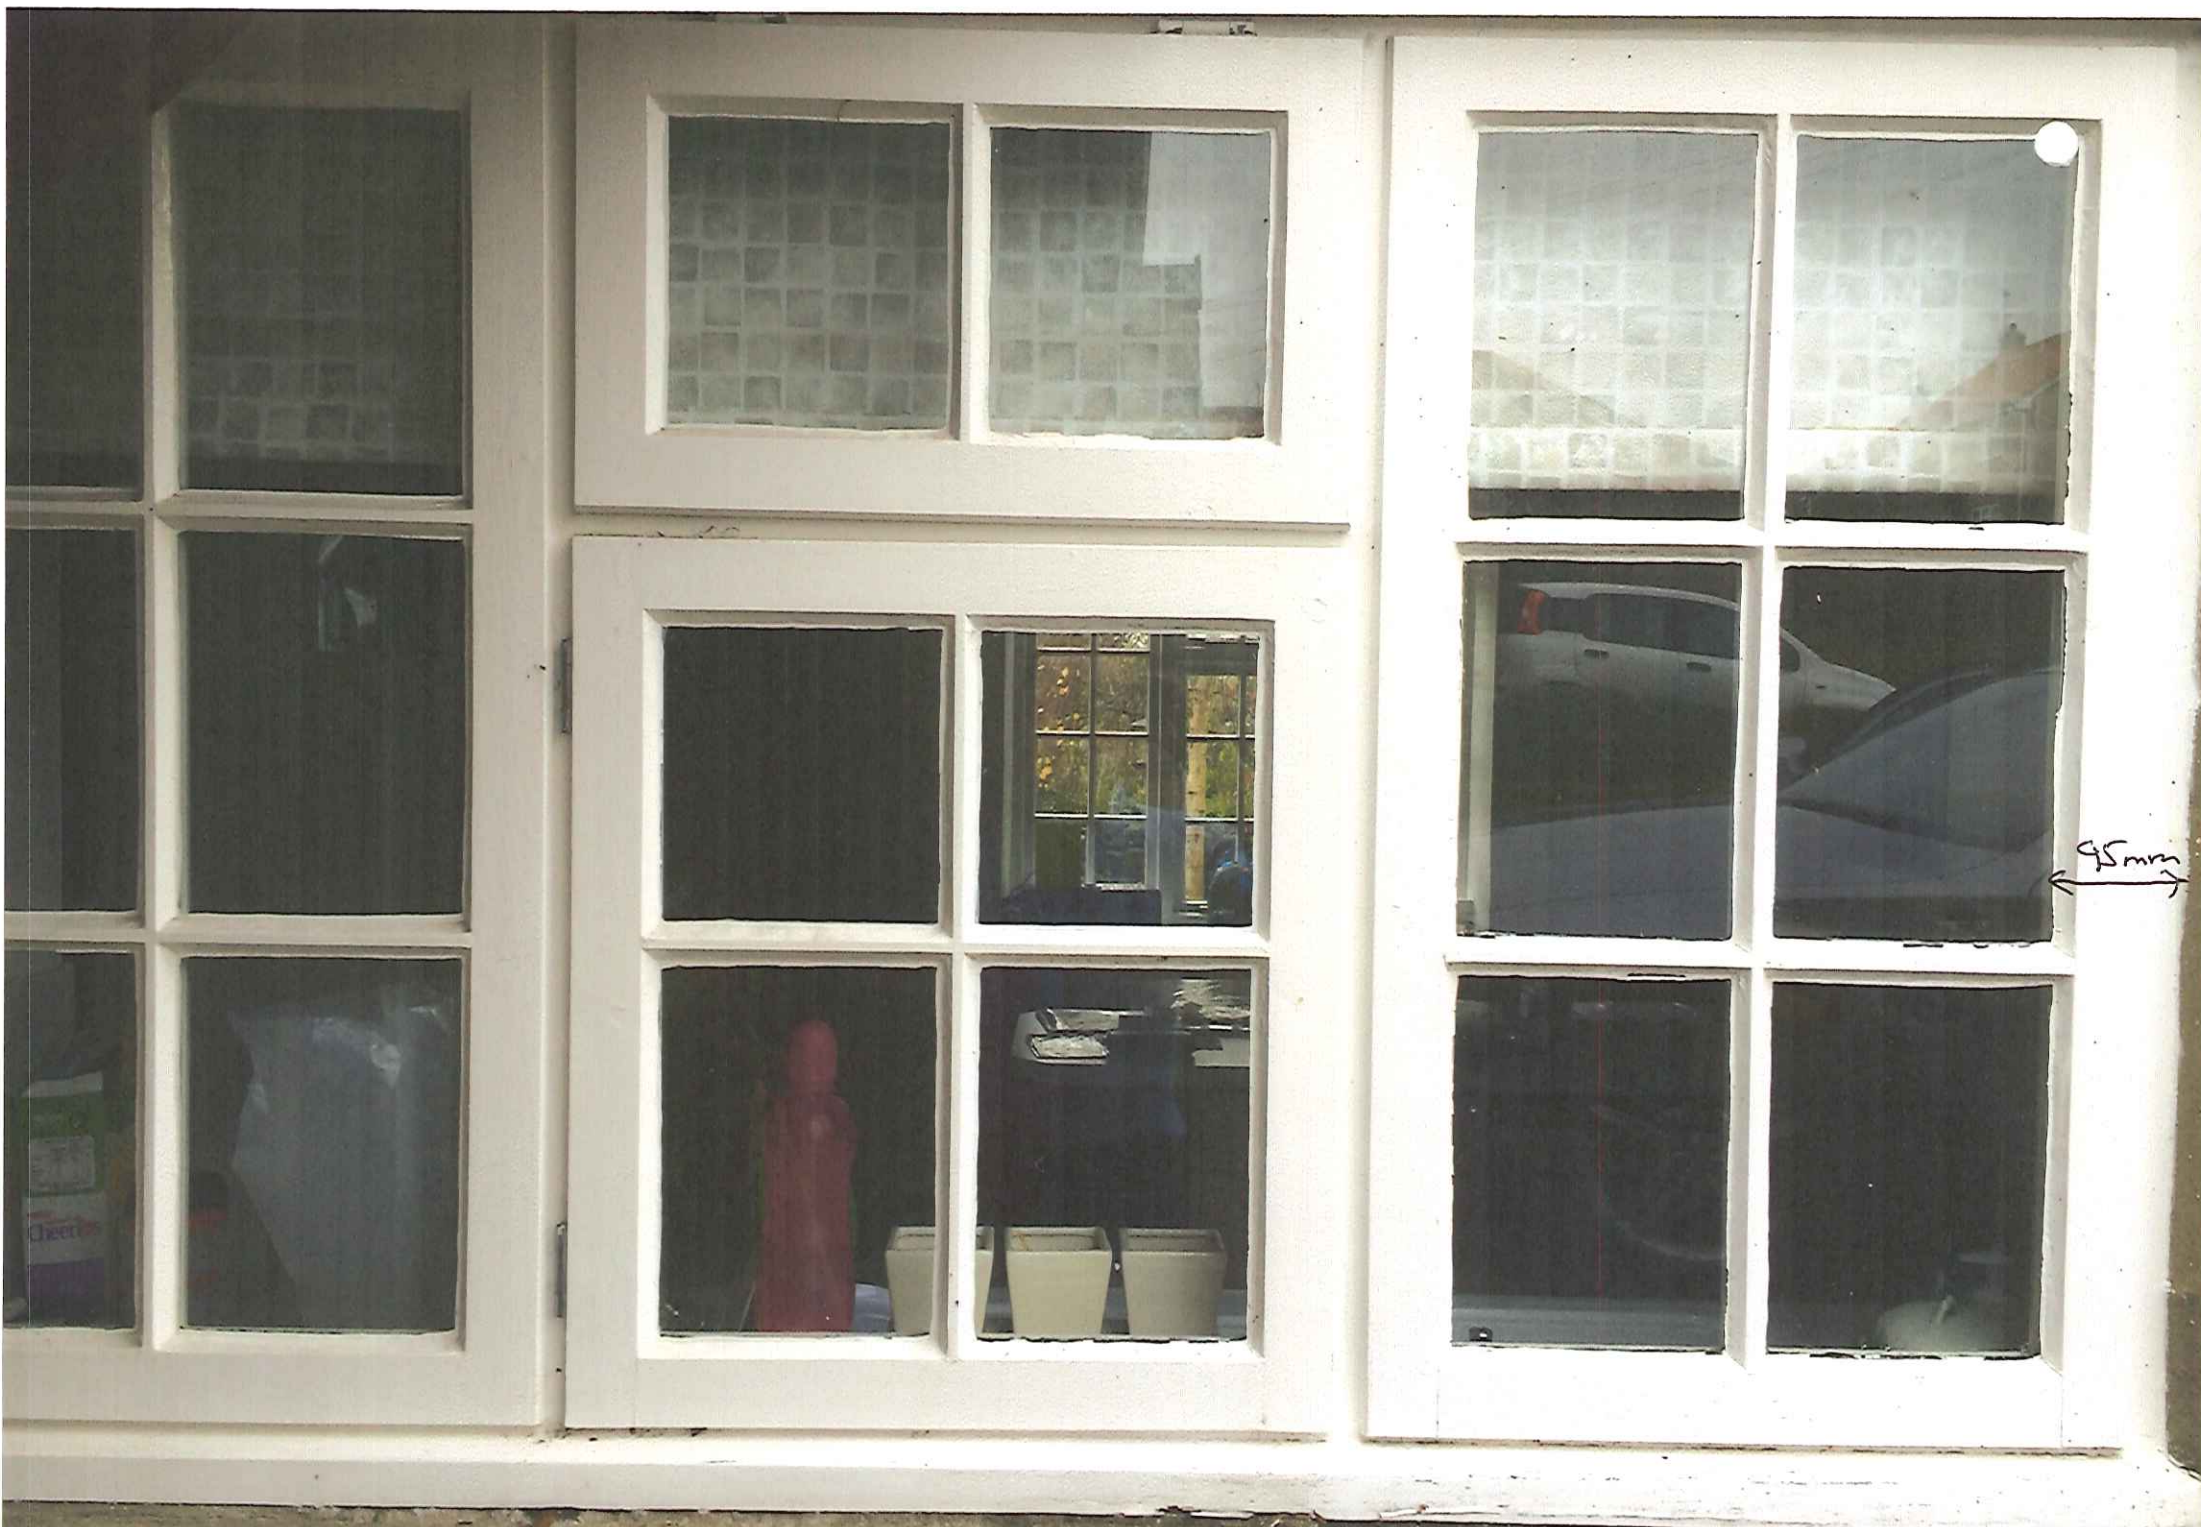
45mm

← Ugly Weather Seal

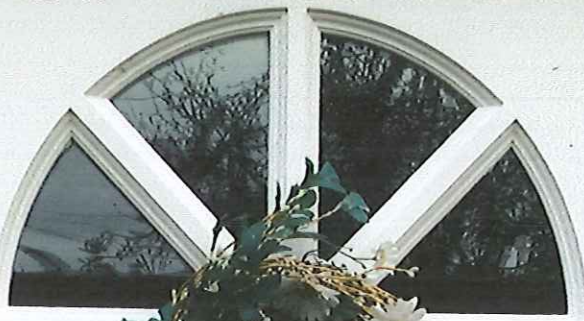
Very Bad State of repair.
Lots of heat loss through
this door.
