# MICHAEL MILLER BA. (Hons) ARCH. MCIAT Architectural Consultant

## HERITAGE STATEMENT for LISTED BUILDING CONSENT PROPOSED ALTERATIONS at YORK HOUSE. KING STREET. ROBIN HOODS BAY.

### 1.0. HERITAGE STATEMENT.

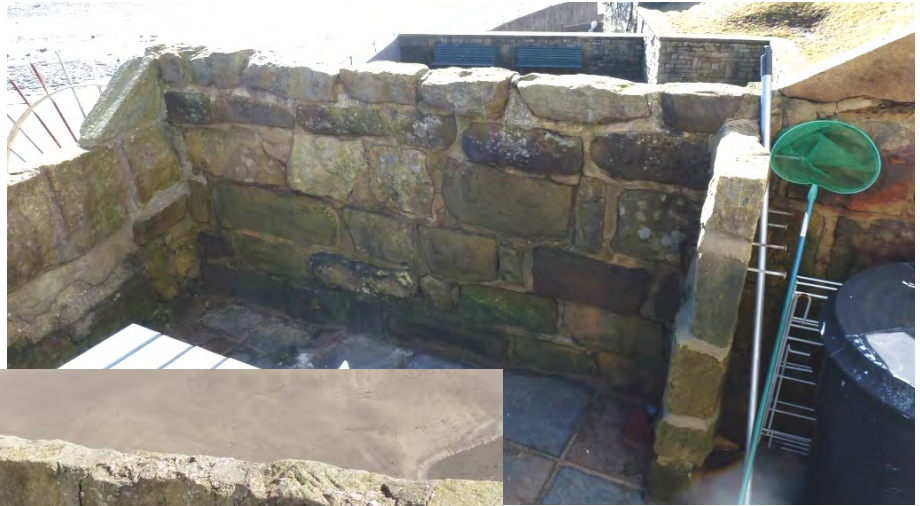
Photo 1. Terrace wall to east.

A free-standing wall constructed of natural stone extends from the neighbouring property along the northerly boundary of the site and returns to meet the host property along the easterly boundary. The wall is approximately 110mm thick at the top and could not be considered to be of adequate thickness for its height and location. Refer to BRE Good Building Guide No. 14 which states that such walls should be a minimum of 215mm thick and in an exposed location such as this, no more than 1075mm in height. The north elevation in particular shows signs of distress from weathering and the construction is abnormal where wall stones have been set on their edge and are disproportionately high.

It is intended that the wall be taken down to Terrace deck level and rebuilt in natural stone min. 215mm thick. Some of the existing stone can be re-used however it will be necessary to import second-hand stone to supplement this. The stone would be herringbone faced, squared and laid stretcher bond to match existing courses in the neighbouring wall. If the wall were to be constructed in two leaves bonded together, then the internal face would be 'fair faced' stonework. If the wall is to be solid then the internal face would be sand/lime rendered with a compatible white colour-wash finish.

A sawn stone capping is to be installed and a simple iron railing along the top. Detail shown on 193.10 Ground Floor Plan as Proposed.

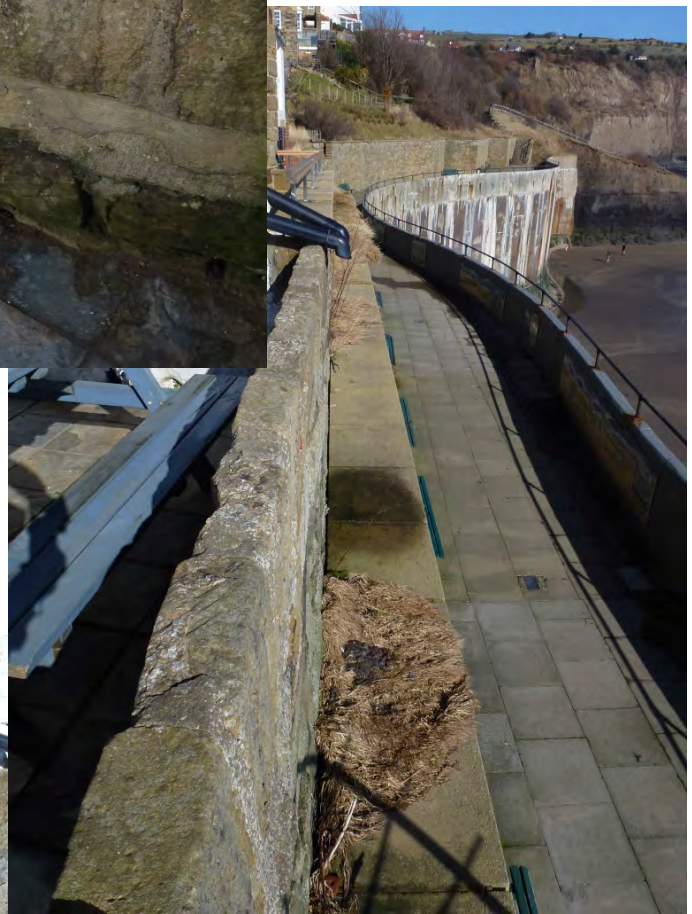
Above.  
Photo 3 shows narrow wall

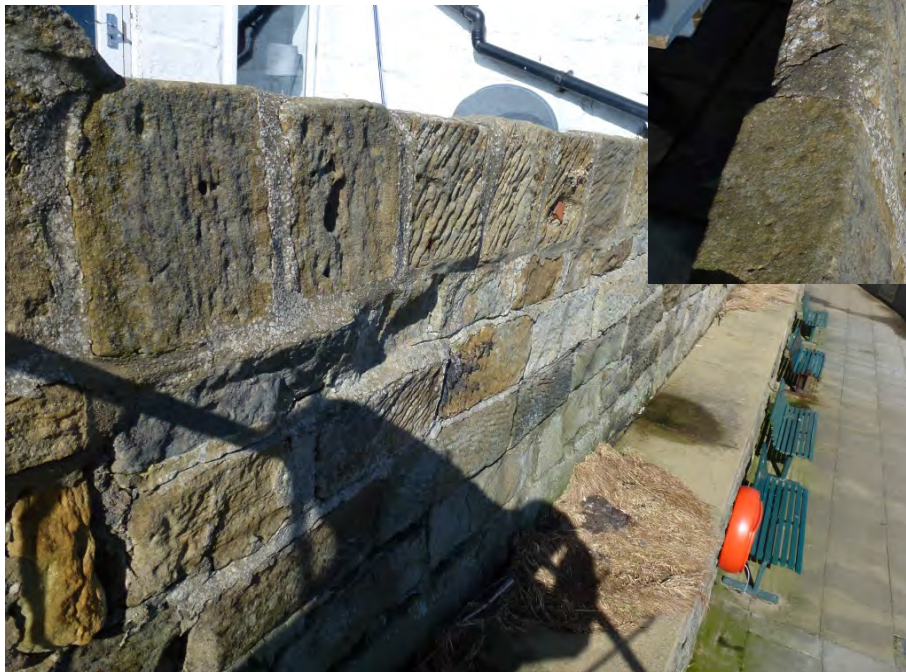
Side.  
Photo 4. shows weathering and  
high coursing

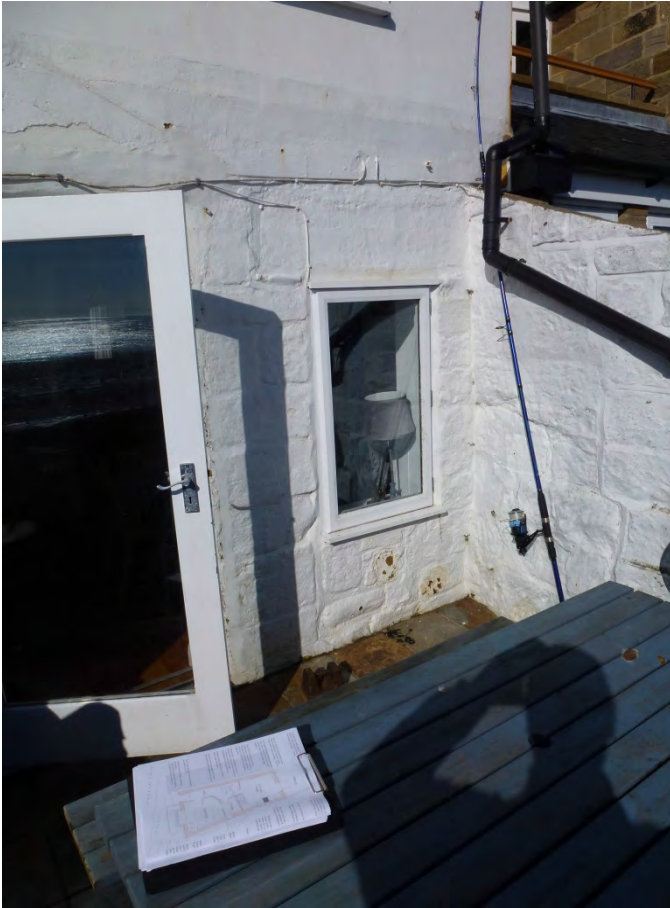
Photo 5. Existing Kitchen window frame and door.

This is presently a side hung outwards opening casement window which is not of traditional vernacular style. The applicants would like to replace the window with a vertical sliding sash model. This would need to have an integral spring balance operating mechanism which would be rebated into the sashes in order to provide a reasonable amount of glazed area.

The existing door is a simple glazed 'picture window' style and not a version that one would expect to see in a building such as this.

A detail of the proposed window frame is shown in drawing 193.14

The applicants would like to replace the door and frame with that as shown in the drawing 193.17.

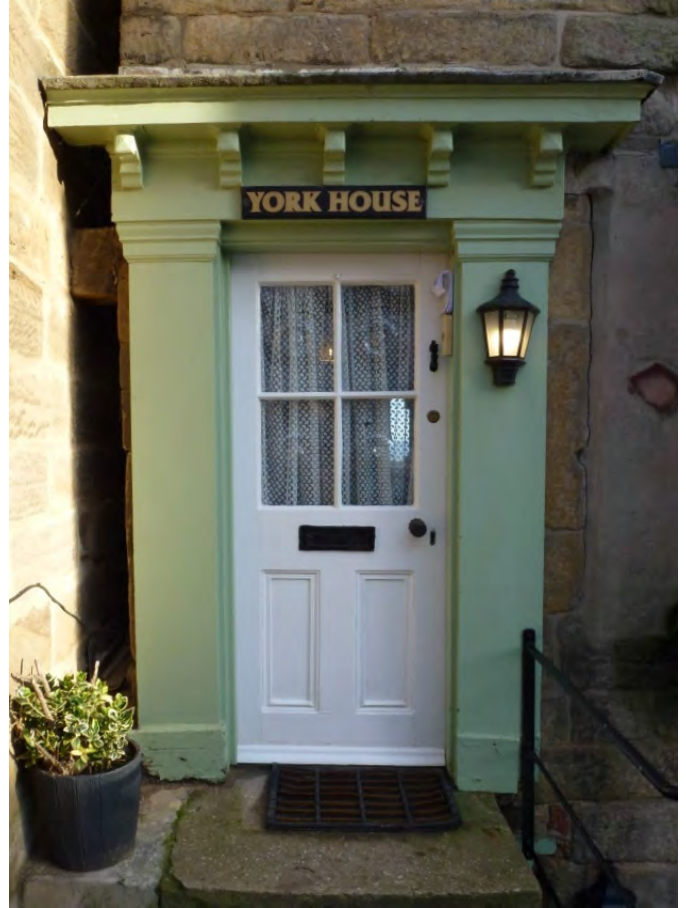
Photo 6. Existing Front door.

The existing door is bowed and does not fit the frame effectively and replacement is required.

Where necessary the existing frame should be removed and replaced on a like-for-like basis.

The door should be the same as existing or as drawing 193.17.

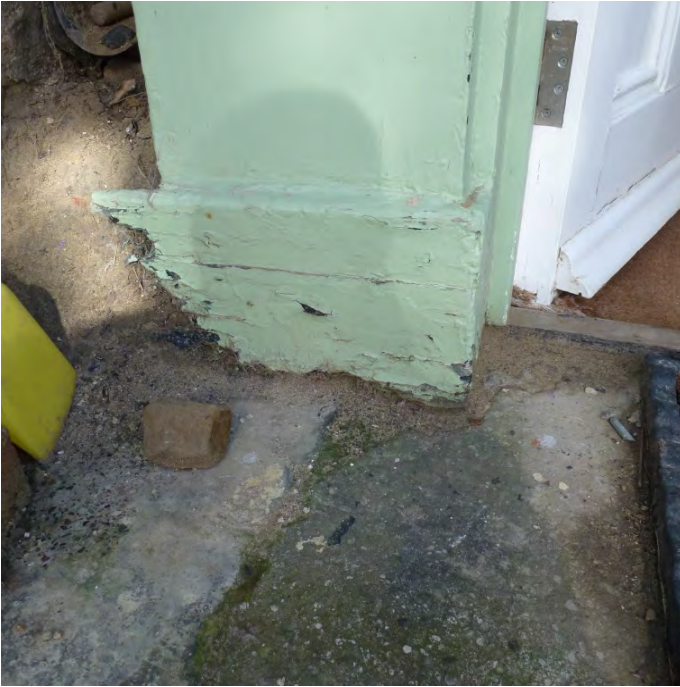
Photo 9. Front door surround LHS

Defective pilaster panels to be replaced on like-for-like basis. Photographs 9 and 10.

Replace lead work to top of door surround on like-for-like basis.

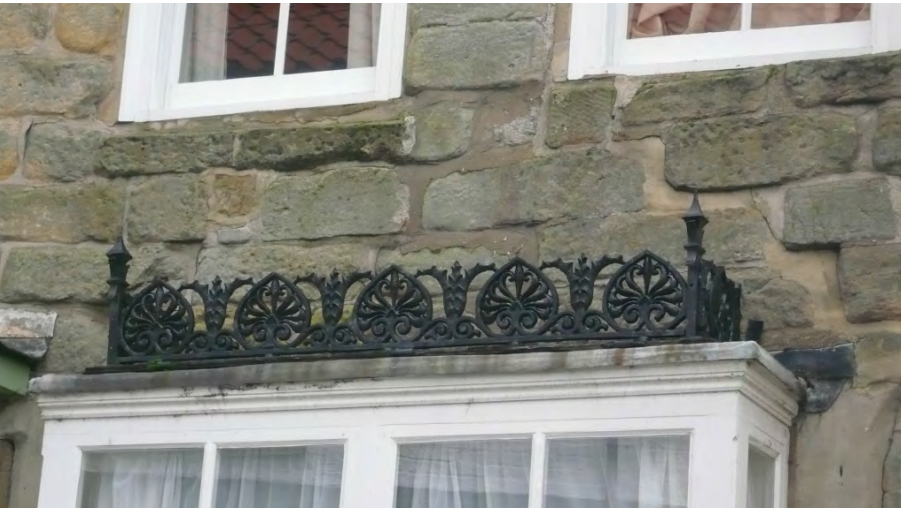
Photo 11. Bay window head & first floor sills

Replacement of stone heads and sills on a like-for-like basis as these are broken, unless Structural Engineer's Report advice varies.

Replace lead sheet roof covering on a like-for-like basis. Photograph 11.

Remedial measures at head/wall as necessary to be taken following issue of Structural Engineer's Report

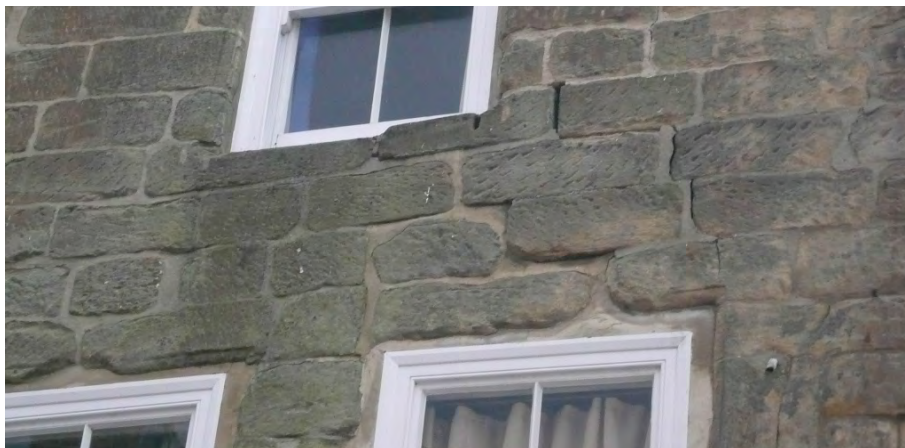
Photo 12. First Floor heads Second Floor sill.

Replacement of stone sill on a like-for-like basis as it is defective, unless Structural Engineer's Report advises otherwise.

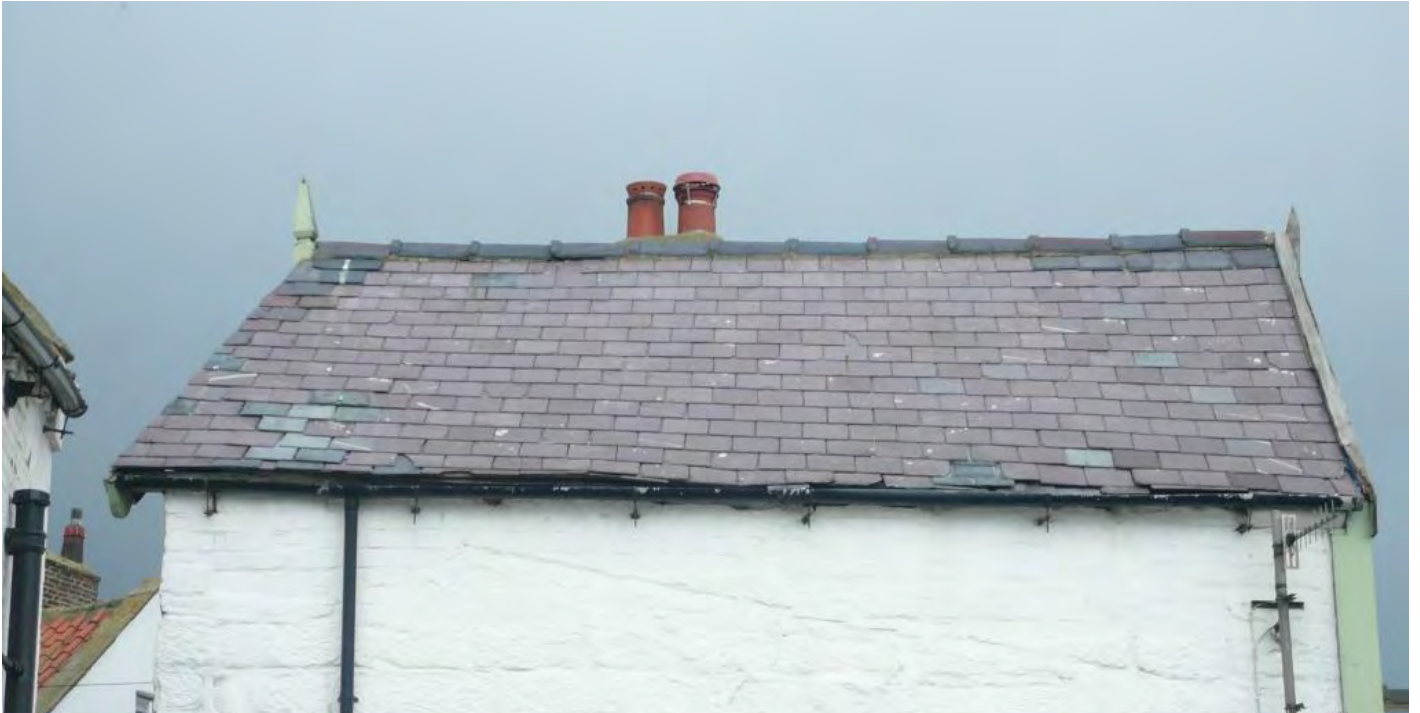
Photo 13. Main Roof.

The main house and recent extension are covered by natural slate roofs. It is clear from visual inspection that both roofs require re-laying as the slates are uneven, missing and yawning.

New timber battens are to be fixed over a breather membrane and slating re-laid in accordance with BS.5534.

Replacement treated timber barge boards like-for-like to be fitted and painted as existing.

The applicants would like to improve the appearance of the rainwater goods and would like to propose that cast aluminium be installed. The system would be black powder coated of proprietary manufacture and a 'heritage' model which would be similar in appearance to a cast iron system.

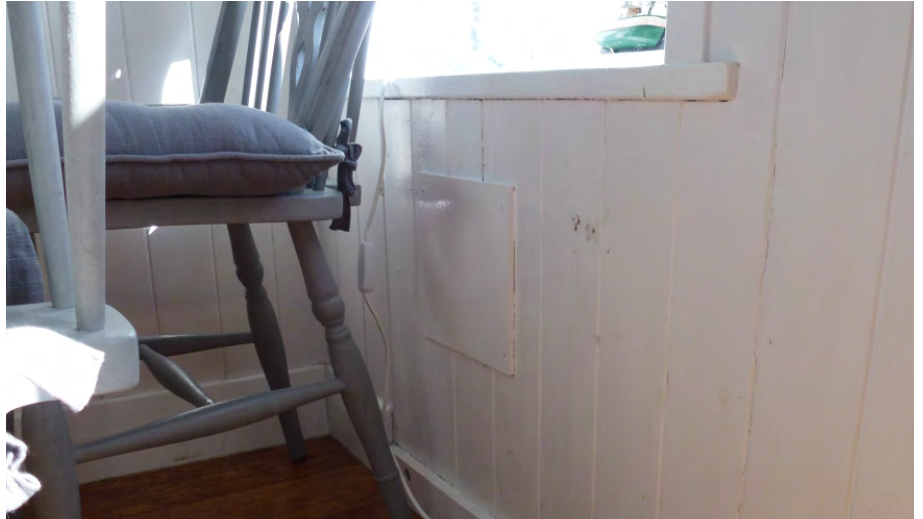
Photo 15. Kitchen Window.

Matchboarding

Repair modern match-boarding like for like.

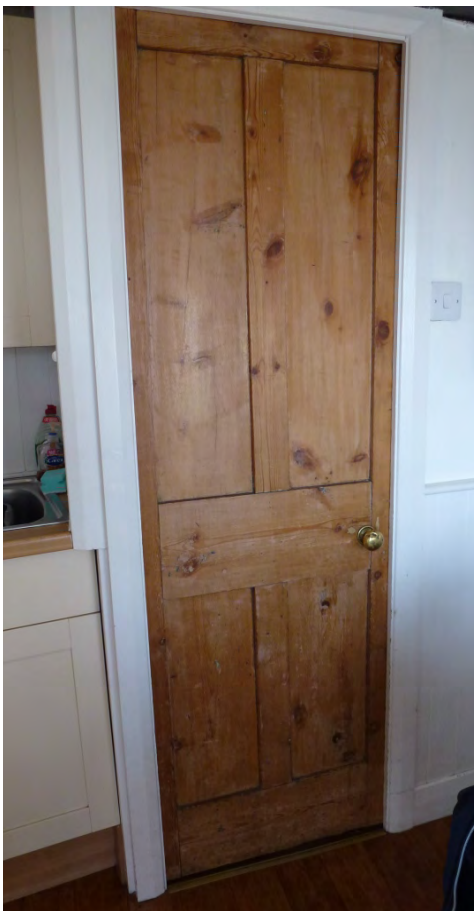
Photo 17. Kitchen/Hallway Door.

Approx 640mm x 1954mm. Existing door is a four flat panel version made of pine and shows joint glue failure due to being 'dipped'. The hinge stile has been excessively planed and it is considered that this is a recent reclaimed addition. The applicant would like to replace this door with an equivalent style. This would need to be a better reclaimed version or, since the opening is not a standard size, a purpose made timber door.

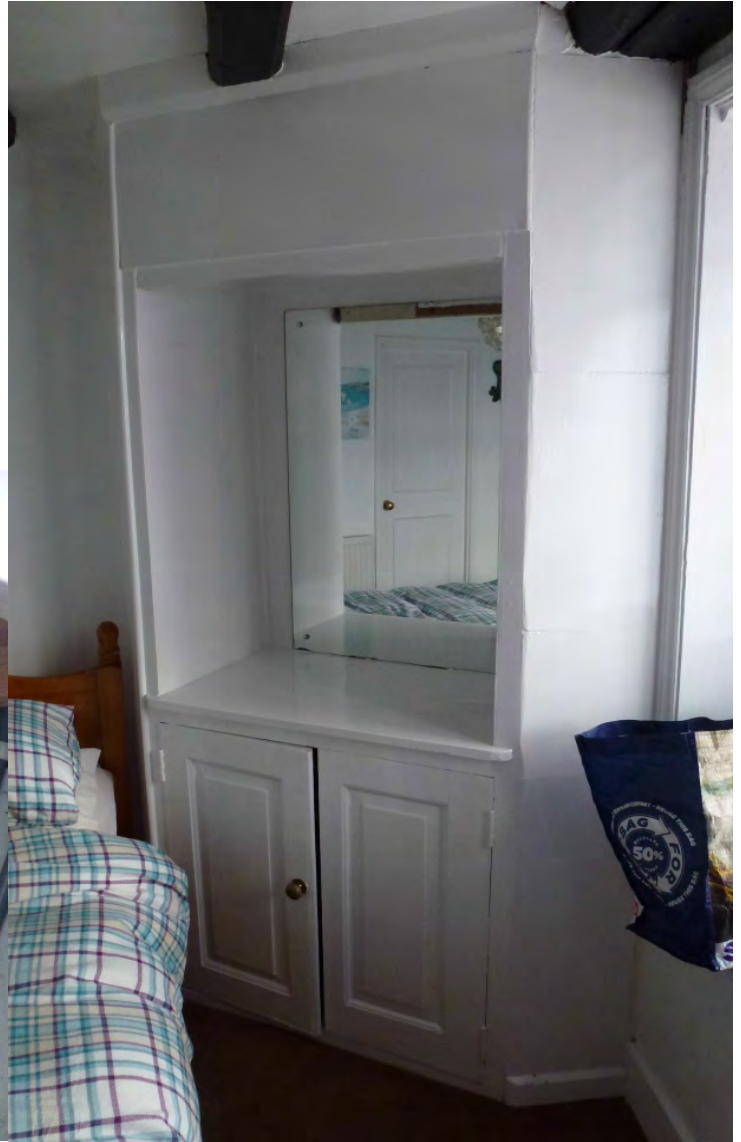
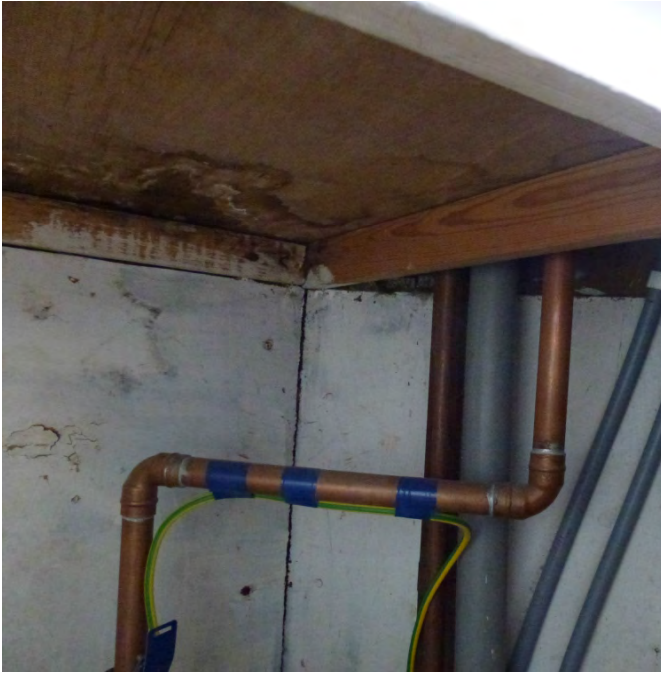
Photo 18. GFL Front Bedroom.  
Built in Corner Unit

Corner cupboard of recent origin has been formed in timber frame and plywood as shown in the photographs. It also acts as a vertical riser duct for services. The intention is to remove this feature and form a new service duct to allow space for a free-standing piece of furniture.

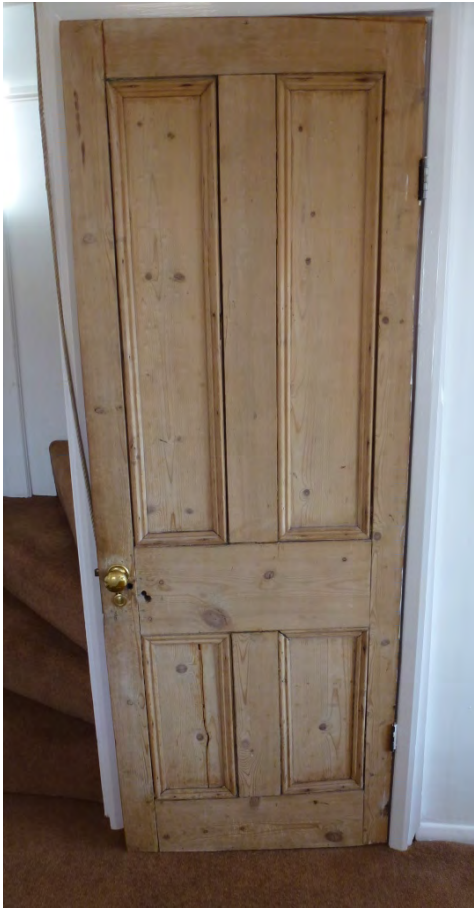
Photo 20. FFL Door to Staircase

Approx 705mm x 1940mm. Existing door shows joint glue failure due to being 'dipped'. The stiles have been planed in order to fit it into the frame and it is considered that this is a recent reclaimed addition. The applicant would like to replace this door with an equivalent style. This would need to be a better reclaimed version or, since the opening is not a standard size, a purpose made timber door.

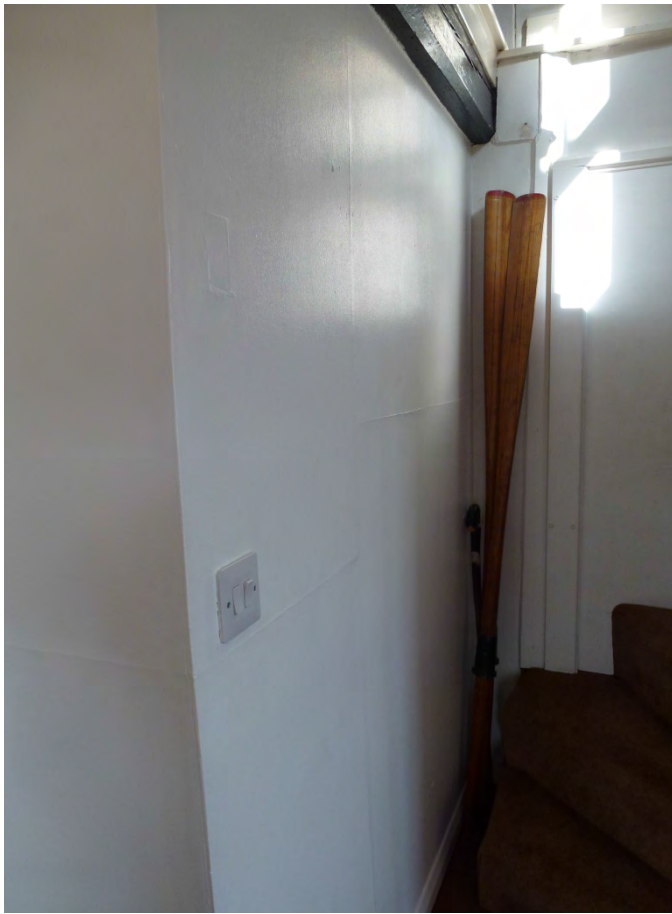
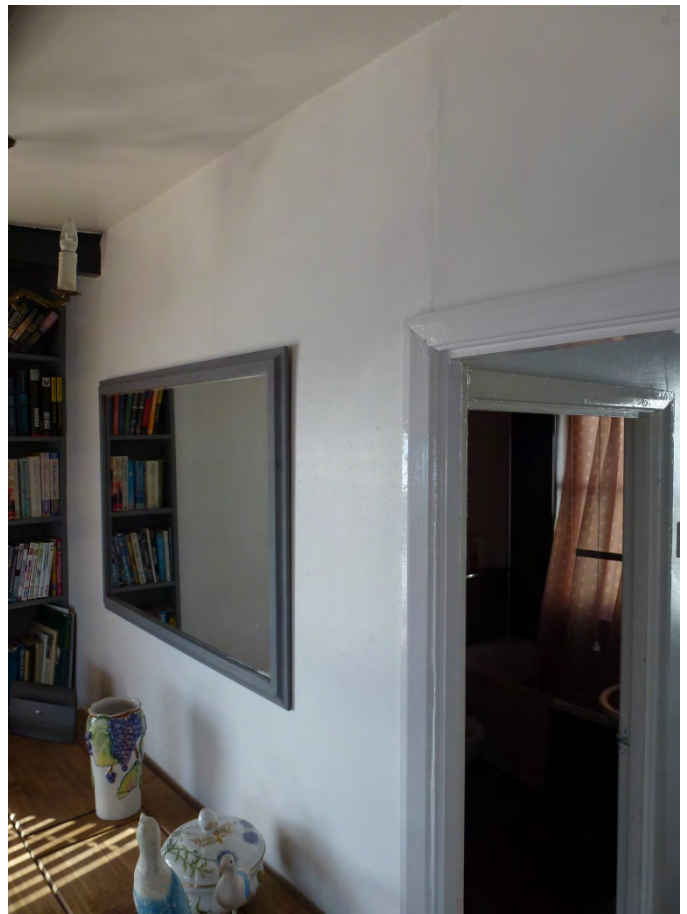
Photo 22. Partition to FFL Front Bedroom Entrance

It is intended that access to the rear Bedroom be modified in order to provide easier access as the door presently opens against the bed. The partition which requires modification is a modern stoothing wall with plasterboard and skim finish. The new partition flanking wall is to be constructed similarly and the existing door re-used.

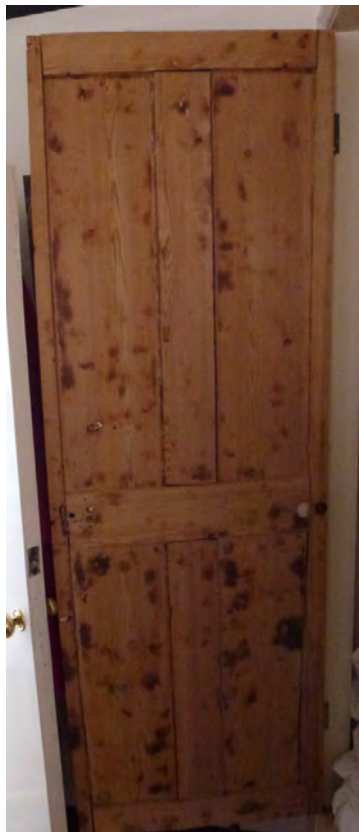
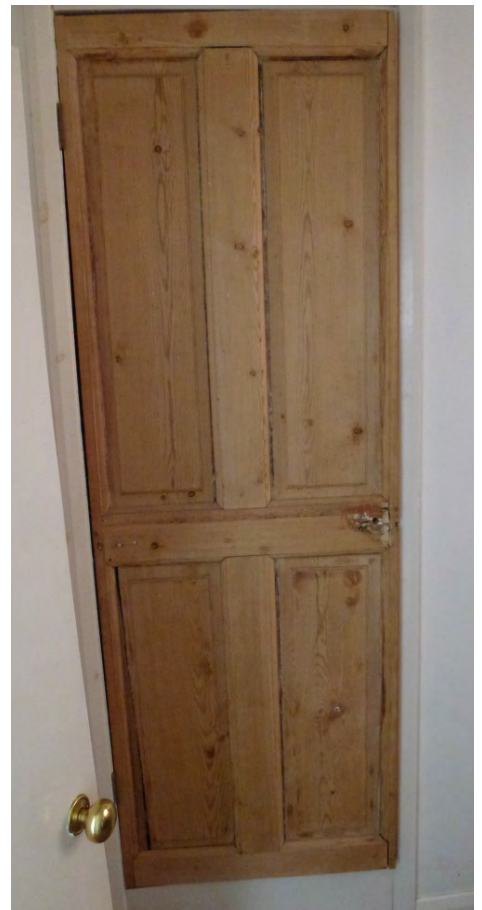
Photo 24. Airing Cupboard.

Approx 620mm wide, the existing door shows joint glue failure due to being 'dipped'. The stiles have been planed in excess in order to fit it into the frame and it is considered that this is a recent reclaimed addition. The applicant would like to replace this door with an equivalent style. This would need to be a better reclaimed version or, since the opening is not a standard size, a purpose made timber door.

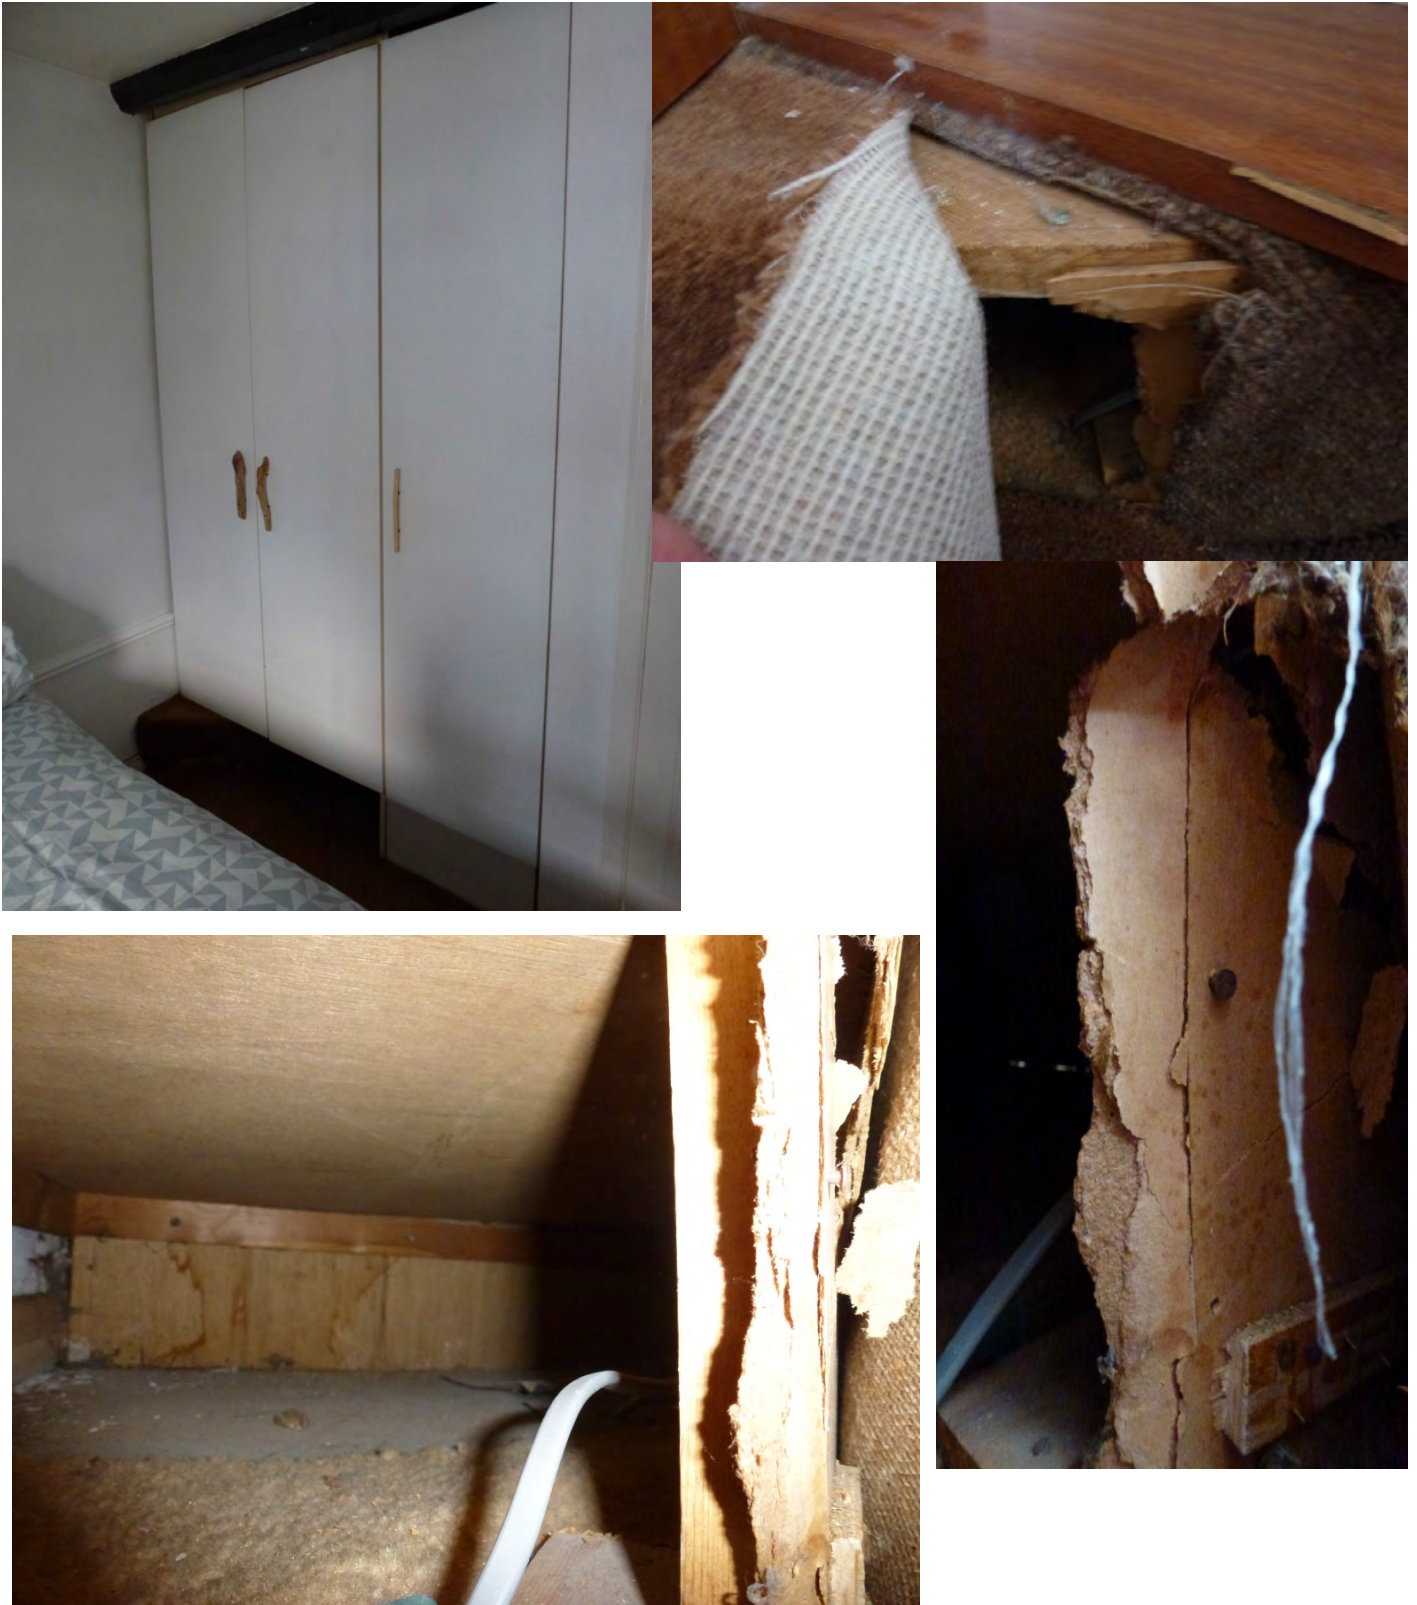
Photo 23. FFL Front Bedroom Built in furniture

Existing built in wardrobe constructed of timber frame and Melamine to be removed. Angular corner is of plywood and timber frame construction and is to be removed to allow for free standing furniture piece which is more constituent with the character of the building.
