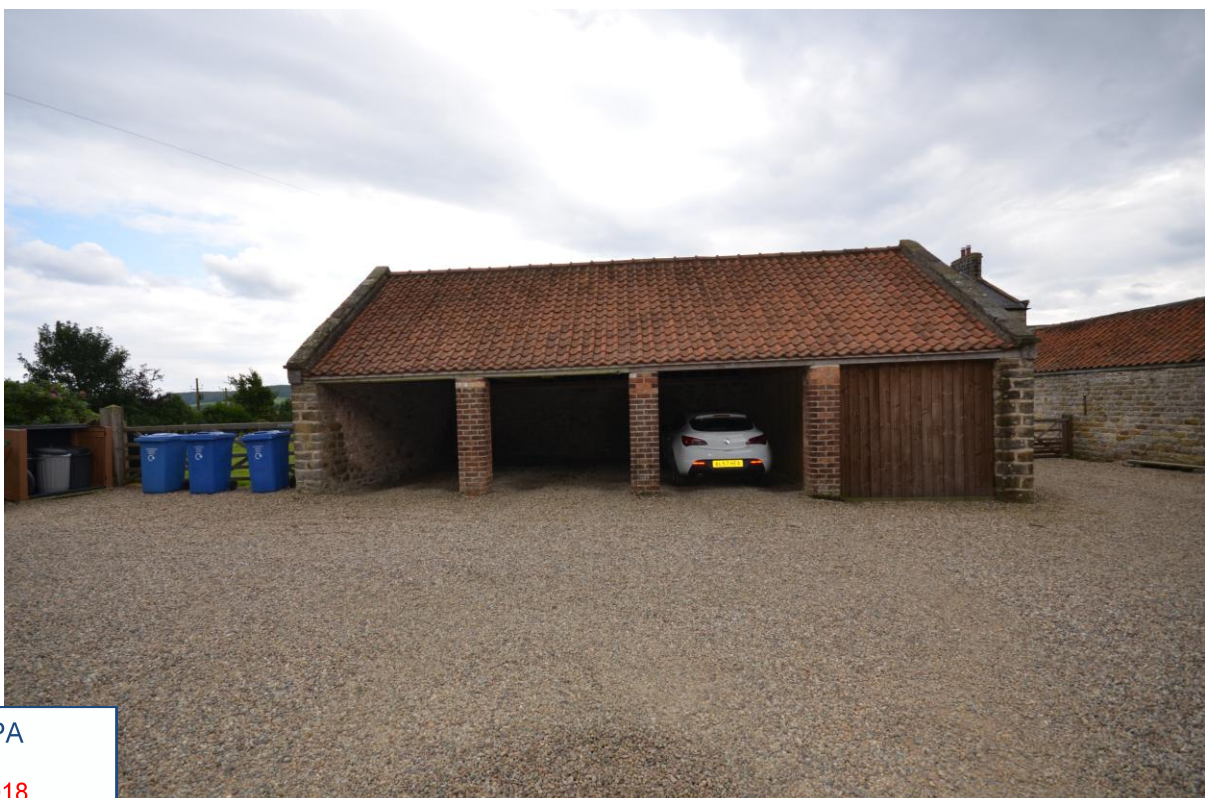
- a. North elevation of barn which has recently been refurbished with a new roof and pointed masonry, it was obviously intended as a garage to the Farmhouse and is now redundant with the Farmhouse being used as a holiday let.

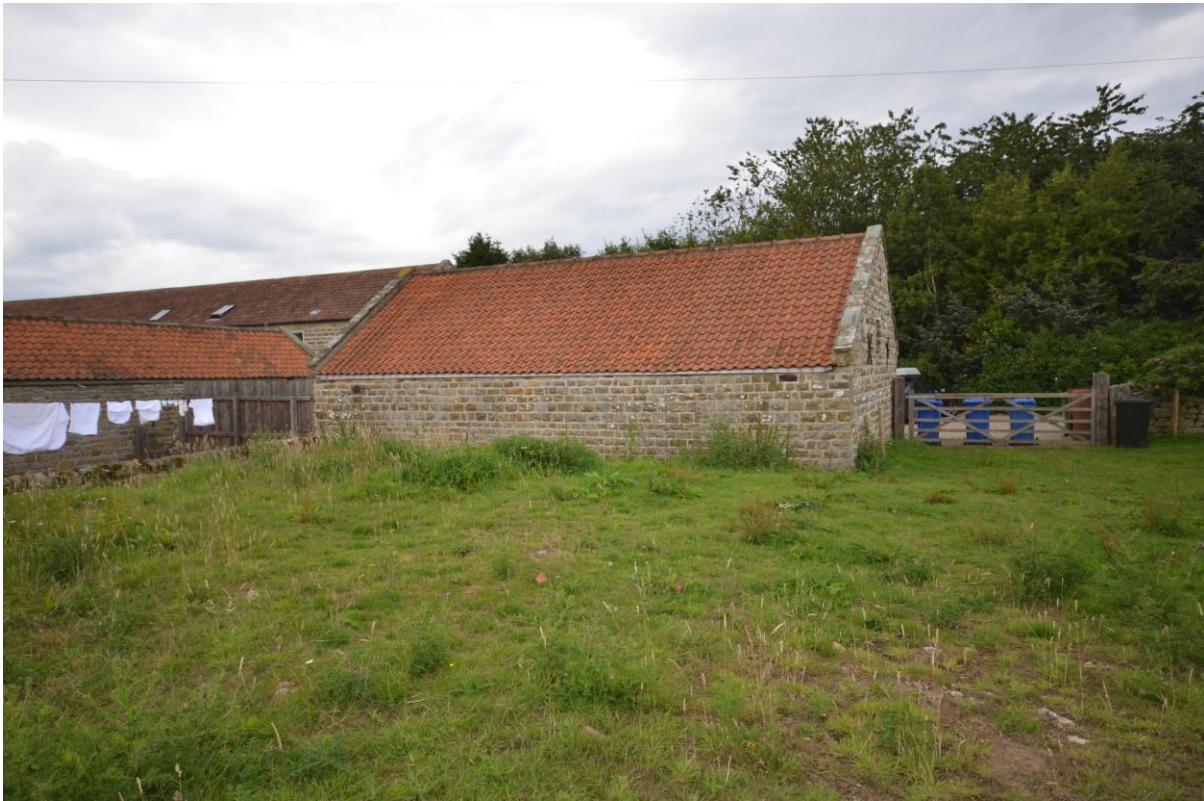
- b. South side of proposed Rowan Cottage, again this has all been reroofed and repointed.
- c. West elevation of proposed Rowan Cottage, it is usually the case that the cross ties are not doing anything useful to the building structure and it will be possible to remove these; the gables will then be appropriately anchored into the structure internally.

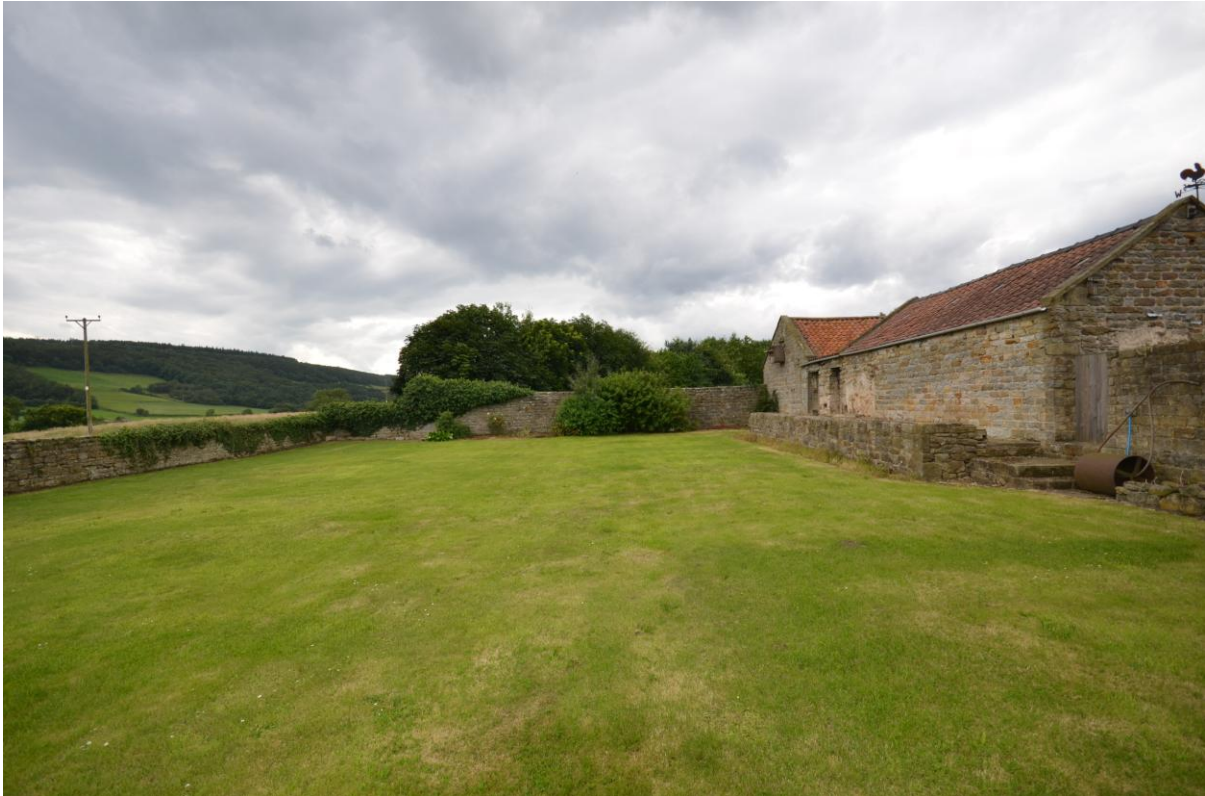
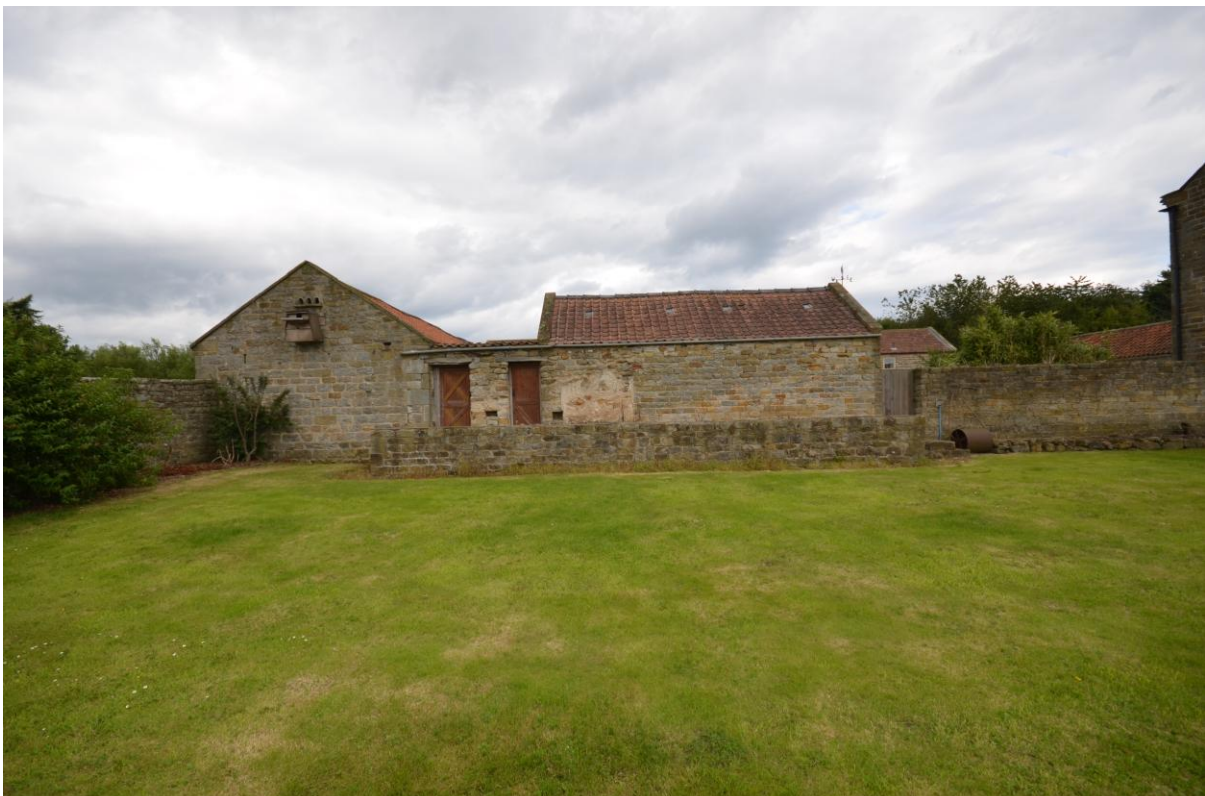
- d. View of the south elevation of proposed Hornbeam Cottage. The walled garden area has been cleared by previous owners removing the mature division hedge and what was probably an orchard / kitchen garden. The plinth to the greenhouse arrangement which is visible on the Google Earth photograph is evident to the south of the building.
- e. Further view of proposed Hornbeam Cottage with the greenhouse plinth and lawn area.

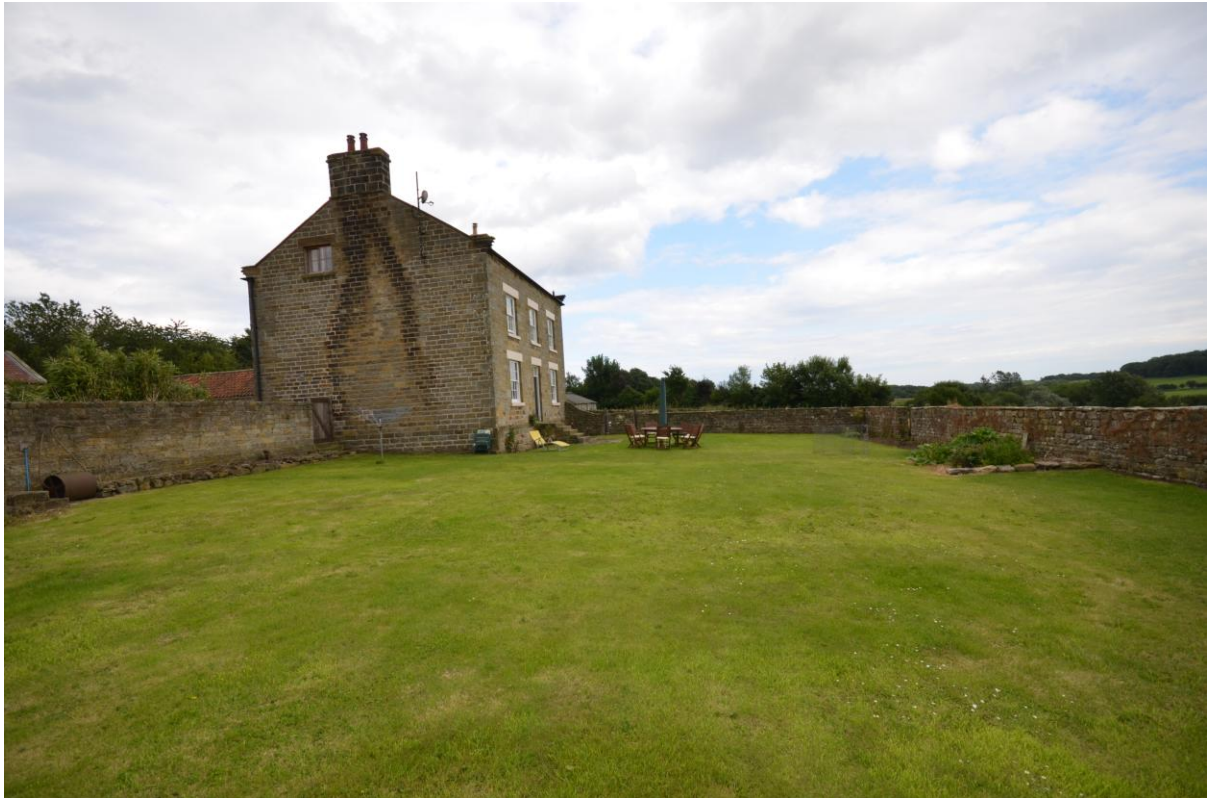
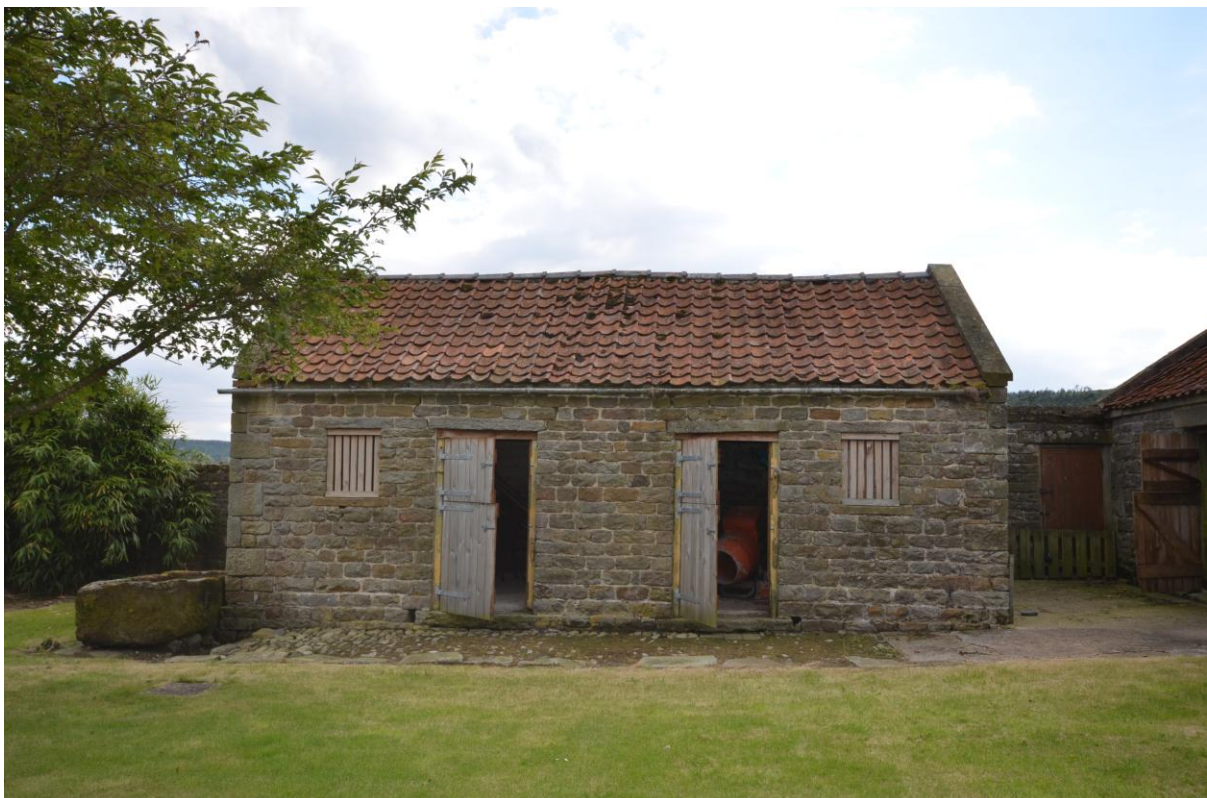
- f. View from the proposed garden to Hornbeam Cottage looking towards the Farmhouse / Listed Building, prior to 2009 this area was divided with a mature hedge.
- g. View of the north elevation of proposed Hornbeam Cottage, it is intended that the existing openings are retained with simple glazed screens; it is also generally evident that the building is in reasonably sound condition.

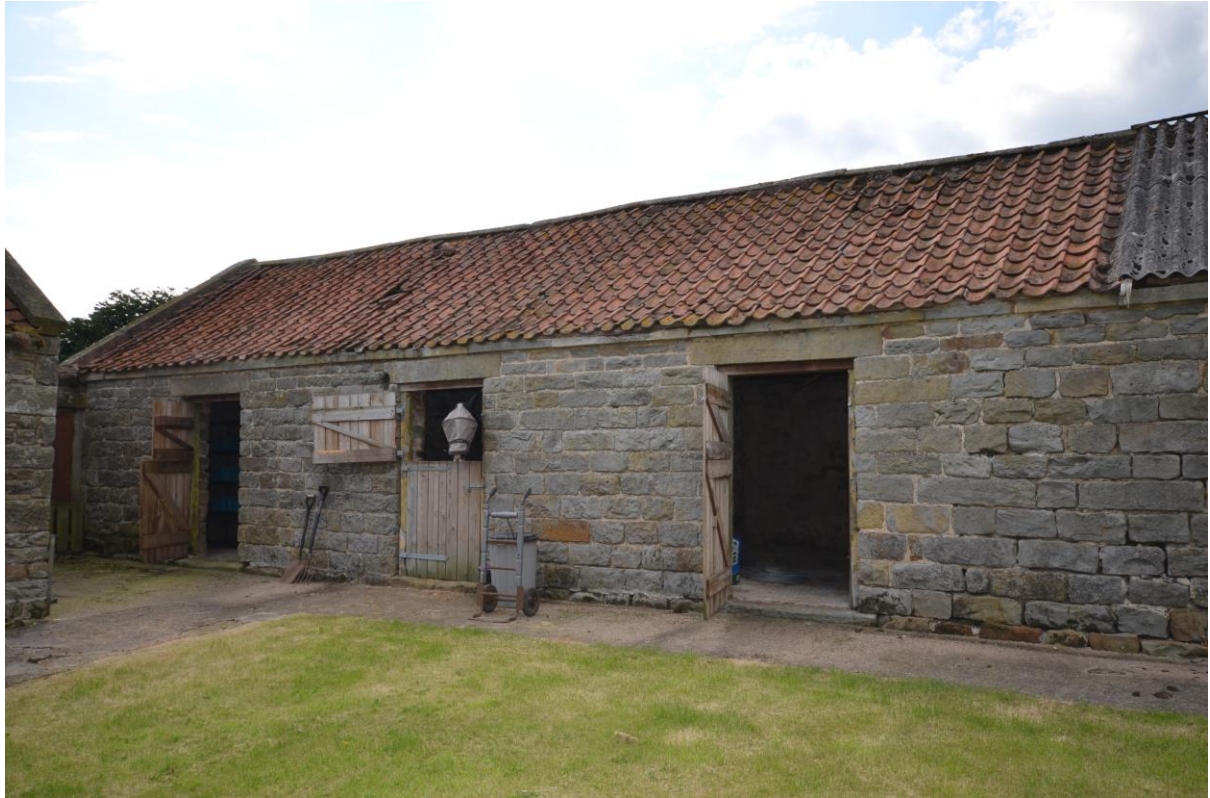
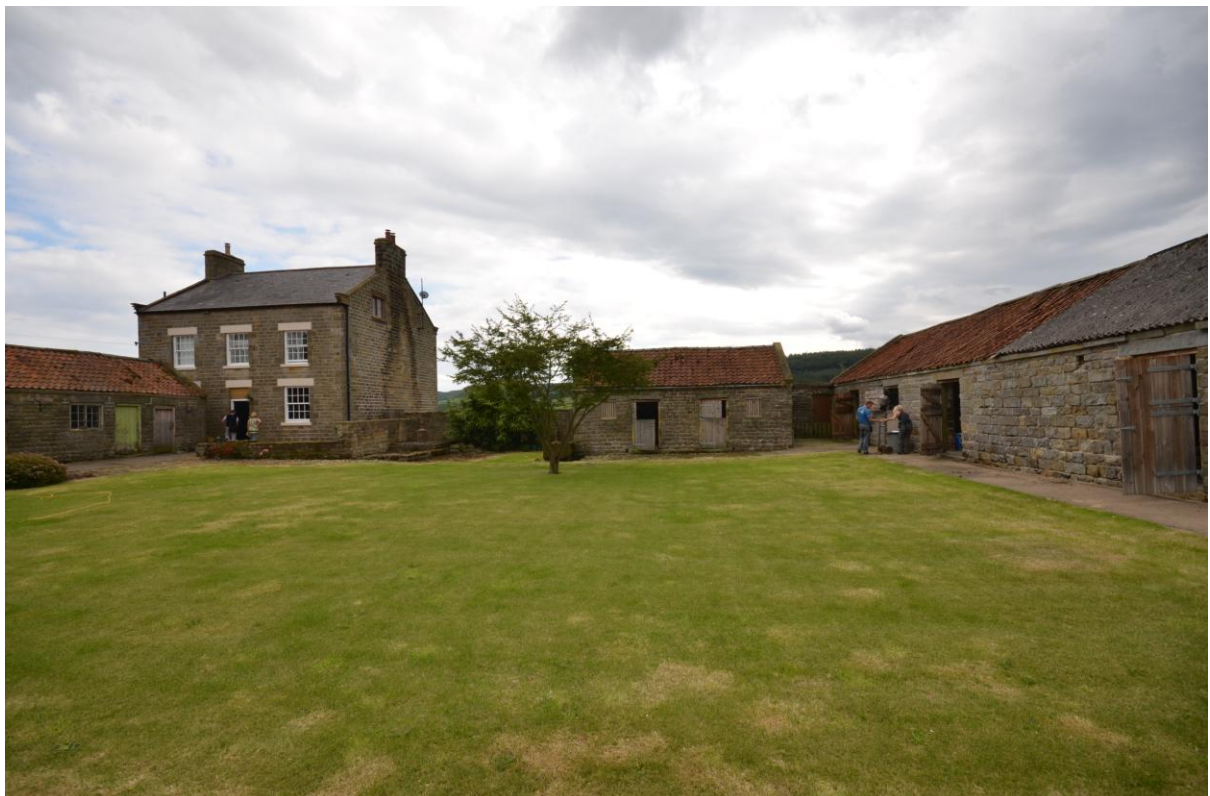
- h. View of the east wing to proposed Hornbeam Cottage, again it is intended that the existing openings are retained and again it is obvious that the buildings are in reasonably sound condition for their age.
- i. View of proposed Hornbeam Cottage across the internal courtyard looking south.

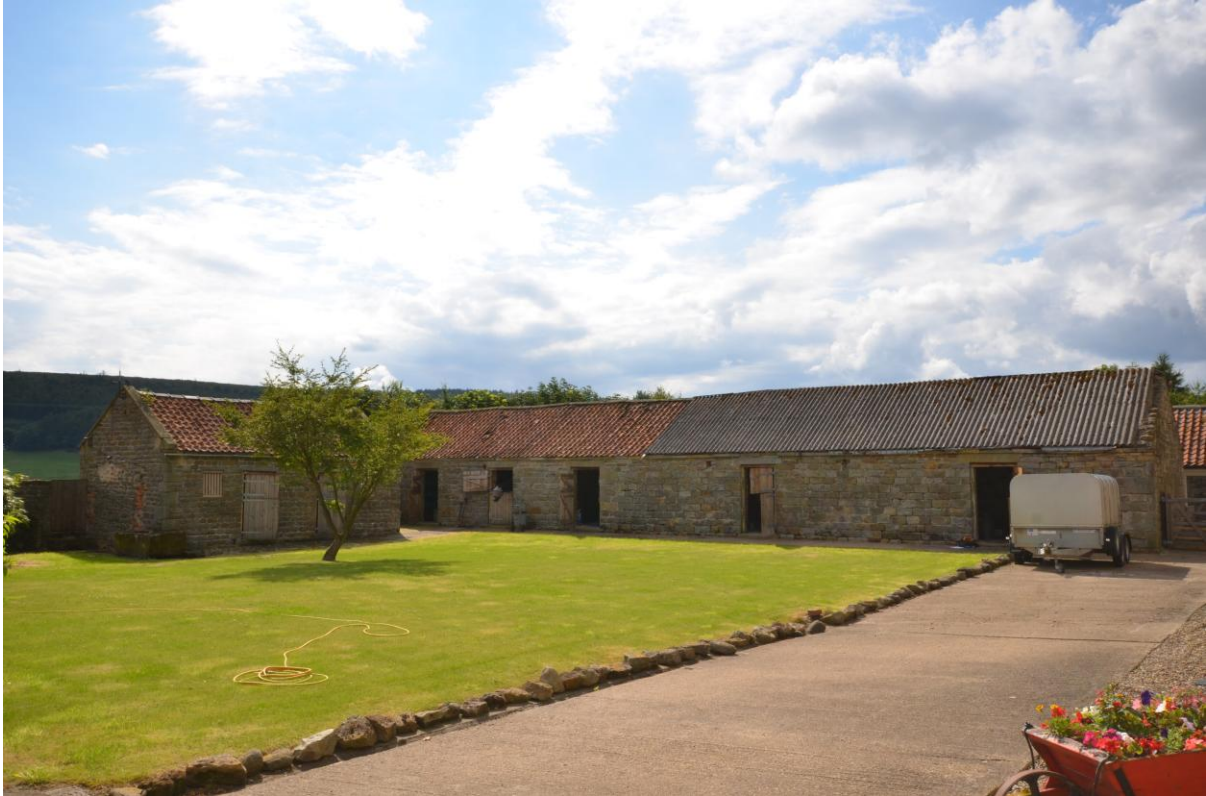
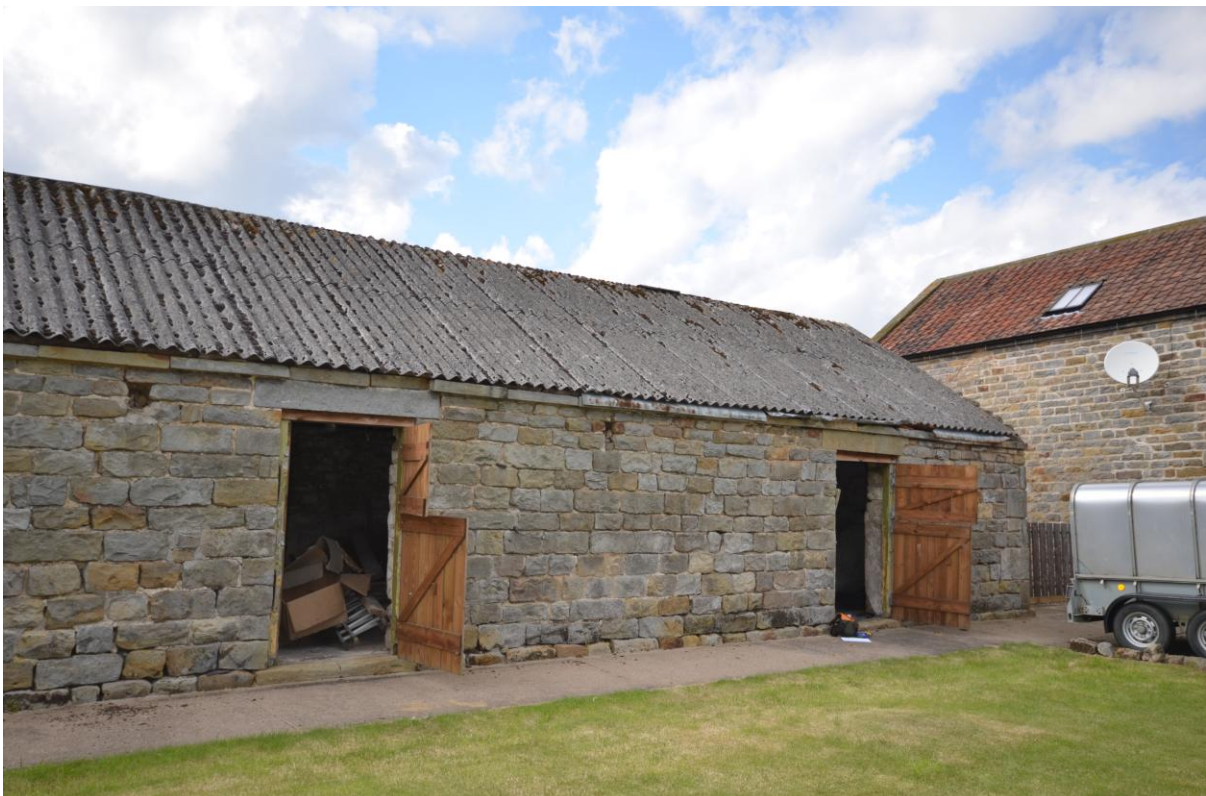
- j. Further view looking towards proposed Hornbeam and Mulberry Cottages across the courtyard looking south west. Permission has recently been granted for replacing footpaths round the courtyard with natural stone paving.
- k. East elevation of proposed Mulberry Cottage, again the barns are clearly sound. The asbestos sheet roof is probably 30-40 years old and clearly the development would benefit with the roof being replaced with matching terracotta pantiles. It is proposed that a further opening is formed to match the existing openings and reflecting the three openings to Hornbeam Cottage.

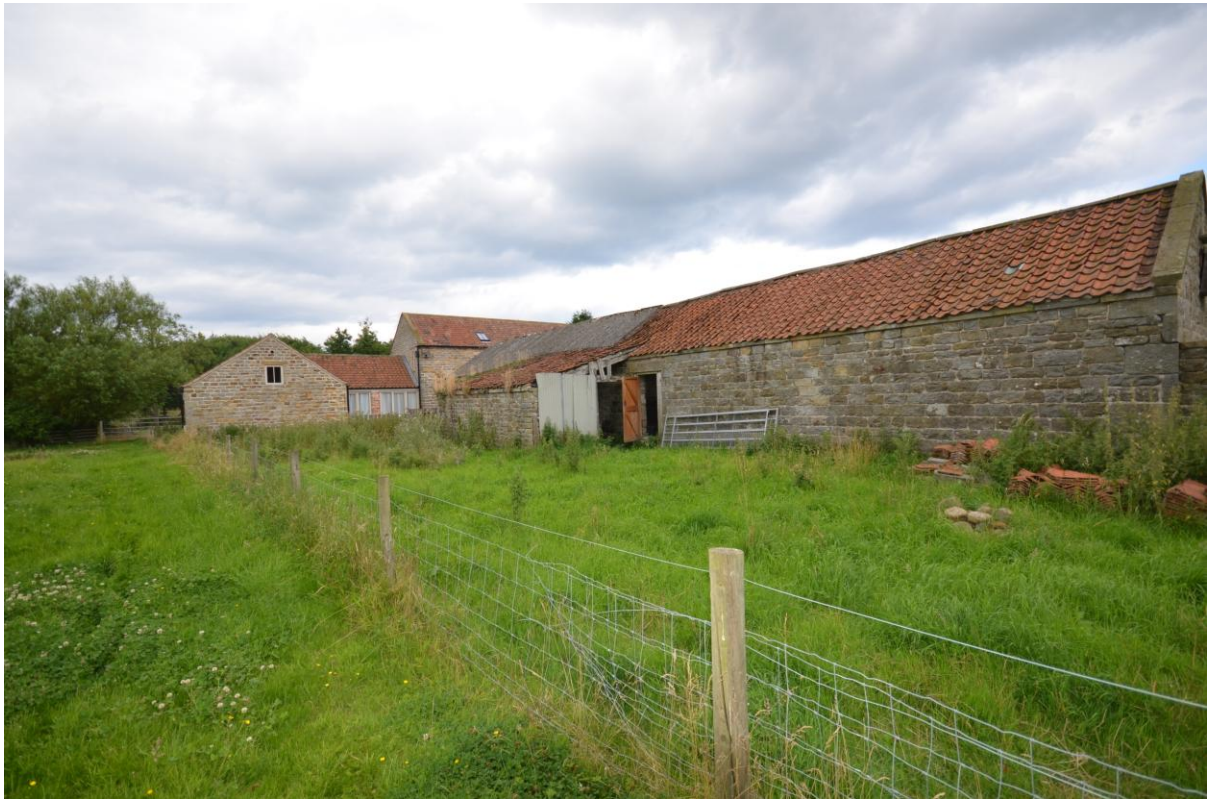
- l. View of the west elevation of proposed Mulberry and Hornbeam Cottages with existing Willow Cottage in the background.

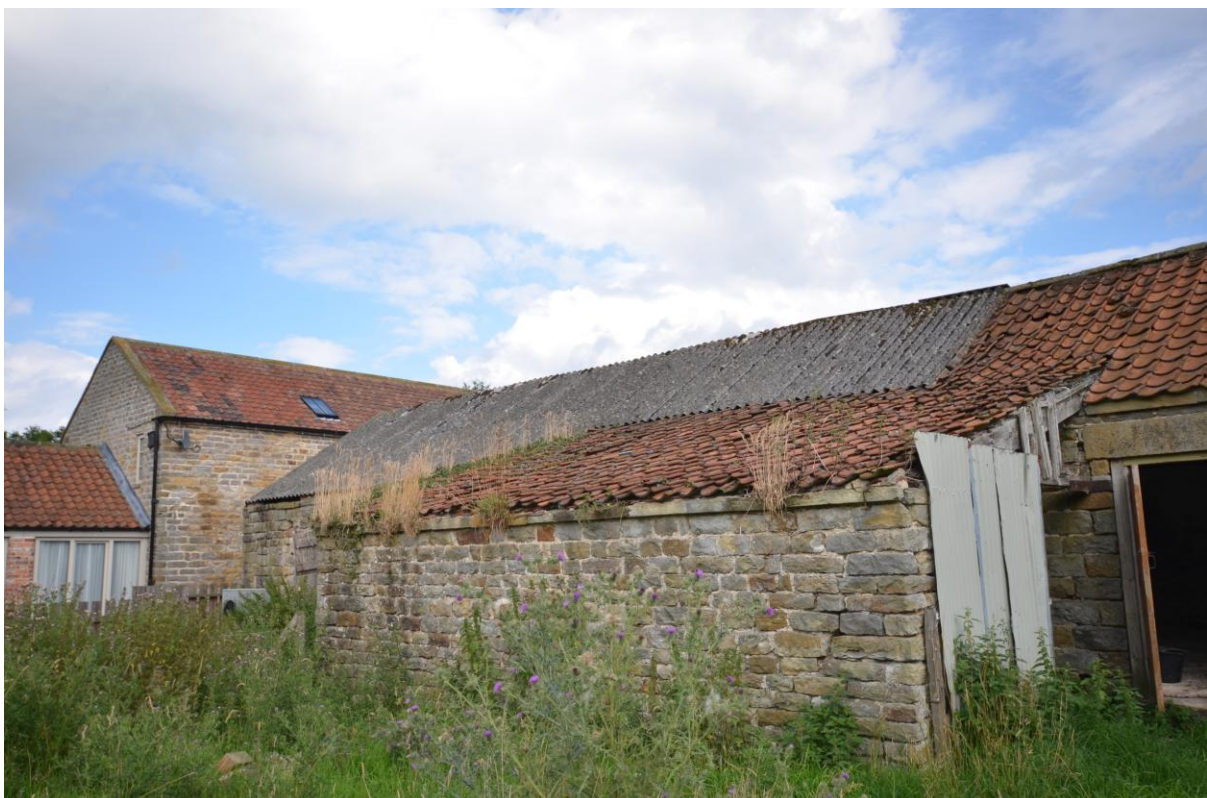
- m. Further view of the west elevation to proposed Mulberry Cottage.

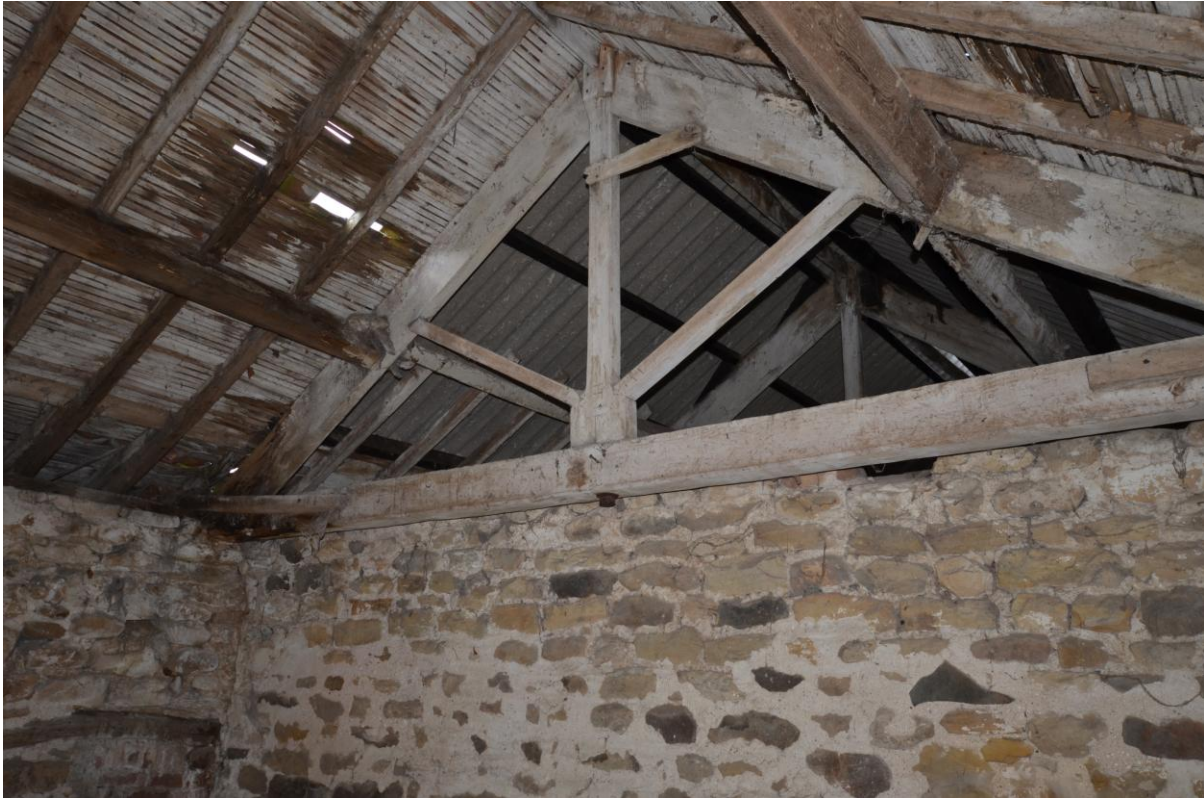
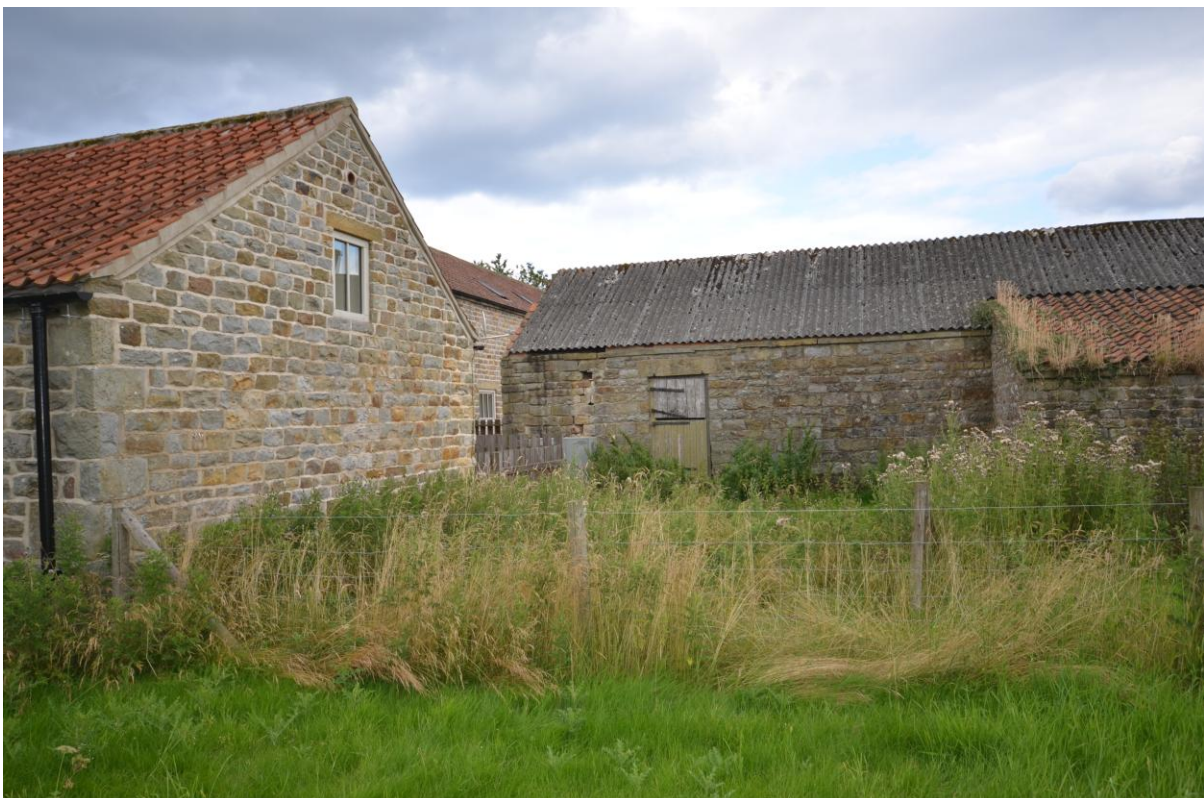
- n. Internal view of the junction between Hornbeam Cottage and Mulberry Cottage, again the structure is all generally in sound condition.
- o. Further view of the west elevation of Mulberry Cottage with the gable of Willow Cottage to the left. It is proposed that small garden areas are incorporated using dry stone walling as the recent planning approval.
