***elliottconsultancy*ltd.**
Arboricultural Consultants

Location:
**Land on Beacon Way
Sneaton**

SurveyType:
**Pre-development Arboricultural Survey
Tree Constraints Plan
Arboricultural Implications Assessment
Arboricultural Method Statement
Tree Protection Plan**

Ref:
AE/ARB/545

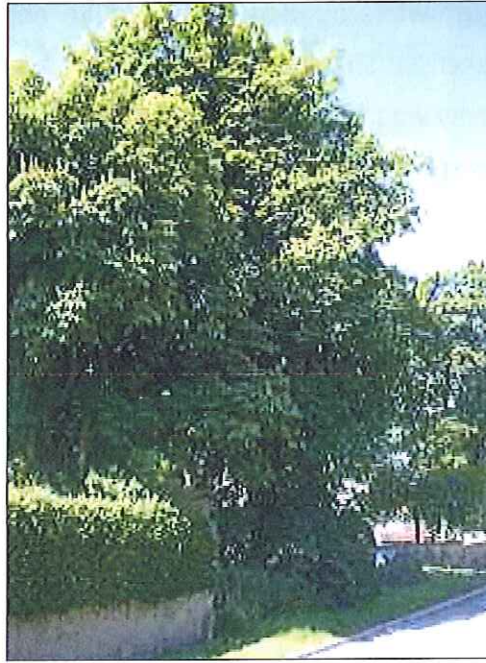
Figure 1: Tree 1543

3.2 Tree 1543:

A mature Horse Chestnut in reasonable condition and with reasonable form. The tree was classified as a **Category B** tree – a tree worthy of retention within the design where possible. If retained consideration must be given to its protection both above and below ground during the design and development process.

Condition: Ivy at base and on stem restricted full inspection. Crown appears in good condition with no discernable faults.

- 4.4 **Potential Conflict 3:** Damage to Tree 1543 during construction.
The tree may be damaged during construction due to a variety of reasons during a development process.
Countermeasure: The tree will be fenced off with immovable fencing (such as Appendix 3A) along the line shown within the Tree Protection Plan prior to any works being undertaken on site. Where scaffolding is required to be within the Root Protection Area, special protection will be required - details are shown within Appendix 3b and the Tree Protection Plan.

4.5 **Potential Conflict 4:** Location and construction of access driveway and the root protection area of Tree 1543.

Countermeasure: The ground in this area is already compacted to a degree due to past vehicle usage. However it would still be recommended that the driveway is constructed using a no-dig construction design. This will require the vegetation to be removed by hand, any undulations in the ground levelled using inert sand, onto which a cellular system is laid and then filled with appropriate aggregate, followed by a final wearing layer – which must be permeable to allow gaseous exchange and water penetration. This access must be constructed prior to any development works being undertaken on site.

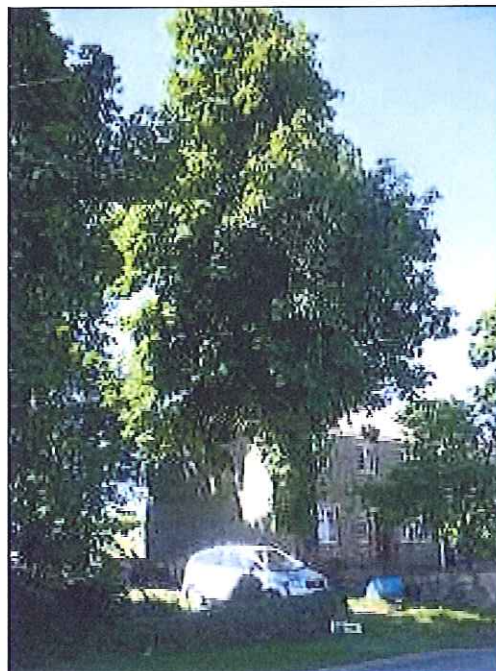
Figure 2: Tree 1544

3.3 Tree 1544:

A mature Horse Chestnut in reasonable condition and with reasonable form. The tree was classified as a **Category B** tree and would normally be retained and protected if possible within a design. Some concerns have been raised as to its already close proximity to the adjacent building.

Condition: It is suspected that the ground level around the base of the tree has at some time been raised slightly - evidenced by the lack of buttress swelling at the base – this is believed to be historic and possibly undertaken when the properties were built on either side of the site approximately 20 years ago. The stem appears in good condition, as does the crown, with only a small amount of occasional twig dieback.

- 4.3 **Potential Conflict 2:** Proximity of new building and driveway to Tree 1544.
The proposed location of the building will be in close proximity to the tree, with the access driveway also being around the trees base – it would be necessary to remove the tree.
Countermeasure: No countermeasure can be recommended.
Compensatory planting in and around the village may be considered as an option.

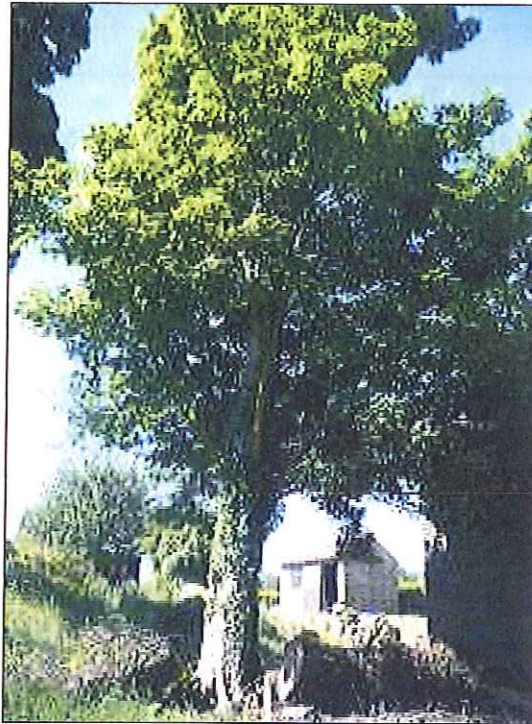
Figure 3: Tree 1545

3.4 Tree 1545:

A poor quality Sycamore with minor basal decay and poor form. The tree was classified as a **Category C** tree – trees not of such quality as to constrain design.

Condition: Around the base of the tree, especially to the west of the main stem, root severance was noted, again it is suspected that this occurred during the construction of the adjacent dwelling approximately 20+ yrs ago. At the base of the tree a cavity was inspected within two buttresses – decay was found immediately around the cavity but there was no evidence of progression off the decayed tissue into the stems base. No fungal fruiting bodies were found, and there was no evidence of root movement, mounding, or shearing present. The trees stem was in good condition, and general crown condition appeared reasonable with no discernable faults other than minor asymmetry.

- 4.2 **Potential Conflict 1:** Location of building and Trees 1545 & 1546.
The proposed location of the building will necessitate their removal.
Countermeasure: No countermeasure is recommended. As the trees are all Category C trees their removal would normally be considered as acceptable.

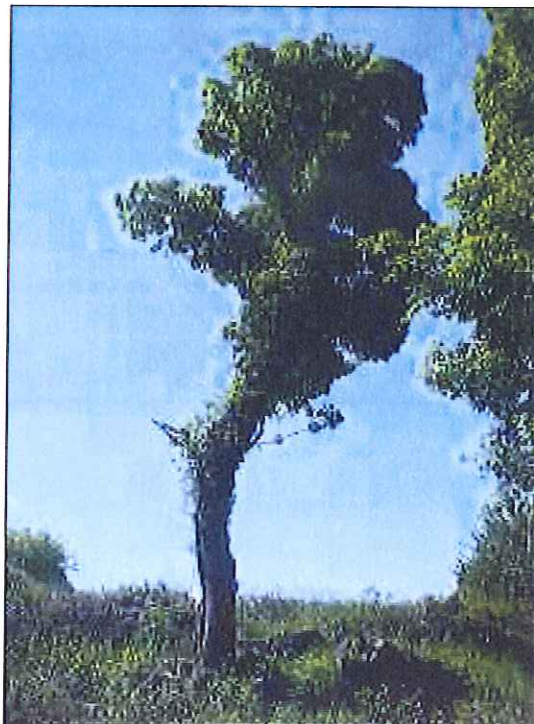
Figure 4: Tree 1546

3.5 Tree 1546:

A poor quality Sycamore with minor stem decay and particularly poor form. The tree was classified as a **Category C** tree, and should not be considered as a constraint to design.

Condition: Undergrowth around the base and Ivy on the stem visibly restricted full inspection. The stem of the tree has a small cavity at 2m, on inspection this cavity was found to be small with no significant decay noted. The trees stem and crown form is particularly asymmetrical due to past light suppression by adjacent trees, with the stem having a significant bend and the crown being particularly affected by the past proximity of adjacent trees. At several places on the stem there is evidence of poor past-husbandry with poorly pruned limbs evident – some with stubs and others with bark tears following limb removals.
