19 December 2014

Mowthorp Bridge, Everley, Hackness, near Scarborough
Listed Building Consent Application
Heritage Statement

+ Design + Access Statement

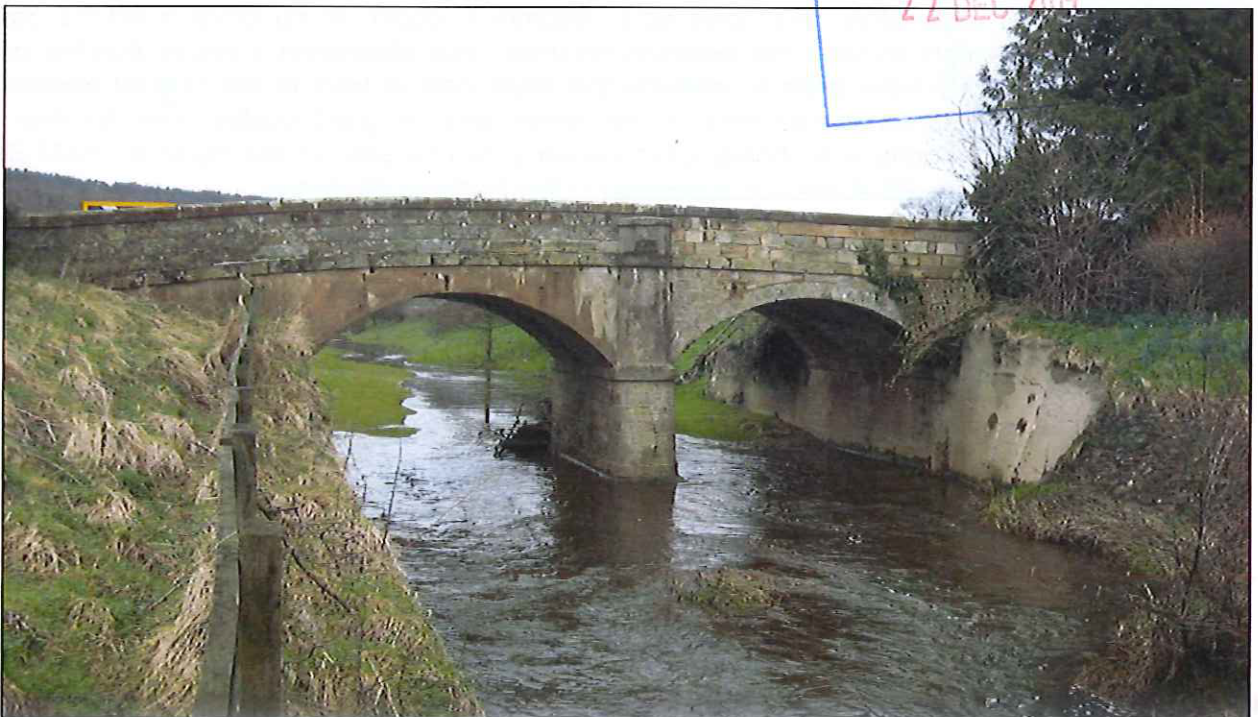
Mowthorp Bridge - Eastern Downstream Elevation

The spandrel walls are generally in poor condition with extensive cracking and some spalling to the concrete and rendered faces and evidence of corroded steel inserts resulting in rust staining, particularly in the concrete widening to the eastern downstream side of the southern arch.
