# TREE REPORT

in support of Planning Application  
to convert the existing barn known as  
Sunny Bank Barn into a dwelling

## Altered access at Sunny Bank Barn Broxa Lane Hackness

LAWSON HARPER  
Amended 18 May 2015

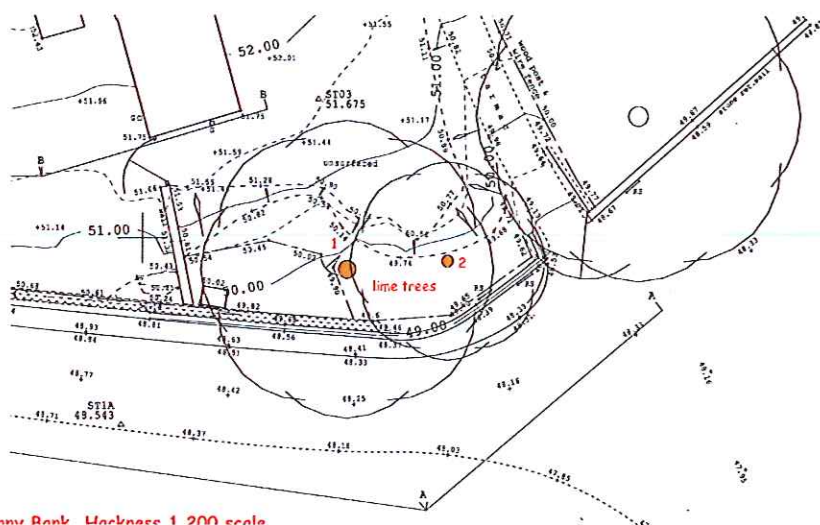
Fig 2 Tree positions and spread

**T1**

Species	<i>Tiliax europaea</i>
Common Name	Common or European Lime
Height	IRO 30 M
Approximate Age	80+ Years
Girth at 1.5 M	1.0 M
Crown Spread North	6.0 M
Crown Spread to East	6.0 M
Crown Spread to South	7.0 M
Crown Spread to West	6.0. M
Overall Condition	Good

**T2**

Species	<i>Tiliax europaea</i>
Common Name	Common or European Lime
Height	IRO 35 M
Approximate Age	80+ Years
Girth at 1.5 M	1.2 M
Crown Spread North	6.0 M
Crown Spread to East	4.0 M
Crown Spread to South	5.0 M
Crown Spread to West	2.0. M
Overall Condition	Good

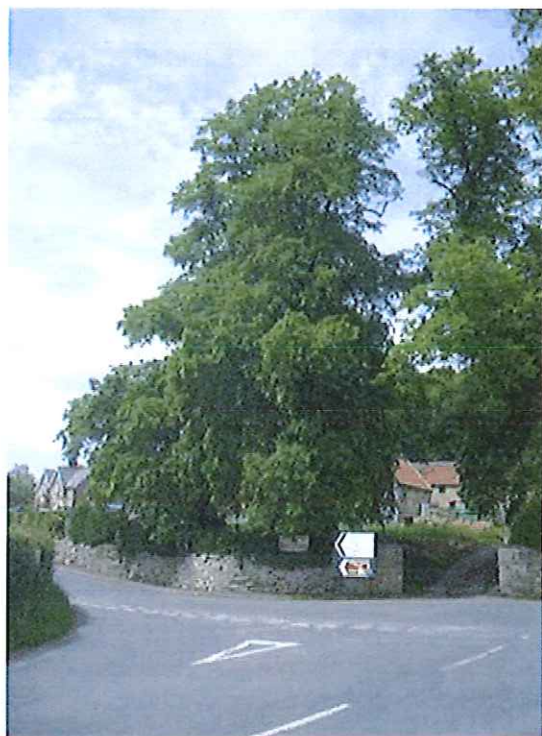
Fig 3 Tree T1 and T2

A pair of mature Limes (T1 and T2) growing approximately five meters apart and having integrated crown. In terms of visual impact the trees are considered as a group along with a third mature lime (T3) on the opposite side of the entrance within the adjacent property.

The overlapping crown of T1 and T2 has resulted in reduced spread for both trees which would be left with unbalanced and poorly shaped crown should either one be removed.

T1 appears to have grown from two leaders which have conjoined. there is a distinct joint ridge on the east and west side of the tree. The dominant lead to the north has a distinct lean to the north. The southern branch has been previously cut back due to overhanging of the highway, this has left a stub with much suckering and several pegs.

There are several short pegs left from previous pruning, most showing dieback, numerous minor healed and healing lesions from minor limb removal.

The tree in tandem with T2 has light, balanced crown but is now growing out from previous thinning, spread has been restricted by previous tree work.

The trees are located within 2 m to 3m of a retaining wall which forms a sharp change of level of some 1.3m. There is no sign of heave or root damage to this wall and the roots appear to have established to accommodate the level change.

There was slight late leafing out towards the top of the tree on the northern side but other than this no major issues observed there is moderate to light suckering at the base. Aphid residue is present as expected for the species but there are no signs of gall mite or fungal disease

Trees 1 and 2 are in good to excellent condition.

The cutting back of the retaining wall to the extent of the sight line would sever the entire southern rooting plate to within 0.75m of the bowl of both trees T1 and T2 removing both the feeding and anchorage roots of both trees over approximately 30% of the rooting area. Despite the roots to the south being restricted by the retaining wall and cutting back of the crown to prevent overhang to the highway, this is highly likely to result in stability issues particularly when the northward lean of T1 is taken into account. It would also potentially affect the long term viability of the both trees.

Localised stress and die back is likely to result with the trees drying after a number of years. Whilst this would offer an opportunity for replacement with the mature T3 remaining. The potential instability could reduce the longevity of the trees and overturning would be likely to damage any adjacent replacement. The condition of T3 suggests the tree is in decline and so can not be relied upon to retain the visual impact. It is therefore considered that realignment of the line of the retaining wall is not an option unless the trees were felled and replaced.

Minor works to T1 to remove or balance the reduced limb to the south  
reduction in the height of the wall and rebuilding to ensure retention capability and stability

Sightlines be accommodates by changes to ground profile

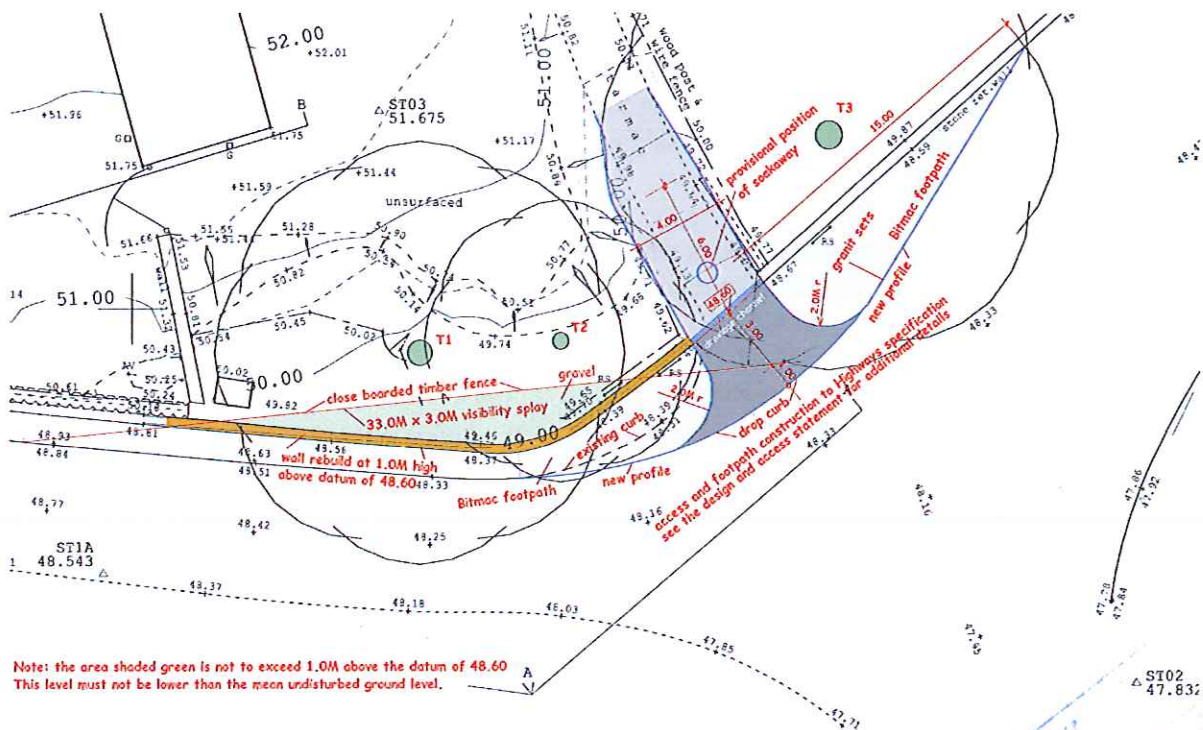
Fig 4: Extent of the proposed works

Cutting back of the retaining wall to to ground level to accommodate the sightline would result in the loss of the trees and is considered unacceptable.

However, the sightline can be accommodated by careful hand grading of the ground profile to **reduce the level of deposited** stones to accommodate a sightline at 1.0m above datum.

**The works can be successfully accommodated without detrimental effect to the trees surveyed by reducing the height of the wall and the ground level in a small section of the land to the south of the trees, as indicated in Fig 4 - The extent of the proposed works**

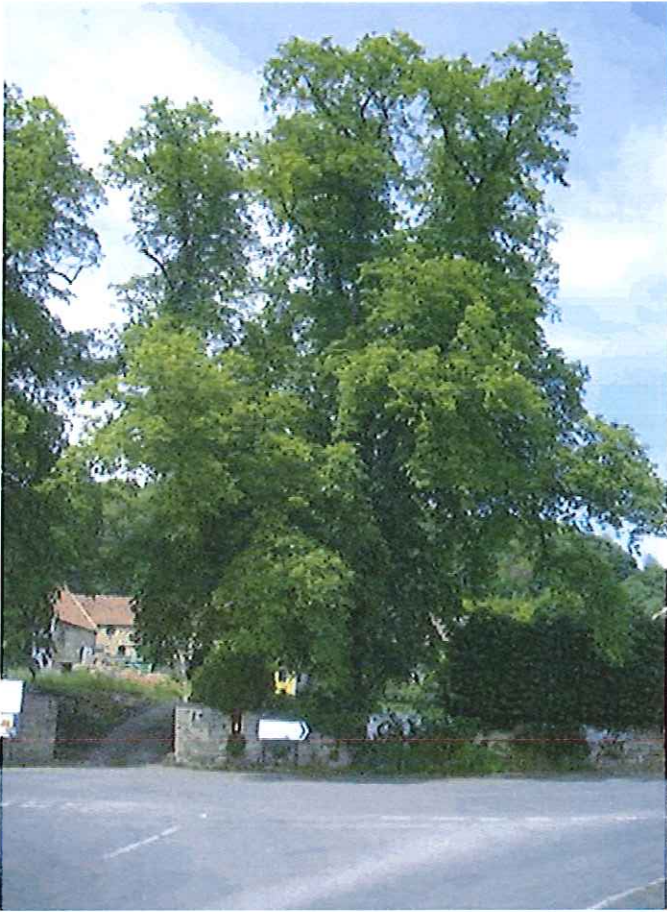
*Fig 5: T3*

<b>Species</b>	<i>Tilia x europaea</i>
<b>Common Name</b>	Common or European Lime
<b>Height</b>	IRO 40 M
<b>Approximate Age</b>	100+ Years
<b>Girth at 1.5 M</b>	1.5 M
<b>Crown Spread North</b>	6.0 M
<b>Crown Spread to East</b>	5.0 M
<b>Crown Spread to South</b>	8.0 M
<b>Crown Spread to West</b>	7.0. M
<b>Overall Condition</b>	Fair

The tree is the largest of the group and appears to have been established prior to those at Sunny Bank. It is not affected by the development and is not subject to the emergency TPO

Th tree has an unbalanced crown with a large limb extending almost right-angled to the south, and three distinct leaders.

The tree showed signs of late leafing and early leaf drop. There was also minor crown dieback on all three stems The tree is showing signs of stress but as no obvious cause can be found and the stress response is general and uniform it is likely to be from age or water table or climatic issues rather than mechanical root damage. The lack of corresponding stress in the trees at Sunny Bank make environmental factors unlikely. The tree is currently in fair condition but this condition can be expected to deteriorate in the near the medium future.

Its condition rules out any proposal that the loss of the trees at Sunny Bank would be mitigated by the retention of this tree.
