Bat, Breeding Bird and Barn Owl Scoping Survey

Woodleigh House, Aislaby

September 2015

**STRUCTURAL APPRAISAL
OF
REDUNDANT OUTBUILDING
AT
WOODLEIGH HOUSE, AISLABY, WHITBY
NORTH YORKSHIRE
FOR
MS I FRANKLIN**

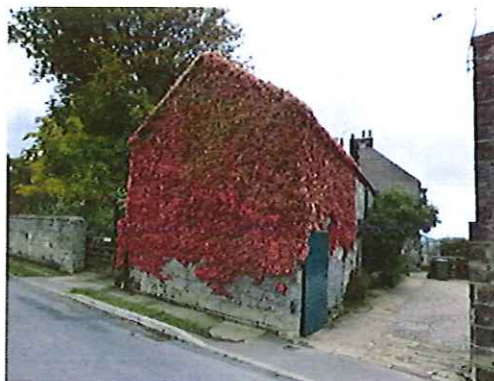
Photo 2: Northern gable end is covered in ivy making it difficult to identify crevices

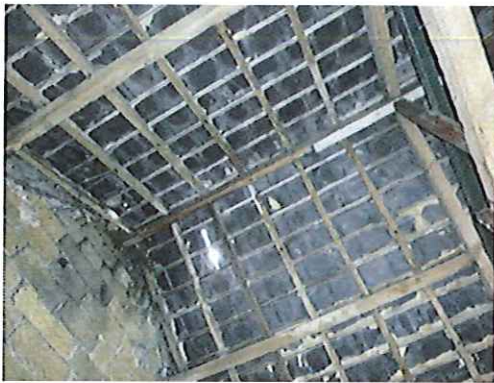
Photo 3: Internal ridge of garage is clear in places but not polished

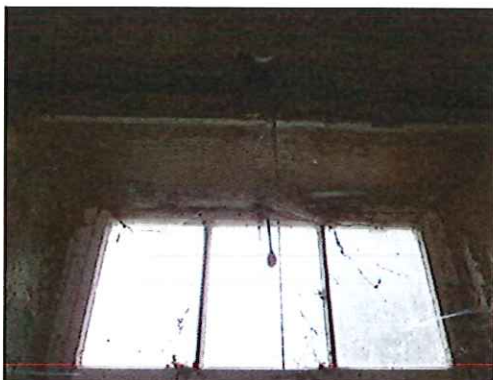
Photo 5: Cobwebby windows

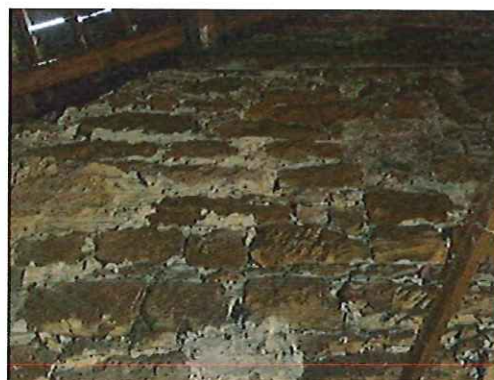
Photo 6: Internal crevices in garage

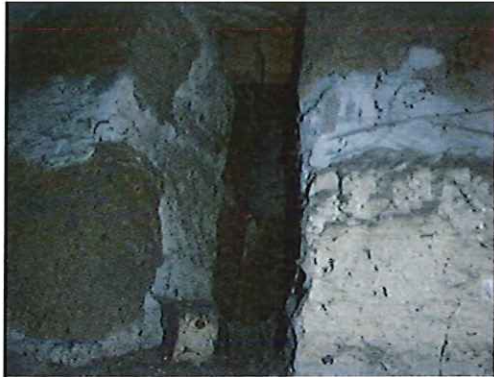
Photo 7: Large internal crevice

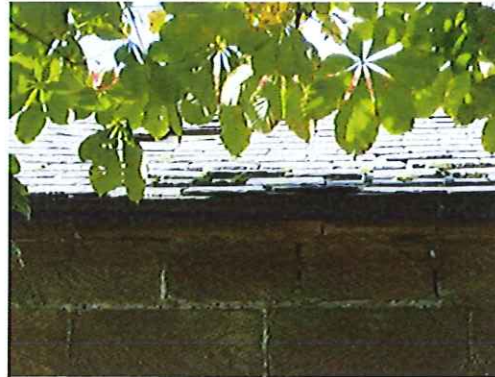
Photo 8: Slipped tiles east side of roof

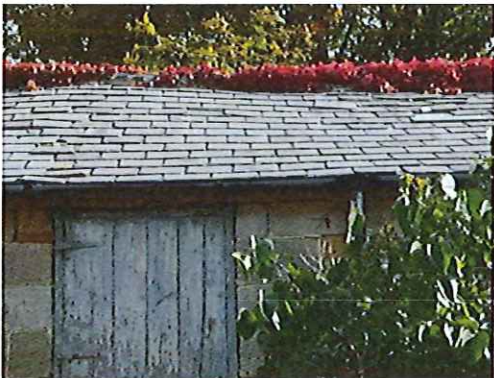
Photo 9: Slipped tiles west side of roof

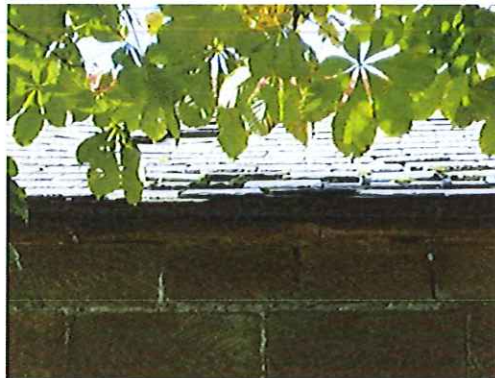
Photo 10: Eaves are obscured by guttering. Shallow masonry crevices in east wall

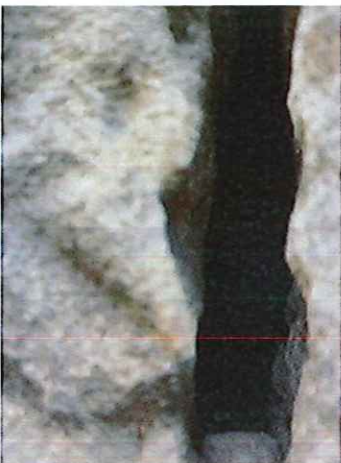
Photo 11: Cobwebs and mouse droppings found within large crevice in west wall

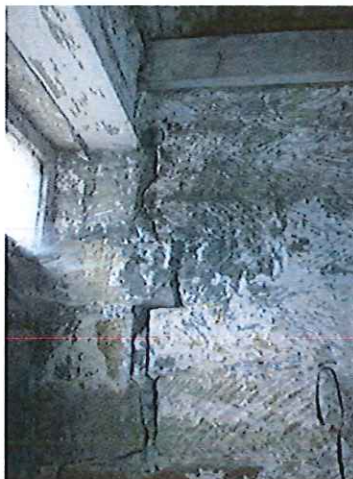
Photo 12: Large internal crevice
